ESTEEM

Volume 5, Number 1

Experience in Stabilisation of Rock Slopes in Pahang

Two cases regarding the histories of rock slopes repair and stabilisation of unstable boulder along Bukit Cincin to Genting Highlands and along the road from Gap to Fraser Hill in Pahang are presented. On 30th October 1997, 10 locations of road failure occurred along the road from Bukit Cincin to Genting Highland and in December 1997, 33 locations of slope failures occurred along the road from Gap to Fraser Hill during the monsoon seasons. Loose and fractured rocks were removed and covered with polyvinyl chloride (PVC) coated anchored wire netting to prevent rocks fall while rock buttress was used to stabilise unstable boulders in soil slope. The repair works at Location 5 along the road from Bukit Cincin to Genting Highland where highly fractured rock slope and unstable boulder in soil slope occurred and the repair works at Location 10 along the road from Gap to Fraser Hill where highly fractured rock slope occurred are fully discussed in this paper.

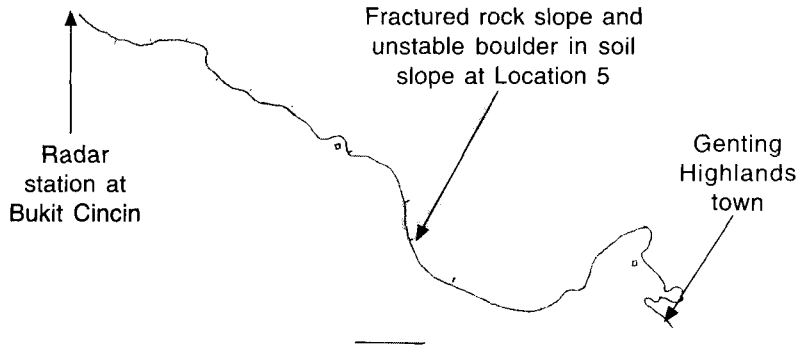
Figure 2: Fractured Rock Slope and Unstable Boulder in Soil Slope at Location 5 along Genting Highlands Town to Bukit Cincin Road

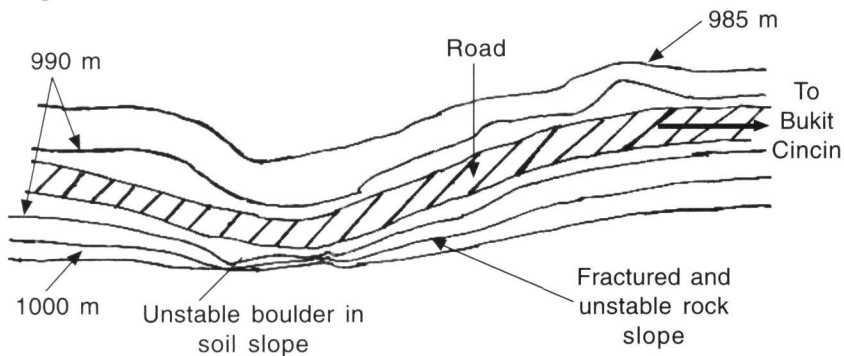
At Location 5, some rock outcrops were observed on the cut slope. Loose and fractured rocks were observed at the rock slope and unstable boulder, which protruded out from the cut soil slope, presented danger to the road users. The exposed rock slope was essentially of grade I to II granite rocks. Figure 4 shows the plan locations of the fractured rock slope and the unstable boulder.

Figure 4: Unstable Boulder and Fractured Rock Slope at Location 5

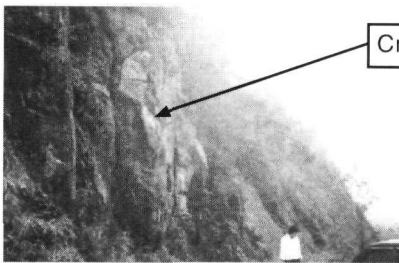
Figures 5 and 6 show the fractured rock slope at Location 5. Instability in the fractured rock was due to the inherent cracks or joints and became worst due to weathering process that caused loosening of rock materials (Ahmad, Mohamed, Mahamood, 2000a). Cracks can be seen on the vertical rock surface.

Figure 5: Fractured Rock Slope at Location 5

Loose and fractured rocks were removed before the rock surface was covered with rock netting. Figure 12 shows the typical cross section of the repaired rock slope surface where rock was covered with wire netting and fixed to the rock surface using rock bolts. The rock netting consisted of double twisted hexagonal PVC coated wire mesh, which was a product of Maccferri Sdn. Bhd. Rock bolts of size 35 mm diameter and 500 mm long were used to fix the rock netting to the rock surface with the help of anchor wires. The anchor wires and rock bolts fixed the rock netting firmly on to the rock surface. A hole of 50 mm in diameter was drilled in the rock mass. Rock bolt was then placed in the hole and later grouted. The rock bolts were placed at a grid of 0.5 m spacing as designed by Bumi Hiway (1998). Figure 13 shows the typical cross section of the rock bolts fixed into the rock mass. Figures 14 and 15 show the repaired rock slope covered with rock netting after all the loose and fractured rocks were removed. Figure 16 shows the rock bolt with the help of anchor wire fixing the rock netting firmly onto the rock slope surface.

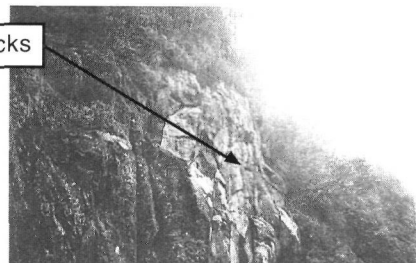
Figure 6: Closed Up View of the Rock Surface. Cracks can be Seen on the Vertical Rock Surface

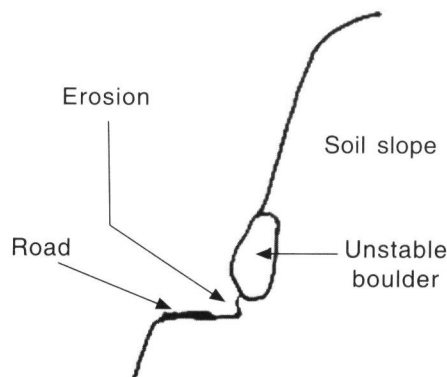
Figure 7 shows the unstable boulder in the soil slope. Instability of the boulder was due to surface erosion of the fine materials surrounding the boulder when the rainwater flow down the slope surface (Ahmad, 2000b).

Figure 7: Cross Section of the Soil Slope with Unstable Boulder

Loose soil surrounding the unstable boulder was removed. Stone pitching rock buttress was then constructed under the boulder as described by Bumi Hiway (1998). Figure 17 shows the detail of the repair works to stabilize the unstable boulder.

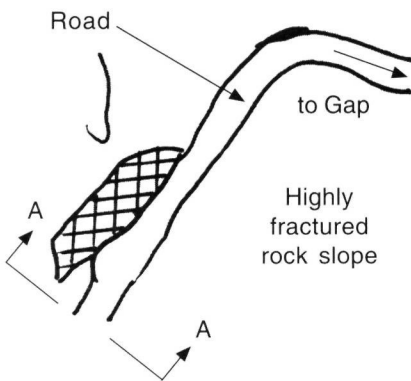
was characterised with discontinuities. The engineering geology of the area consisted mostly of granitic formation with weathering grades ranging from Grade II (slightly weathered rock). The highly fractured rock was either due to extreme folding of rock bedding or due to shearing of rock mass near fault zone as described by Ahmad et al. (2000a) and Jamaluddin (2007). Since the rock slope was highly fractured, it was unstable and rocks fall could occur at any time. Figure 8 shows the location of the highly fractured rock slope while Figure 9 shows the cross section of the highly fractured rock slope at Location 10. Figures 10 and 11 show the highly fractured rock slop.

Figure 8: Plan of the Highly Fractured Rock Slope at Location 10

All loose and fractured rocks were removed and the firm rock surface was covered with wire netting. The netting was fixed to the rock surface using 1 m long rock bolt at 2 m vertical and horizontal spacing as described by Terratech Consultant (1998). Figure 18 shows the cross section of the repaired rock slope while Figure 19 shows the completed repair works at Location 10.

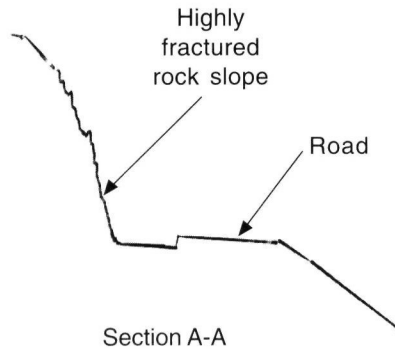
The angle of the rock slope was about 60 degrees with slope height of 15 m. The rock, highly fractured granite, was slightly weathered and

Figure 9: Cross Section of the Highly Fractured Rock Slope at Location 10

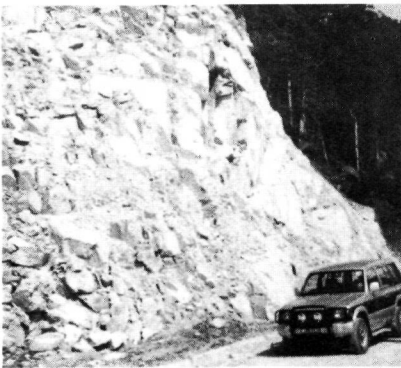
Figure 10: Close Up View of the Highly Fractured Rock Slope at Location 10

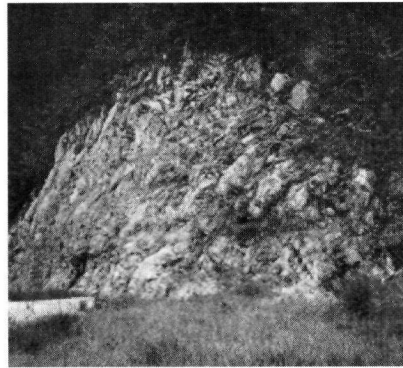
Figure 11: Another View of the Highly Fractured Rock Slope at Location 10

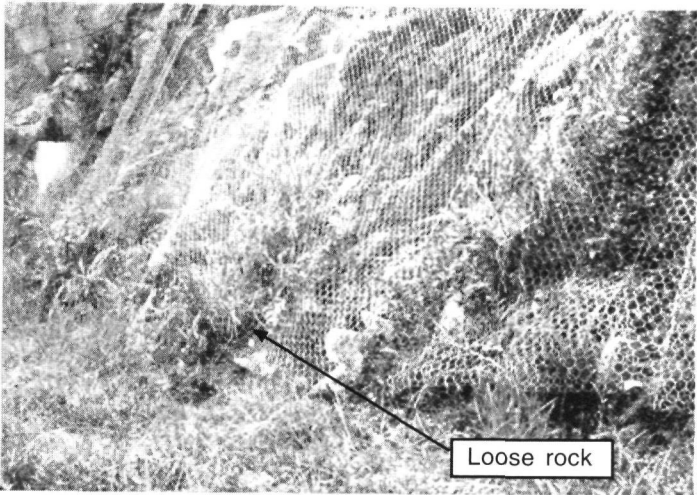
Figures 20 and 21 show how effective the usage of rock wire netting in preventing loose rocks from falling onto the road. The falling is controlled and loose rocks are trapped behind the netting.

Figure 20: Loose Rocks are Trapped behind the Wire Netting

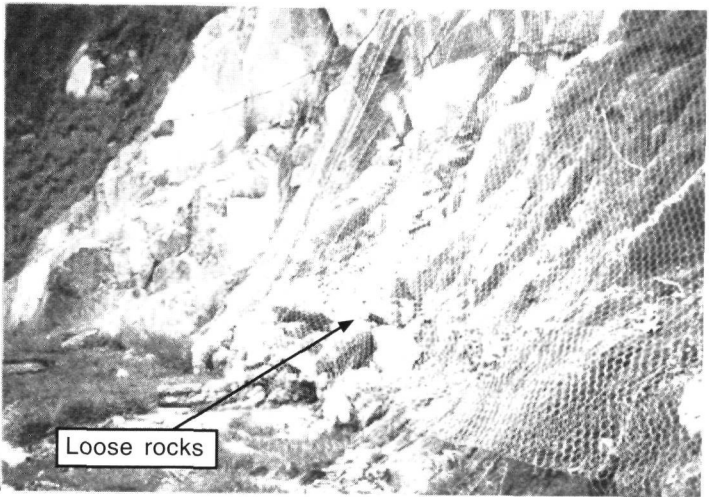
Figure 21: Another View where Loose Rocks are Trapped behind the Wire Netting
