**MANAGEMENT AND SUPERVISING OF MECHANICAL AND
ELECTRICAL WORK AT PHASE 2 THE HAVRE BUKIT JALIL**

**Prepared by:
AZAD BUKHARI BIN AZIZ
2016458536**

**DEPARTMENT OF BUILDING
FACULTY OF ARCHITECTURE, PLANNING AND SURVEYING
UNIVERSITI TEKNOLOGI MARA
(PERAK)
DECEMBER 2018**

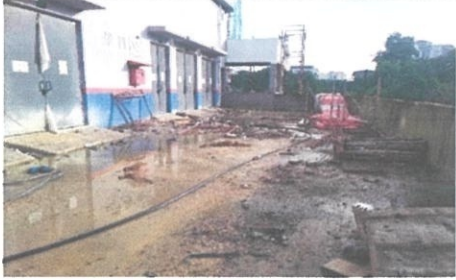
<p>Figure 3.35 condition before</p>

<p>Figure 3.34 transfer water tank</p>
<p>6</p>	<p>Housekeeping for inspection</p> <ul style="list-style-type: none"> • For TNB and lift inspection • Provide clean and dry area for incoming officer • To give well expectation before the inspection

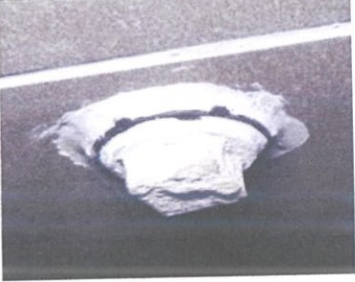
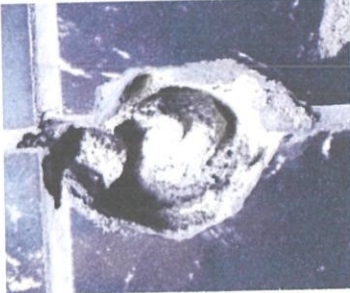
NO	PROBLEMS & SOLUTION	DIAGRAM	PARTY INVOLVE
1	<p>Piping work</p> <ol style="list-style-type: none"> 1) Ask permission from architect department to repair the point if the tile broke with proper information 2) Inform to sub-contractor to repair the point in given date 3) After finish, inform to architect department to repair the finish. <ol style="list-style-type: none"> 1) When the skirting disturb the pipe area, ask the tiler to cut and customize the size 2) Then ask the plumber to install the pipe

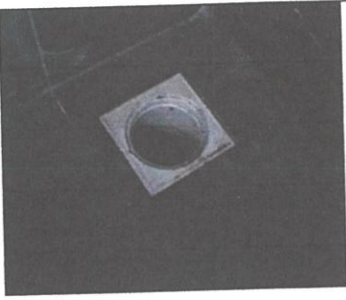
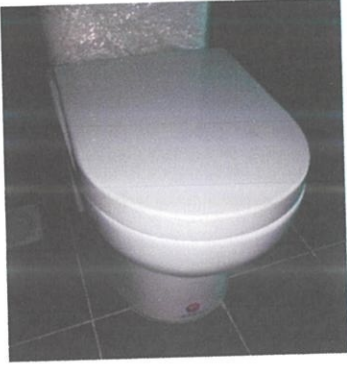
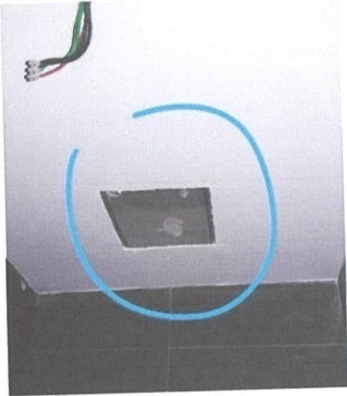
<p>2</p>	<p>Sanitary appliances</p> <ol style="list-style-type: none"> 1) The floor trap must be closed anytime 2) Ask the tiler to give closer to floor trap <ol style="list-style-type: none"> 1) The sanitary ware must have the protection 2) Ask the related sub-contractor to give protection to the material with proper place information <ol style="list-style-type: none"> 1) The opening for exhaust fan must be accurate with the dimension 275mm x 275mm 2) The steel for hang the fan must be on it 3) When the dimension is false and no have the steel 4) Ask the architect staff and sub-contractor from their party to install and repair it. 5) Once done, tell the s to install it.

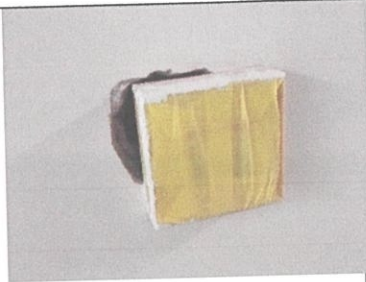
<p>3</p> <p>Electrical work</p> <ol style="list-style-type: none"> 1) The area around the switches break, cause of plaster or installer 2) Inform to architect staff to sent the worker to repair the broken wall without touch the swithes <ol style="list-style-type: none"> 1) The back box and conduit break cause of wall hacked. 2) Architect staff will inform the broken material 3) Check and inform to the sub-contractor related <ol style="list-style-type: none"> 1) The sub-con supervisor will mark the mistake at wall 2) Find the mark and inform to architect staff to break the tiles and make a new proper holes

<p>Figure 3.46 wall break</p>

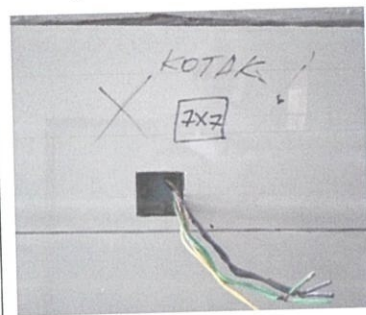
<p>Figure 3.47 mistake cutting position</p>	<ul style="list-style-type: none"> • Mechanical and electrical department • Architect department • 1 sub-cons worker • 1 plasterer • 1 tiler
<p>4</p> <p>Operation procedure</p> <ol style="list-style-type: none"> 1) The render work will start first before anyone take place 2) Once render finish, either pipe or paint can start work 3) Inform to plumber to break the pipe and give way to renderer run their work 4) Once finish a day, the pipe may install

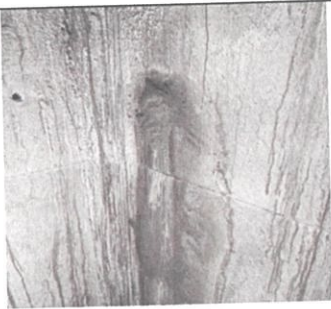
<p>5</p> <p>Water leaking in lift shaft</p> <ol style="list-style-type: none"> 1) The water come from planter box outside the wall 2) It has 4 place that leaking happened 3) Ask for PU Inject team from director 4) Bring them to that place 5) Once finish, clean the overhead 6) Then apply one layer of mortar

<p>Figure 3.51 leaking wall</p>
