**RESTORATION OF ROOF AND CEILING**

**Prepared by:  
MUHAMMAD FAIZ AHDA BIN KHAIROL  
2016458334**

**DEPARTMENT OF BUILDING**  
**FACULTY OF ARCHITECTURE, PLANNING AND SURVEYING**  
**UNIVERSITI TEKNOLOGI MARA**  
**(PERAK)**

**DECEMBER 2018**

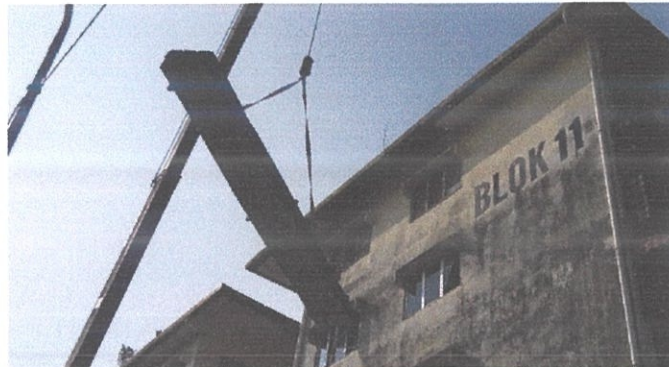
The restoration process starts by lifting all the materials to the roof level by using mobile crane. The surrounding area around the crane needs to be cleared to prevent any unwanted accidents. The material has been tied carefully and neatly to ensure that the material will not fall down.

Figure 3.2: Lifting Materials

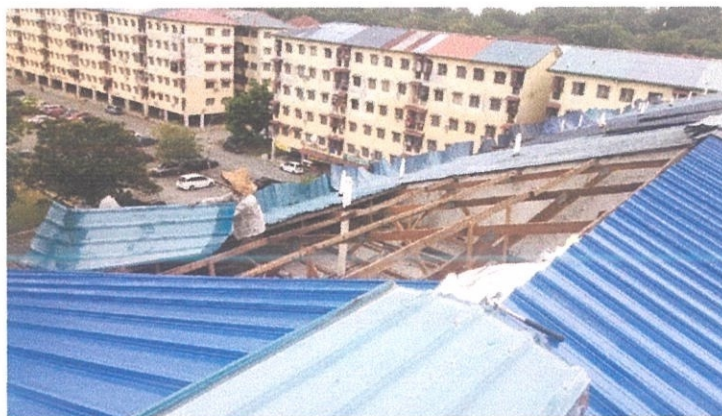
After that, the existing roof structure such as covering will be dismantles and put aside. However, for the roof trusses, only the one which has malfunctioned will be removed.

Figure 3.3: Dismantle of existing roof structure

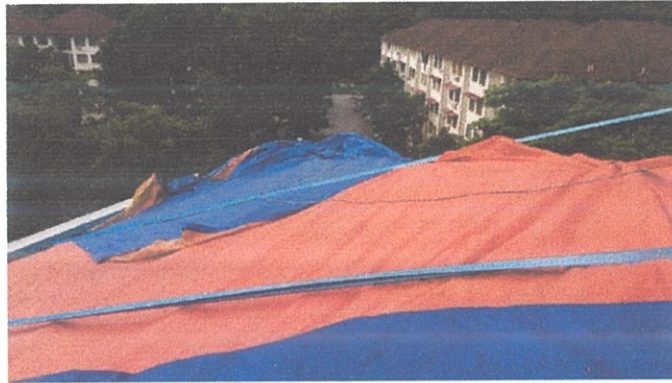
The exposed area will be covered if when raining to ensure prevent the water from entering the inner side of the building.

Figure 3.4: Temporary covering for roof structure

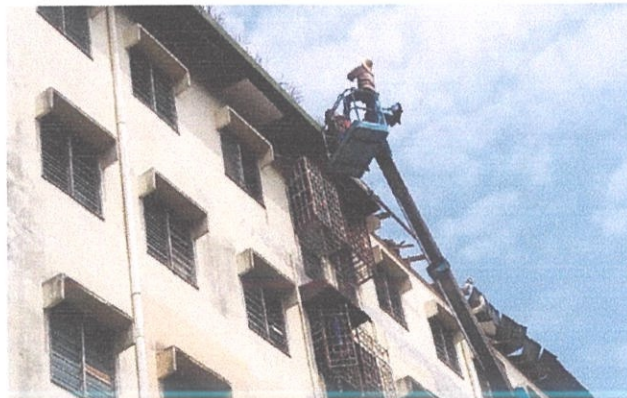
After dismantling roof structure, the workers will dismantle the gutter and rain water down pipe by using sky lift.

Figure 3.5: Dismantle gutter

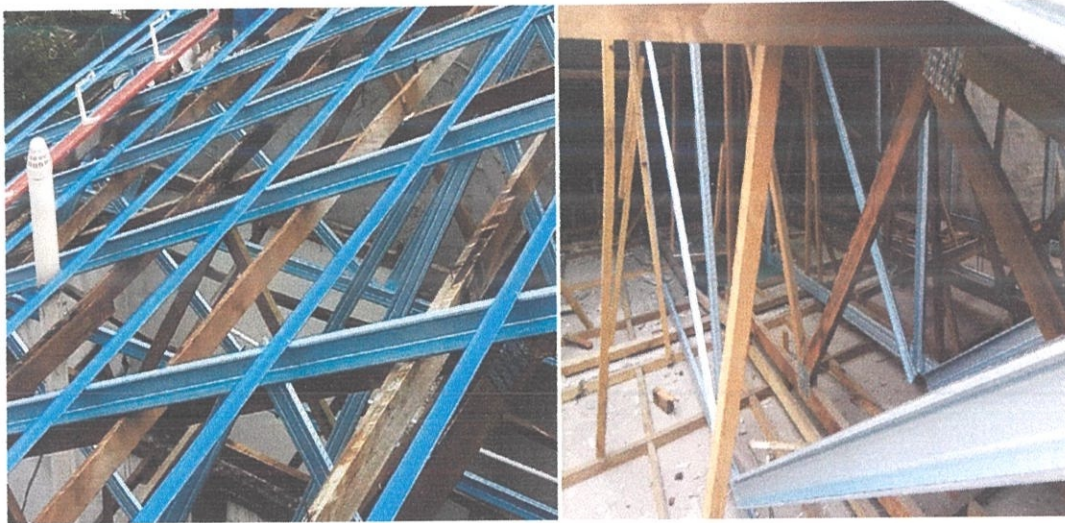
Next, the installation of new trusses will begins. This project use lightweight steel trusses which proved to be last longer than the existing trusses which is from wood. The new trusses were installed besides the existing trusses.

Figure 3.6: Installation of new trusses system

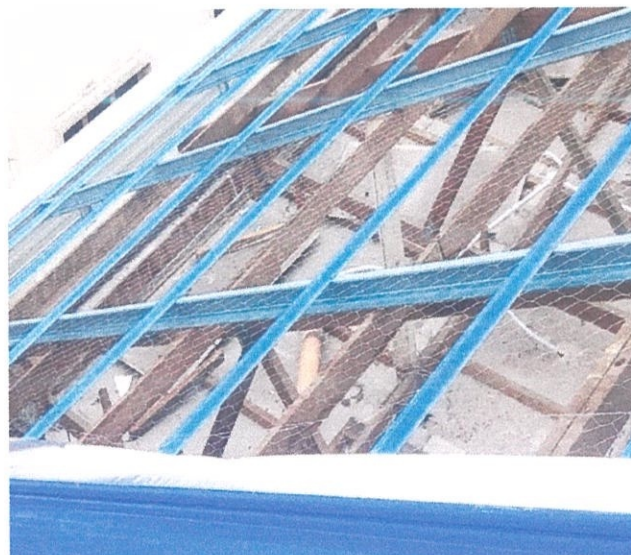
The next process involved the installation of wire netting which is also known as chicken netting on top of the new trusses. The netting acts as the support for roofing underlay and insulation. On the other hand, chicken netting can also been used to provide safety nets during renovation process.

Figure 3.7: Installation of wire netting

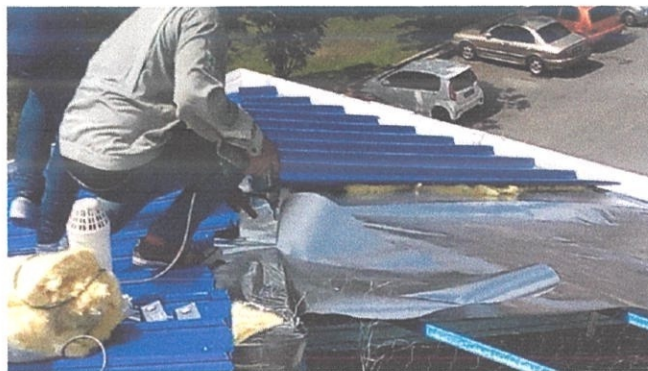
After that, the workers laid double-sided aluminium foil on top of the wire netting. The aluminium foil acted the insulation for the roof. It is widely uses for metal deck roof system due to its ability to withstand and reflect unnecessary heating from outer environment. The aluminium foil also known to be light in weight and easy to conduct. Aluminium foil was installed by drilling it to the new trusses.

Figure 3.8: Installation of Aluminium Foil

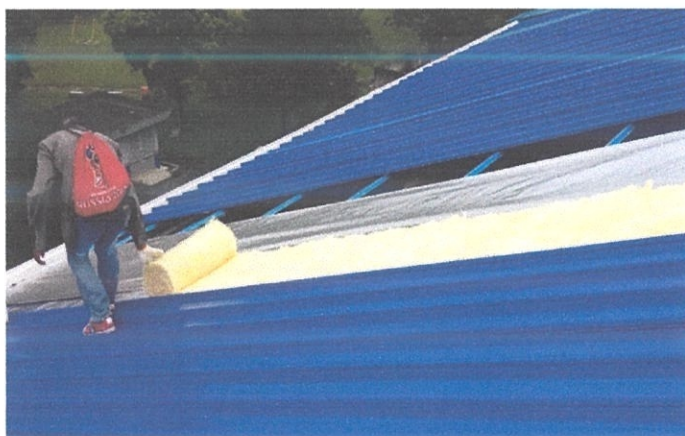
The next process is installation of fiber glass wool. Fiber glass wool is usually use with metal deck roofing system. This is because metal deck roof tend to produce loud noise during raining weather. Therefore, fiber glass wool is introduced to reduce unnecessary noise which can cause nuisance to the residents.

Figure 3.9: Installation of Fiber Glass Wool

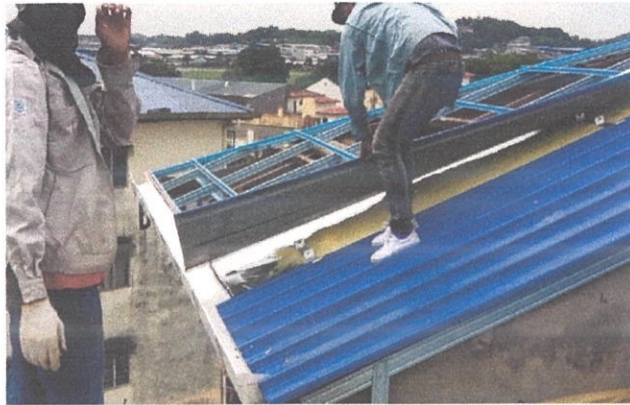
After that, the metal deck covering is installed. The covering will be place on top of the fiber glass wool. Once all the covering is installed, ridge capping will be placed.

Figure 3.10: Installation of Metal covering

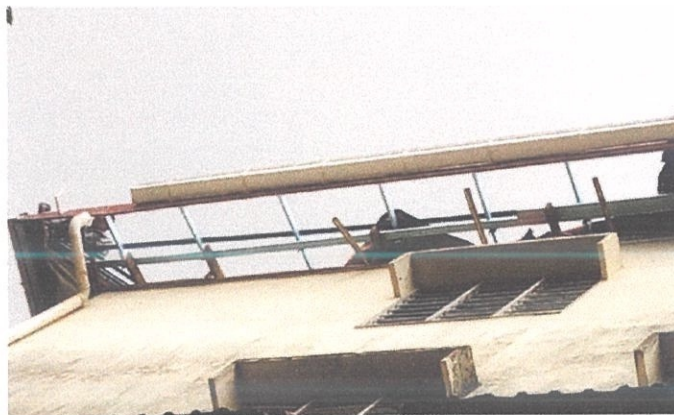
The gutter system for the roof is installed just before the installation of roof covering. It is functional to flow rain water to the rain water down pipe system. Bear in mind that gutter cannot be installed after roof covering or otherwise its function cannot be fully used.

Figure 3.11: Installation of gutter

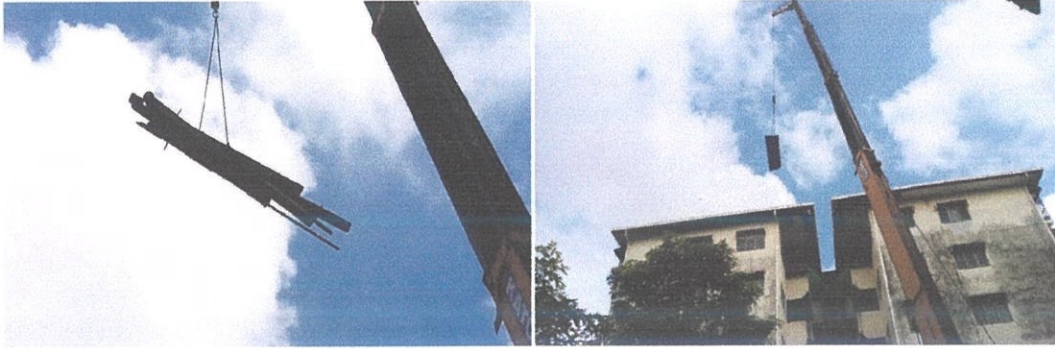
Last but not least, after the renovation process is finished, the waste is taking down by using mobile crane. While this process undergo, residents not allowed to roaming around the working area to prevent any unwanted accidents.

Figure 3.12: Clearing process

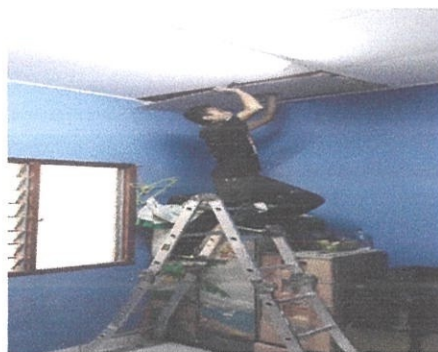
Firstly, the contractor will studied the drawing to identify the amount of ceiling needed in each house to avoid excessive waste. Bear in mind that only the damaged ceiling will be replaced while other are only be applied new finishes. Then, the progress at site starts by dismantling of existing ceiling structures including ceiling trusses. For the ceiling which located on the outside, Sky lift and staging will be used for dismantle process.

Figure 3.13: Dismantle existing ceiling structure.

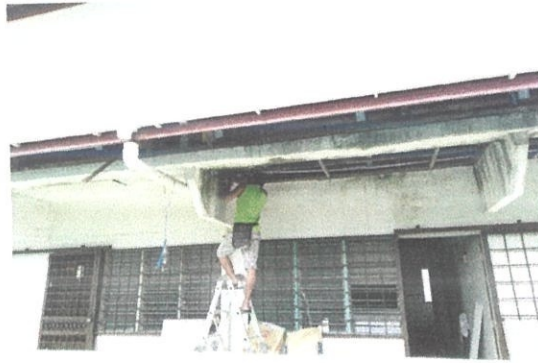
Third process is installation of new ceiling structure or trusses. This is important to ensure that it can cover the load of the ceiling and thus prevent it from collapse. For the outside area of ceiling, a sky lift is used.

Figure 3.14: Installation of ceiling structure

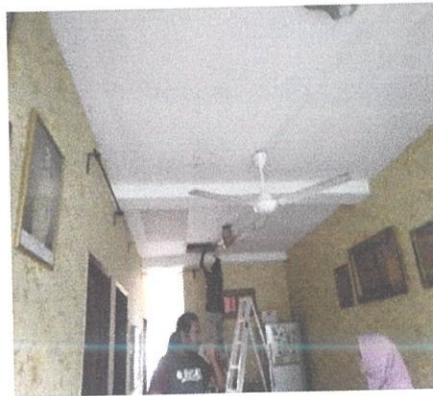
Then, the new ceiling will be installed by using specific nails for the ceiling. As usual, for the outside ceiling works, a sky lift will be used.

Figure 3.15: Installation of ceiling

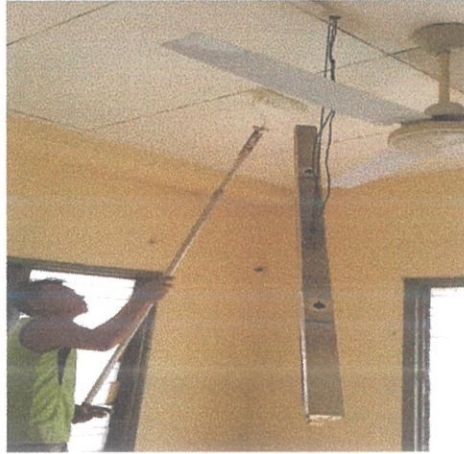
Last but not least, the new ceiling that be installed alongside with old ceiling that still can be used, will be applied new finishes, the finishes used is white Maxilite paint. As before, sky lift will be used for ceiling works outside the building.

Figure 3.16: Apply ceiling finishes

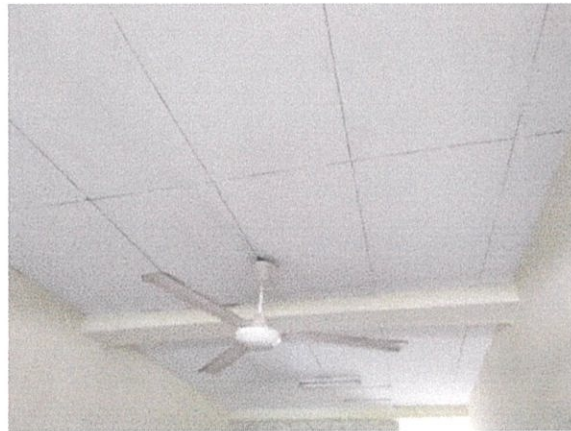
The same process will be repeated for ceiling works in all house units at 5<sup>th</sup> floor.

Figure 3.17: completed ceiling works
