## DEFECTS AND DILAPIDATION OF BRITISH COLONIAL BUILDINGS IN NEGERI SEMBILAN, MALAYSIA

### **Case Study 1: District Office and Survey Department Building**

## Case Study 2: Seremban Railway Station

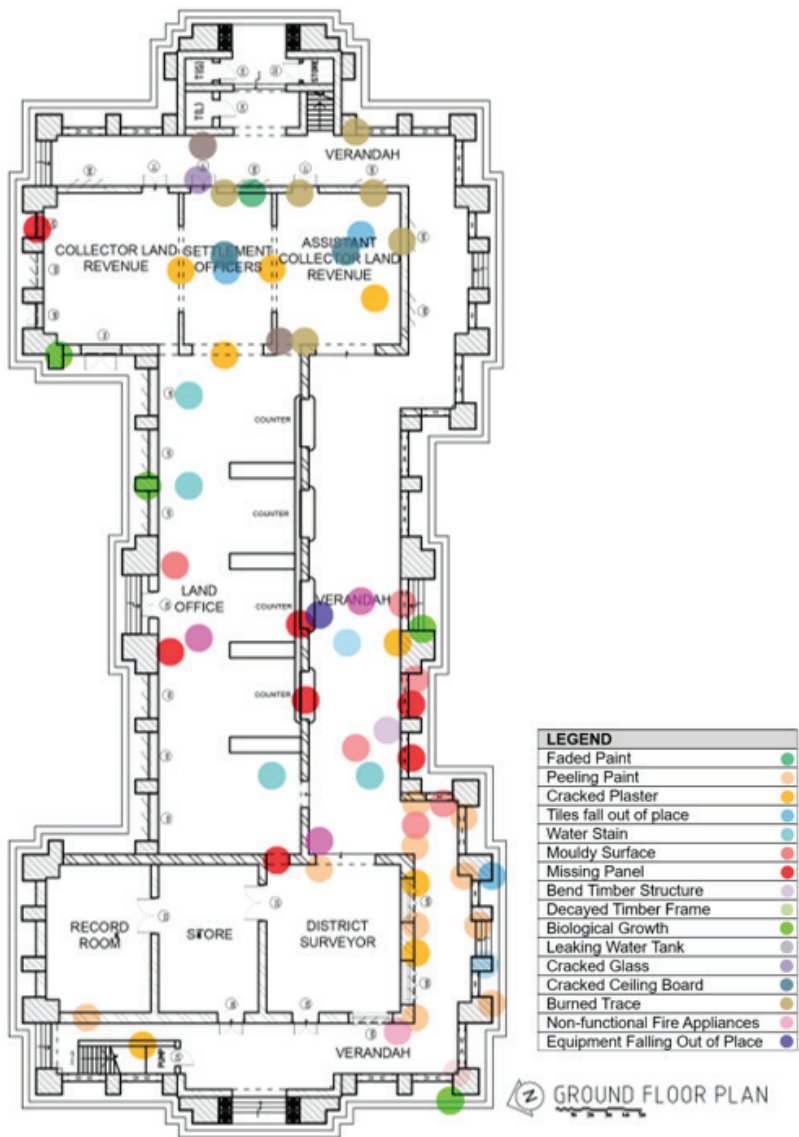
**Figure 8. Common Defects in the Ground-floor Area of Case Study 1**  
Source: Author, 2025

Case Study 1 displays a variety of defects primarily resulting from neglect and environmental conditions. The roof is notably affected by missing or broken tiles, timber structural decay, and mouldy surfaces. The exterior walls experience issues such as dampness, crumbled plaster, peeling paint, and mould. Interior walls show dampness, cracks, peeling paint, mould, burned traces, and holed partitions. Additional problems include decayed timber frames, missing panels, and broken glass in doors, as well as peeling paint on windows. Columns and beams are compromised by dampness, crumbled plaster, peeling paint, and mould, while the floor has missing or broken tiles, water stains, damp surfaces, and decayed timber. The stairs exhibit cracks, moss, damaged handrails, and mouldy surfaces, and the apron suffers from cracks and moss. Services are affected by damaged rainwater downpipe covers and dysfunctional electrical appliances and wiring systems.

The causes of defects in Case Study 1 are multifaceted. High humidity and exposure to rain significantly contribute to issues such as mould growth, damp walls, and peeling paint. Vandalism has exacerbated the deterioration through timber structural decay and burned traces on interior walls. Additionally, neglect and inadequate maintenance have critically impacted the integrity of timber frames, plaster, and services. Problems with floors and stairs are further compounded by improper installation and ongoing exposure to environmental elements.

To address these defects, several measures were recommended. Regular inspections and maintenance are essential for early detection and remediation of issues. Implementing damp-proof courses and sealing roofs and windows can effectively manage moisture ingress. Utilisation of high-quality materials, such as treated timber for structural elements and durable tiles for roofing and flooring, is advised. Maintaining proper drainage systems is crucial to prevent water accumulation. Anti-mould treatments and enhanced security measures to deter vandalism are also important. Specific repairs should include replacing missing tiles, fixing leaks, and repairing or replacing damaged structural components.

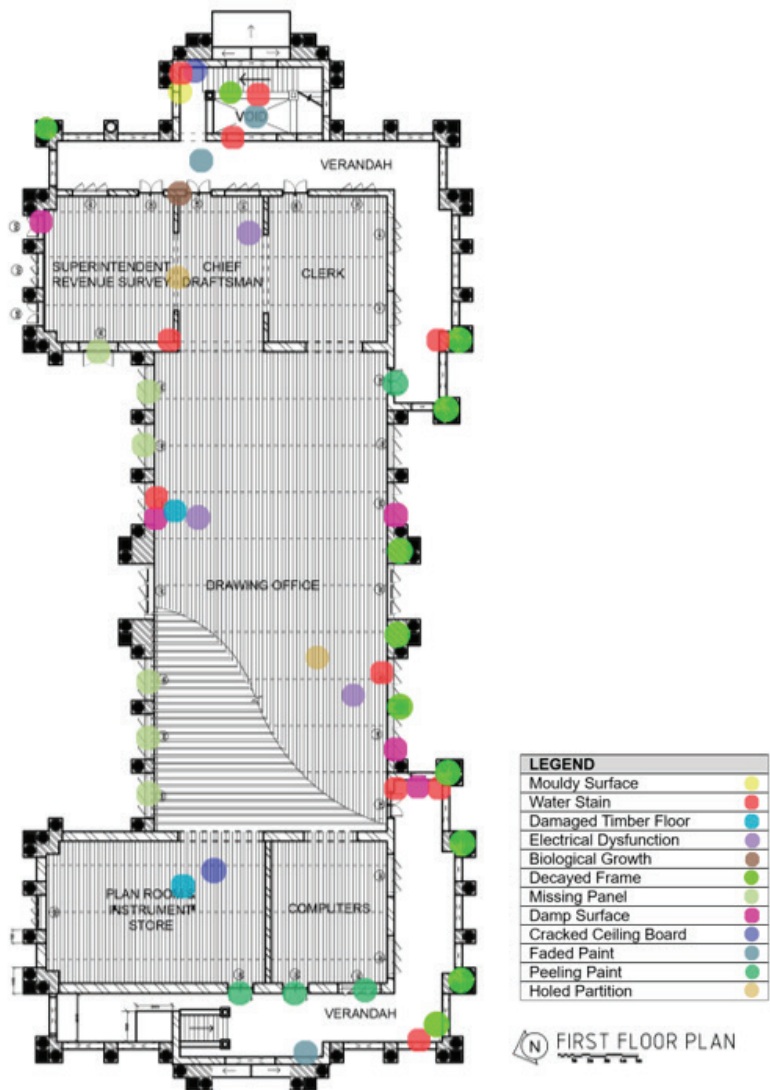
**Figure 9. Common Defects in the First-floor Area of Case Study 1**  
Source: Author, 2025

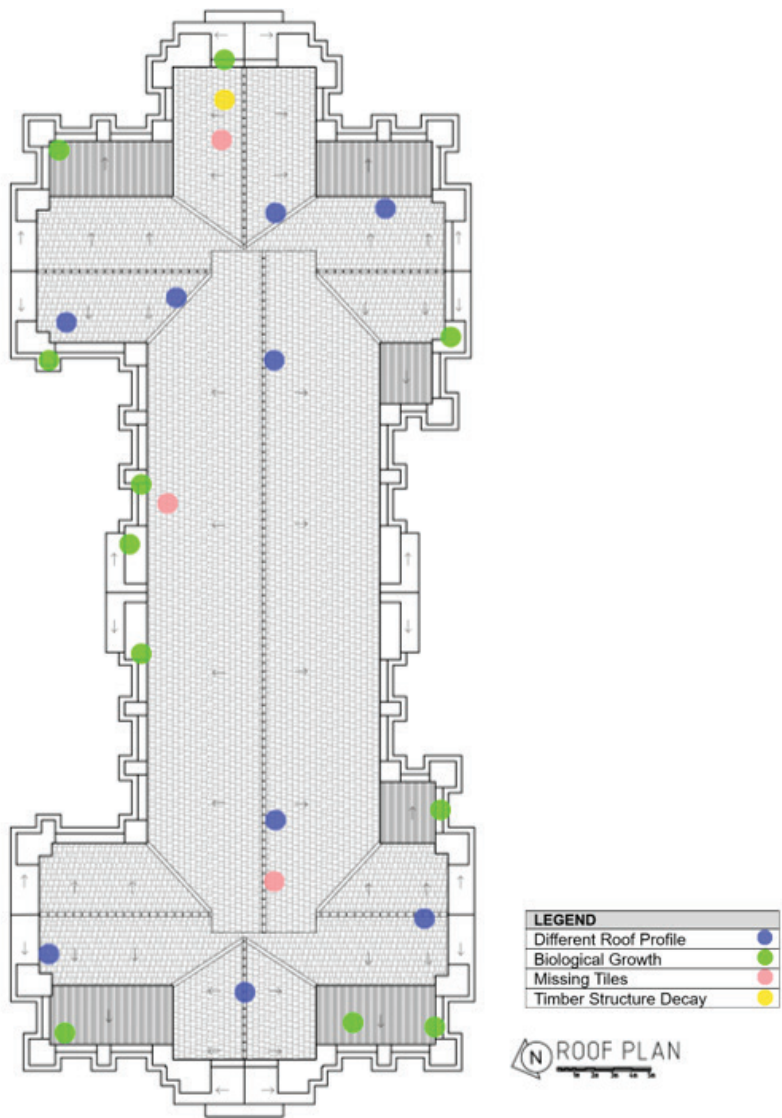
**Figure 10. Common defects in the roof area of Case Study 1**

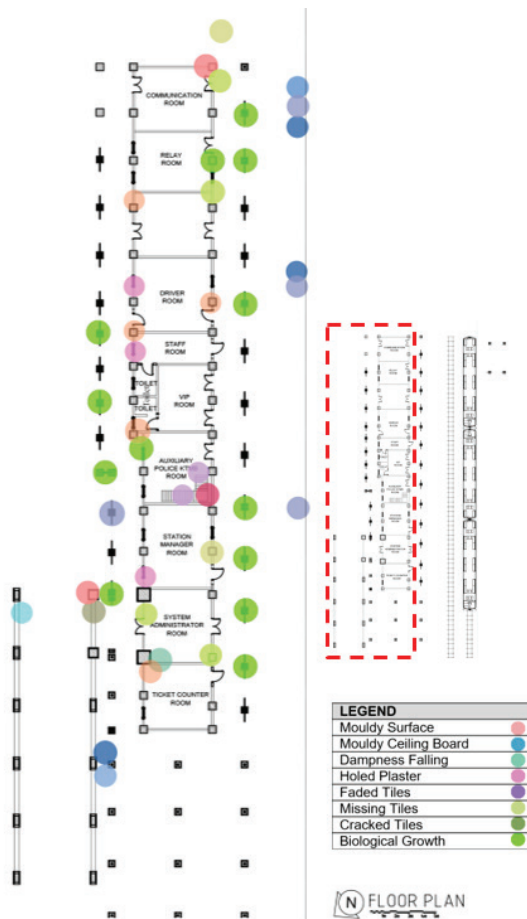
**Figure 11. Common Defects in the Ground-floor Area of Case Study 2**  
Source: Author, 2025

Case Study 2 presents a range of defects primarily attributable to maintenance challenges. The roof exhibits missing or broken tiles, faded tile surfaces, mould attacks, biological growth, and issues with rainwater downpipes. The exterior walls are affected by dampness, cracked bricks, peeling paint, and flaking plaster. Interior walls show cracks, whereas doors and windows generally remain intact. Columns and beams are afflicted by peeling paint, cracks, and insect damage. The ceiling displays dampness, cracks, missing panels, mouldy surfaces, and holed plaster. Floors are characterised by standing water, uplifted tiles, and cracked tiles. Similar issues were observed in the stairs and apron, including standing water, uplifted tiles, and cracked tiles. Additionally, services suffer from poor air-conditioning unit installation, leading to leaks and mould growth.

The causes of defects in Case Study 2 are predominantly environmental. High humidity, rainfall, and exposure to intense sunlight contribute to issues such as faded tiles, mould growth, and damp walls. Maintenance challenges, including temporary repairs and inadequate installation, further exacerbate these problems. Additionally, natural aging contributes to defects like cracked bricks and tiles. Although evidence of vandalism is less prevalent compared to Case Study 1, maintenance-related issues are notably more pronounced.

To address these defects, several recommendations were proposed. Implementing consistent maintenance practices is crucial to preventing recurrence of issues. Regular inspection and cleaning of roof tiles, application of anti-mould treatments, and the use of appropriate materials for repairs are essential. Installing new damp-proof courses and ensuring proper sealing of cracks and gaps will help prevent moisture ingress. Replacing damaged components with high-quality materials, such as bricks, tiles, and timber, is recommended. Effective drainage systems should be maintained to avoid standing water and uplifted tiles. Regular maintenance checks on air-conditioning units and other services are necessary to prevent leaks and subsequent mould growth. Specific repairs should include replacing missing roof tiles, recoating faded tiles, fixing leaks, and repairing damaged structural elements.

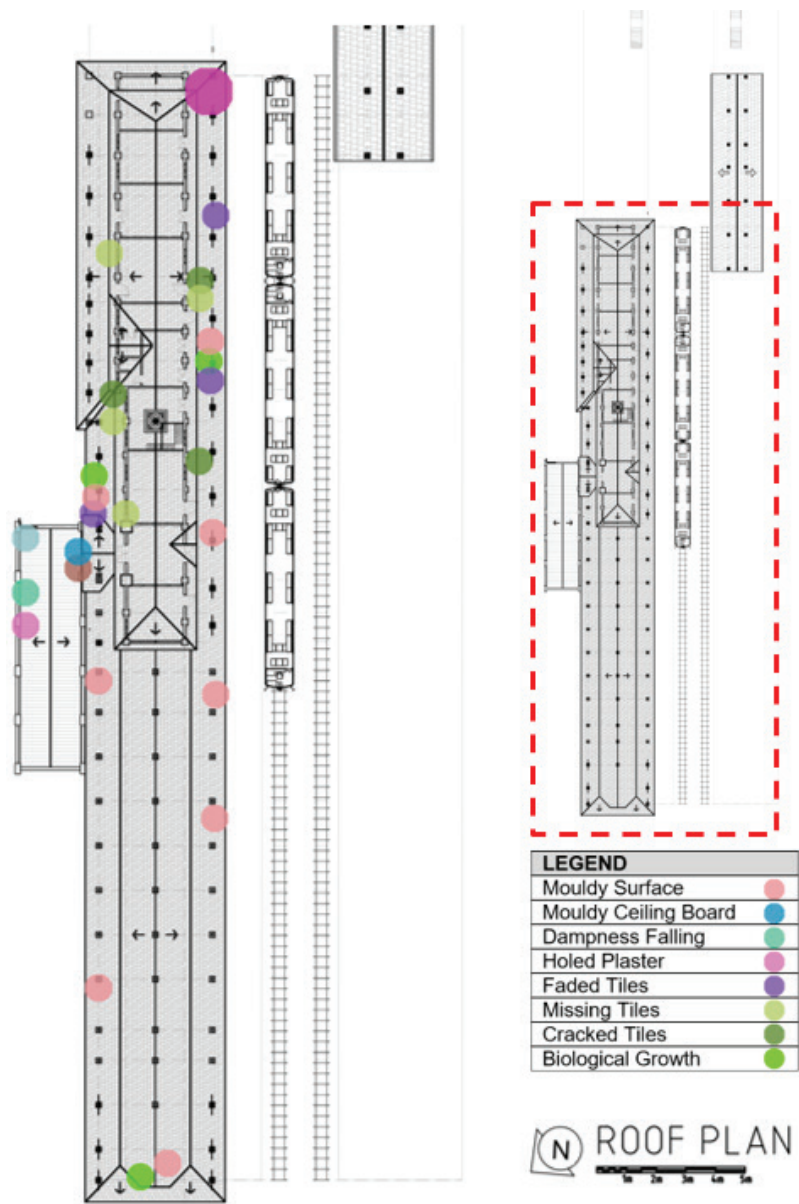
**Figure 12. Common Defects in the Roof Area of Case Study 2**  
Source: Author, 2025
