Settlement Monitoring of Georehabilitation Solution at Bridge and Culvert Approaches using Polyurethane Foam Injection System

Keywords: Bridge Approach, Culvert Approach, Differential Settlement, Georehabilitation, Polyurethane Foam

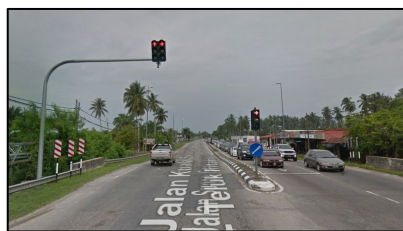
Figure 2. Overview of the Jalan Sungai Gulang-Gulang culvert approach intersection.

The topography at the Jalan Sungai Gulang-Gulang consists of flat terrain surrounded by commercial building, housing areas and agricultural land as shown in Figure 5. The settlement occurred on the left and right side of the box culvert causing undulation and discomfort to the traffic users.

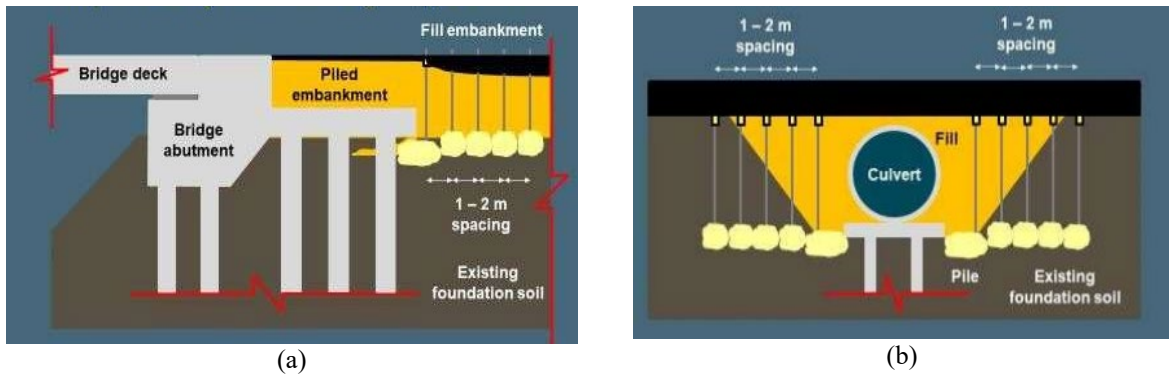
Figure 7. The rehabilitation technique applying polyurethane foam/resin at (a) bridge and (b) culvert approaches (Courtesy of Geocon (M) Sdn. Bhd.).

The concepts of typical implementation of PU foam injection system at bridge and culvert approach are shown in Figure 7. The injection points were arranged from 1 m to 2 m spacing. The curing time of the expansion foam is about fifteen (15) minutes after each injection. The packer was dismantled, and the holes were grouted with a suitable material. Any diffused and spilt PU needs to be removed before the crack repair can be executed. This stage is executed to plug the voids beneath the culvert or abutment structure creating a lightweight curtain wall, thus preventing the adjacent compacted earthfill material migrating into the voids. This will reduce the migration of the compacted soil into the void spaces, hence reduces the rate of differential settlement at the approach section.

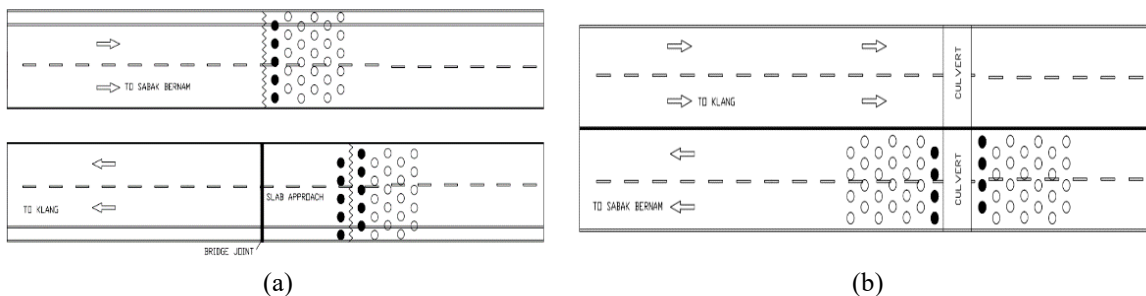
Figure 8. The area injected with PU foam at (a) Kuala Selangor Bridge (both direction of one of abutment); and (b) Culvert at Sg Gulang – Gulang (Route from Klang to Teluk Intan) (Zainuddin *et al.*, 2021).

The configuration of the injection points is based on the geoforensic investigation explained by Zainuddin *et al.* (2021) shown in Figure 8. The construction of a grout curtain using the PU foam injection method at the edge of the piled embankment can plug the void and prevent migration of fill material into the cavities created due to the global settlement of the ground surrounding the bridge and culvert approaches. PU foam injection system was carried out during the midnight hours to avoid heavy traffic and complaint by the traffic user due to road closure. The photos of rehabilitation work using PU injection method are shown in Figure 9 and Figure 10. The quantity of PU foam needed to fill the cavities detected below the piled box culvert or piled embankment was calculated based on the analysis data from ERI and JKR Probes results provided by Zainuddin *et al.* (2021). About 2,605 liter of PU foam was injected below the bridge transition at Kuala Selangor bridge abutment and about 2,250 liter of PU foam was injected beneath the transition approach of culvert at Sg. Gulang-Gulang.

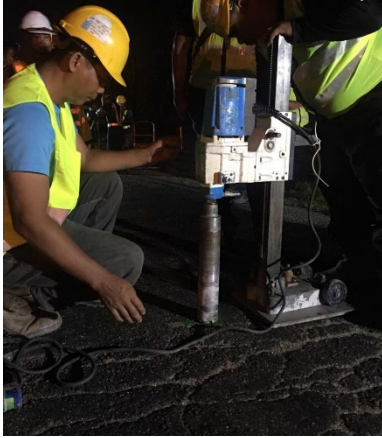
Figure 9. Coring of the asphalt layer before injecting PU foam underneath the piled embankment (Zainuddin et. al., 2021).

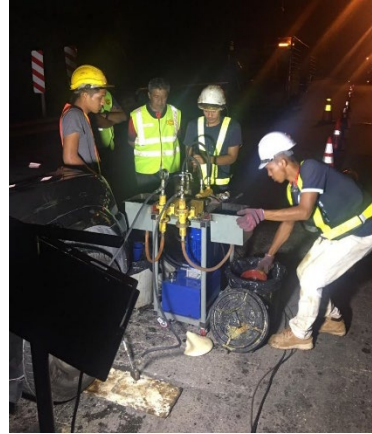
Figure 10. Injecting the PU foam mixture at designated injection pressure in situ into the ground (Zainuddin et. al., 2021).

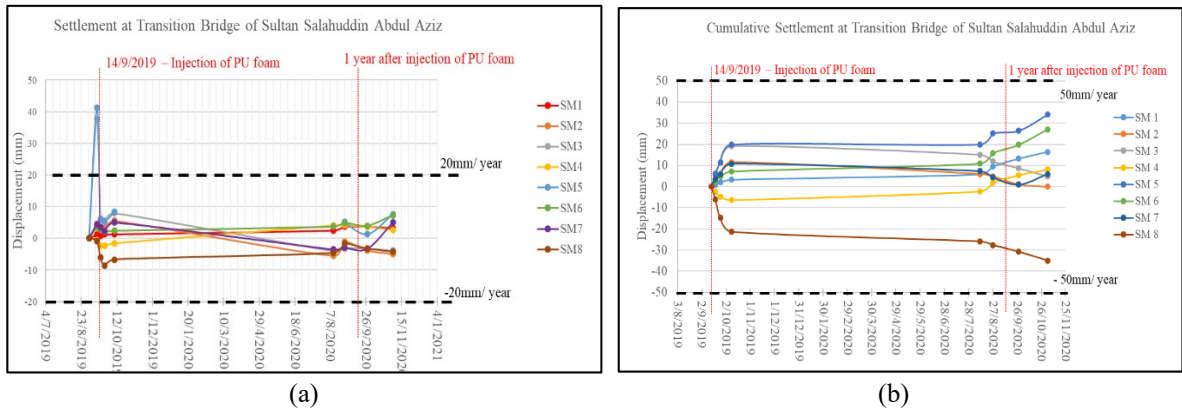
Based on the eight (8) recorded data observed, it can be concluded that the settlement readings for all the settlement markers during the period of 14 months are considered within tolerable limits which is 250mm/5 year (total settlement) and 100 mm/5 years (differential settlement). After a year, at settlement markers SM 2 and SM 3 which is located on the compacted fill showed that the road experienced drastic settlement just after the PU foam injection location. PU foam expands and plug the edge of piled embankment and filled the cavities. At the same time, it densifies and increases the soil beneath the structures. The settlements at SM 4 and SM 5

are slowly increased because at median of the approach, there were no injection points located. All the data varied within 14 weeks due to uplifting since the buoyancy characteristic of the PU foam and rearrangement of soil particles to achieve a stable compaction condition. The deformation presented in Figure 13(a) and Figure 13(b) showed either settlement or uplifting due to buoyancy effect of the PU foam injected at Kuala Selangor Bridge.

Figure 13. The deformation monitoring at the transition of Kuala Selangor Bridge (a) settlement (b) Cumulative settlement.

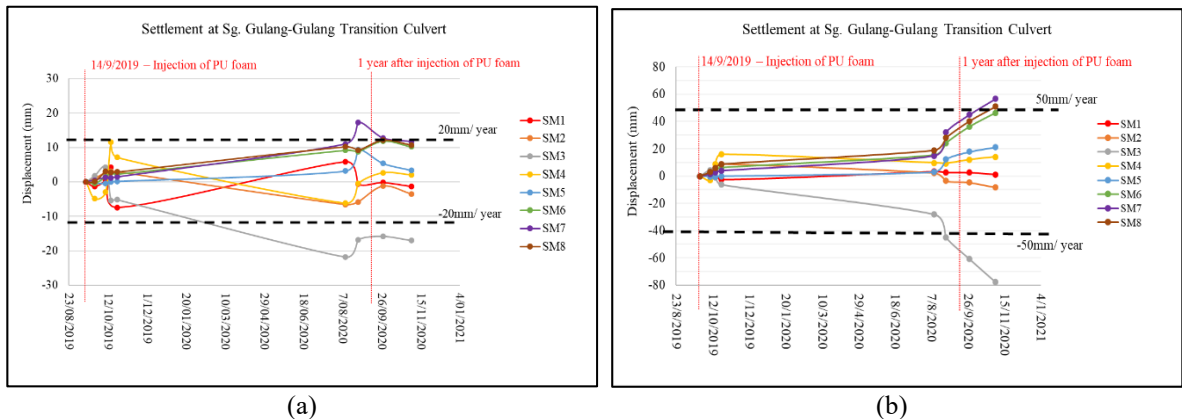
The deformation presented in Figure 14(a) and Figure 14(b) illustrated that the settlement is either increasing or decreasing after a year of improvement. From the observation of displacement monitored at Sg Gulang-gulang Box Culvert, displacements at settlement markers SM 6, SM 7 and SM 8 are more than the tolerable limit within a year for total settlement and near to the limit set for differential settlement. At settlement markers, SM 6, SM 7 and SM 8 located at west bound (slow lane direction from Teluk Intan to Klang), was not injected by PU foam due to limitation of cost for the georehabilitation solution and during that time, the route was already repaired by different method. Furthermore, the possibility of large settlements at SM 6, SM7 and SM 8 are due to the fact that the area is founded on loose compacted material, hence causing migration of the fill material into the enlargement of the void present underneath the piled box culvert. In addition, at settlement marker SM3, the settlement value is slightly excessive and there is presence of uplifting due to the lightweight capability of the PU foam.

Figure 14. The deformation monitoring at transition box culvert (a) settlement (b) Cumulative settlement.

Based on this study, it is recommended that the settlement monitoring be extended to evaluate the performance of the bridge and culvert transition approaches. In addition, this treatment is an alternative rapid solution without excavation, minimal road closure and stationed traffic diversion.
