Evaluation of Tabular Leg Structure of Mobile Offshore Production Unit (MOPU) Life Extension using Condition Assessment Method

Emi Hafizzul Jamaluddin, Azli Abd Razak, Mohd Shahrman Adenan,
Mohd Faizal Mohamad
Faculty of Mechanical Engineering, Universiti Teknologi MARA,
40450, Shah Alam, Malaysia
azlirazak@uitm.edu.my

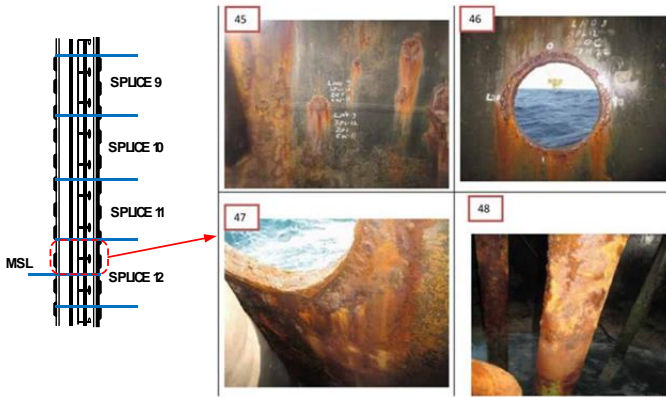
- ii. Inspection (CVI): Internal visual inspection via abseil of all welds (circumferential and vertical) and pinholes from sea level to leg top.
Findings: During the internal visual inspection of the jacking legs, damage to the paint coating with surface corrosion of the exposed bare metal was observed together with some active corrosion, especially between splice zone no. 11 and 12 of leg number 3, just above the main sea level (MSL) as depicted in Figure 7 with tag no (45), (46), (47) and (48). No indication of weld flaws was observed on both, the circumferential and the longitudinal welds.

Figure 7: Observed paint damage and surface corrosion at leg 3.
