# SIMPOSIUM NUSANTARA<sup>9</sup>

PAPER CODE : AC114

# BUILDING CONDITION ASSESSMENT AFTER CONSERVATION WORK AT MASJID LAMA KAMPUNG DAL, PADANG RENGAS, PERAK

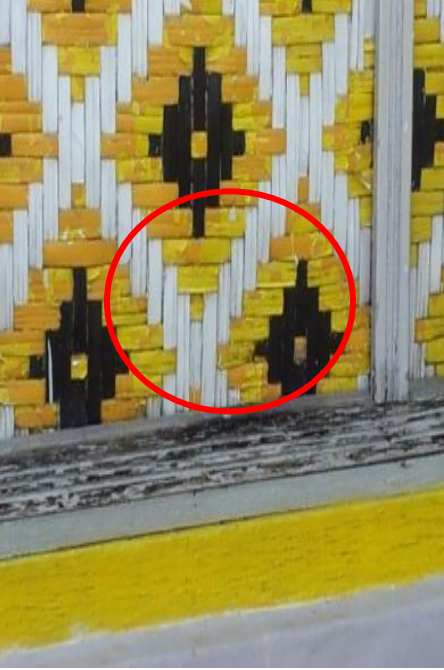
Defect Sheet No:	GF/W/P/01	Level	Ground floor

Peeling paint is a common defect that has been found in the building including on the external bamboo wall. Based on BARIS Assessment, the condition of the defect is rated as 2 , which is fair and needs a minor repair. Meanwhile, for priority assessment, the defect is rated as 1 which is functional and only cosmetic defect. Peeling

paint is occurred due to exposure to weather such as rain and sunlight. Other possible cause is due to the double layer of paint. The external wall was firstly painted in orange – yellow scheme colour based on the original scheme colour of the wall. But before the officiating ceremony that was scheduled to be held in 2010, Sultan Perak had instructed the contractor to repaint the wall to royal yellow scheme colour similar to the scheme colour of Istana Kenangan wall. Due to this contribution factor, the upper layer paint started to peel off badly especially on the external wall after being exposed to weather. For the internal wall the painting was remained with the first scheme colour and they are in a good condition during the assessment done. Peeling paint will affect the appearance of the building. Therefore as corrective measure, it is suggested to scrap off or sand off both layers of the painting, cleaning them and then repaint the wall.

Location	External Wall			
	Element	Wall			
	<b>BARIS</b>				
	Condition	Priority	Matrix	Colour	
	2	1	2		
	Defect Description				
	Peeling paint				
	Possible Causes				
	<ul style="list-style-type: none"> <li>• Exposure to weather</li> <li>• Double layer of paint</li> </ul>				
	Remedies				
Sand off all outside skin of the bamboo surface, clean it and then paint it.

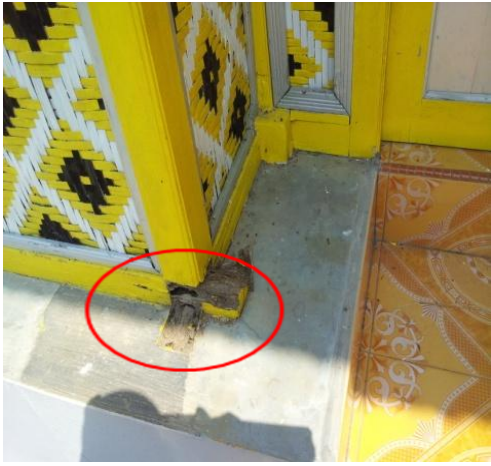
Defect Sheet No:	GF/CO/TA/02	Level	Ground floor

Termite attack is a typical defect to timber building including Masjid Lama Kg Dal. There is one defect found at beam located at external facade near staircase of the building. Timber can deteriorate easily if it is exposed to water penetration, high moisture content and loading beyond its capacity. Based on BARIS assessment, the condition of the defect is rated as 3, which is poor and need replacement. Meanwhile, for priority assessment, the defect is rated as 2 which is minor defect, but can lead to serious defect if left unattended. The possible cause is the existence of insect or termite attacks usually happen in a damp and digestible timber. It is dangerous to leave the timber with many insect or termite holes because they may soften the timber and form further cracks. For above case, the affected timber should be replaced and after replace it should be pressure-spraying with insecticide or fumigant insecticidal processes to prevent reoccurrence of the defect.

Location	External façade near staircase			
	Element	Timber column and beam			
	<b>BARIS</b>				
	Condition	Priority	Matrix	Colour	
	3	2	6		
	Defect Description				
	Termite attack				
	Possible Causes				
	Insect or termite attacks happen in a damp and digestible timber				
	Remedies				
Replace affected timber and pressure-spraying with insecticide or fumigant insecticidal processes

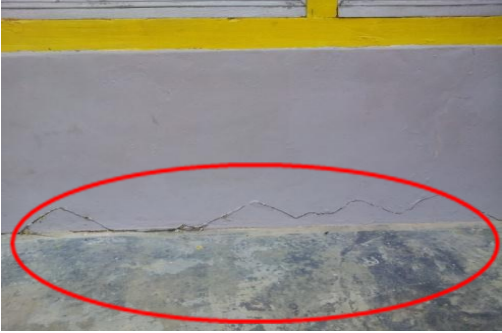
Defect Sheet No:	GF/W/C/03	Level	Ground floor

From the observation, there is one minor crack found at the joint of external brickwall and apron of the building. Based on BARIS Assessment, the condition of the defect is rated as 2, which is fair and need minor repair. Meanwhile, for priority assessment, the defect is rated as 1 which is functional and only cosmetic defect. It is caused due to the minor settlement occurred at the problematic area. The crack is minor and will not affect the strength of the building. It is suggested to inject an epoxy resin as sealant to the crack as corrective measure. Epoxy resins are excellent binding agents with high tensile strength.

Location	External			
	Element	Brick wall and apron			
	<b>BARIS</b>				
	Condition	Priority	Matrix	Colour	
	2	1	2		
	Defect Description				
	Minor Crack				
	Possible Causes				
	Minor settlement				
	Remedies				
Injection of epoxy resin as sealant to the crack

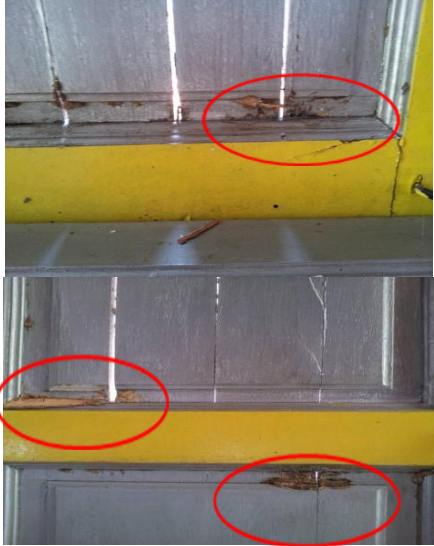
Defect Sheet No:	GF/WD/TD/04	Level	Ground Floor

Timber decay is another major defect occurred in Masjid Lama Kg Dal. It is found at most of the windows of the building. Based on BARIS assessment, the condition of the defect is rated as 3, which is poor and need replacement. Meanwhile, for priority assessment, the defect is rated as 2 which is minor defect, but can lead to serious defect if left unattended. The possible cause of timber decay is wet rot. Wet rot is occurred due to dampness and it's promotes fungus. The fungus causes brown rot decay, leaving timber brittle and eventually will form a hole

Location	Internal		
		Element	Window		
		<b>BARIS</b>			
		Condition	Priority	Matrix	Colour
3	2	6			
Defect Description					
Timber decay					
Possible Causes					
<input type="checkbox"/> Caused by wet rot .The fungus causes brown rot decay, leaving timber brittle.					
Remedies					
<input type="checkbox"/> Increasing the ventilation and drying out the affected areas. <input type="checkbox"/> Rectifying any cause of dampness. <input type="checkbox"/> Replacing required timber.

at window and affect the appearance of the building. For corrective measures it is suggested to increase the ventilation and drying out the affected areas, rectify any cause of dampness and replace required timber.

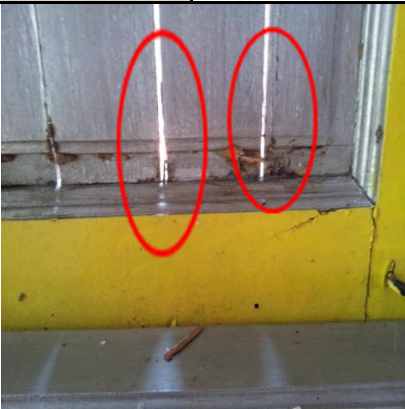
Defect Sheet No:	GF/WD/TS/05	Level	Ground floor

Timber shrinkage happened at almost every window panel of Masjid Lama Kg Dal. Shrinkage is a defect occurring during the seasoning process. Seasoning is the reduction of moisture content of timber to that of the surrounding air. Seasoning is important to increase the strength of the timber panel. However due to insufficient seasoning process of the timber before installation, it can cause the timber to shrink after being installed and leaving a gap between window panels. The gap will allow rain penetration into the building and may lead to more defect to the other part of the building. Based on BARIS assessment, the condition of the defect is rated as 3, which is poor and need replacement. Meanwhile, for priority assessment, the defect is rated as 2 which is minor defect, but can lead to serious defect if left unattended. As for corrective measure, it is required to replace the affected timber panels.

Location	Internal		
		Element	Window		
		<b>BARIS</b>			
		Condition	Priority	Matrix	Colour
3	2	6			
Defect Description					
Timber Shrinkage					
Possible Causes					
<input type="checkbox"/> Caused by insufficient seasoning process of the timber before installation					
Remedies					
<input type="checkbox"/> Replacing required timber.
