**TITLE
BUILDING CONDITION ASSESSMENT: DAMPNES**

**NURDIYANA BINTI MOHD SOBRI
2010357149
DIPLOMA IN BUILDING SURVEYING**

PRACTICAL TRAINING REPORT

AMAS FM Consultant Sdn. Bhd. (AFC) was engaged by Etiqa Insurance Bhd to conduct a Building Condition Assessment exercise at Akademi Etiqa. AMAS FM Consultant is a building surveying consultant that provides building surveying and asset management consultancy.

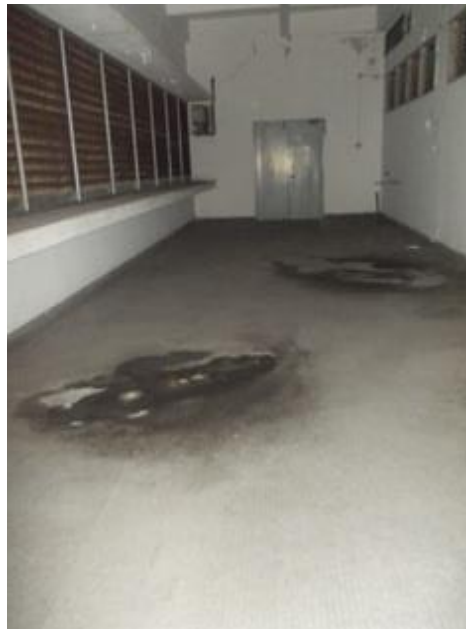
Figure 1.9 Water mark on the floor

The floor is constructed of RC with tiles finishes. For office area, various type of finishes has been used depending on tenant. The floor noted that generally the carpet and tiles finishes is in good condition however significant signs of water mark.

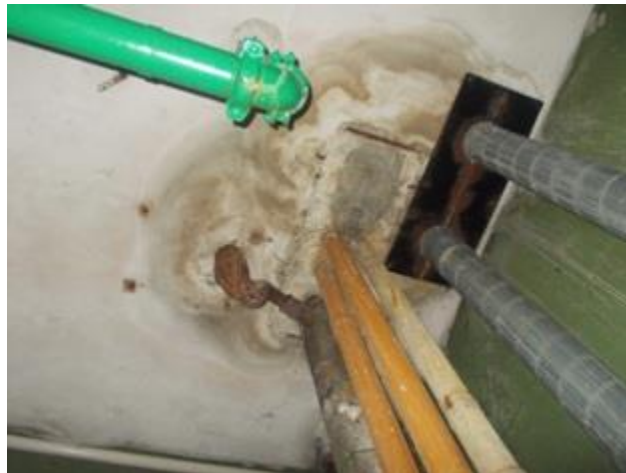
Figure 2.1 Water mark on ceiling

The ceiling is installed with gypsum board, plaster ceiling and soffit slab. That was noted that generally the plaster ceiling and gypsum boards is in good condition however it's noted the ceiling boards at basement, staircase, AHU room and office. Also there are some water marks on ceiling surfaces on chillers room and store at level 7. This is probably due to water leaked from plumbing joint problem.

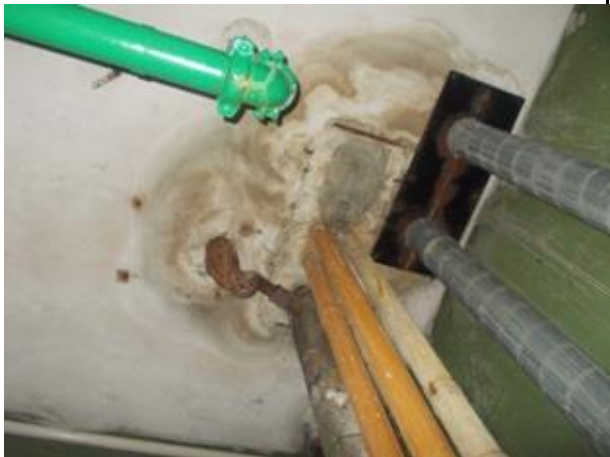
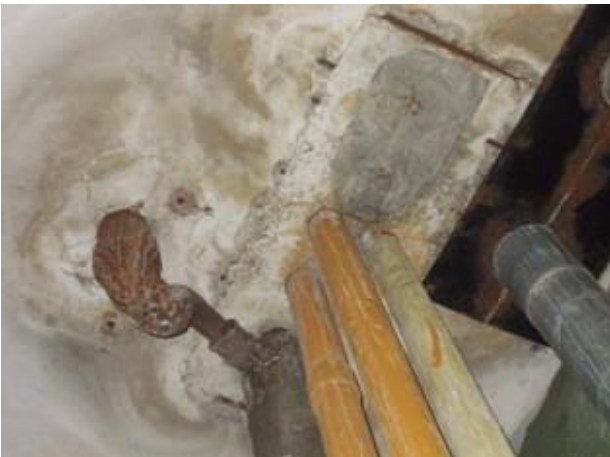
Element	System	Asset	Date
Building Akademi Etiqa	Architecture	Ceiling	Soffit slab	
Location : Akademi Etiqa / Level 5 / AHU Room		Ref. No: AR/AE/L5/DSCN2988, AR/AE/L5/DSCN2989

Defect: Water Mark On Soffit Slab				
Remarks: <ul style="list-style-type: none"> • Leaking on plumbing joint 				
Condition	4	Priority	2	Condition Priority Index
Recommendation: <ul style="list-style-type: none"> ○ Check plumbing system ○ Repaint the soffit slab ○ Refer to professional engineer

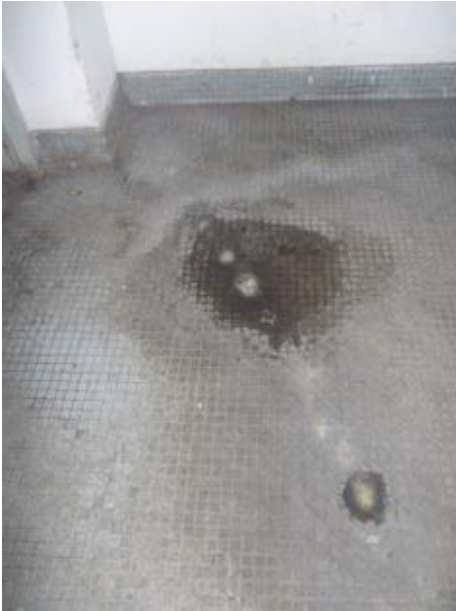
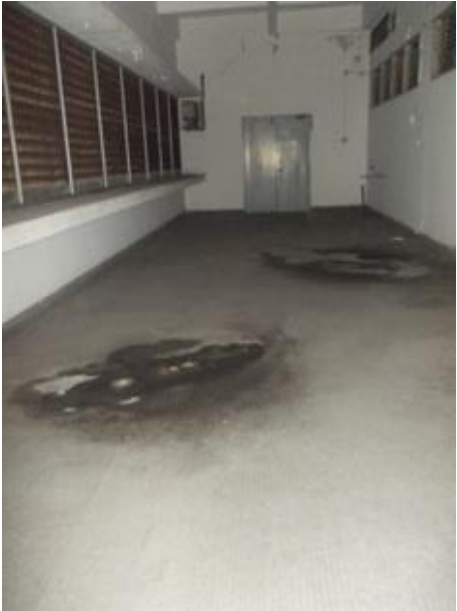
Element	System	Asset	Date
Building Akademi Etiqa	Architecture	Floor	Floor finishes	
Location : Akademi Etiqa / Level 7 / Chiller Room		Ref. No: AR/AE/L7/DSCN3035, AR/AE/L7/DSCN3038

Defect: Water Mark On Floor Surface				
Remarks: <ul style="list-style-type: none"> • Leaking on plumbing joint 				
Condition	4	Priority	4	Condition Priority Index 16
Recommendation: <ul style="list-style-type: none"> ○ Check plumbing system ○ Remove the stain on the floor surface

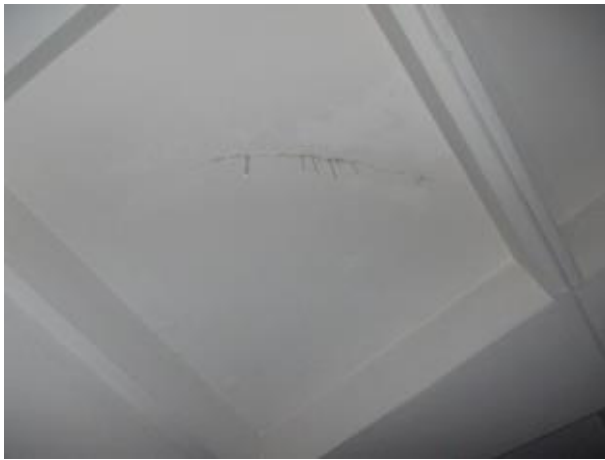
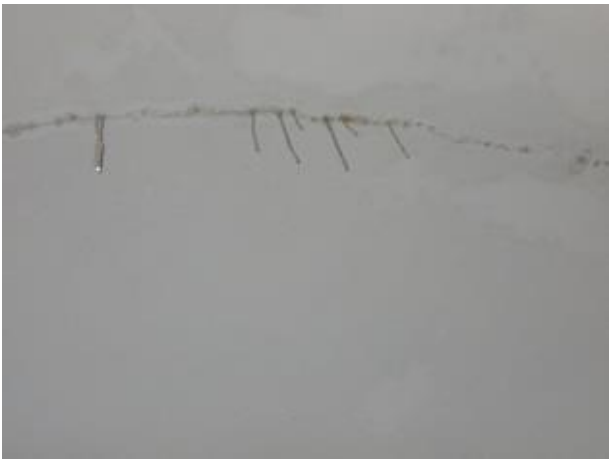
Element	System	Asset	Date	
Building Akademi Etiqa	Structure	Ceiling	Soffit slab		
Location : Akademi Etiqa / Level 7 / Chiller Room		Ref. No: AR/AE/L7/DSCN3040, AR/AE/L7/DSCN3041

Defect: Water mark on ceiling surface					
Remarks: <ul style="list-style-type: none"> • Leaking on plumbing joint 					
Condition	4	Priority	4	Condition Priority Index	16
Recommendation: <ul style="list-style-type: none"> ○ Check plumbing system ○ Apply new paint

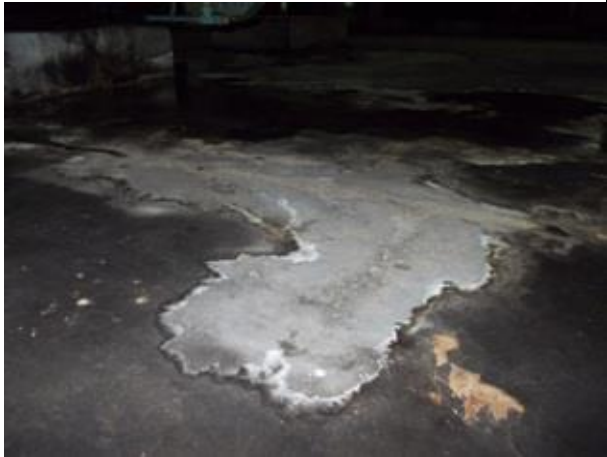
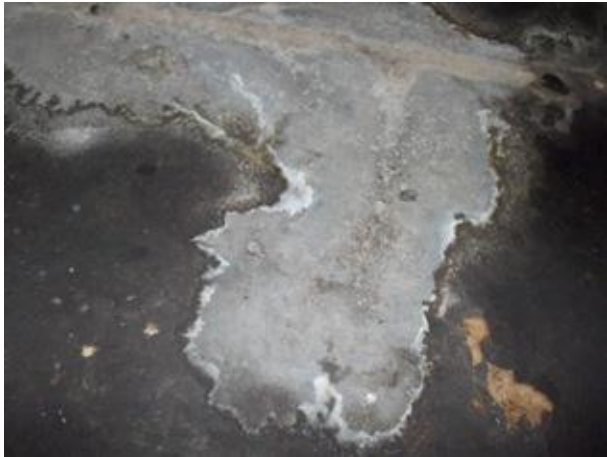
Element	System	Asset	Date	
Building Akademi Etiqa	Architecture	Floor	Floor concrete		
Location : Akademi Etiqa / Level 7 / Chiller Room		Ref. No: AR/AE/L7/DSCN3066, AR/AE/L7/DSCN3067

Defect: Water Mark On Floor Surface					
Remarks: <ul style="list-style-type: none"> • Leaking on plumbing joint 					
Condition	4	Priority	3	Condition Priority Index	12
Recommendation: <ul style="list-style-type: none"> ○ Remove the stain ○ Check plumbing system
