**THE WORK FLOW OF BUILDING INSPECTION AT TRAINING NURSE HOSTEL  
(BLOCK E)**

**NUR FARHANAH BINTI MA'ZIN  
2015881846  
DIPLOMA IN BUILDING SURVEYING**

**PRACTICAL TRAINING REPORT  
MARCH – JULY 2018**

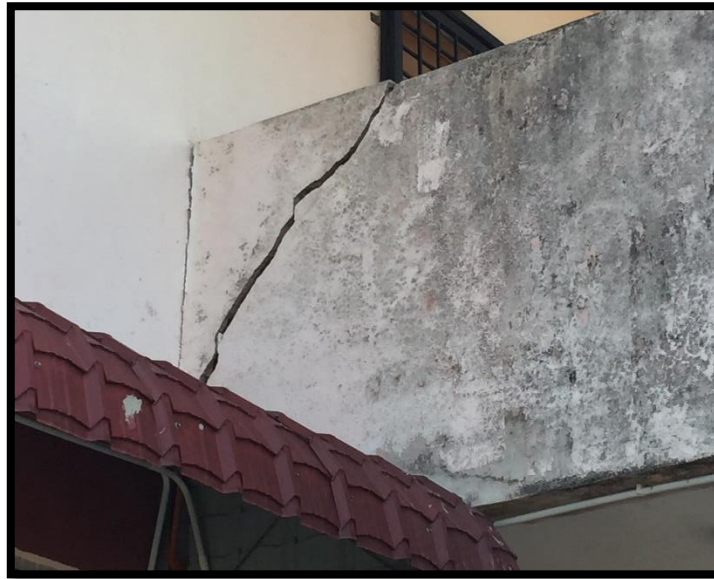
Figure 3.4: the concrete crack on parapet wall

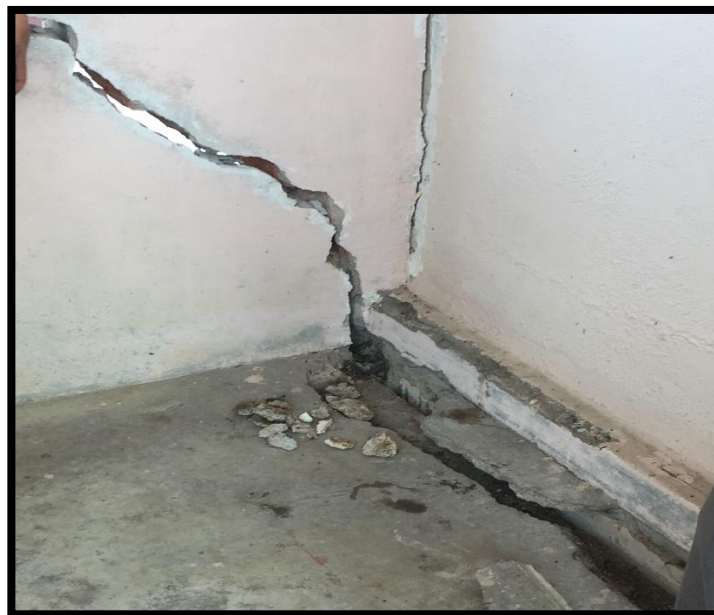
Figure 3.5: the crack on the slab of additional staircase

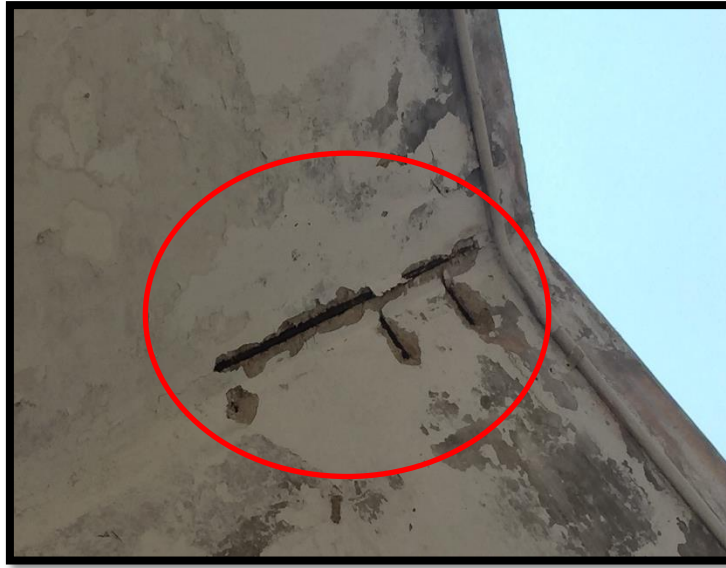
Figure 3.6: the concrete spalling and concrete delamination

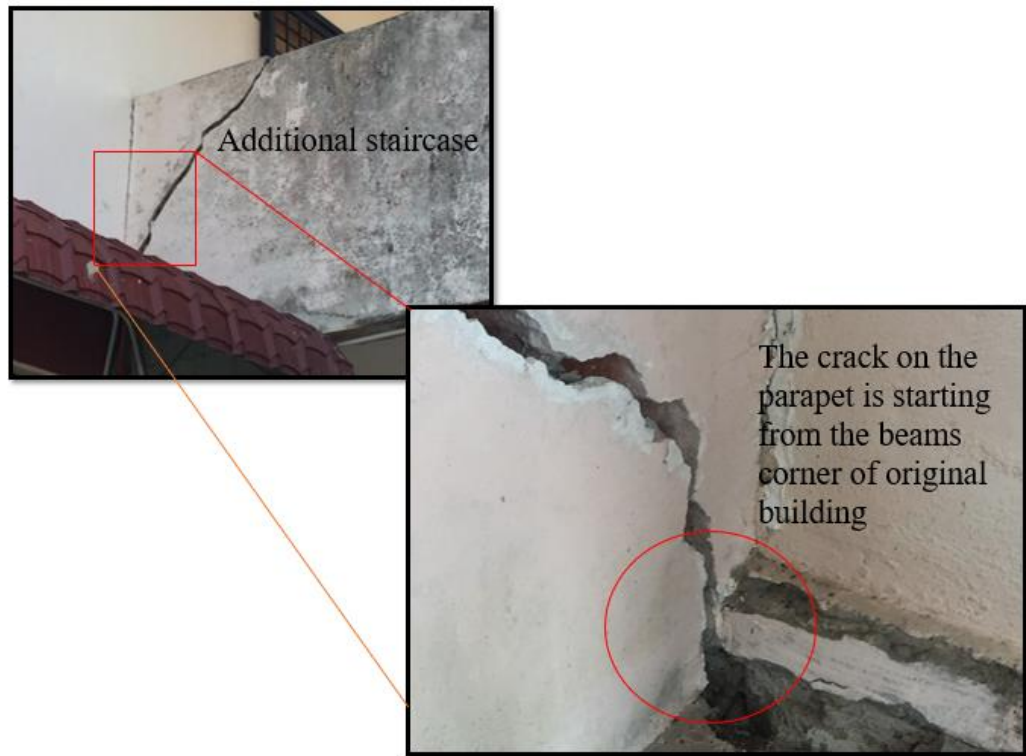
The structure and the parapet wall are not monolithic and not built at all. Therefore, it should not be tied to any of the original building structure and should be allowed to move freely. In comparison, the correct connecting method is to use expansion joint or sealant that allow any movement to occur.

Figure 3.9: the view concrete crack on the parapet wall

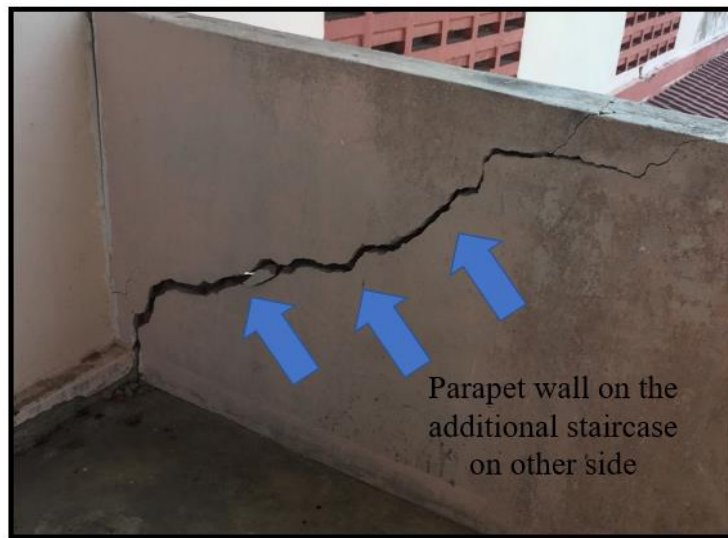
Figure 3.10: the view of parapet on other side

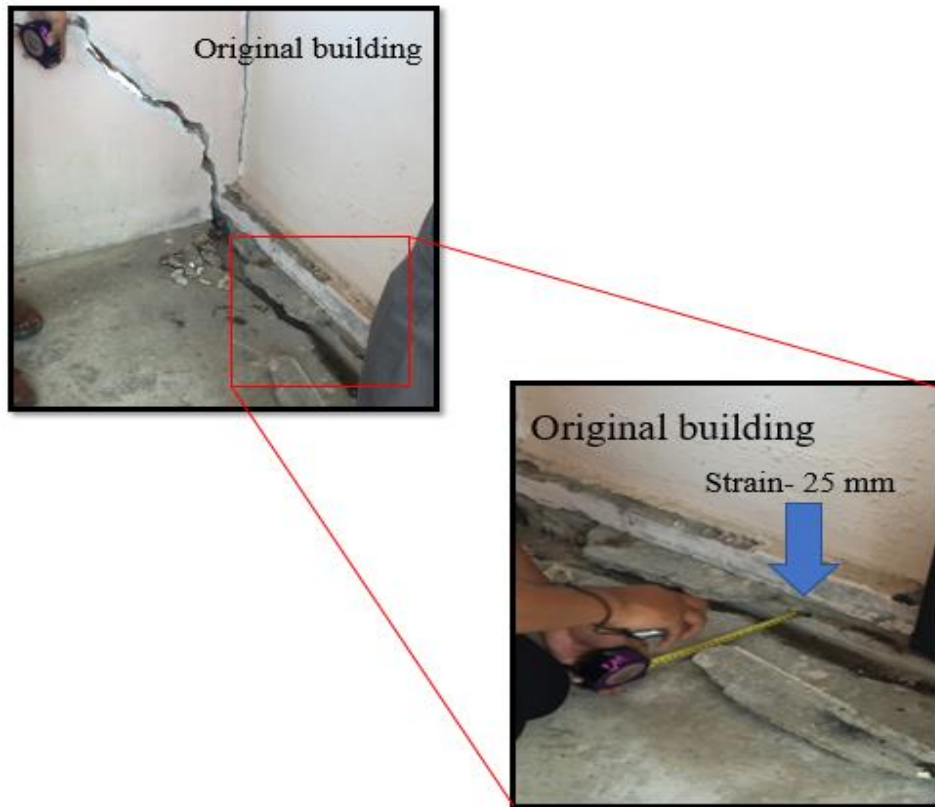
Figure 3.11: there is a stretch about 25 mm between the original building and slab of the additional staircase.

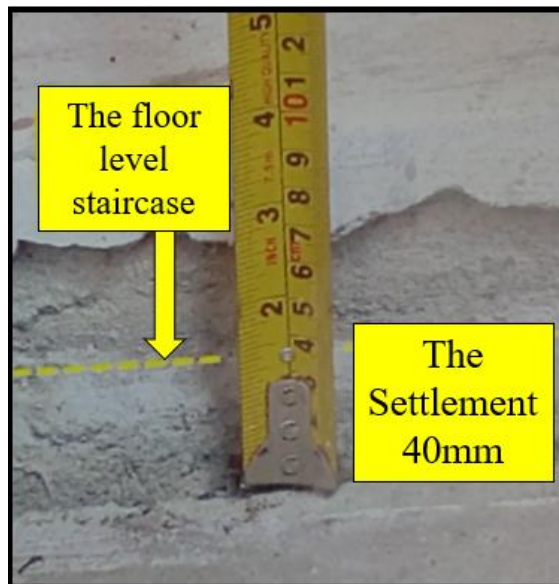
Figure 3.12: the settlement on the slab of the additional staircase is 40 mm.

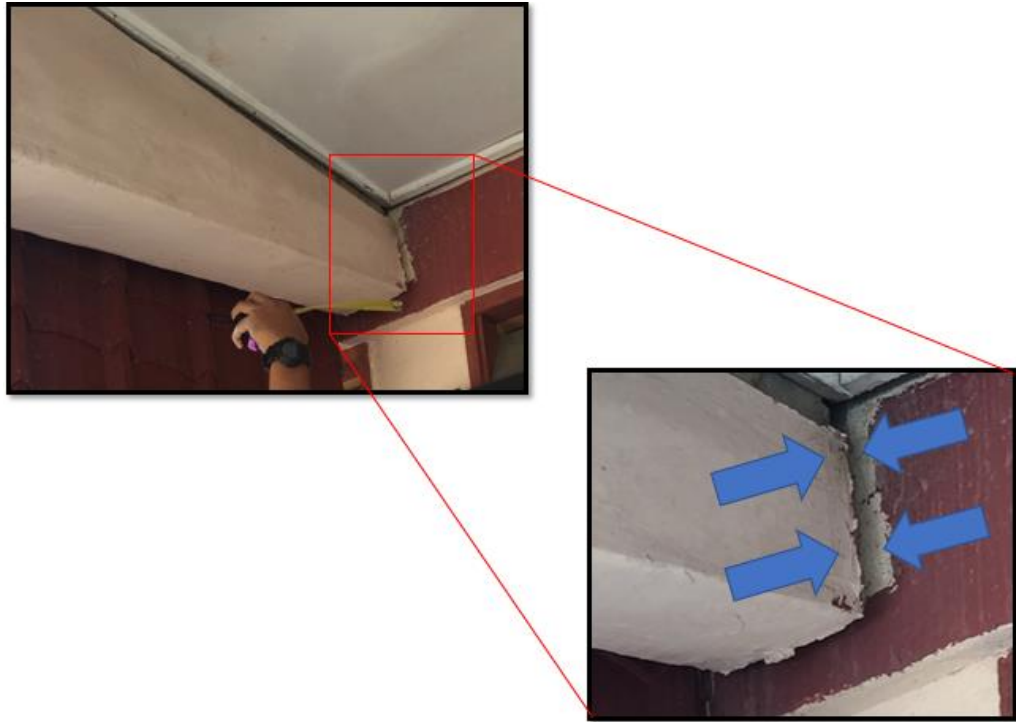
Figure 3.13: there is a strain between the beam and the slab of the staircase with the original building.

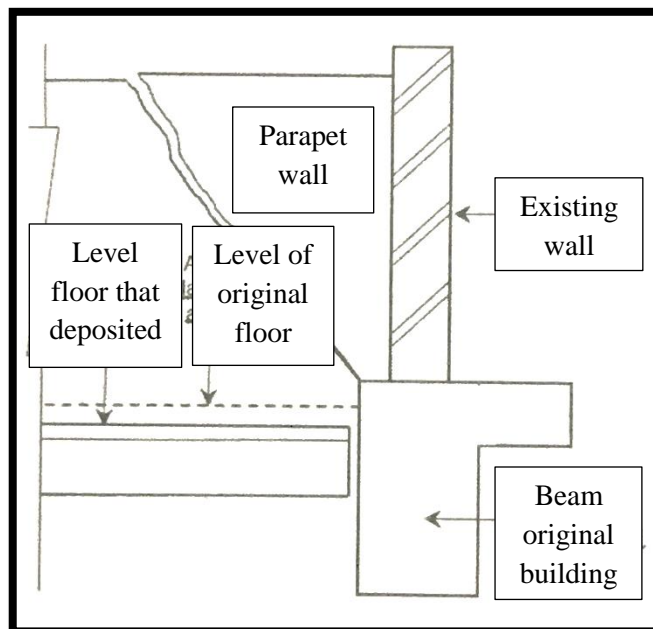
Figure 3.15: sketches condition of connection after deposited or structural movement occur

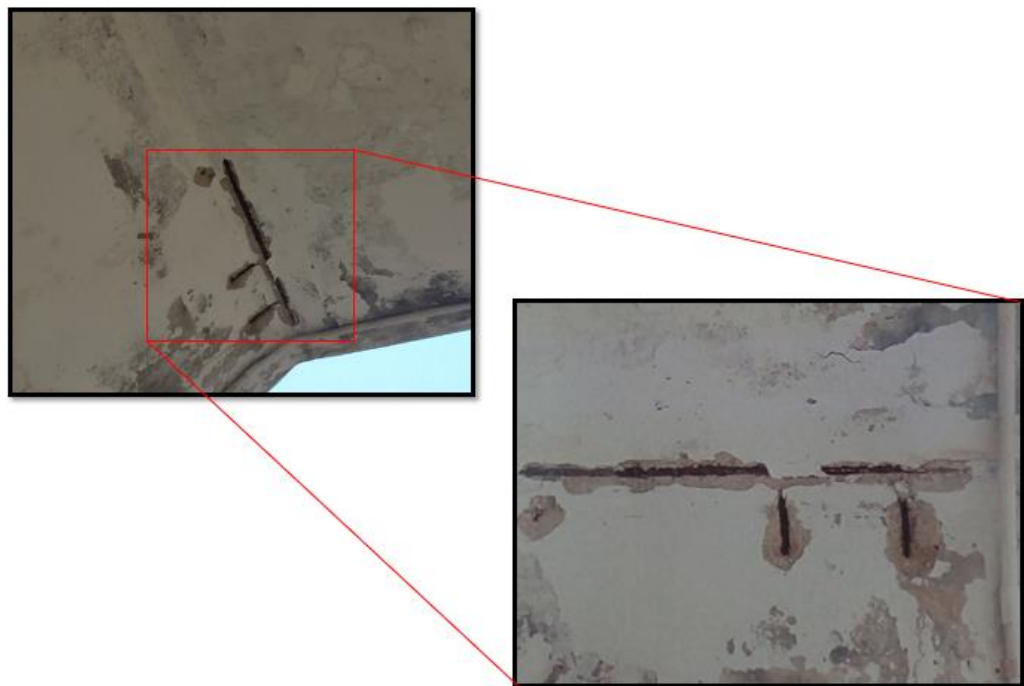
Typically, oxidation responses occur when a passive protective layer of steel reinforcement is destroyed by long carbon coating activity. In addition, inadequate concrete cover also contributes to increased carbonization rates

Figure 3.17: the concrete spalling at staircase soffit

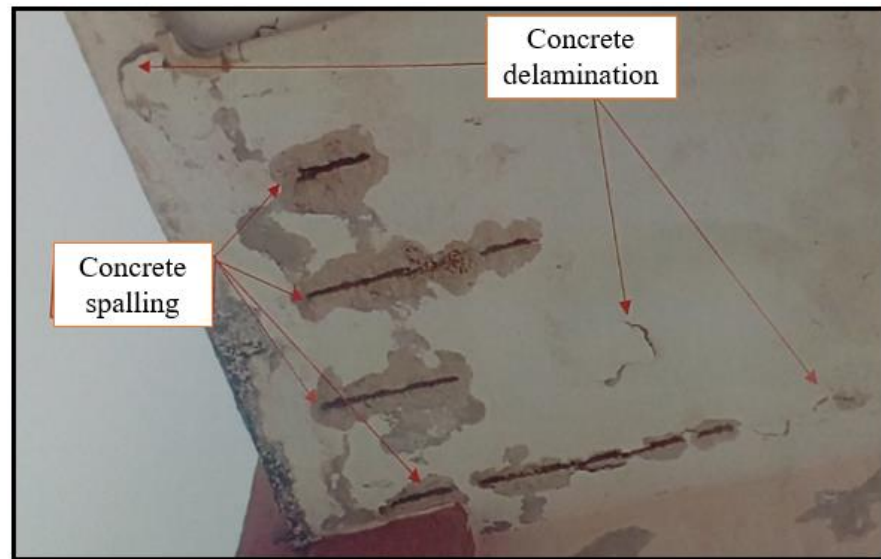
The concrete spalling at staircase soffit at level 2. The visual inspection found that steel reinforcement has been rusted and the thickness of the concrete cover is believed to be insufficient

Figure 3.18: the concrete spalling at staircase soffit.

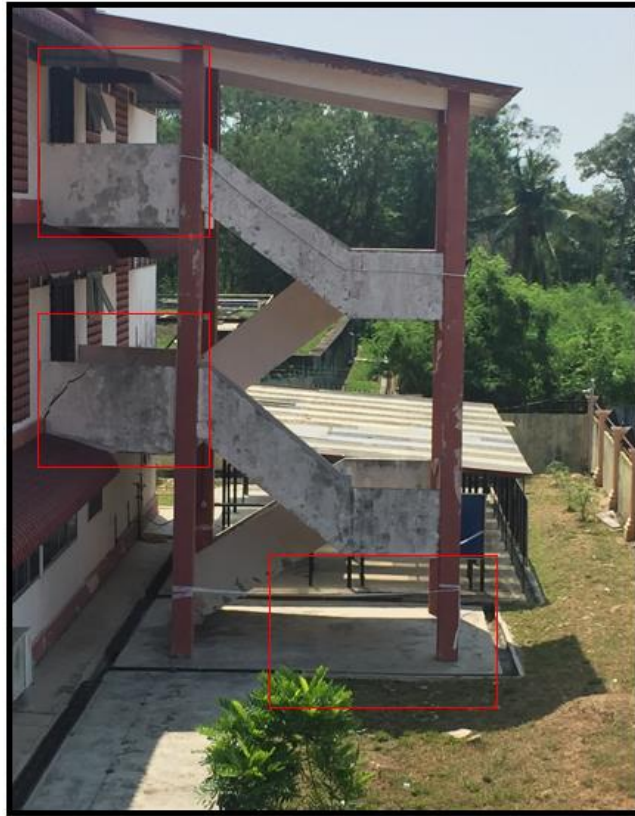
Figure 3.19: the area that appear the defect on staircase.

The suggestion of the repairing work is conduct regular monitoring of column pitch and stretch through the method Tiltmeter and Building Settlement Marker (BSM) in six months. This suggestion should be do as soon as possible before the appropriate repair method are recommended.

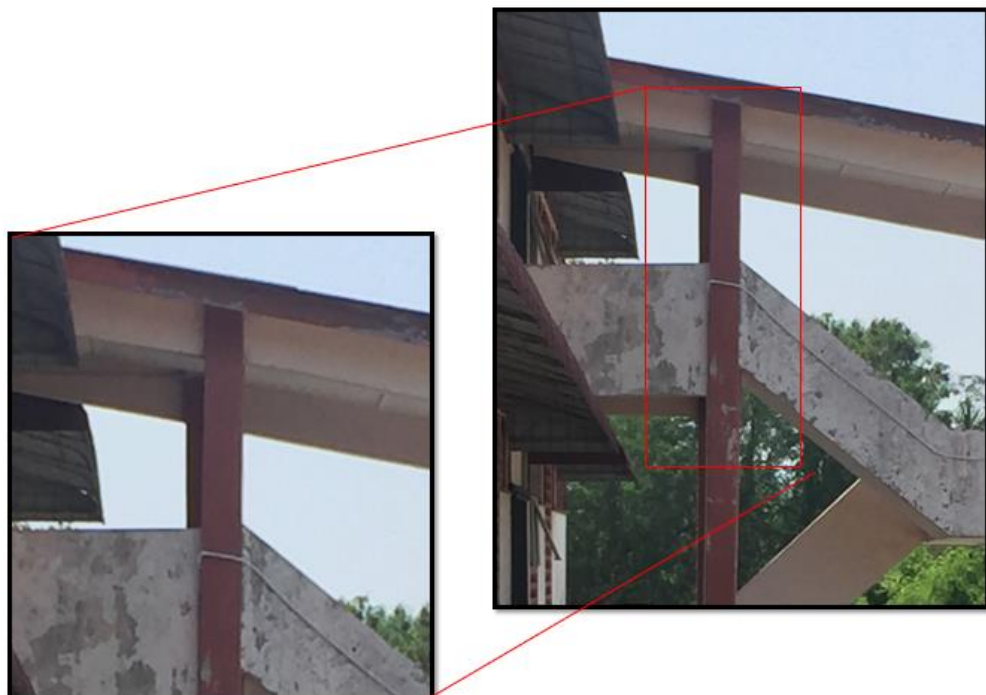
Figure 3.20: show the pole structure that start from the step of staircase at level 1.

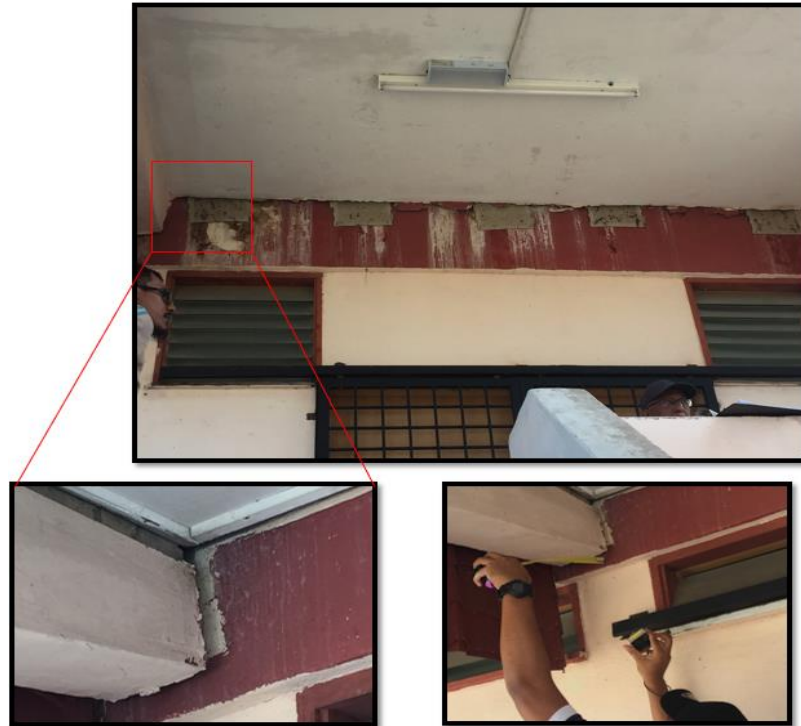
There are the few defects that appear on the staircase based on the Geotechnics Inspection. There has a strain that happen on the staircase which is the magnitude of strain is between 40mm to 50mm

Figure 3.21: strain on staircase beam structure

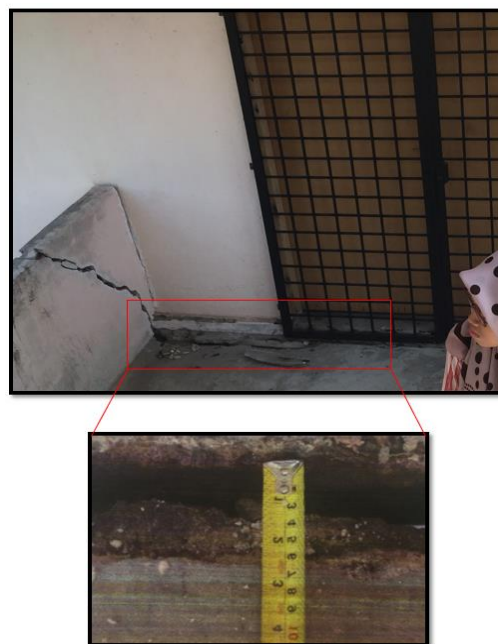
Figure 3.22: strain on staircase slab.

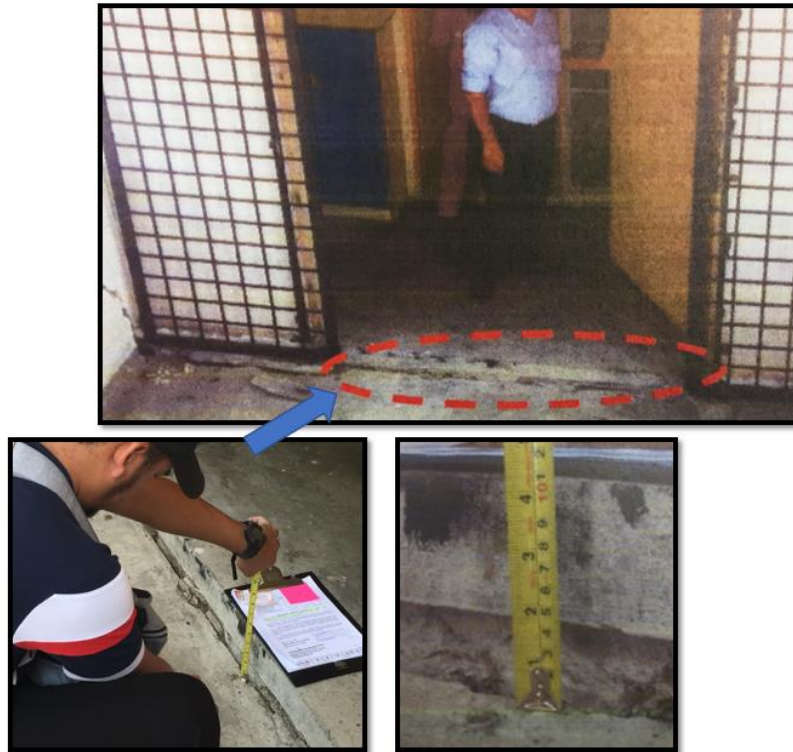
This is the crack that happen on the diagonal parapet wall. The slab beam of the staircase at level 1 was also found there is a deposit which is around 50mm.

Figure 3.23: crack on diagonal parapet wall.

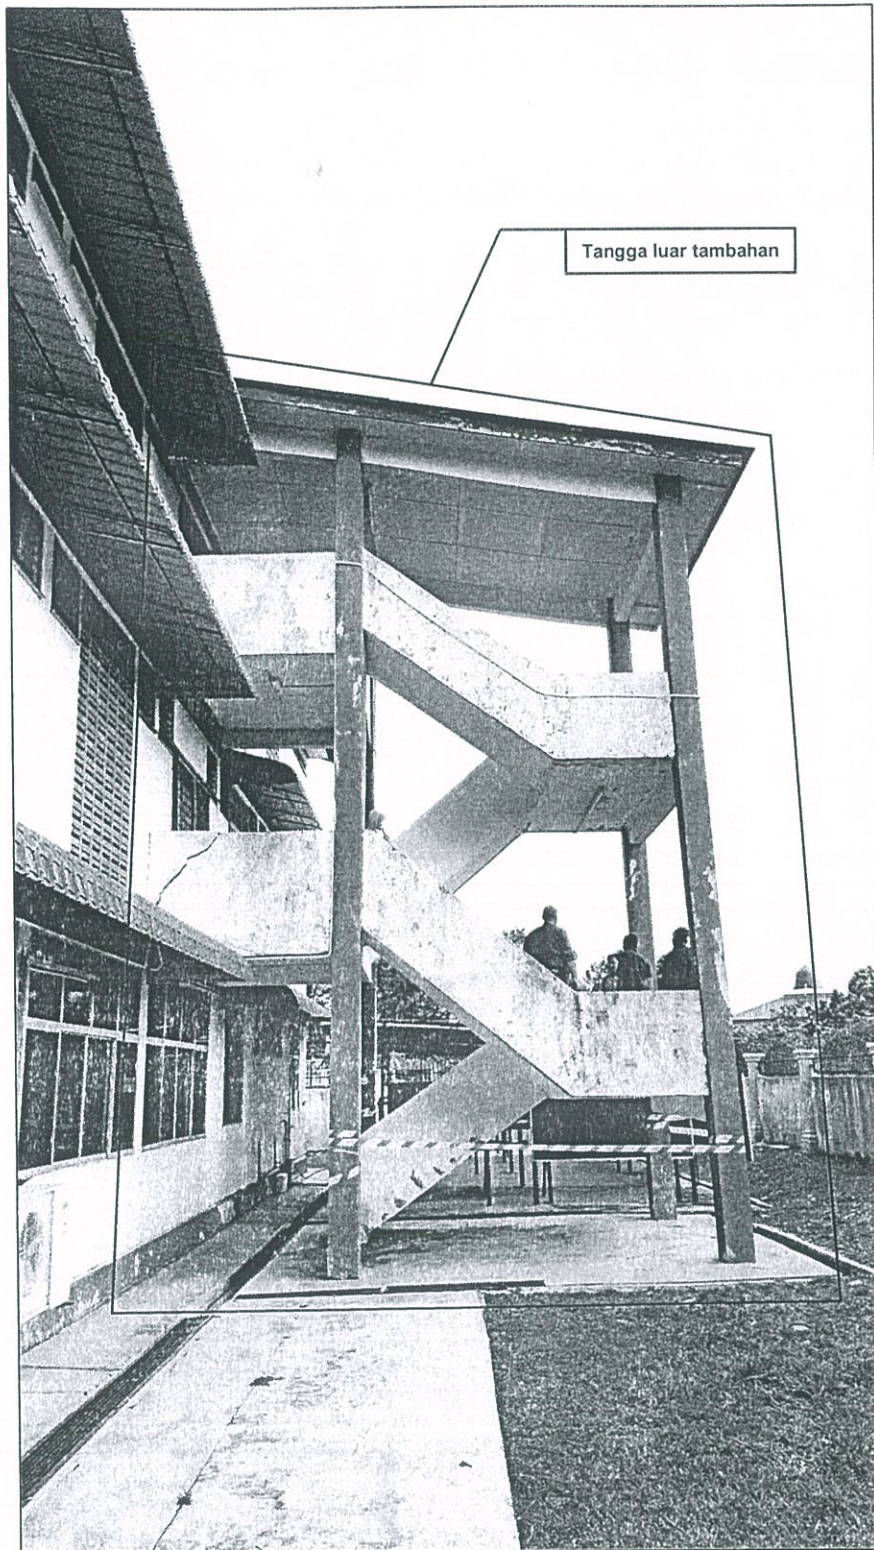
**Lokasi : Tangga 2 (Di bahagian belakang Blok E)**

**Gambar 3** : Salah satu tangga luar tambahan yang dibina berasingan dari bangunan asal asrama. Tangga ini terletak di bahagian belakang Blok E dan telah ditutup dari sebarang penggunaan. Tiada keretakan struktur dikesan pada mana-mana komponen struktur tangga ini.

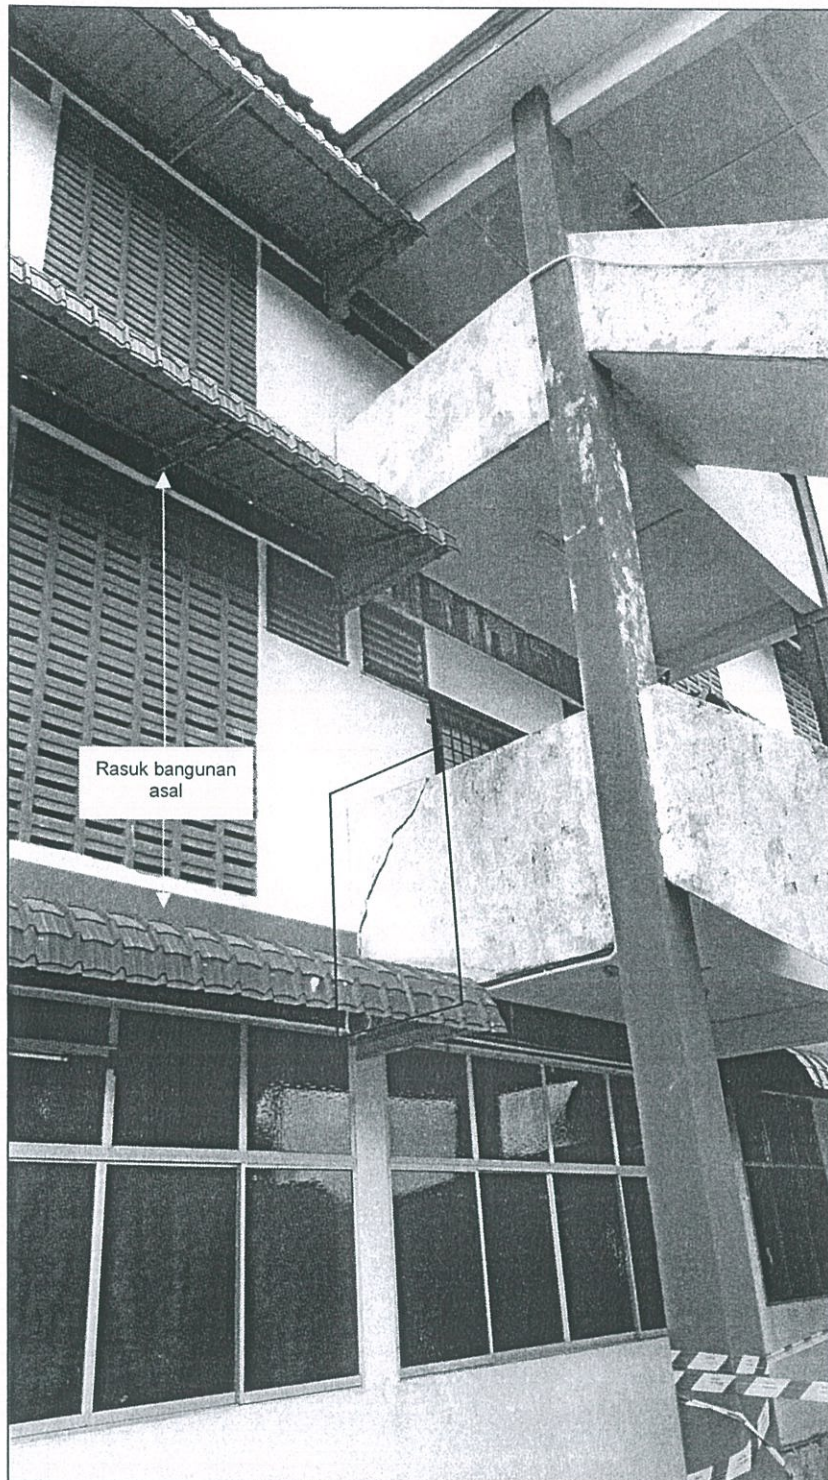
**Gambar 5 :** Pandangan dari luar menunjukkan keretakan pepenjuru pada dinding parapet tangga tingkat satu. Keretakan dikesan bermula dari pepenjuru rasuk bangunan asal.

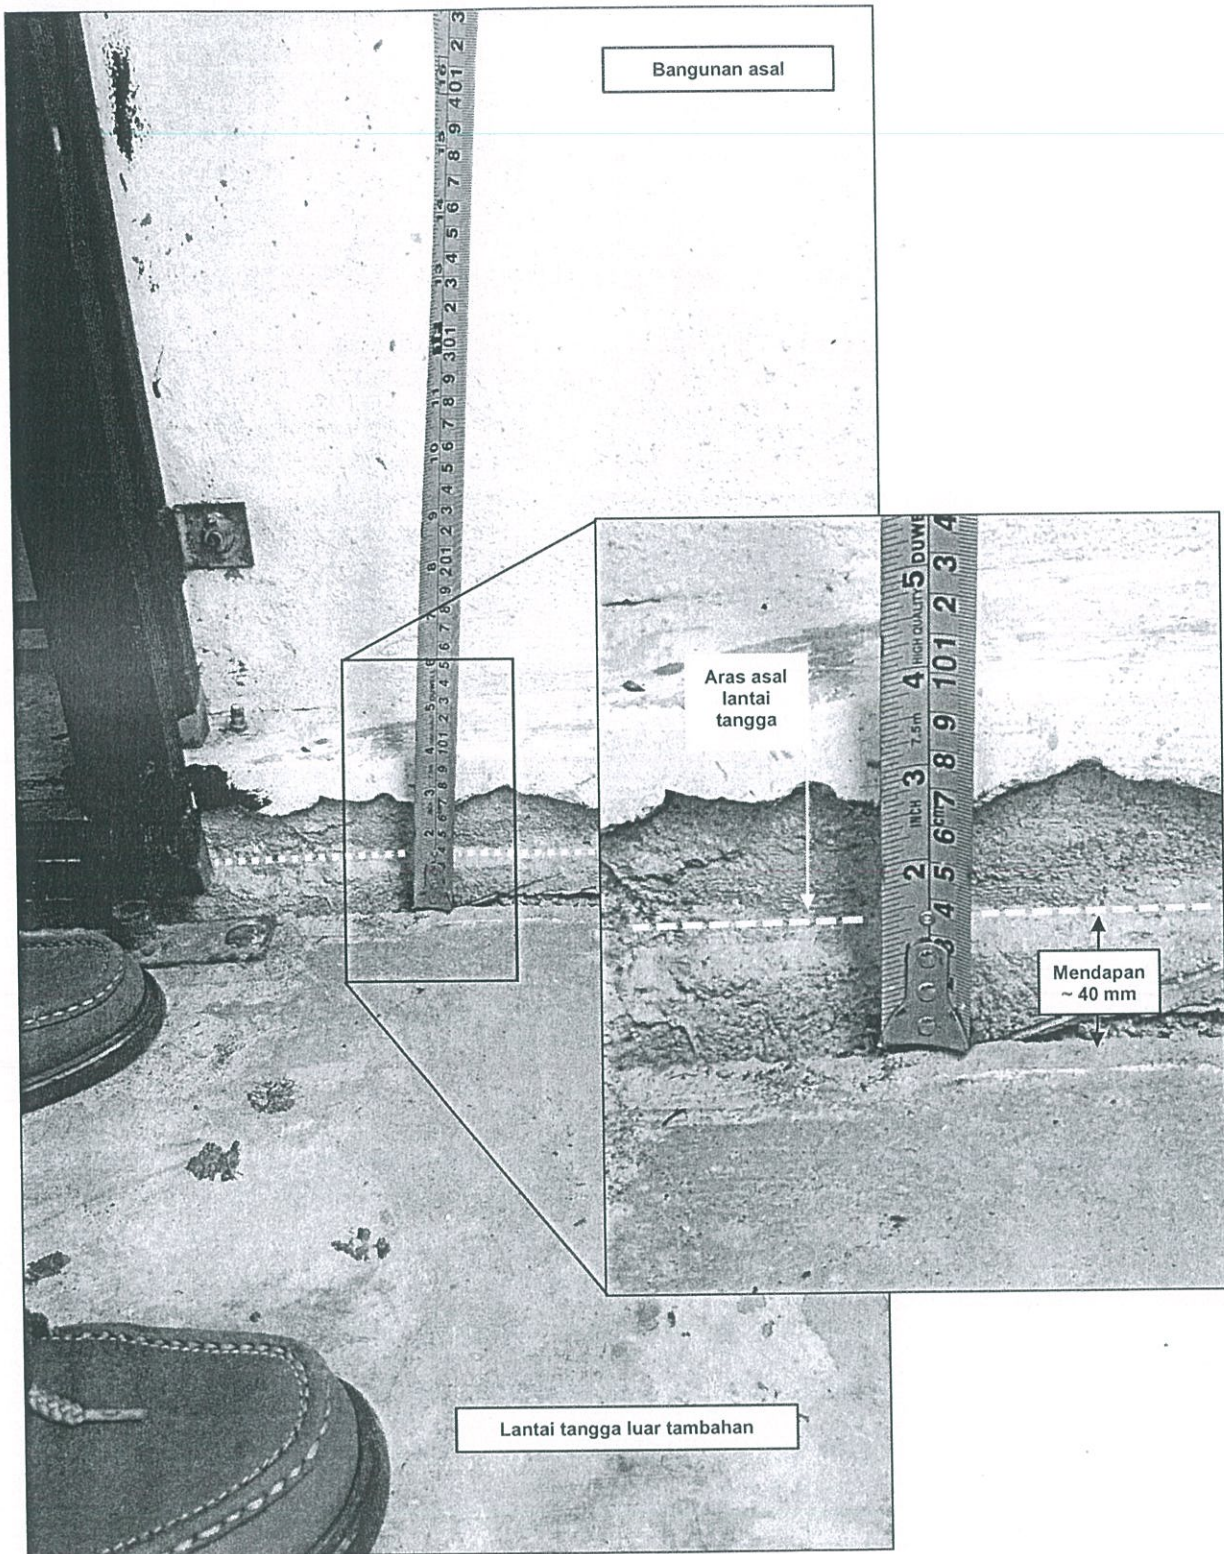
Gambar 9 : Terdapat pemendapan papak tangga luar sebanyak 40 mm dari aras lantai tangga.

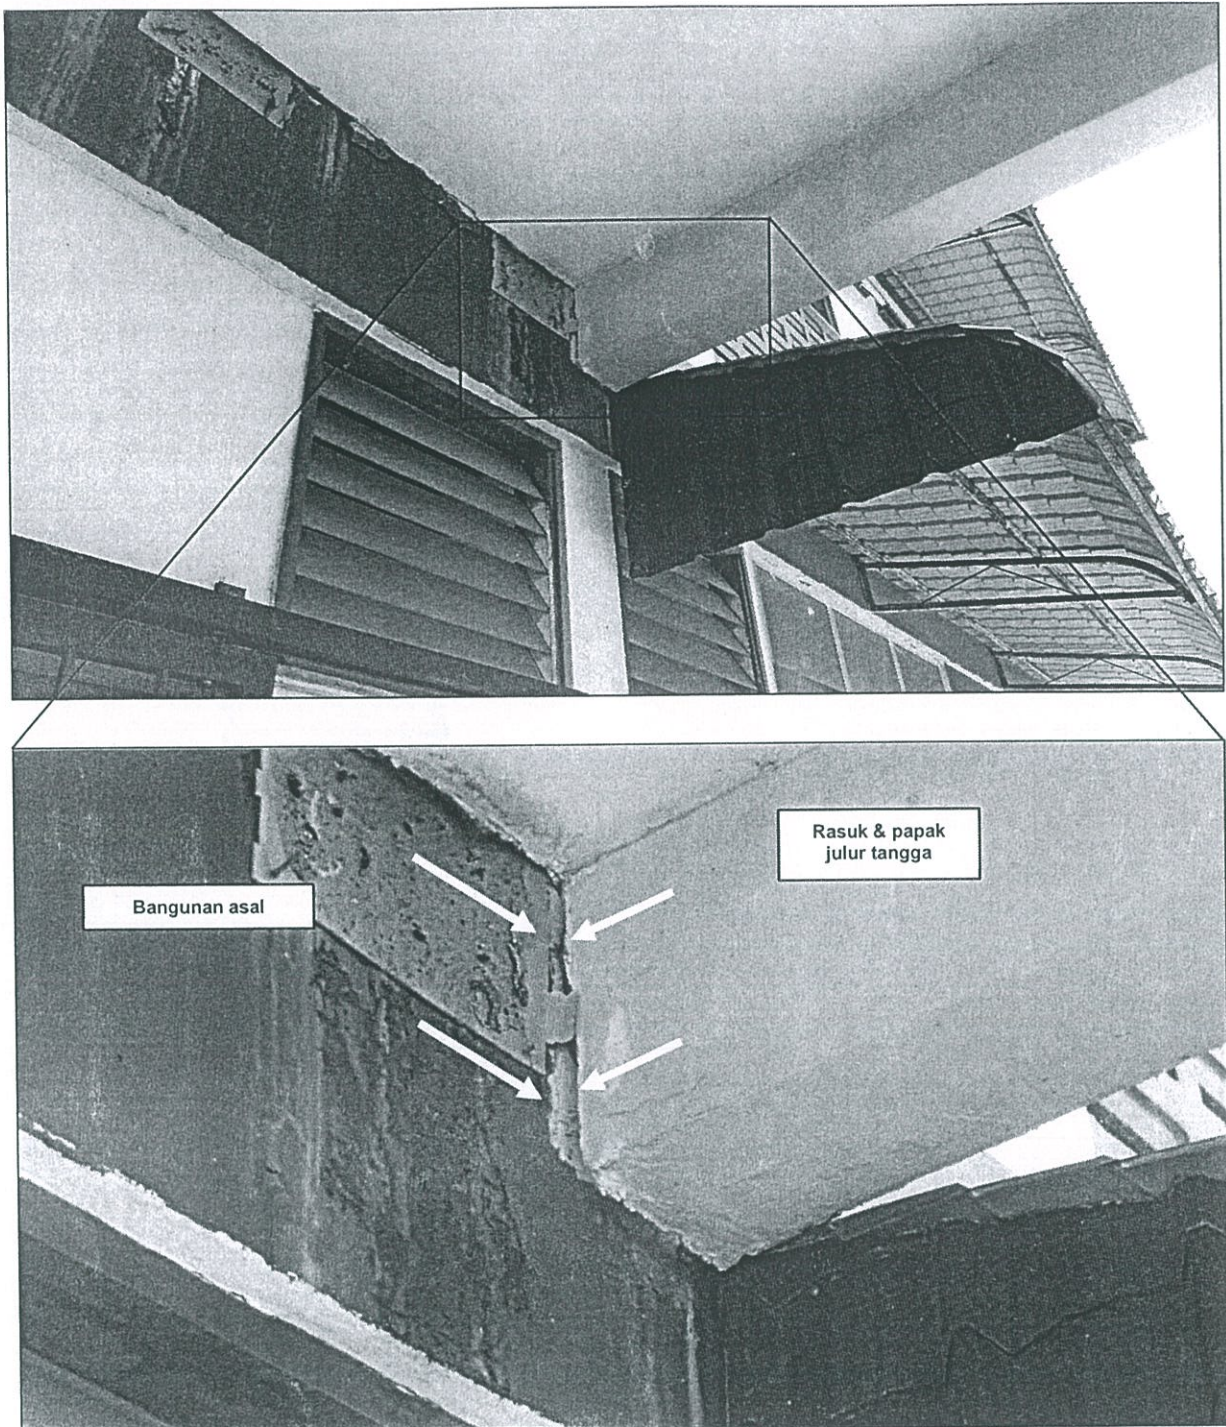
**Gambar 11** : Terdapat regangan di antara rasuk dan papak julur tangga luar dengan bangunan asal. Rasuk juga didapati telah mendap.
