DEFECT IN CONSTRUCTION SITE

**Prepared by:
MUHAMMAD HARITH HAZIQ BIN ABDUL AZIZ
2019435976**

**DEPARTMENT OF BUILDING
FACULTY OF ARCHITECTURE, PLANNING AND SURVEYING
UNIVERSITI TEKNOLOGI MARA
(PERAK)**

FEBRUARY 2022

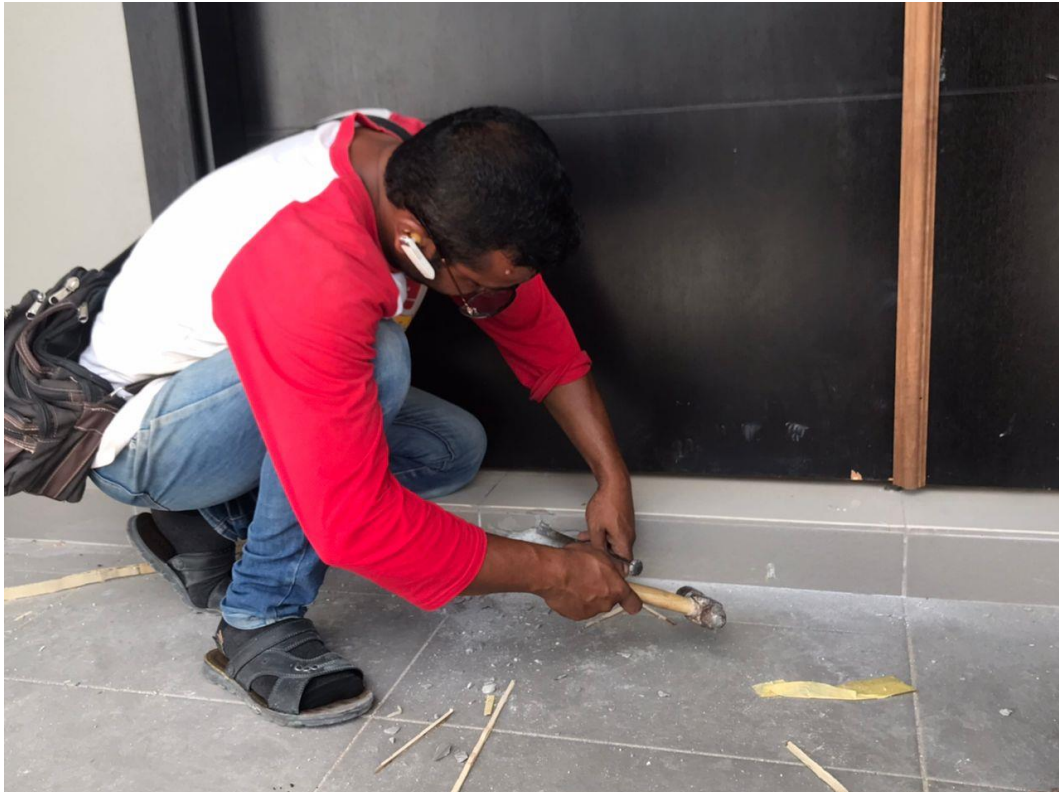
Figure 3.4: The Tiler Do The Rectification Works.

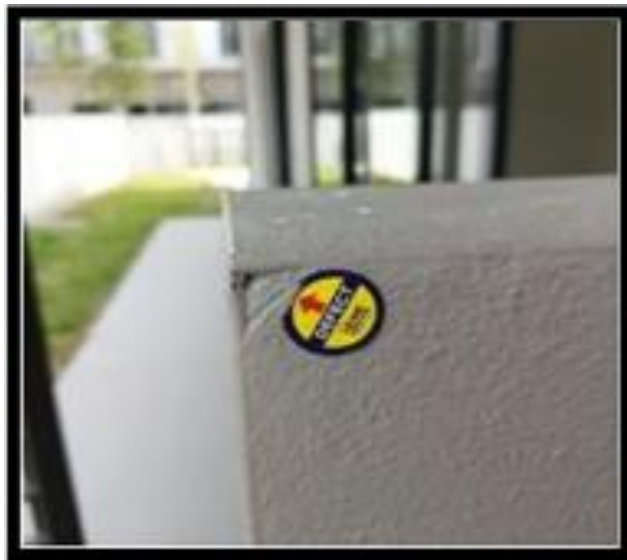
Figure 3.7: Chipping Wall.

Peeling from plaster might be caused by a lack of thorough wetting of the white coat when the plaster was first put, resulting in surface chalking. Another cause of peeling might be the use of a glue size that absorbs water and keeps it beneath the paint. Extreme temperature swings from day to night (from air conditioning) and vice versa, for example, might cause the wall to get moist and peel. It can be fix with by using plaster skim (JOTAPLAST MAX).

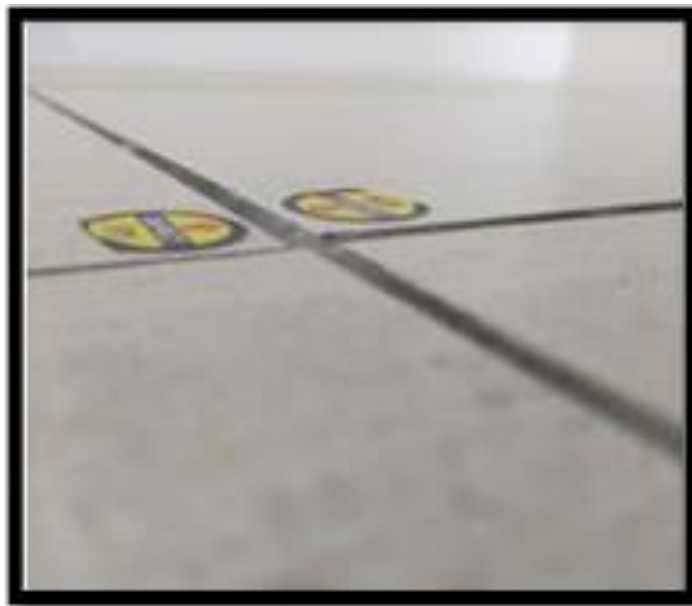
Figure 3.8: Tile Lippage.

Tile lippage happened because of Poor craftsmanship, severe warpage or thickness fluctuation in the tile, an uneven substrate surface, a tile fitted in an offset larger than 1/3 for tiles with edges longer than 18", and grout joints that are too small can all contribute to excessive lippage. Lippage occurs when one tile edge is higher or lower than the adjacent tile and when the surface is not levelled. To fix it by reattach and seal the tile back.

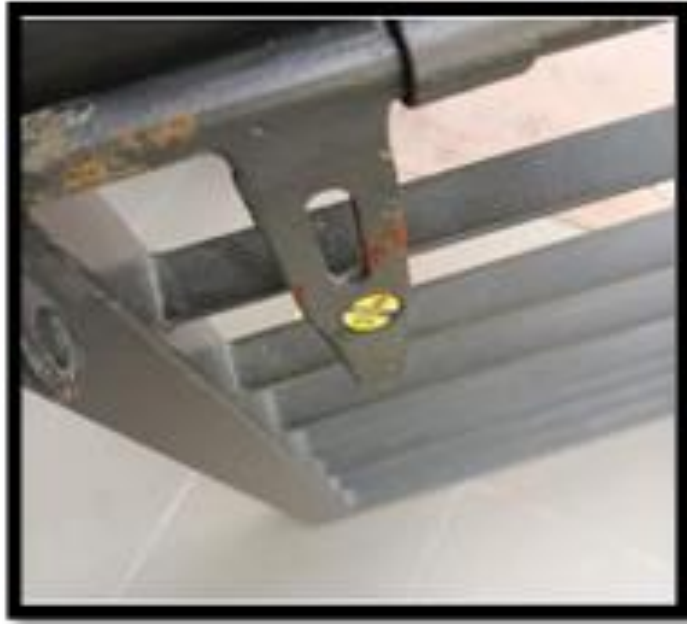
Figure 3.9: Rusty Frame.

This defect is common in house building. When iron and oxygen come into touch with water, moisture, or humidity, a metal gate can rust. Many metals used to make automatic gates, such as iron and steel, are prone to rust. Rust can be reddish, orange, or brown in colour. It may seem powdered, flaky, or crusty. It can be repair by using sandpaper and painting it back. If the defect cannot be fix, replace it to new one.

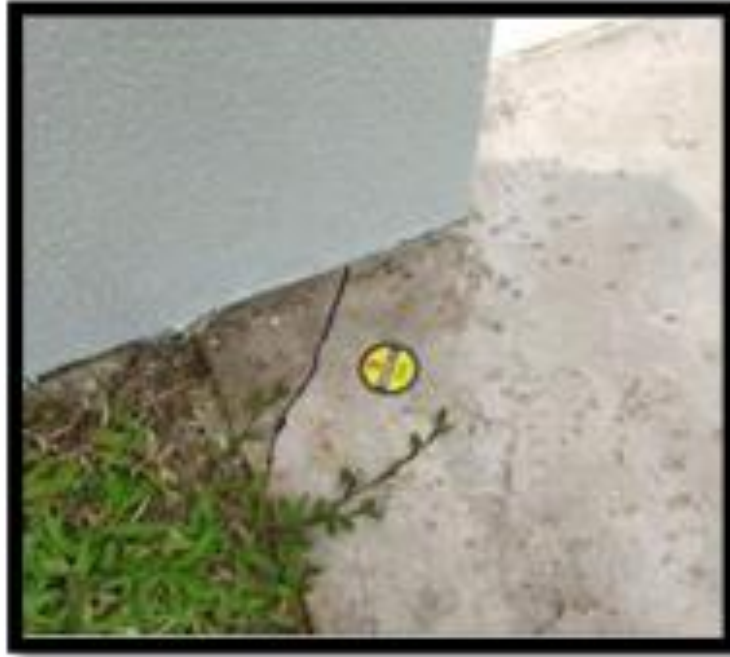
Figure 3.10: Cracked Imprint.

Slab cracking that occurs unexpectedly is a common source of complaints. Drying shrinkage, heat contraction, constraint (external or internal) to shortening, subgrade settlement, and other variables can all contribute to cracking. The overall water content of concrete is the most important element controlling its drying-shrinkage qualities. The quantity of shrinking increases proportionately as the water content rises.

Cracks can also be generated by saturated concrete freezing and thawing, alkali-aggregate reactivity, sulphate assault, or reinforcing steel corrosion. Can used either 2 materials which is Sikadur 215 or liquid repair 1000. If the crack is too deep, use the epoxy injection for the rectification work.

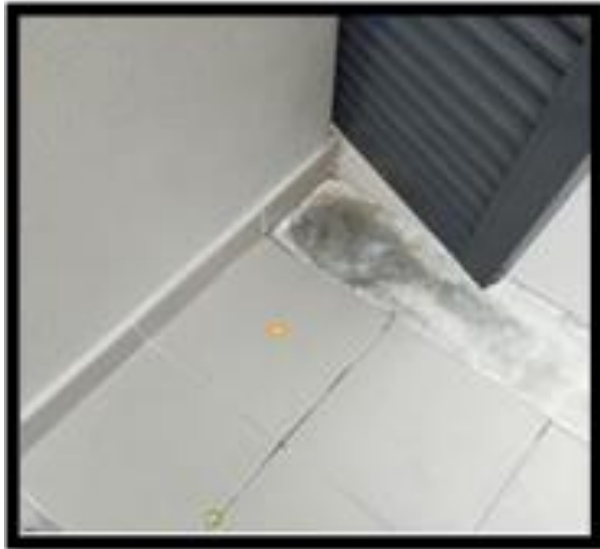
Figure 3.11: Hollow Tile.

Hollow tiling is the most common defect area complaint by owner. The reason why it happens is because during the tile installation, poor quality components such as screed, mortar, glue, and/or the tile itself were used. Lack of oversight and poor craftsmanship (the way the tile is set, the mortar & slurry is produced, the glue is utilised, and so on). Furthermore, an uneven flooring or incorrect subfloor cleaning prior to tile installation prevents the formation of a consistent adhesive bonding layer. If the flooring is directly exposed to sunlight and the adhesive/bonding layer is not solid, debonding due to tile expansion is a possibility. Tiles may pop up or buckle as a result of this.

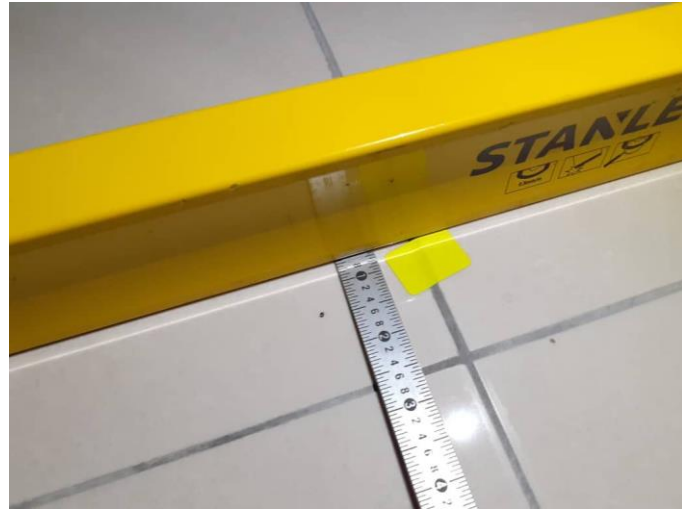
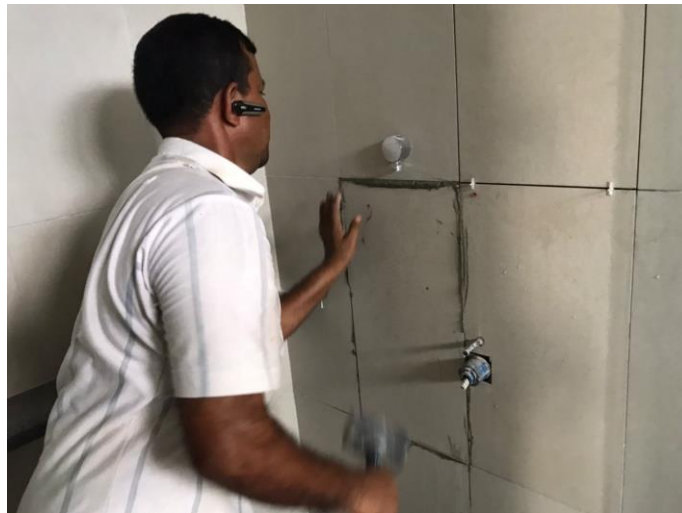
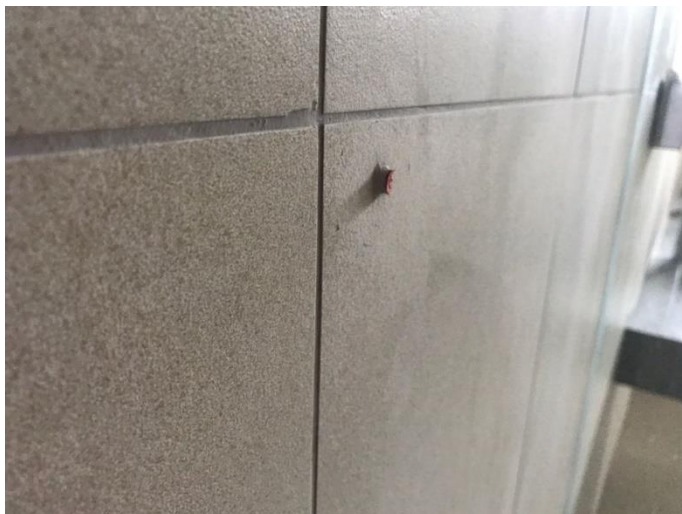
Due to the activity of the employees, this problem commonly arises during construction. First of all, this problem is caused by poor workmanship or poor installation. It because when the surface in not levelled and tile lippage happened. Besides that, the grout joints is too narrow. Narrow grout joints may look pleasing to the eyes, but it increases the chance of tile lippage. At the same time, the certain areas of the tile is hollow because of the tile is not bonded properly with mortar on the tile surface. This problem is found when the site supervisor inspects the the tile after the tile installed, this problem is discovered. The site supervisor using the spirit level to identify the tolerance given for hollowness and lippage. If the tolerance is not too much, the tile hollowness and lippage is accepted.

Figure 3.17: Checking the Tolerance with Spirit Level.

Figure 3.18: Tile Installation.

Figure 3.19: The Finished Work.

Repair work was required after the site supervisor noticed the wall was in bad condition. The way to repair the lippage and hollow tile is cut around the tile section carefully so that the tile can be reused. After that, remove all old plaster thoroughly before applying new plaster using this materials which is cement and Weberset CTF Grey as ceramic tile adhesive. Use a rubber mallet hammer to compact and level the plaster all over the space. These process are important so that tile is in good after installation and to avoid the same mistakes.

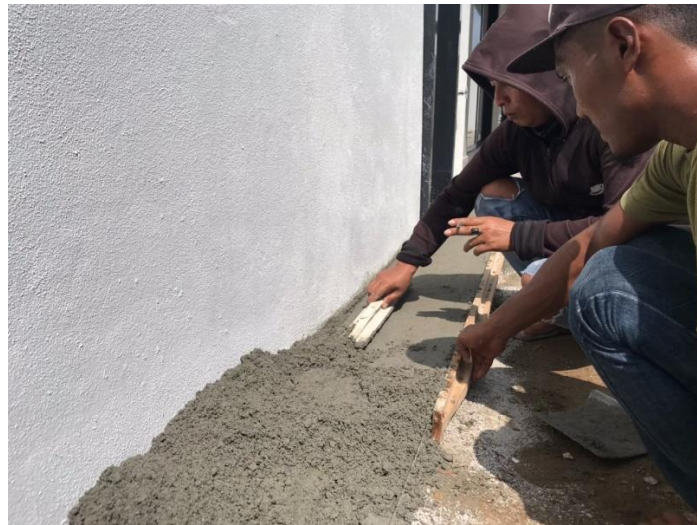
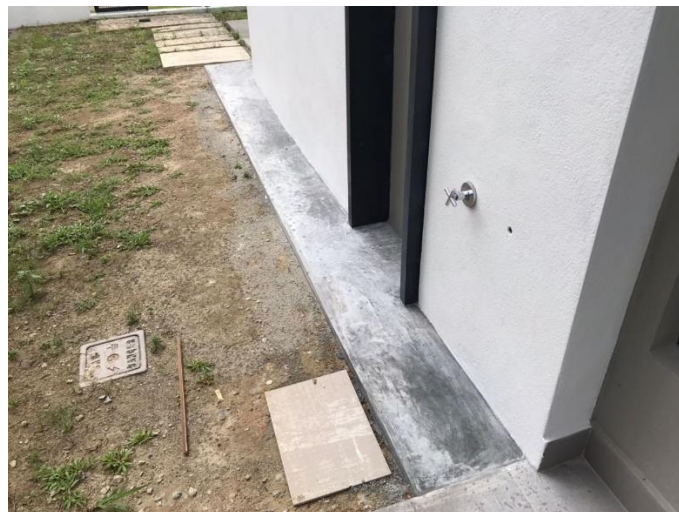
This problem arises when the owner went to his new house due to inspection, he found the apron slab of his house has hairline cracked slab. He asked the site supervisor to fix the slab as soon as possible. The supervisor inspects the cracked slab and asked the workers to repair it. The slab need to epoxy for the rectification works. This problem occurs there is a possibility of heavy objects that fall on the slab such as bricks, hammer and so on and cause the floor to crack.

Figure 3.20: Progress of Rectification Works.

Figure 3.21: The Finished Work.
