**FACULTY OF ARCHITECTURE, PLANNING AND
SURVEYING**

DIPLOMA IN BUILDING

**PRE-CONSTRUCTION DILAPIDATION SURVEY ON
BUILDING AND ROAD INFRASTRUCTURE AT SUNGAI ARA
PENANG**

FEBRUARY 2022

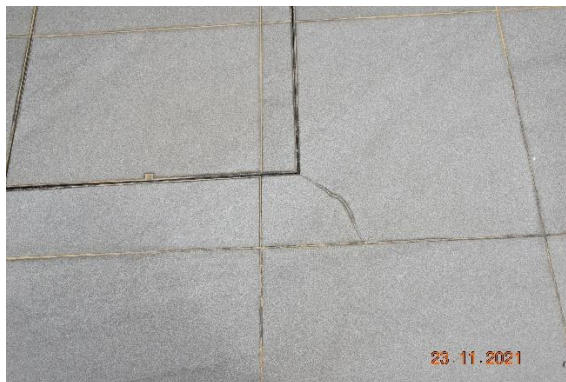
Figure 3.2: Crack on floor tiles

Figure 3.2 was showed that cracked was located on floor tiles and that is means the cracked is less than 5mm because the picture it does not show that crack ruler was exist in that photo. For instance, when the crack ruler was existed in the photo that is means the cracked is above than 5mm or maybe more.

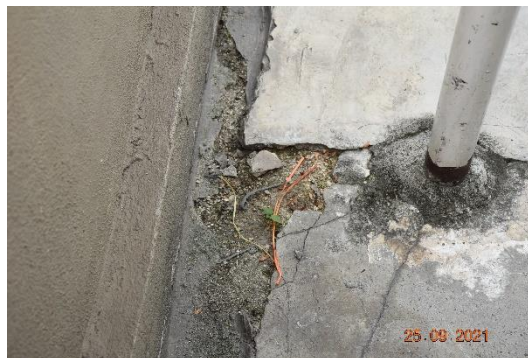
Figure 3.4: Chipped off cement screed.

In figure 3.4 was showed the defects was located on apron which is the back lane of the house between drainage and drain wall. It was cleared that defect was obviously chip off because can see something come off in flakes.

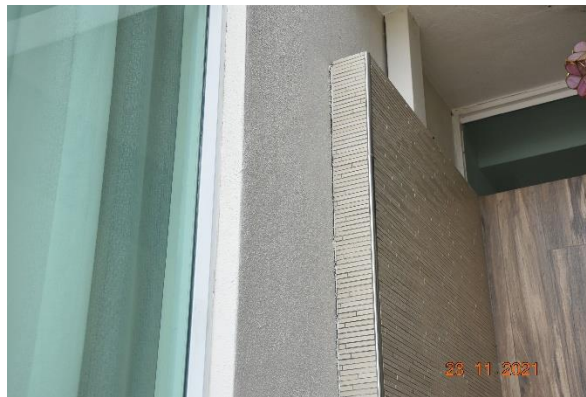
Figure 3.5: Separation gap on wall tiles.

Separation gap is the building has gap between one element in building which is the easier that can be found between wall to wall, between skirting and wall, wall and door frame. This is because when the underground piling has started it can affected to elements in building because of soil movement. In addition, for water stain mark it usually happened because of leak pipe.
