**THE CONSTRUCTION OF
REINFORCED CONCRETE BEAM FOR
LOW-COST BUNGALOW IN MUKIM
NAGA**

MUHAMMAD RIDWAN BIN MUSA

**PRACTICAL REPORT TITLE
THE CONSTRUCTION OF REINFORCED CONCRETE BEAM FOR
LOW-COST BUNGALOW IN MUKIM NAGA**

JANUARY 2021

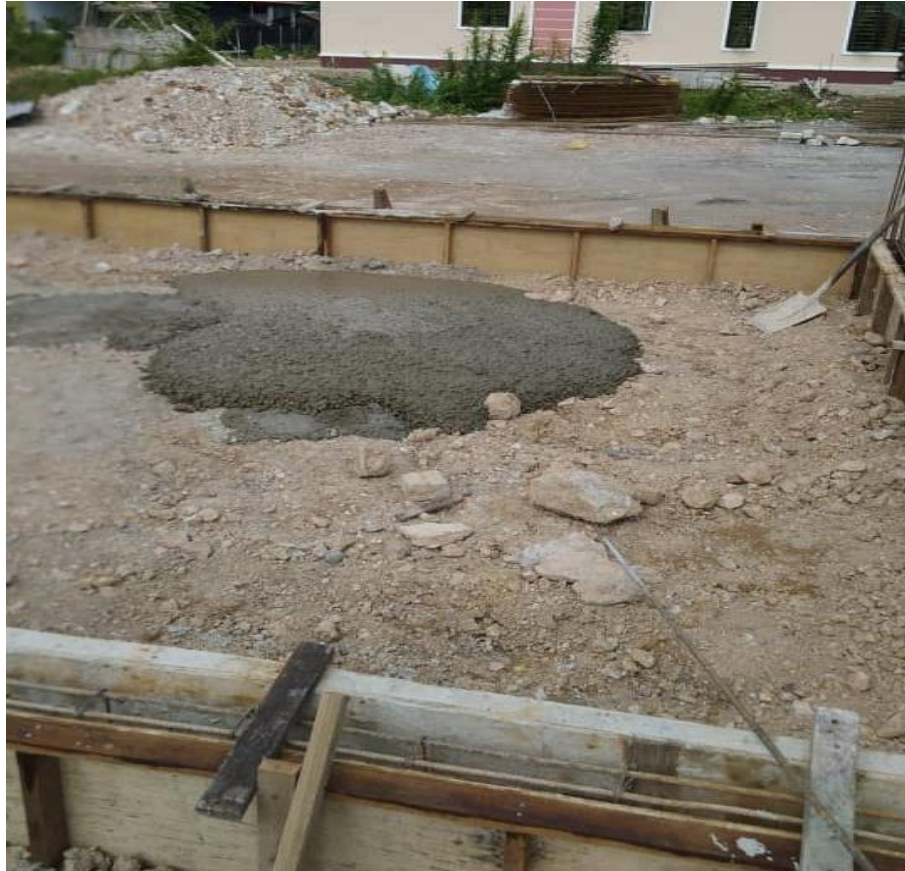
After that, the worker used a trowel to distribute the concrete evenly on the surface before making sure the concrete was only 14 inches. Upon of this, there were 2 inches of the links appeared with upper Y10mm steel that tied to the links. The shortage of labor made the progress of concreting slowed and yet there were some of the beam's formworks that had not been filled with concrete. The concrete was not fully used because most of it started to harden. So the truck driver threw the balance of concrete that had not been used around 1m³ yet into the house area. The driver also needs to go somewhere else for his duty. The concreting work can't be continued after that because of heavy rain.

Figure 10.0: The balance of concrete that starts to harden that dumped by the truck.

As the result, some of the beam's formworks were poured with the concrete made by the worker by using the concrete mixer at the site on the next day. According to Hussain (2017), this method was called the construction joint which is be defined as stopping positions in the concrete casting, and they are needed because of the impracticality to cast concrete in one continuous process.

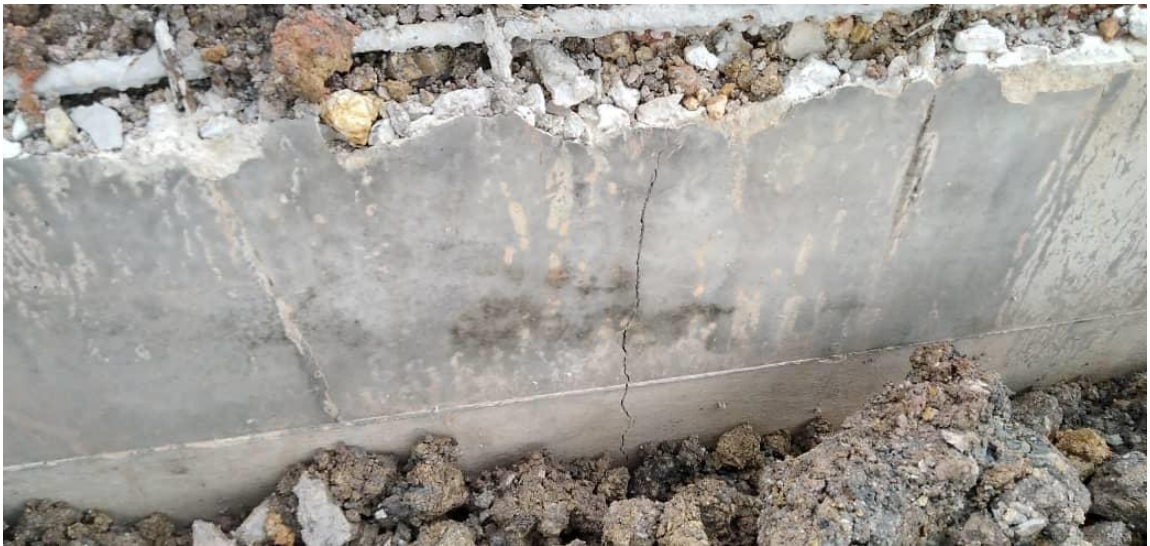
After the concrete had fully cured, the formworks were inaugurated on October 30, 2021. The labors gathered all of the formwork in one location and organized it, including the short woods, after they had opened all of the formwork. There were a few cracks found on the hardened concrete. The honeycombs were also found on the hardened concrete but in small quantity and small size around 1 to 3 inches. All the cracks and honeycombs were repaired and fixed by using the step in subtopic 3.3.

After the ground beam's formworks were opened and gathered in one place. The color of the ground beam concrete was brownish. The supervisor teams were checked for any cracks or spalling that formed on the hardened concrete beams. The crack and spalling are the common problems that came after the concrete was fully hardened. There were 12 cracks and 8 spalling found on the hardened concrete beams. Cracks in concrete may occur in both the plastic state as well as hardened state owing to the internal stresses that arise from the response of the constituent's materials to the external excitation as well as their environment. According to Atif (2006) cracks in hardened state occurs due to design errors, construction defects, inadequate cover to reinforcement, incorrectly made construction joints, poor compaction, segregation, poor curing, the loading of the structure

in excess of the design load, due to change in use, unforeseen accident, such as explosion, impact and accidental effect due to fire. Honeycombing in concrete is when the finished concrete has air voids in it or most of the aggregate without mortar between them. The cause of honeycomb in concrete is the mortar not filling the spaces between the coarse aggregate particles. It can be seen right after the formwork is opened, showing the voids between the coarse aggregates and stony concrete surface. Most of the honeycombing in concrete happens because of the over-used reinforcement bars in small formwork and improper vibration of concrete during in formwork.

Figure 13.0: The cracks that been spotted during the inspection

Both problems that has been stated can reduce the strength and the durability of the concrete. The solution used by the workers and the supervisor for this problem was hand-applied mortar. The workers have used the mortar that mixed with water to patch the honeycombs and the cracks that have been found. This method is suitable for the small and isolated areas that have honeycombs or cracks. The workers were used epoxy which was cement-based by following the manufacturer's instructions. According to Atif (2006) The thickness of the layer built up and application procedure can vary greatly depending upon the material used and the orientation of the surface being repaired. A typical procedure is to apply layers of 25-50 mm thick for vertical work and 20-30 mm thick for overheads areas in each layer. Care should be taken when additional layers to ensure that the previous mortar has gained sufficient strength but has not been set. The hand-applied mortar method was using a trowel, bucket, and the surrounding concrete as a guide.

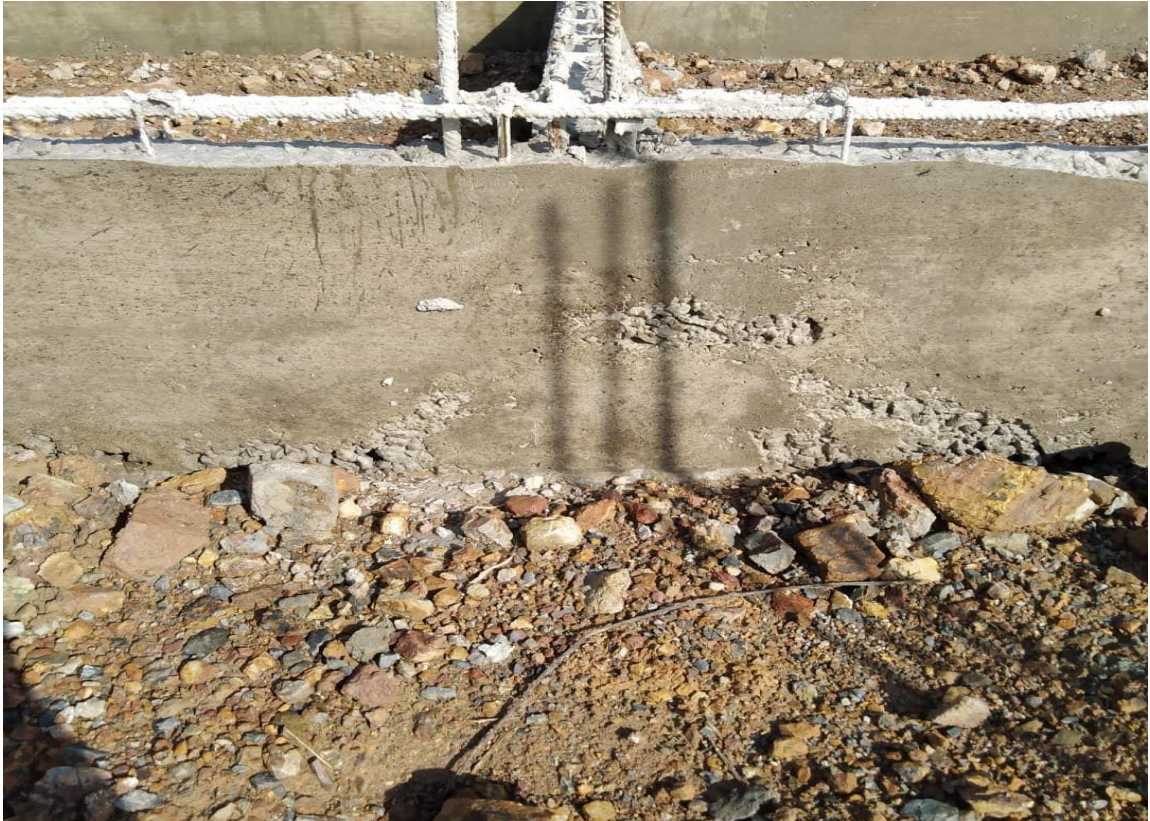
Figure 14.0: The honeycombing in the concrete formed and spotted after the formworks were opened
