ASSET MONITORING PROCEDURE IN PUTERI ISLAND RESORT

MUHAMMAD SHAHID BIN MUZAFAR 2019443544

DEPARTMENT OF BUILDING FACULTY OF ARCHITECTURE, PLANNING AND SURVEYING UNIVERSITI TEKNOLOGI MARA (PERAK)

(10th January 2022)

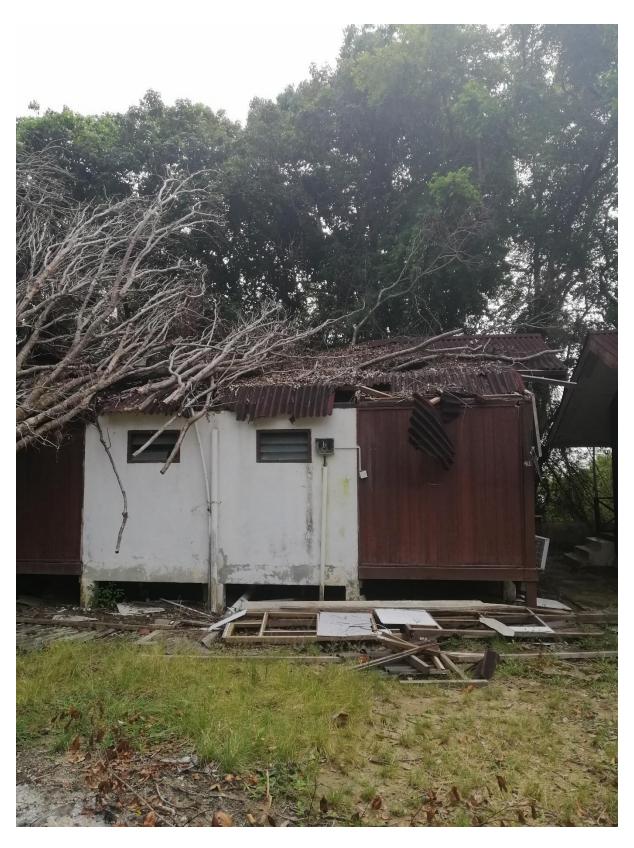
Last but not least, the problem faced during monitoring work is damage problem. This is a common problem for any building, since the resort has been in operation for a long time because it was built in the 90s. There are two types of damage problem, which is minor damage and major damage. Example of minor damage is non-structures such as broken doors, windows and leaking ceilings. While the example of major damage is severe structural damage such as perforated roofs, broken walls and perforated floors. Minor damage problems do not have a significant impact on monitoring work procedure. However, major damage problems will affect the work procedures as the officers cannot enter the damaged building to perform monitoring work due to safety factors.

Figure 3.5 Damaged chalet roof because of fallen tree due to storm.

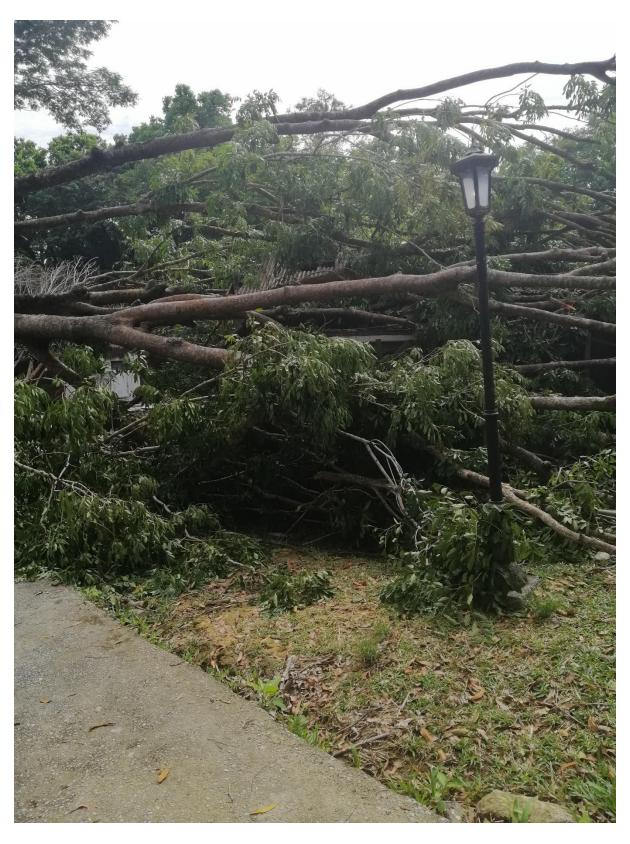
Figure 3.6 A total loss chalet.
