## **BUILDING RISK ANALYSIS AND INSURANCE**

PRACTICAL TRAINING REPORT

# AVENUE D'VOGUE

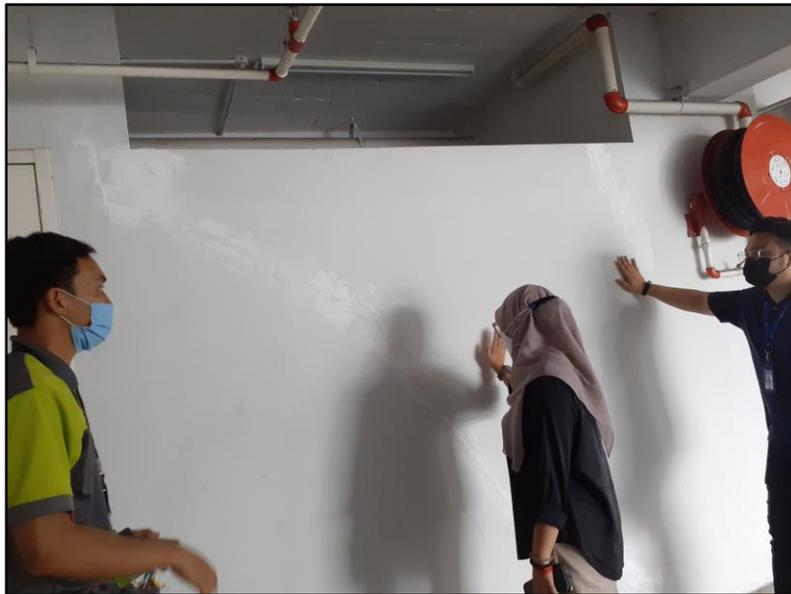
*Picture 11: Building Audit with Technician, Mr. Aidil*

Building auditing will be carried out with the assistance of technicians in order to examine and identify the existing condition of the site. Only physical and visual inspections are needed to conduct a building audit, and there are few essential items that are frequently given attention during the building audit. Few of them such as fire alarm panel, genset room, lv room, barrier gate, CCTV, lift motor room, water tank, aviation obstruction light, plate glass, and common property. Pictures were taken throughout the inspection to enable the process of documentation after the inspection carried out.

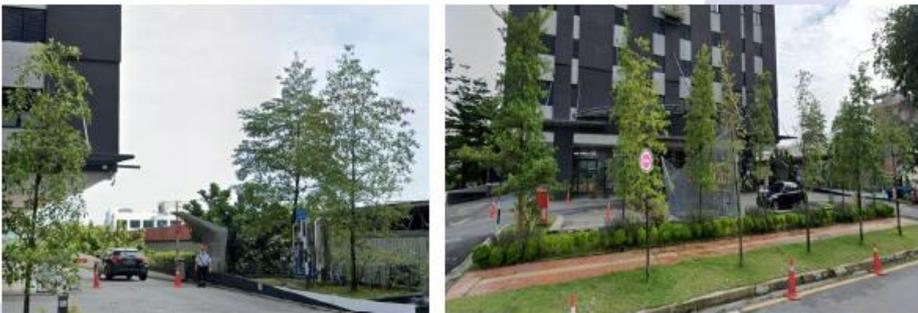
2) **Damage by Falling Trees**

Recommended to include this peril to cover the fences/awning/roof damaged caused by the falling trees in and/or outside the compound of Menara Inspiration. (see image below)

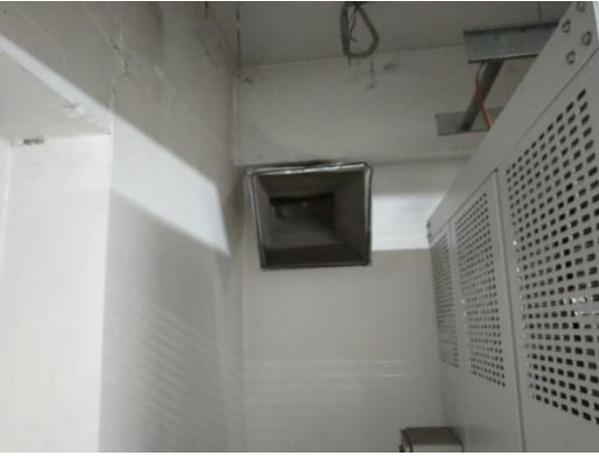
- **Ventilation system has faulty and cause the room to overheat.**

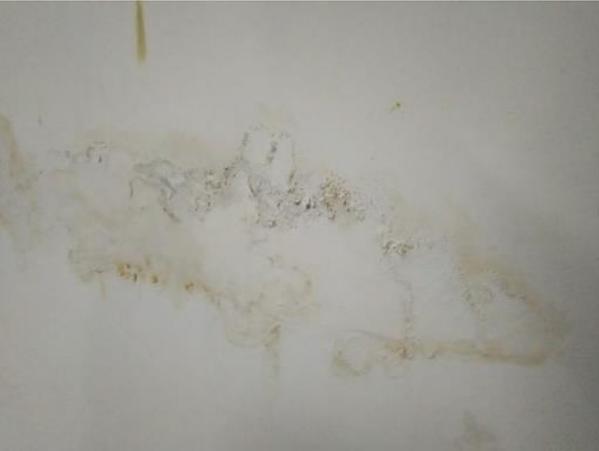
- **The bulging of paint and water stain appears at the RC tank.**

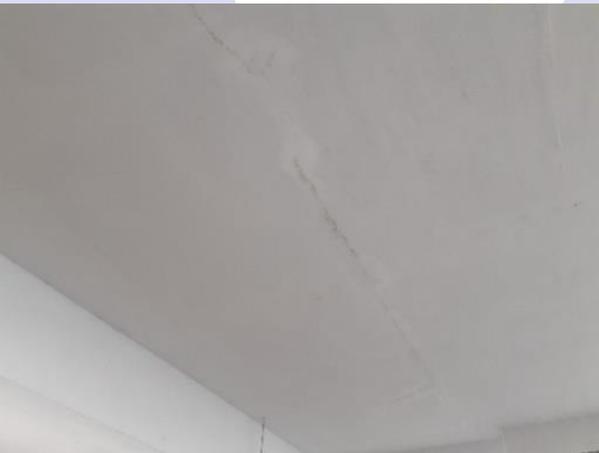
- **The ceiling of basement parking shows hairline crack.**

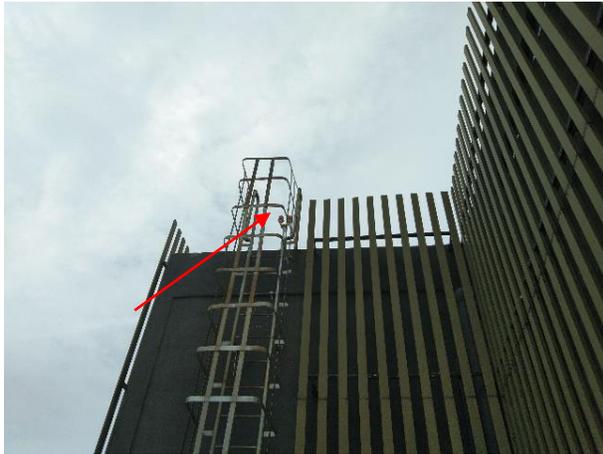
- Aviation obstruction light faulty may be due to lightning arrester

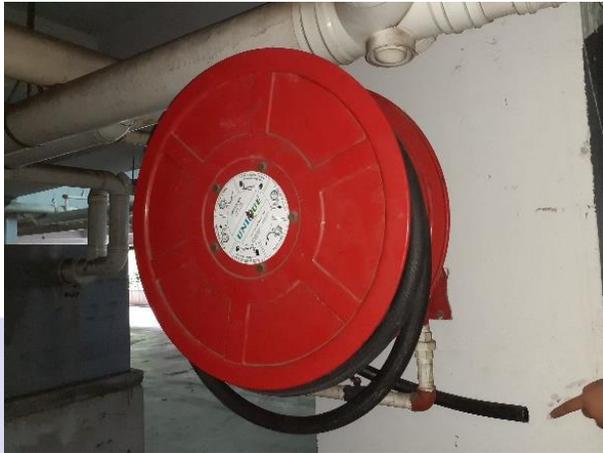
- Hose reel situated in safe condition. However, the fire nozzle was found missing

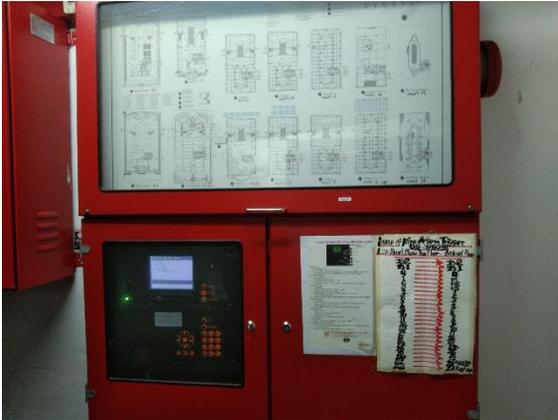
Picture 1.1

1. Main fire alarm panel functional and in good condition.

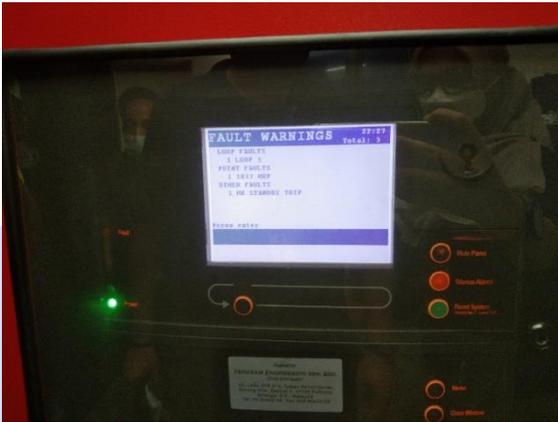
Picture 1.2

2. It shows faulty due to unattached cable at the pump room.

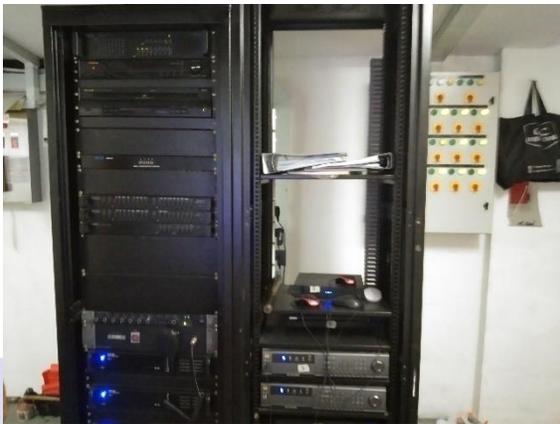
Picture 2.2

**2. DVR in good condition and well-maintained**

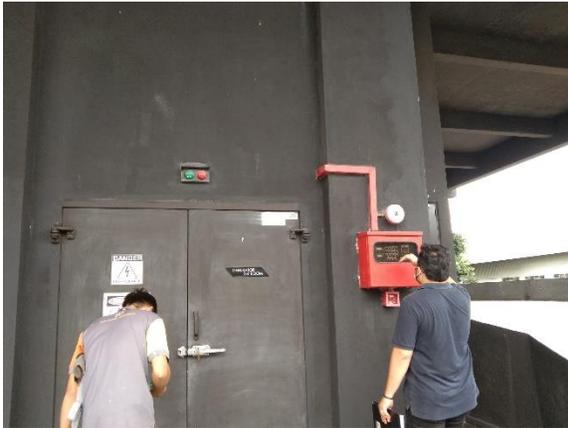
*Picture 3.1*

- 1. Light alarm indicator and fire alarm panel fully operate and in good condition**

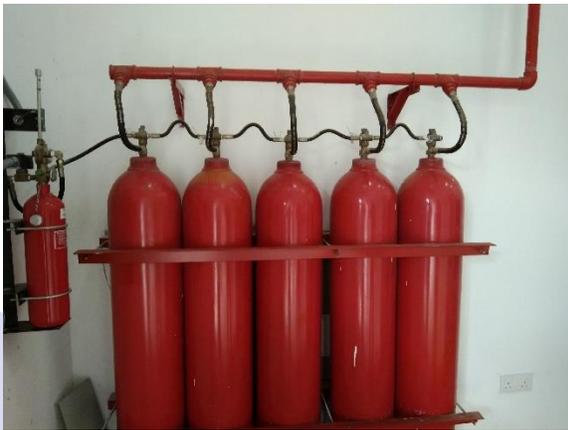
*Picture 3.2*

- 2. CO<sub>2</sub> cylinder installed in good manner and in good condition**

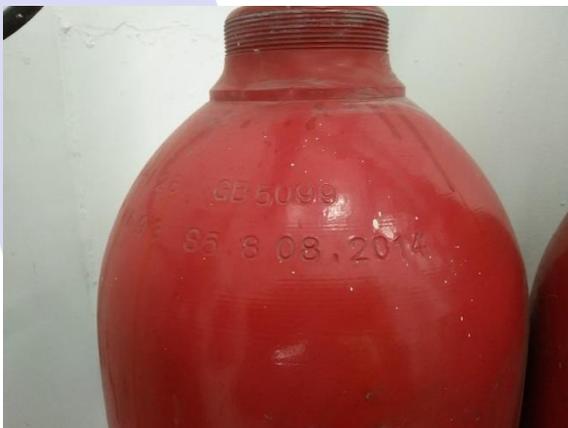
*Picture 3.3*

- 3. CO<sub>2</sub> cylinder stamping shows manufacture year in 2014**

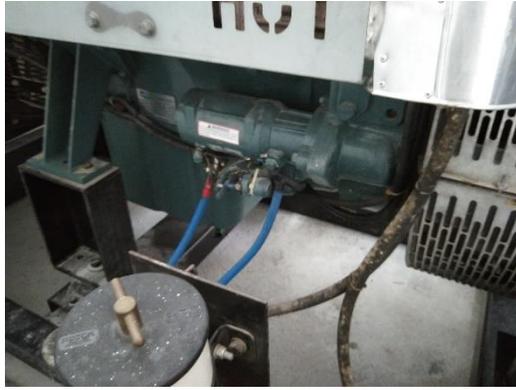
Picture 3.8

**8. Auto starter in good working condition**

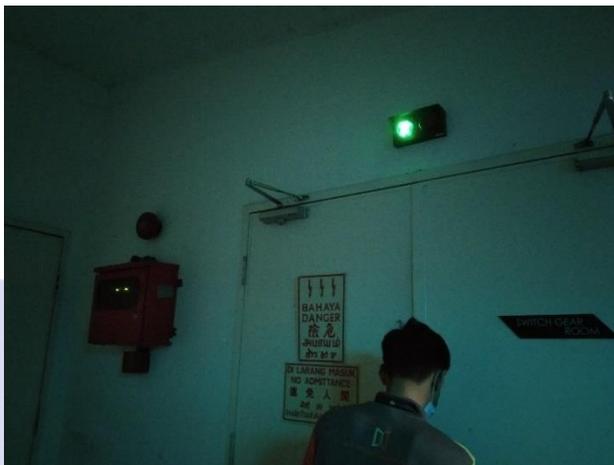
Picture 4.2

2. Fire alarm panel and light alarm indicator in good working condition.

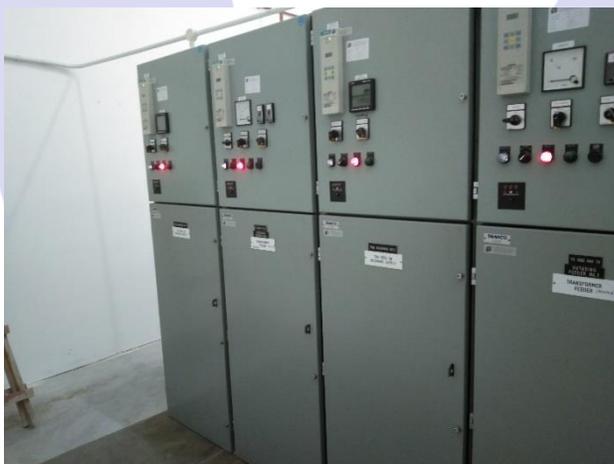
Picture 4.3

3. The switch panel in good working condition and serviceable repair.

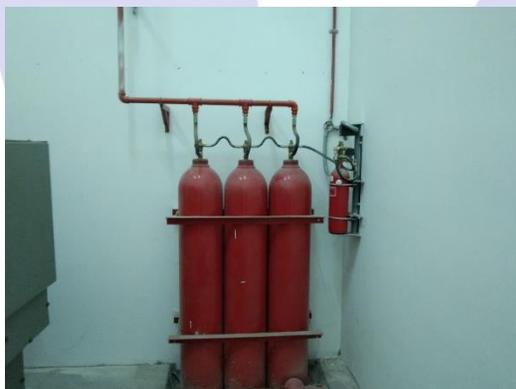
Picture 4.7

7. CO<sub>2</sub> cylinder positioned in good order and satisfactory condition.

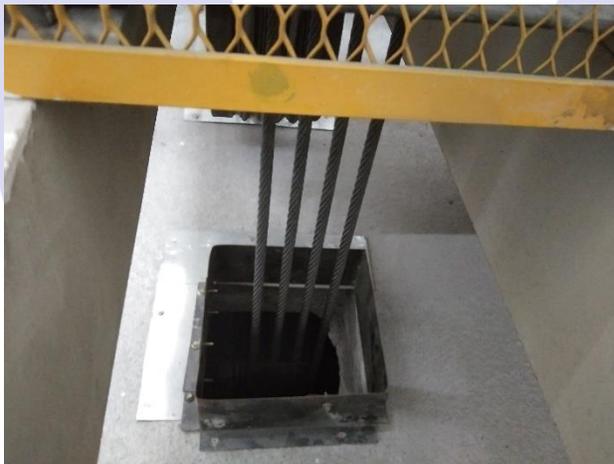
*Picture 5.3*

**1. Lift motor room appears in good condition.**

**2. Lift motor in good working condition**

**3. Lift rope in good condition. However, the inspection does not cover the entire length of the rope and assessed based on visual inspection only.**

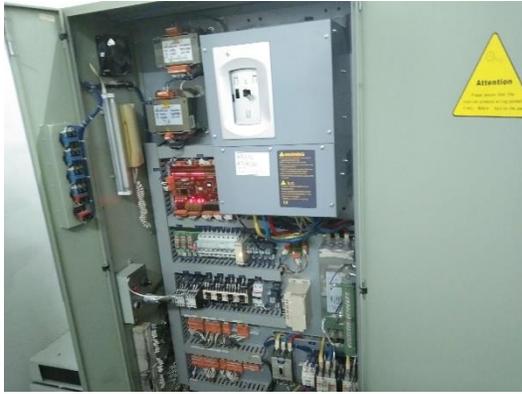
Picture 5.4

**4. Lift motherboard in good working condition and well-maintained.**

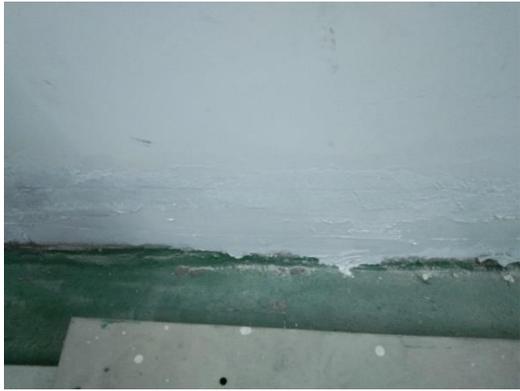
Picture 5.5

**5. Water proofing which was installed by the technician.**

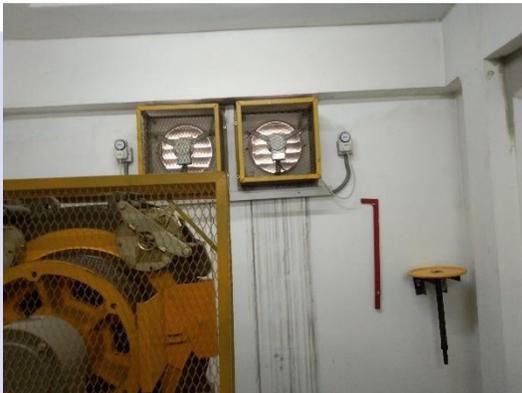
Picture 5.6

**6. Ventilation fan in good working condition. the present of stain at the wall was due to previous issues occurred.**

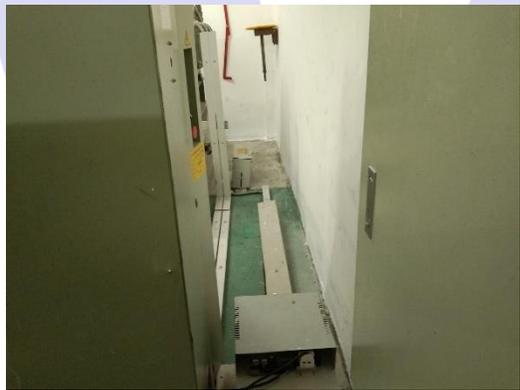
Picture 5.7

**7. Copper tape in place and secured.**

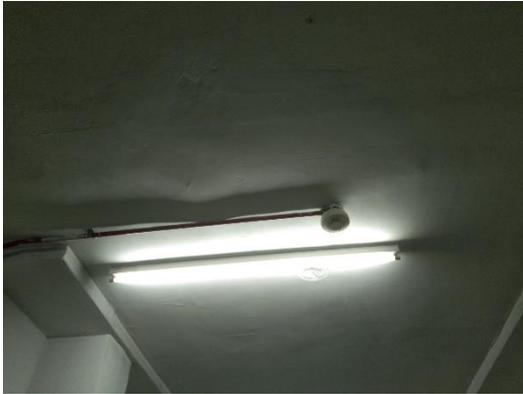
Picture 5.8

**8. Smoke detector installed in place and in good working condition.**

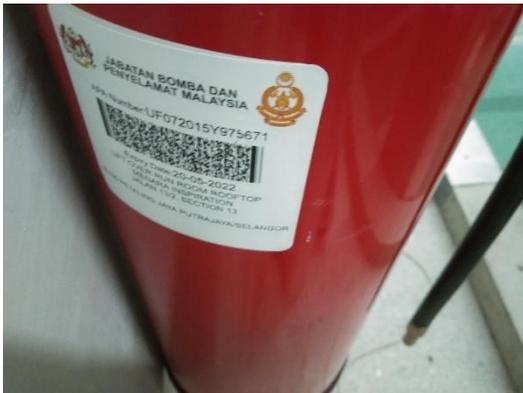
Picture 5.9

**9. Fire extinguisher expiry on 20/05/2022**

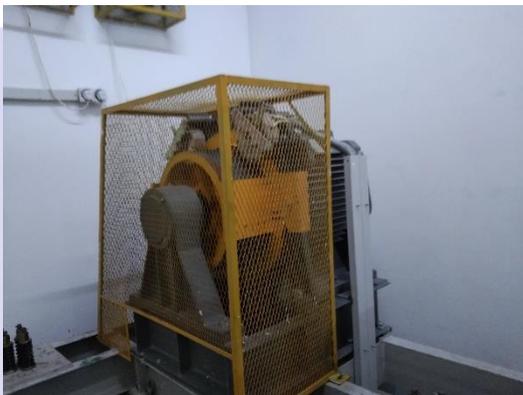
Picture 5.10

**10. Lift motor in good working condition and well-maintained.**

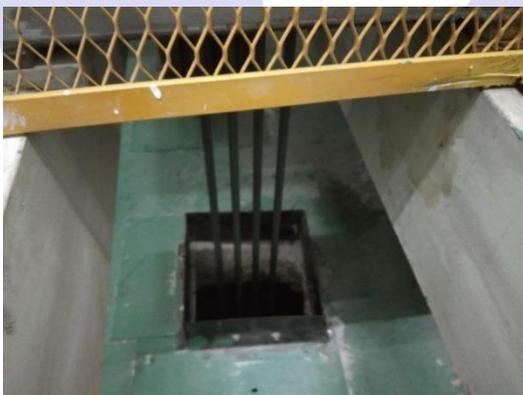
Picture 5.11

**11. Lift rope in good condition. However, the inspection does not cover the entire length of the rope and assessed based on visual inspection only.**

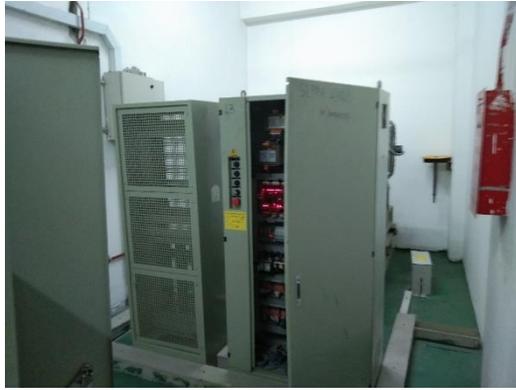
*Picture 5.12*

**12. Lift motherboard in good working condition and well-maintained.**

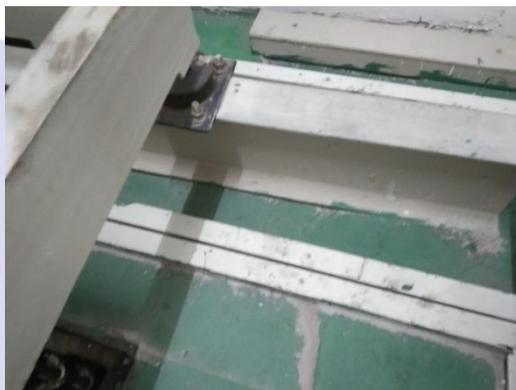
*Picture 5.14*

**14. Copper tape in place and in good working order.**

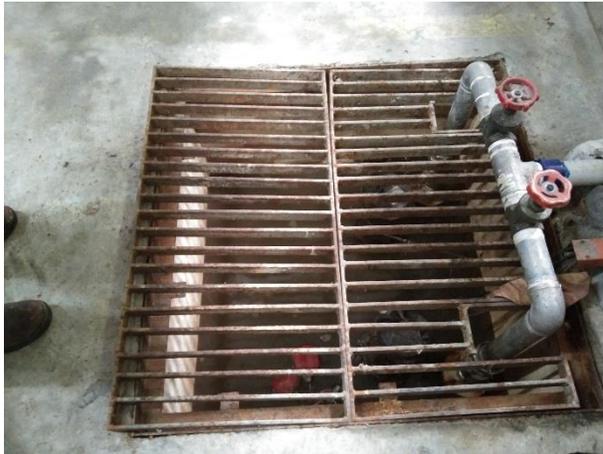
Picture 6.1

1. During the site inspection, testing on the sump pump has been conducted. All pumps work properly and the sensor as well in good condition.

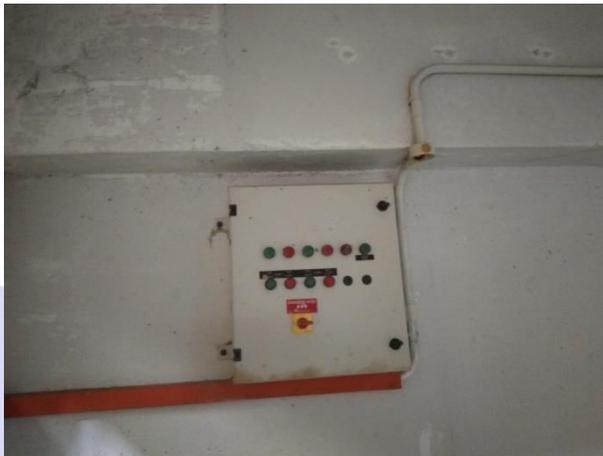
Picture 6.2

2. Control board in good condition.

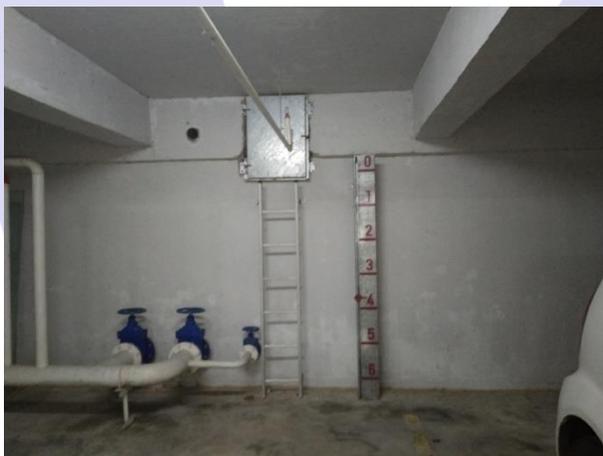
Picture 6.3

3. Water level indicator in place and serviceable condition. Tank cover as well in place and always enclosed.

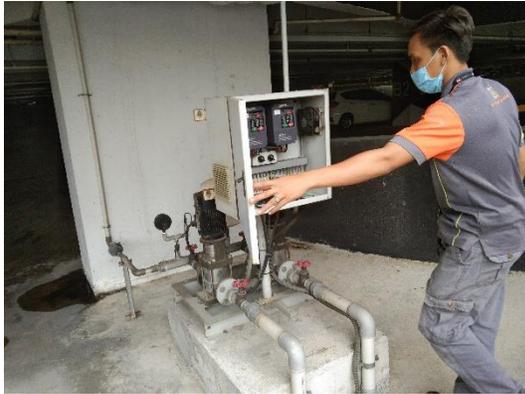
Picture 6.4

4. Water harvesting system is used for cleaning purpose. The panel in good working condition and serviceable repair.

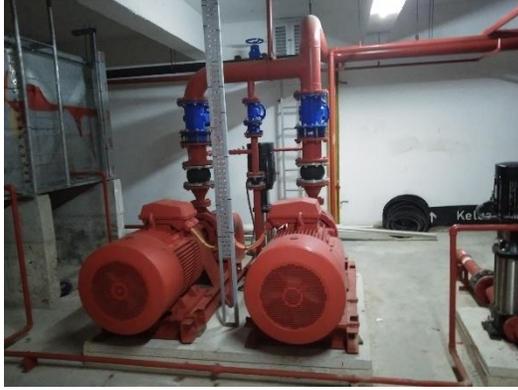
Picture 6.8

**8. Fire pump in good condition and properly working**

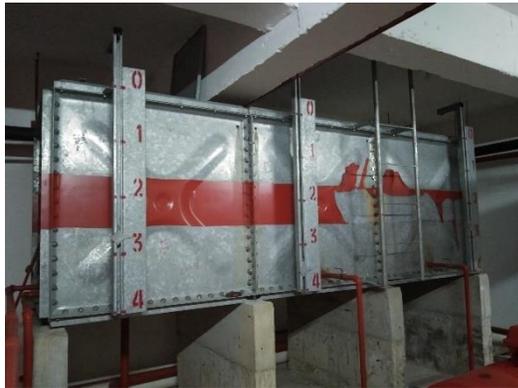
Picture 6.9

**9. Water tank intact with the water level indicator in place and readable.**

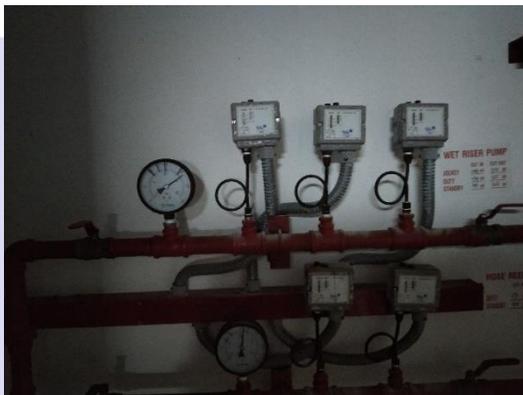
Picture 6.10

**10. Meter gauge in good condition and functional.**

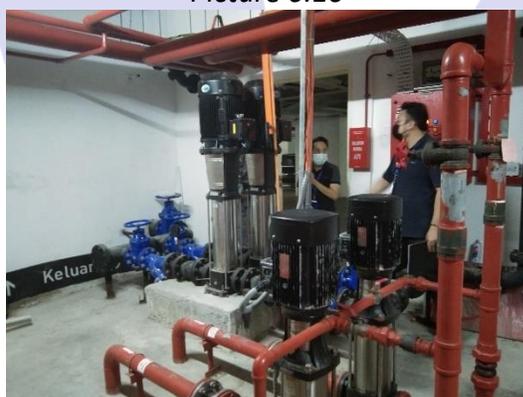
Picture 6.11

**11. The duty pump has minor leaking and set off by the technician. While standby pump in good condition and properly working.**

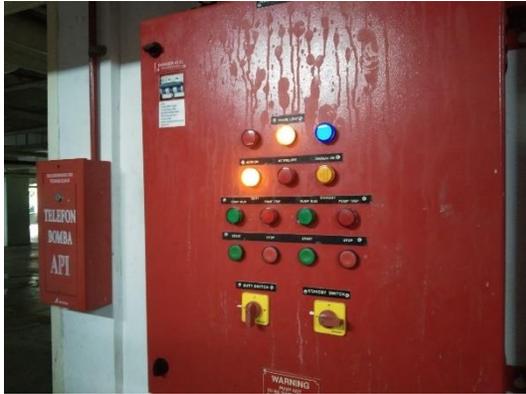
Picture 6.12

12. The control board shows duty pump is set to off mode due to leaking. Meanwhile the standby pump is in manual mode.

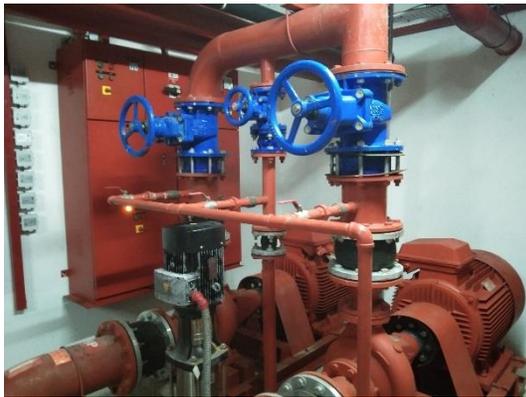
Picture 6.13

13. The pump in good working order and well-maintained.

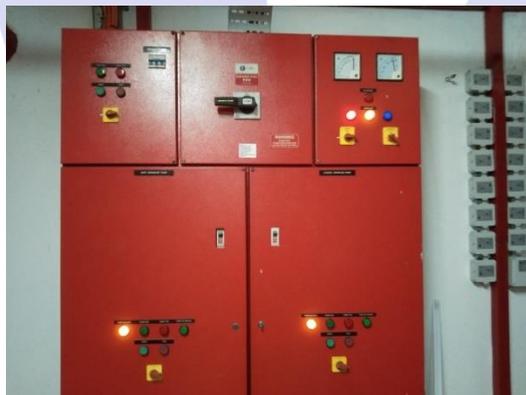
Picture 6.15

15. Water sprinkler control board in good condition and always enclosed.

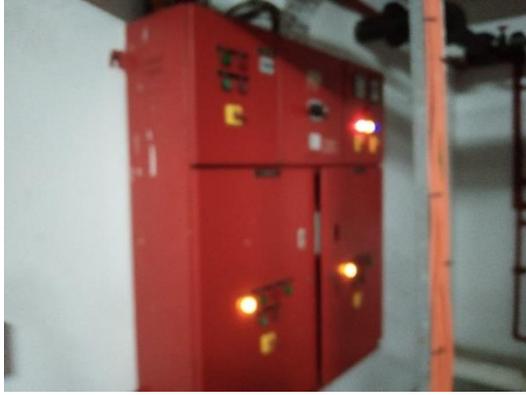
Picture 6.16

**16. BOMBA control board in good condition and properly enclosed.**

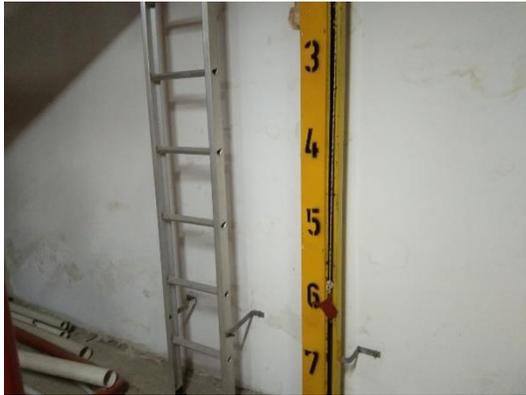
Picture 6.17

**17. Water level indicator in good working condition and readable.**

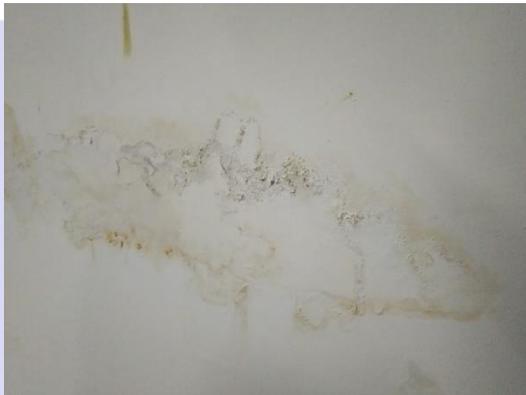
Picture 6.18

**18. The bulging of paint and water stain appears at the RC tank.**

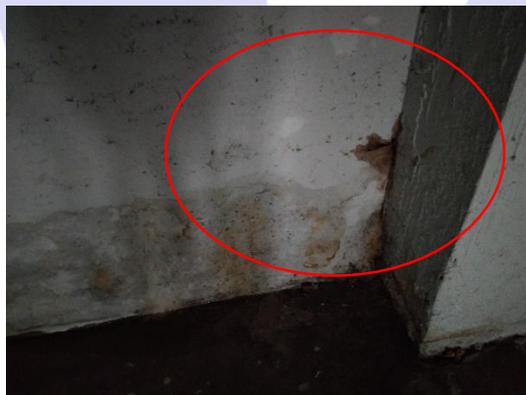
Picture 6.19

**19. RC tank has leaking. The water stain and chipped of concrete are visible at the bottom of the tank.**

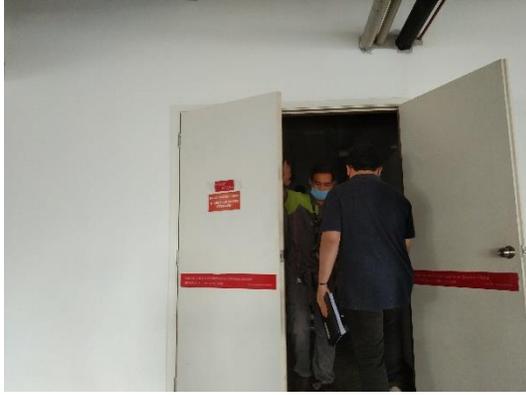
Picture 6.20

**20. Pump room appears in good condition and well-maintained.**

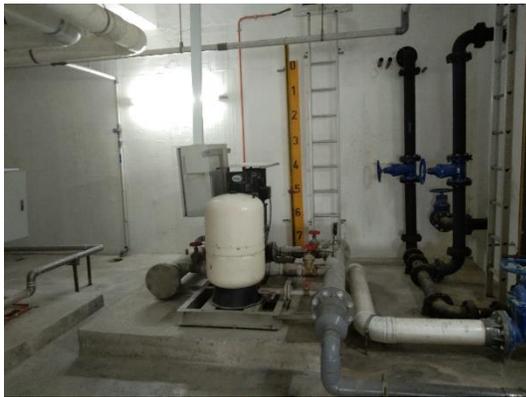
Picture 6.21

**21. Water filter and pumps working in rotation basis and well-maintained.**

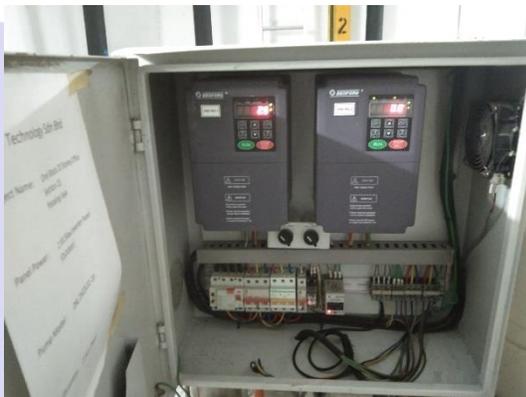
Picture 6.22

**22. Panel power working and in good condition.**

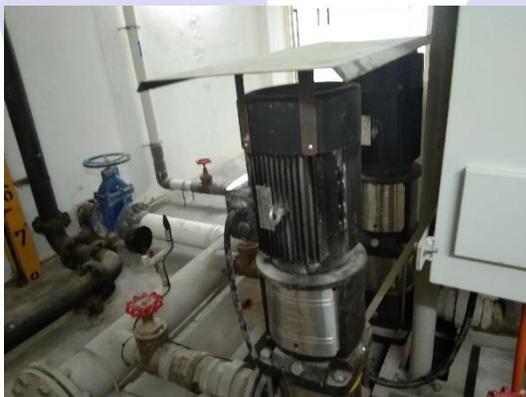
Picture 6.23

**23. The pumps in good working condition and well-maintained.**

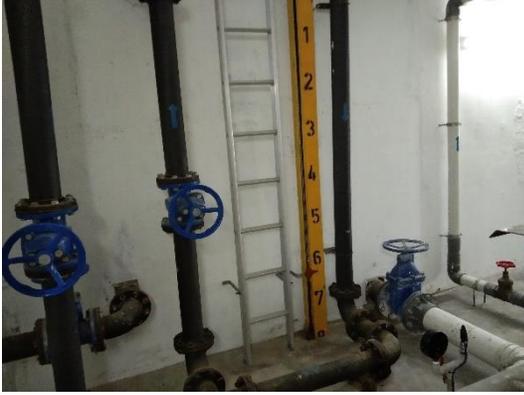
Picture 6.24

**24. Water level indicator in good working order and readable.**

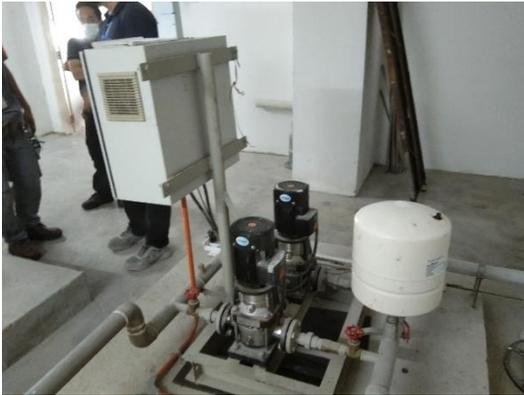
Picture 6.25

**25. Water filter and pump booster in good condition and functional.**

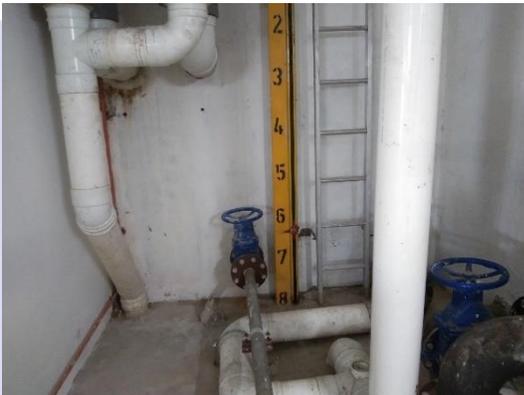
Picture 6.26

**26. Water level indicator working and in good condition.**

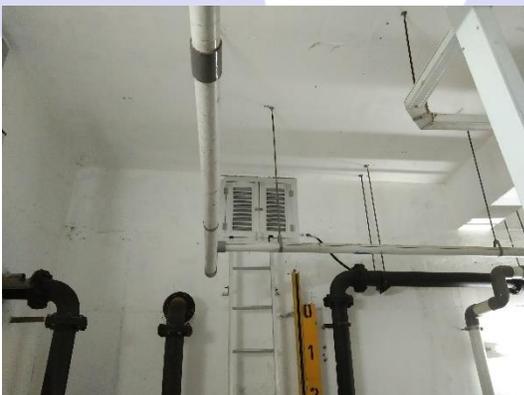
Picture 6.27

**27. Tank cover in place and intact**

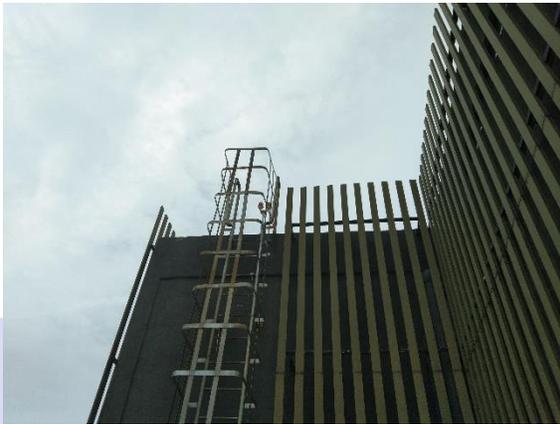
*Picture 7.2*

**1. Lighting arrester in place and in good condition.**

**2. Aviation obstruction light dysfunction may be due to lightning strike.**

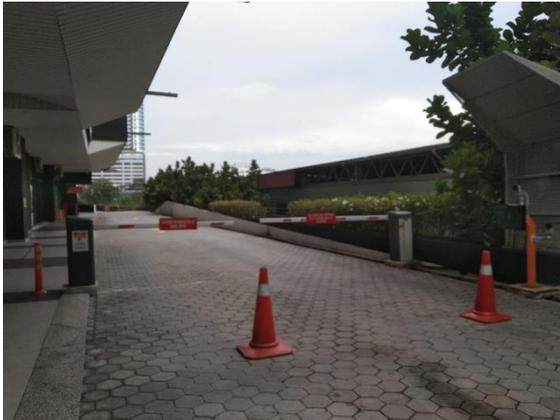
*Picture 8.1*

- 1. Barrier gate functional and serviceable repair.**

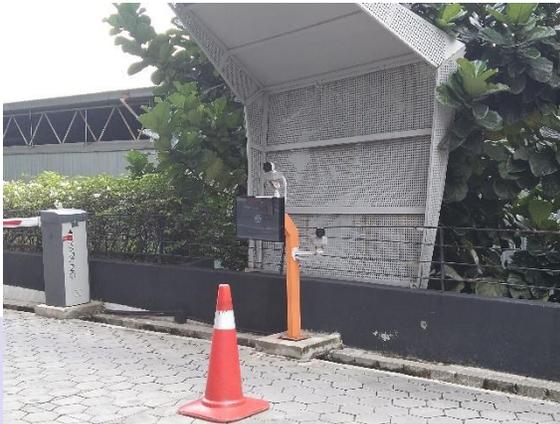
*Picture 8.2*

- 2. Access card reader positioned in good condition and functional. The CCTV as well working**

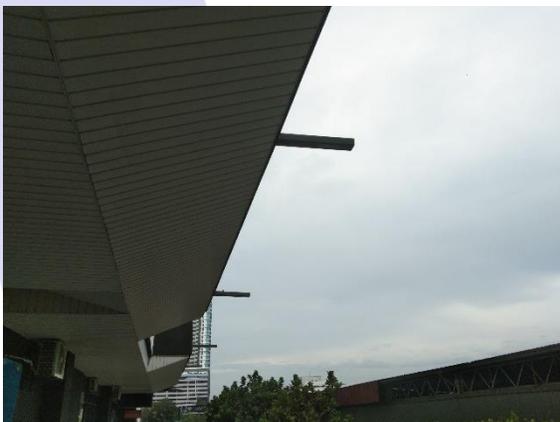
*Picture 8.3*

- 3. Lighting at the barrier gate not properly function. The technician has noted the issues for maintenance work.**

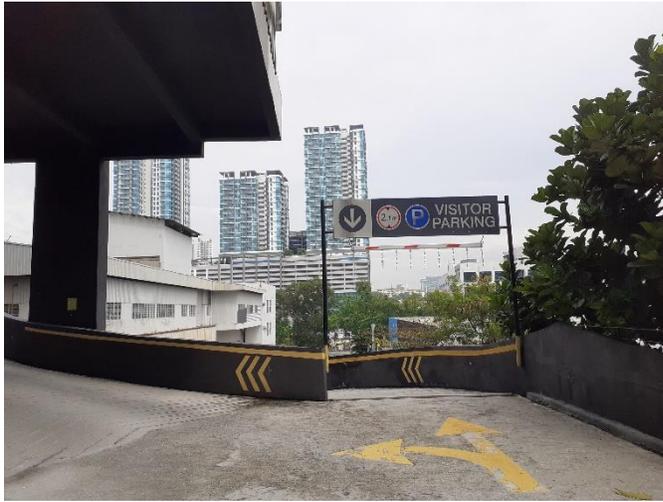
*Picture 9.1*

1. Access road to parking area. The signage in good condition.

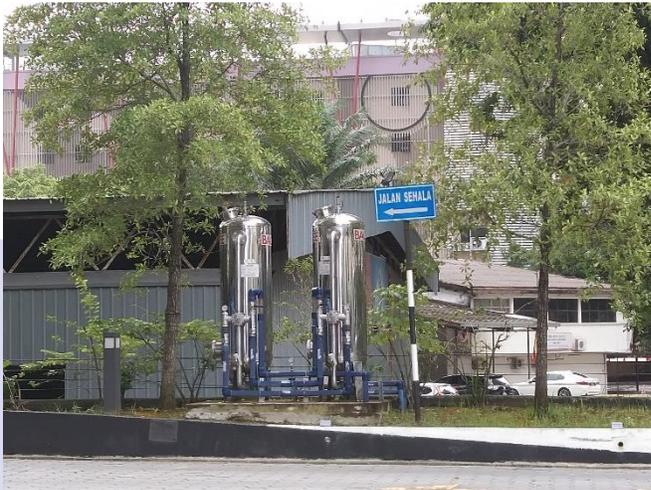
*Picture 9.2*

2. Backwash and water filter in good working condition.

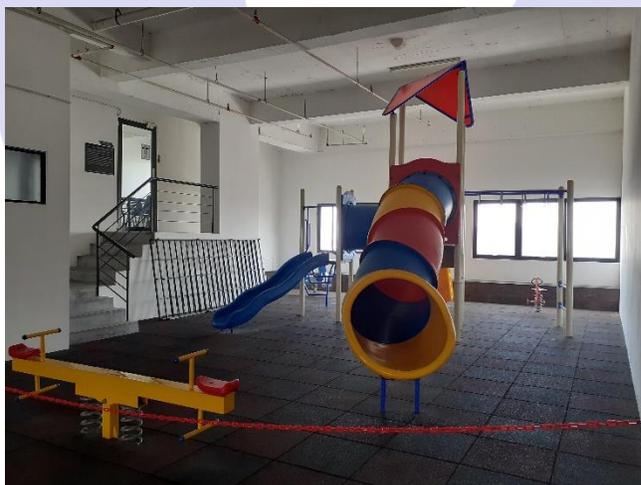
*Picture 9.3*

3. Playground appears in good condition

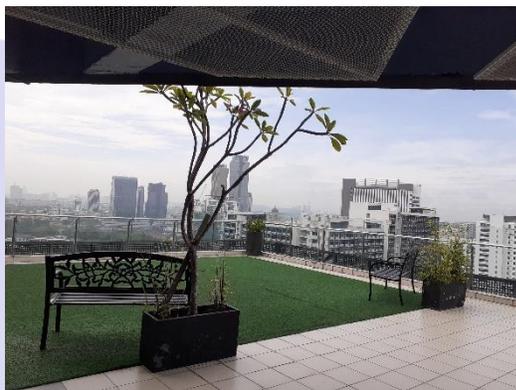
*Picture 9.10*

**10. The corridor appears in good condition, clean and well-maintained.**

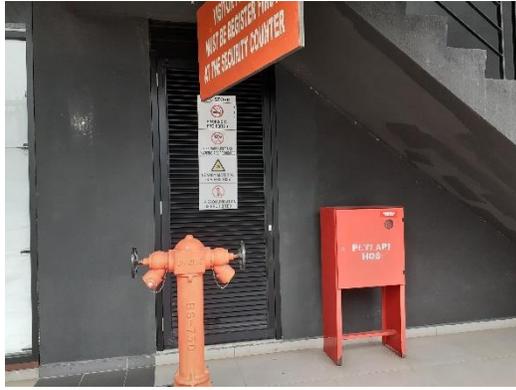
Picture 9.20

**20. Fire hydrant and hose reel in good condition and well-maintained**

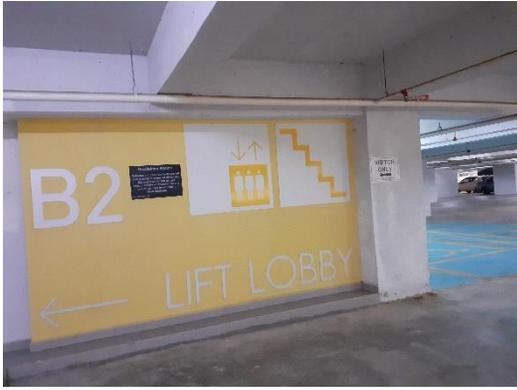
Picture 9.24

**24. The signage at the basement appears in decent condition.**

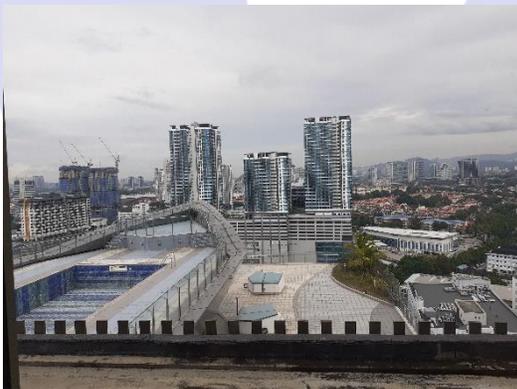
Picture 9.27

**27. Swimming pool at the rooftop is under developer.**

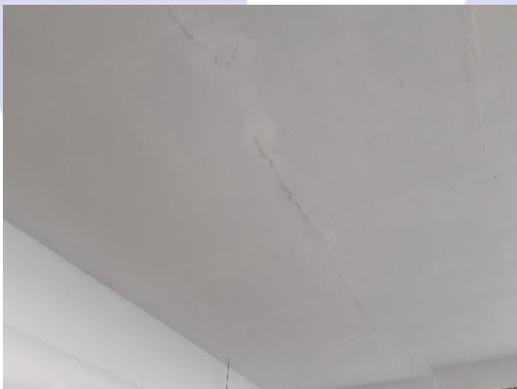
Picture 9.35

**35. The ceiling of basement parking shows hairline crack.**

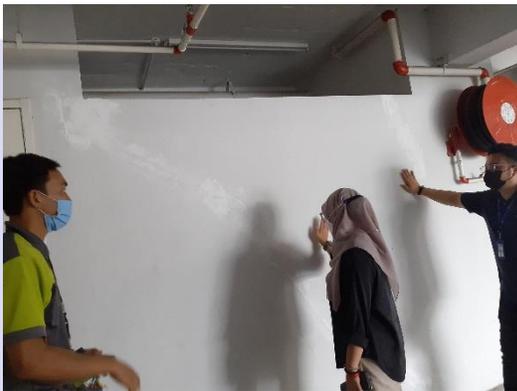
*Picture 9.38*

**38. The plastering work to cover the crack that occurred at the surau**

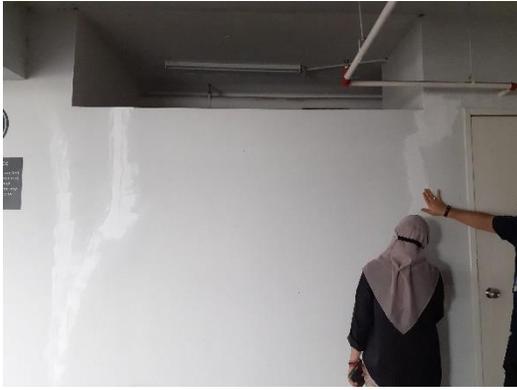
Picture 9.40

**40. The plastering work to cover the crack that occurred at the surau**

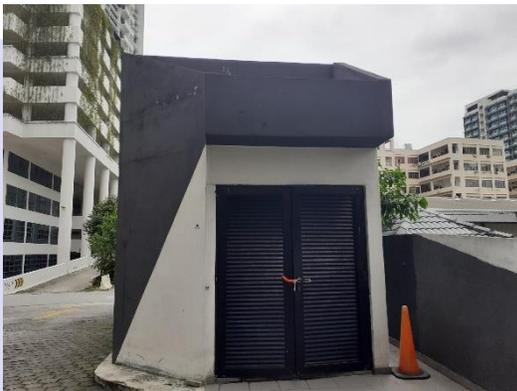
Picture 9.42

**42. Rubbish house appears in good condition and well-maintained. It was informed the rubbish house had fire due to unknown source and repairing work has undertaken**

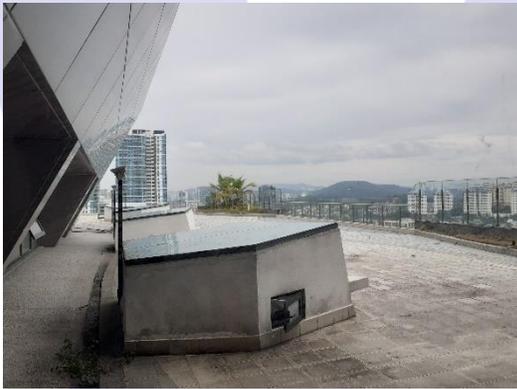
Picture 9.43

**43. Air well in good condition.**
