**PERIODICAL BUILDING INSPECTION UNDER
ACT 133 AT SUMMIT SUBANG USJ**

PRACTICAL TRAINING REPORT

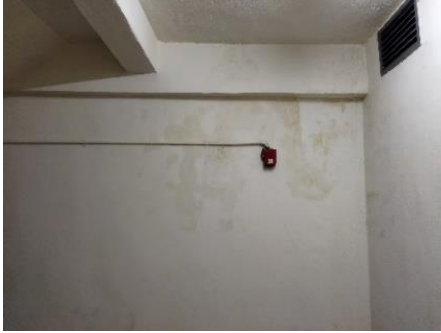
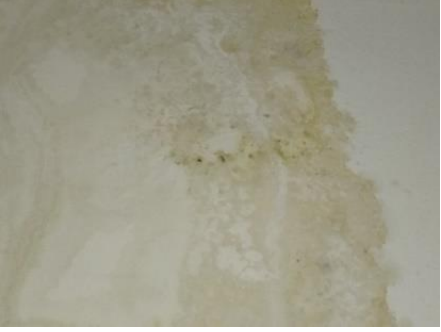
No. of Defect Sheet	A-001	Level	Basement 3

Location	Stair		
		Element / Component	Wall

BARIS			
		Condition	Priority	Matrix	Color
		3	3	9	
Defect Description					
Water seeping					
Possible Causes					
Due to continuous flow of groundwater and causing the reaction on the concrete material.

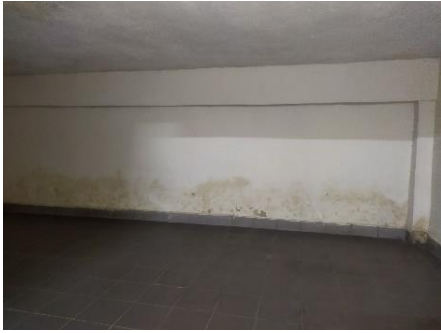
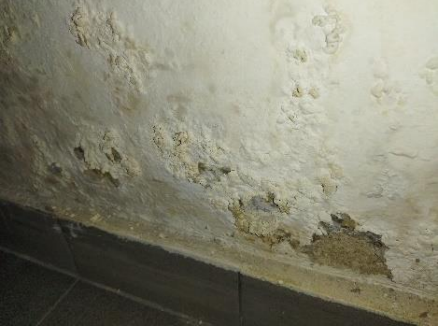
No. of Defect Sheet	A-003	Level	Basement 3

Location	Stair		
		Element / Component	Wall

BARIS			
		Condition	Priority	Matrix	Color
		3	3	9	
Defect Description					
Water seeping					
Possible Causes					
Due to continuous flow of groundwater and causing the reaction on the concrete material.

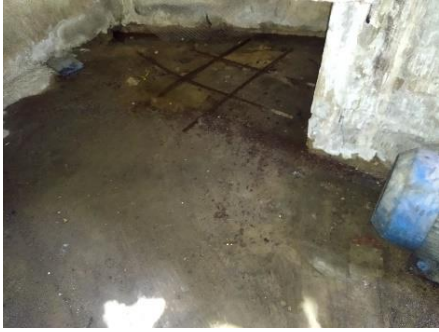
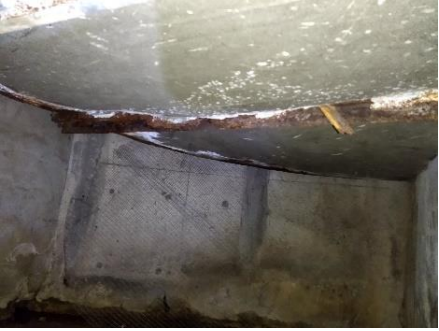
No. of Defect Sheet	A-005	Level	Basement 3

Location	Fan Room (B3-N0-1)			
	Element / Component	Floor			
BARIS					
Condition	Priority	Matrix	Color		
3	4	12			
Defect Description					
Water stagnant					
Possible Causes					
Leaking from ventilation fan.

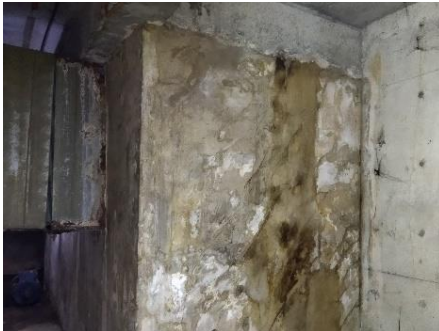
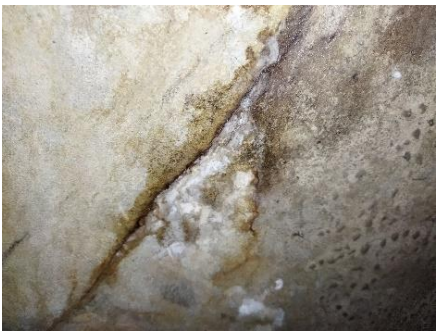
No. of Defect Sheet	A-008	Level	Basement 3

Location	Fan Room (B3-N0-1)			
	Element / Component	Wall			
BARIS					
Condition	Priority	Matrix	Color		
3	3	9			
Defect Description					
Water seeping					
Possible Causes					
Due to continuous flow of groundwater and causing the reaction on the concrete material.

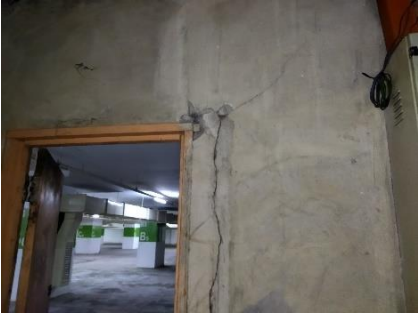
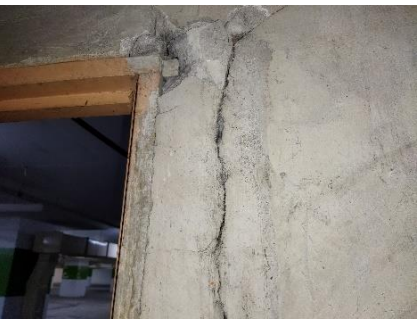
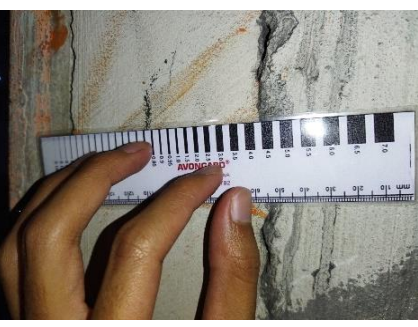
No. of Defect Sheet	A-012	Level	Basement 3

Location	Fan Room (B3-2/4)		
		Element / Component	Wall		
		BARIS			
Condition	Priority	Matrix	Color		
3	3	9			
Defect Description					
Fair crack (1-5mm)					
Possible Causes					
Probably due to vibration from the ventilation duct fan / soil settlement

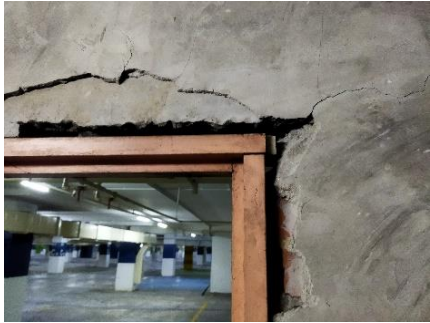
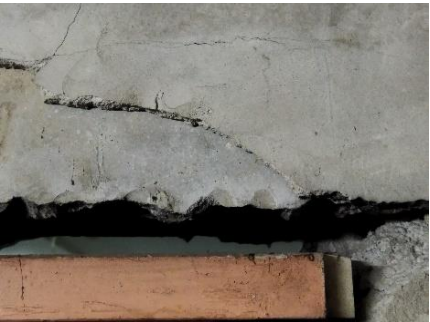
No. of Defect Sheet	A-039	Level	Basement 3

Location	Fan Room (B3-5/6)			
	Element / Component	Wall

BARIS				
	Condition	Priority	Matriks	Color	
	3	3	9		
Defect Description					
Broken of concrete wall					
Possible Causes					
Object Impact

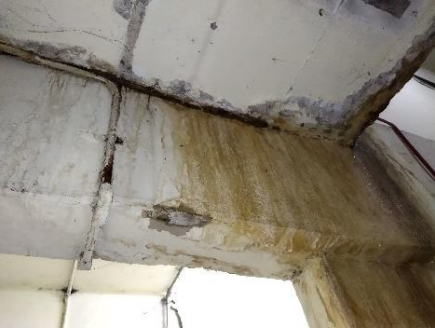
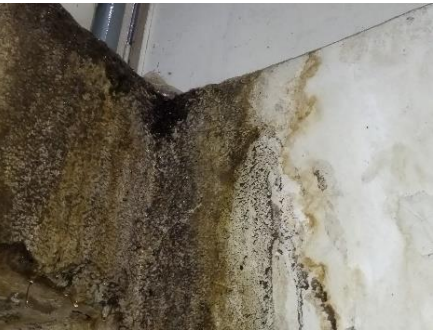
No. of Defect Sheet	A-040	Level	Basement 3

Location	Stair			
	Element / Component	Beam

BARIS				
	Condition	Priority	Matrix	Color	
	3	3	9		
Defect Description					
Water seeping					
Possible Causes					
Water seeping from the top.

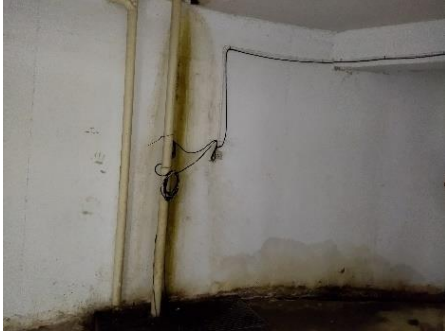
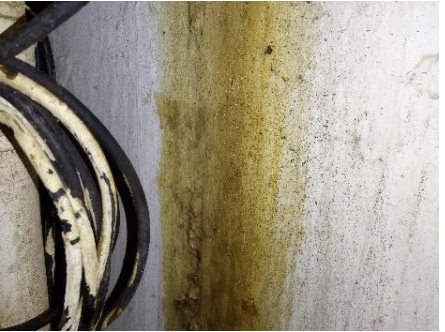
No. of Defect Sheet	A-044	Level	Basement 3

Location	Office Parking		
		Element / Component	Ground Floor Wall

BARIS			
		Condition	Priority	Matrix	Color
		3	3	9	
Defect Description					
Water seeping					
Possible Causes					
Due to continuous flow of groundwater and causing the reaction on the concrete material.

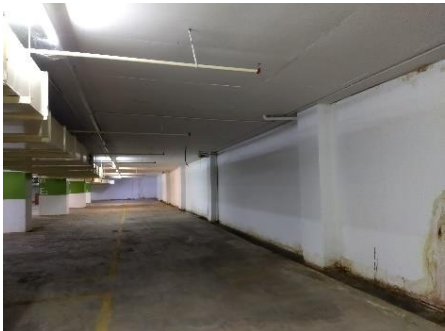
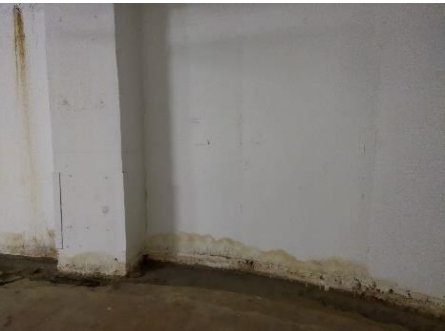
No. of Defect Sheet	A-046	Level	Basement 3

Location	Office Parking		
		Element / Component	Ground Floor Wall

BARIS			
		Condition	Priority	Matrix	Color
		3	3	9	
Defect Description					
Water seeping					
Possible Causes					
Due to continuous flow of groundwater and causing the reaction on the concrete material.

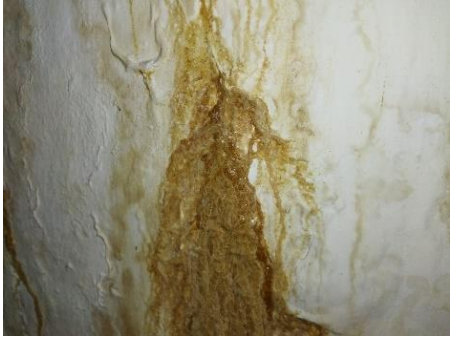
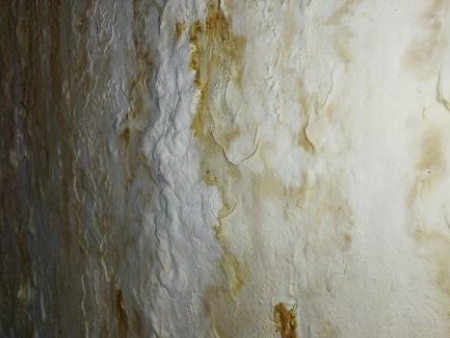
No. of Defect Sheet	A-047	Level	Basement 3

Location	Office Parking			
	Element / Component	Ground Floor Wall			
BARIS					
Condition	Priority	Matrix	Color		
3	3	9			
Defect Description					
Water seeping					
Possible Causes					
Due to continuous flow of groundwater and causing the reaction on the concrete material.

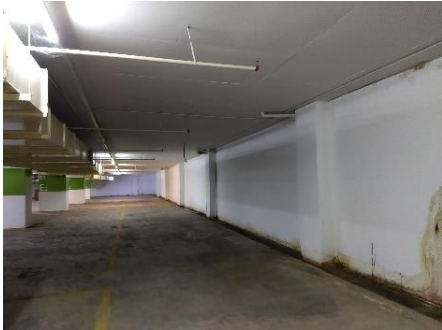
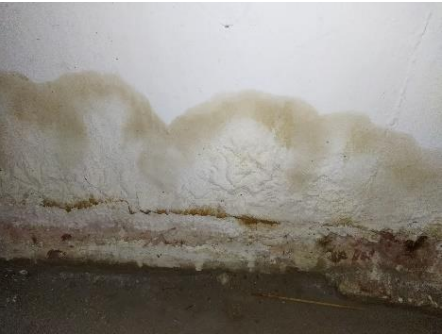
No. of Defect Sheet	A-048	Level	Basement 3

Location	Office Parking			
	Element / Component	Ground Floor Wall			
BARIS					
Condition	Priority	Matrix	Color		
3	3	9			
Defect Description					
Water seeping					
Possible Causes					
Due to continuous flow of groundwater and causing the reaction on the concrete material.

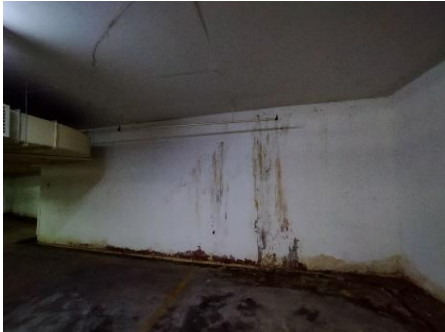
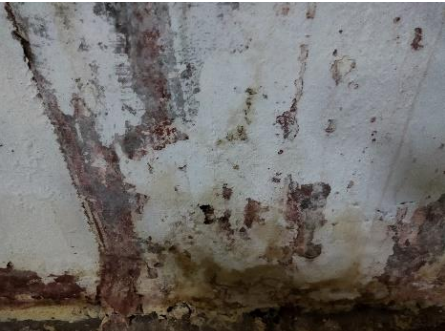
No. of Defect Sheet	A-060	Level	Basement 3

Location	Office Parking		
		Element / Component	Ground Floor Wall

BARIS			
		Condition	Priority	Matrix	Color
		3	3	9	
Defect Description					
Water seeping					
Possible Causes					
Due to continuous flow of groundwater and causing the reaction on the concrete material.

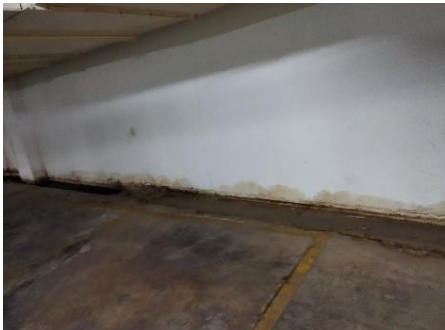
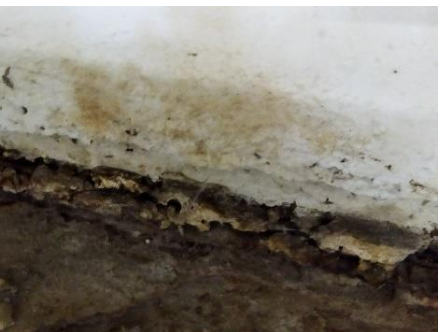
No. of Defect Sheet	A-061	Level	Basement 3

Location	Office Parking		
		Element / Component	Ground Floor Wall

BARIS			
		Condition	Priority	Matrix	Color
		3	3	9	
Defect Description					
Water seeping					
Possible Causes					
Due to continuous flow of groundwater and causing the reaction on the concrete material.

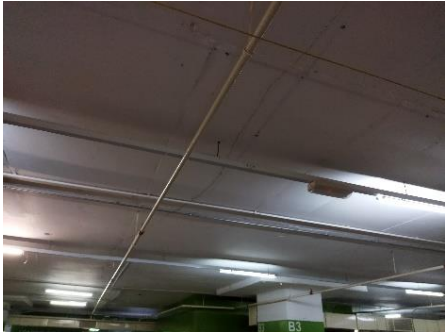
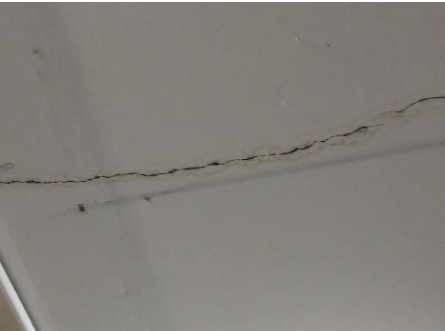
No. of Defect Sheet	A-062	Level	Basement 3

Location	Office Parking		
		Element / Component	Concrete Ceiling

BARIS			
		Condition	Priority	Matrix	Color
		3	3	9	
		Defect Description			
		Fair crack (1-5mm)			
		Possible Causes			
		Soil settlement / load pressure.

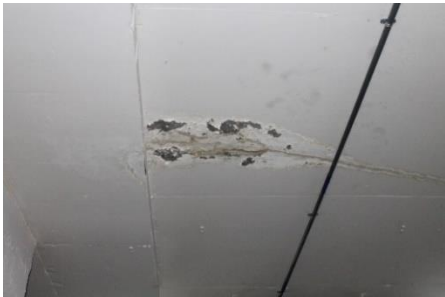
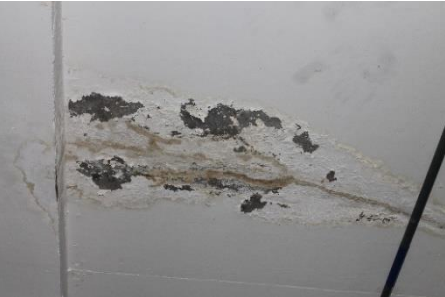
No. of Defect Sheet	A-066	Level	Basement 3

Location	Office Parking		
		Element / Component	Concrete Ceiling

BARIS			
		Condition	Priority	Matrix	Color
		3	3	9	
		Defect Description			
		Water seeping			
		Possible Causes			
		Water seeping from the top.

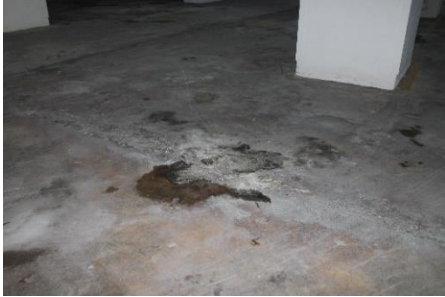
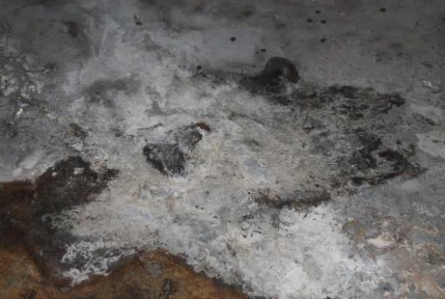
No. of Defect Sheet	A-078	Level	Basement 3

Location	Office Parking		
		Element / Component	Floor

BARIS			
		Condition	Priority	Matrix	Color
		3	3	9	
Defect Description					
Water seeping					
Possible Causes					
Due to continuous flow of groundwater and causing the reaction on the concrete material.

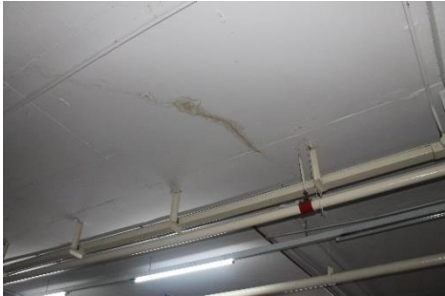
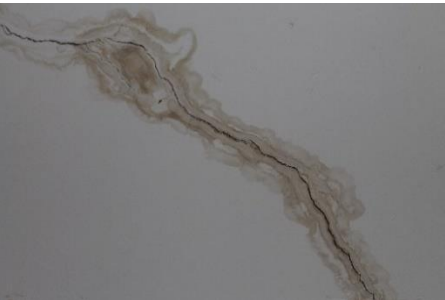
No. of Defect Sheet	A-079	Level	Basement 3

Location	Office Parking		
		Element / Component	Concrete Ceiling

BARIS			
		Condition	Priority	Matrix	Color
		3	3	9	
Defect Description					
Fair crack (1-5mm)					
Possible Causes					
Soil settlement / load pressure.

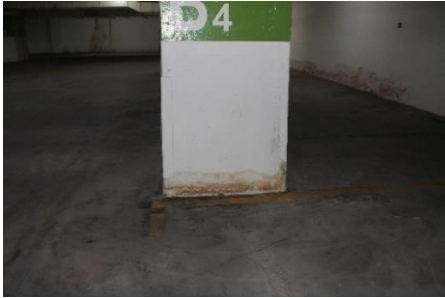
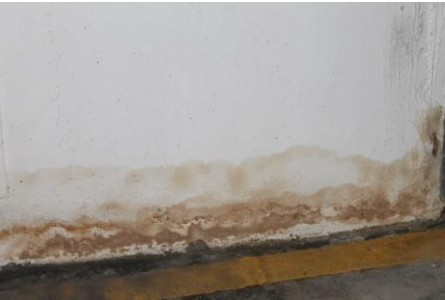
No. of Defect Sheet	A-080	Level	Basement 3

Location	Office Parking		
		Element / Component	Column		
BARIS					
Condition		Priority	Matrix	Color	
3		3	9		
Defect Description					
Water seeping					
Possible Causes					
Due to continuous flow of groundwater and causing the reaction on the concrete material.

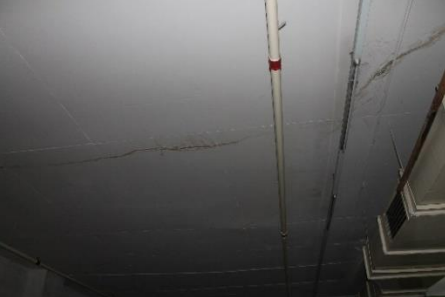
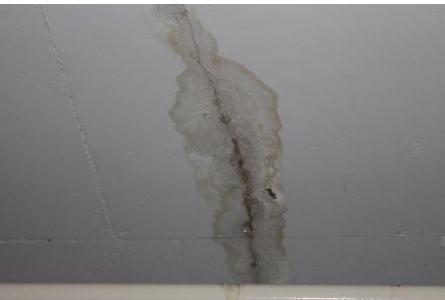
No. of Defect Sheet	A-082	Level	Basement 3

Location	Office Parking		
		Element / Component	Concrete Ceiling		
BARIS					
Condition		Priority	Matrix	Color	
3		3	9		
Defect Description					
Fair crack (1-5mm)					
Possible Causes					
Soil settlement / load pressure.

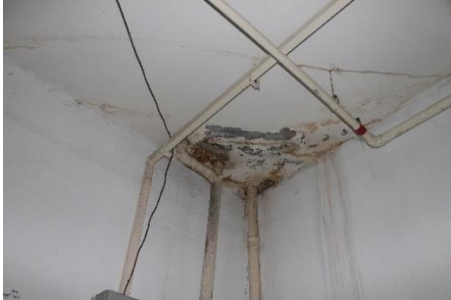
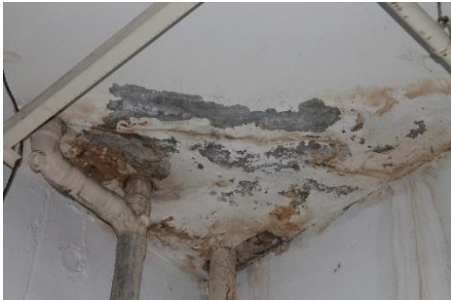
No. of Defect Sheet	A-118	Level	Basement 3

Location	Office Parking		
		Element / Component	Concrete Ceiling		
BARIS					
Condition	Priority	Matrix	Color		
3	4	12			
Defect Description					
Water seeping					
Possible Causes					
Water seeping from the top.

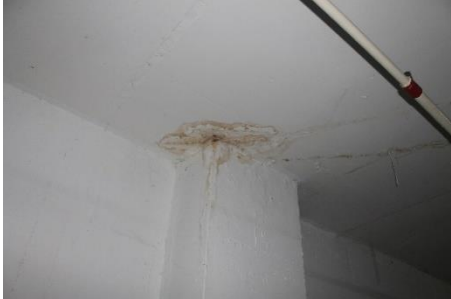
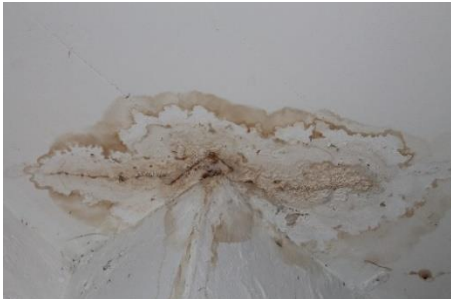
No. of Defect Sheet	A-153	Level	Basement 3

Location	Mall Parking		
		Element / Component	Concrete Ceiling		
BARIS					
Condition	Priority	Matrix	Color		
3	4	12			
Defect Description					
Water seeping					
Possible Causes					
Water seeping from the top.

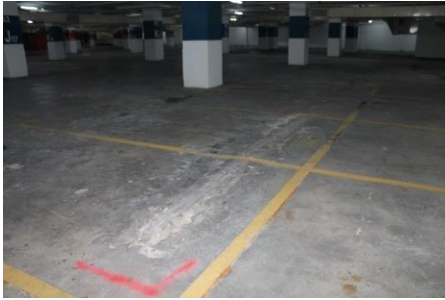
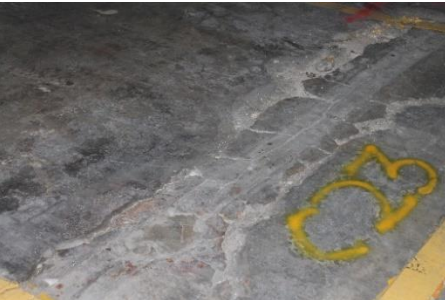
No. of Defect Sheet	A-167	Level	Basement 3

Location	Mall Parking		
		Element / Component	Floor		
BARIS					
		Condition	Priority	Matrix	Color
		3	3	9	
Defect Description					
Broken					
Possible Causes					
Object impact or vehicle friction.

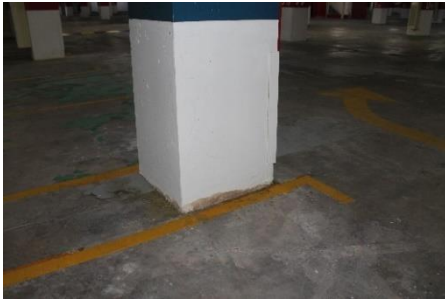
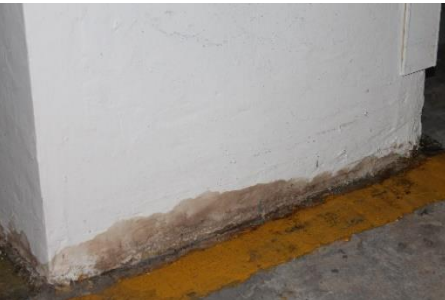
No. of Defect Sheet	A-184	Level	Basement 3

Location	Mall Parking		
		Element / Component	Column		
BARIS					
		Condition	Priority	Matrix	Color
		3	3	9	
Defect Description					
Water seeping					
Possible Causes					
Due to continuous flow of groundwater and causing the reaction on the concrete material.

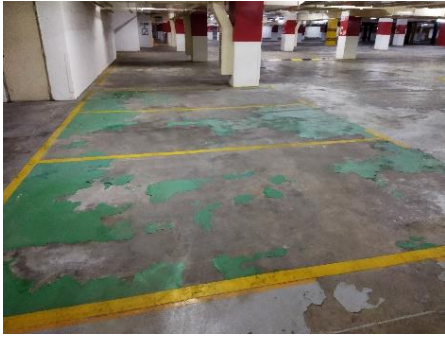
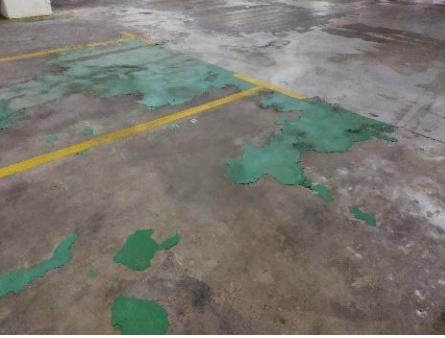
No. of Defect Sheet	A-195	Level	Basement 3

Location	Mall Parking		
		Element / Component	Floor		
BARIS					
Condition		Priority	Matrix	Color	
3		3	9		
Defect Description					
Water seeping					
Possible Causes					
Due to continuous flow of groundwater and causing the reaction on the concrete material.

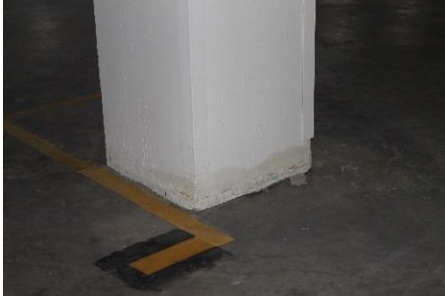
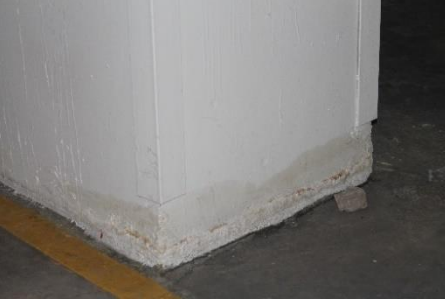
No. of Defect Sheet	A-204	Level	Basement 3

Location	Hotel Parking		
		Element / Component	Column		
BARIS					
Condition		Priority	Matrix	Color	
3		3	9		
Defect Description					
Water seeping					
Possible Causes					
Due to continuous flow of groundwater and causing the reaction on the concrete material.

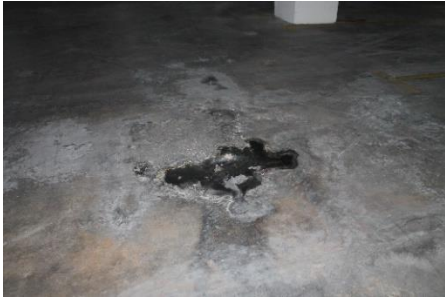
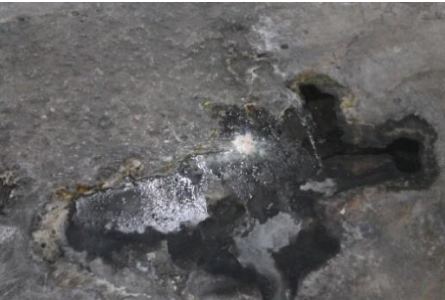
No. of Defect Sheet	A-206	Level	Basement 3

Location	Hotel Parking		
		Element / Component	Floor

BARIS			
		Condition	Priority	Matrix	Color
		3	4	12	
Defect Description					
Water seeping					
Possible Causes					
Due to continuous flow of groundwater and causing the reaction on the concrete material.

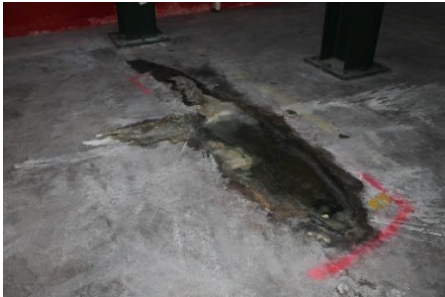
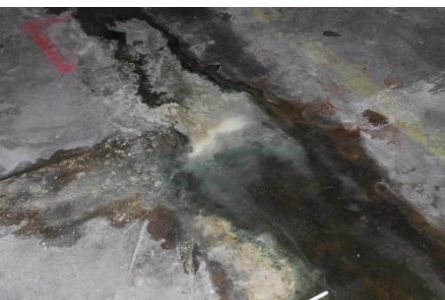
No. of Defect Sheet	A-219	Level	Basement 3

Location	Hotel Parking		
		Element / Component	Floor

BARIS			
		Condition	Priority	Matrix	Color
		3	3	9	
Defect Description					
Water seeping					
Possible Causes					
Due to continuous flow of groundwater and causing the reaction on the concrete material.

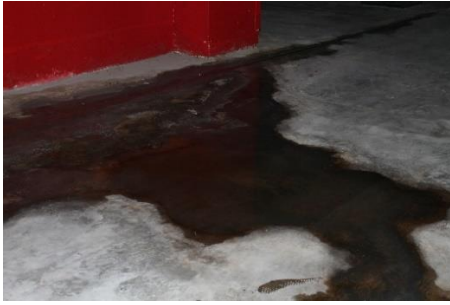
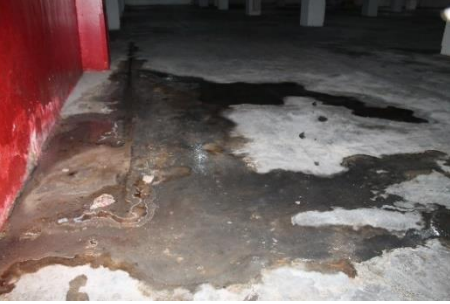
No. of Defect Sheet	A-220	Level	Basement 3

Location	Hotel Parking		
		Element / Component	Floor		
BARIS					
Condition	Priority	Matrix	Color		
3	3	9			
Defect Description					
Water seeping					
Possible Causes					
Due to continuous flow of groundwater and causing the reaction on the concrete material.

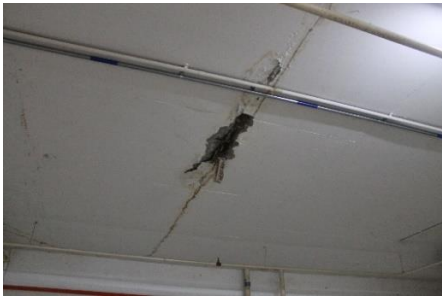
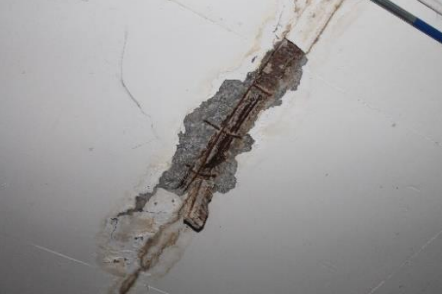
No. of Defect Sheet	A-229	Level	Basement 3

Location	Hotel Parking		
		Element / Component	Concrete Ceiling		
BARIS					
Condition	Priority	Matrix	Color		
3	4	12			
Defect Description					
Concrete spalling on ceiling					
Possible Causes					
Rusty reinforcement steel due to existence of moisture.

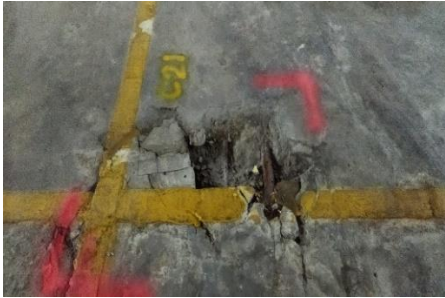
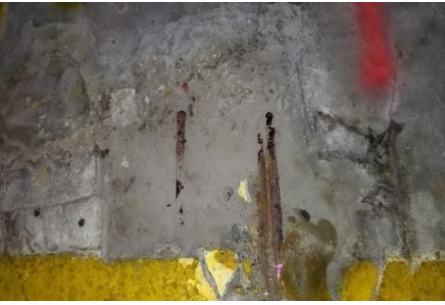
No. of Defect Sheet	A-248	Level	Basement 3

Location	Hotel Parking			
	Element / Component	Floor			
BARIS					
Condition	Priority	Matrix	Color		
3	4	12			
Defect Description					
Broken floor					
Possible Causes					
Object impact or vehicle friction.

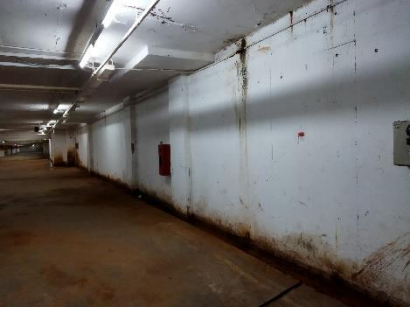
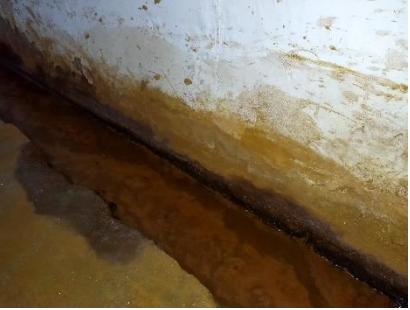
No. of Defect Sheet	A-257	Level	Basement 3

Location	Hotel Parking			
	Element / Component	Ground Floor Wall			
BARIS					
Condition	Priority	Matrix	Color		
3	3	9			
Defect Description					
Water seeping					
Possible Causes					
Due to continuous flow of groundwater and causing the reaction on the concrete material.

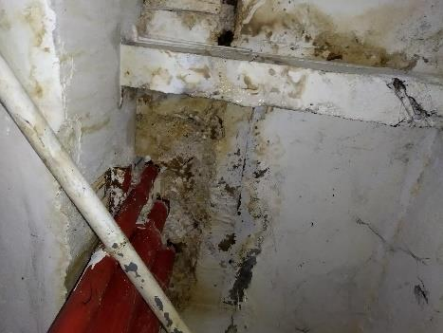
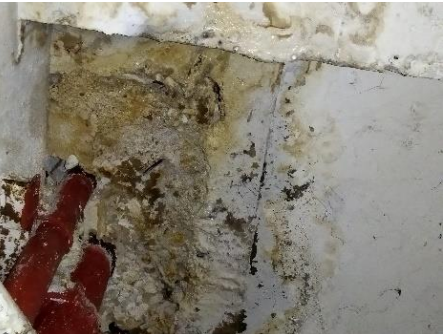
No. of Defect Sheet	A-266	Level	Basement 3

Location	Hotel Parking		
		Element / Component	Concrete Ceiling

BARIS			
		Condition	Priority	Matrix	Color
		3	3	9	
Defect Description					
Water seeping					
Possible Causes					
Water seeping from the top.

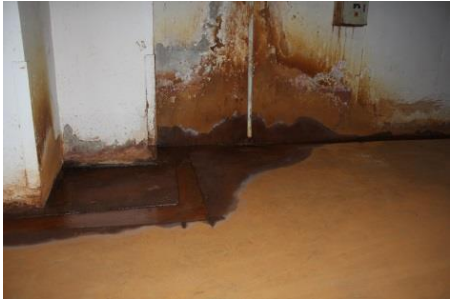
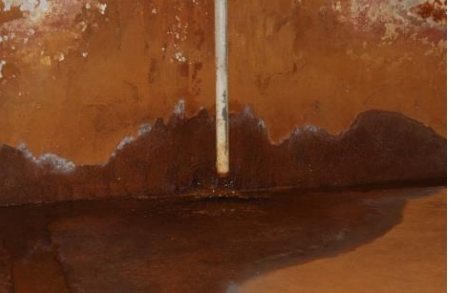
No. of Defect Sheet	A-281	Level	Basement 3

Location	Hotel Parking			
		Element / Component	Wall			
BARIS						
Condition	Priority	Matrix	Color			
3	4	12				
Defect Description						
Water seeping

Possible Causes
						Due to continuous flow of groundwater and causing the reaction on the concrete material.
