**BUILDING CONDITION ASSESSMENT (BCA) FOR TYPICAL
STRATA RESIDENTIAL UNIT**

PRACTICAL TRAINING REPORT

D'Rapport Residences is a Leasehold Condominium that located at Jalan Nipah, Ampang Hilir, 55000, Kuala Lumpur. This building was completed in year 2019 and the developer that involved is ACMAR GROUP. This building consists of 38 floors and a total of 1,099 units. The build-up size is 1,108 to 10,560 sqft. The facilities at D'Rapport include Sauna, Parking, Jacuzzi, Squash court, Cafeteria, Tennis court, BBQ, Playground, Wading pool, Jogging track, 24-hours security, Gymnasium, Swimming pool.

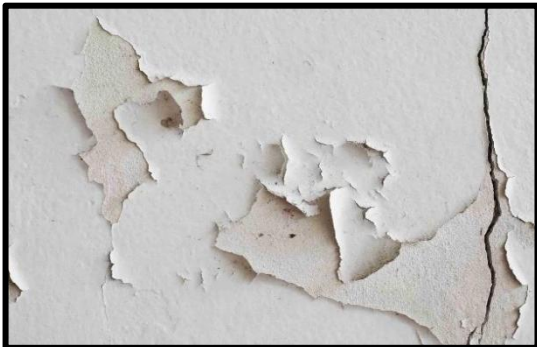
<p data-bbox="576 1489 924 1523">Figure 22: Peeling of paint</p>	<p data-bbox="1061 1173 1437 1305">It might be happened due to regularly wet by rain or dew on a particular wall location.</p>
2.

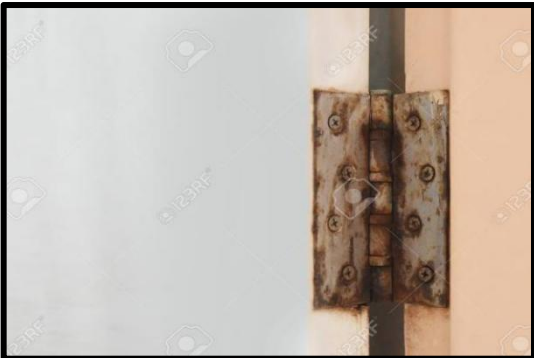
<p data-bbox="628 1957 873 1991">Figure 23: Rusting</p>	<p data-bbox="1061 1635 1437 1966">Rusting of metal appliances seen on door hinges, screws, door lockset, tissue holder and others. It might be happened due to the presence of moisture at the location.</p>

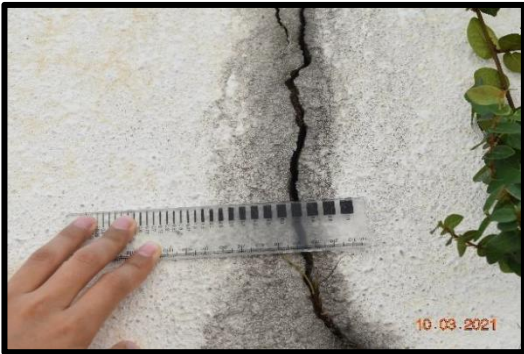
<p>Figure 24: Crack</p>	<p>A wide crack might be happened due to the movement of earth, while a fine crack lines usually found on wall.</p>
4.

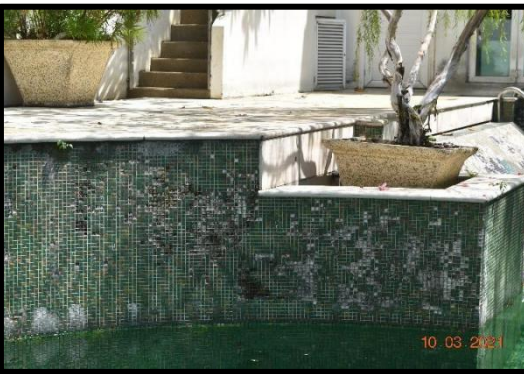
<p>Figure 25: Detached</p>	<p>Detached of wall or floor tiles might be happened due to moisture that seep into the wall and cause the tile to detached from its position or less cement is laid during the installation.</p>
5.

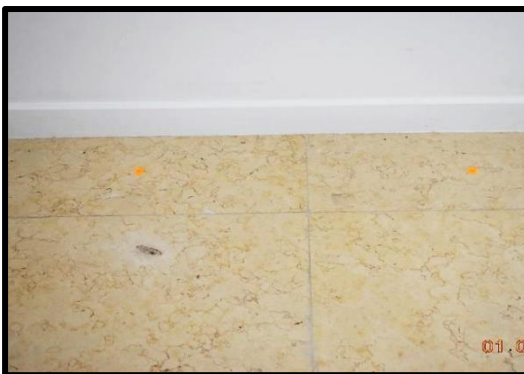
<p>Figure 26: Hollowness</p>	<p>Hollowness of a tile might be happened due to less cement is laid during the installation.</p>

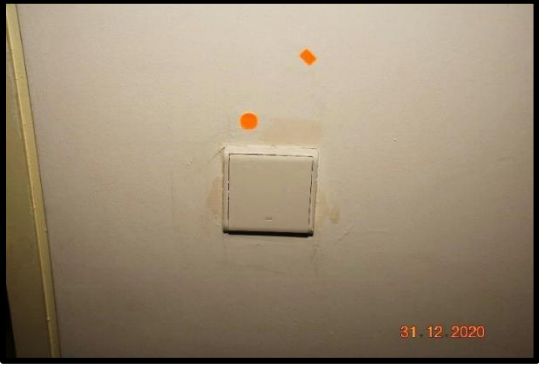
<p>A photograph of a white wall with a square light switch. Above the switch, there are two orange circular markers and a faint, irregular brownish patch on the wall surface. A red timestamp '31 12 2020' is visible in the bottom right corner of the image.</p>	<p>Patch repair mark observed on surface.</p>

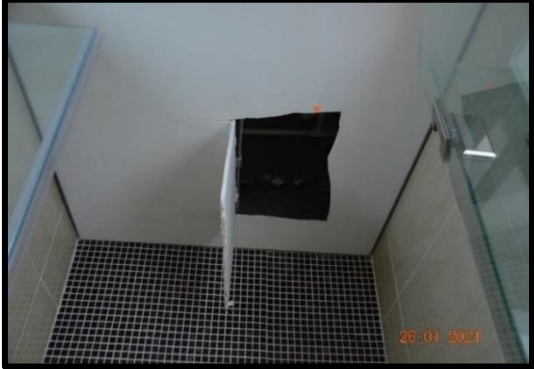
<p>A photograph of a shower stall. A black shower curtain is hanging from a white rod. The ceiling above the shower is cracked and broken, with a piece of material hanging down. The floor is covered in small, dark mosaic tiles. A red timestamp '25 01 2021' is visible in the bottom right corner of the image.</p>	<p>Broken ceiling observed.</p>

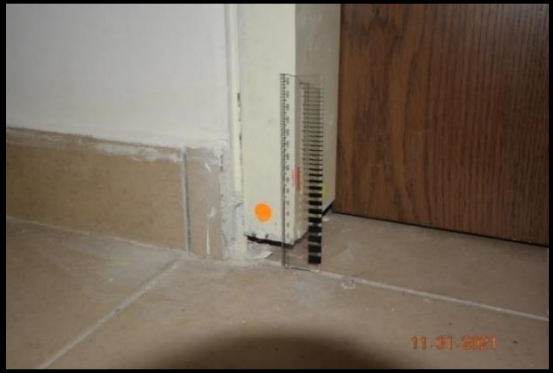
<p>A photograph of a doorway. A white door frame is set into a wall. There is a significant gap between the bottom of the door frame and the floor tiles. A red circular marker is placed on the floor near the gap. A wooden door is partially visible on the right. A red timestamp '11 01 2021' is visible in the bottom right corner of the image.</p>	<p>Visible gap observed between door frame and floor tile, might be due to unsuitable size of door frame.</p>

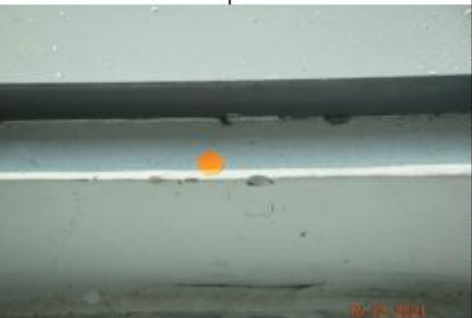
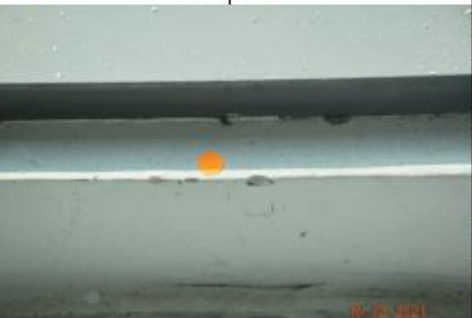
Defect Condition Assessment Category			
		B	General Defect		
		Type of Defect	Broken/Chipped off		
		Observation			
		Chipped off observed on surface.

Cause of Defect			
		Lack of proper care from the other site contractor			
		Remedy Suggestion

1. To scrap off existing paint on affected area for surface preparation 2. To apply one coat of wall sealer (Nippon Vinilex 5300) and 2 coats of finish coat (Nippon Super Vinilex Eco 5000-145 white) respectively .

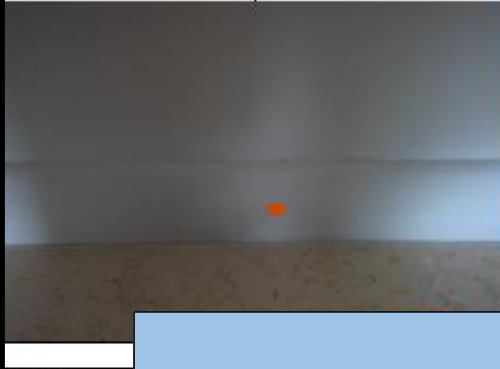
Ref No.	B-31-02/C	Location	Area	Element	Trade
Photo No.	59	B-31-02	Living Hall	Skirting	Timber specialist.

Defect Condition Assessment Category			
		C		In-Complete Work	
		Type of Defect		Separation gap	
		Observation			
		Untidy joint between timber skirtings.			
		Cause of Defect

1. No touch up work after installation.			
		Remedy Suggestion			
		1. To prepare the surface and apply wood filler to fill the gap. 2. Scrub the surface with sand paper 3. To prepare the surface and apply one coat of Nippon Super Vinilex Eco 5000 - 145 white.			
Ref No.		SAMPLE			
Photo No.	60				
		B-31-02	Living Hall	Skirting	Timber specialist.

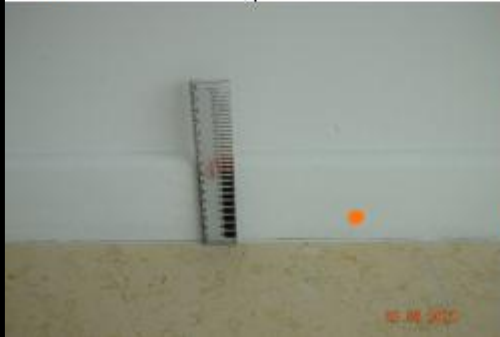
Defect Condition Assessment Category			
		C		In-Complete Work	
		Type of Defect		Separation gap	
		Observation			
		Visible gap observed between timber skirting and marble			
		Cause of Defect			
		Inadequate adhesive applied.			
		Remedy Suggestion

1. Clean up the affected area free any dust and let dry. 2. Apply silicone sealant to fill the gap. 3. Wipe off excessive sealant before let it dries.
