**QUALITY CONTROL OF SEKOLAH AGAMA KEBANGSAAN
JOHOR (SAKJ) PROJECT**

**Prepared by:
FARAH AINA BINTI MOHD ZAM
(2017206676)**

QUALITY CONTROL OF SAKJ PROJECT

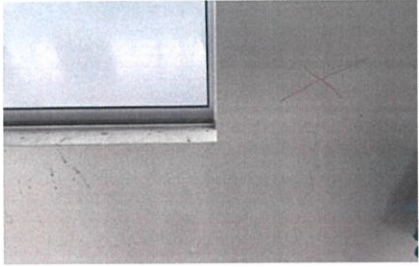
No.	Types and descriptions	Items
1.	Major cracks on sides of window frame and wall

<p data-bbox="791 618 1358 651"><i>Figure 6.3.1: Cracking on the side of window frame</i></p>
2.	Major crack on the edges of wall

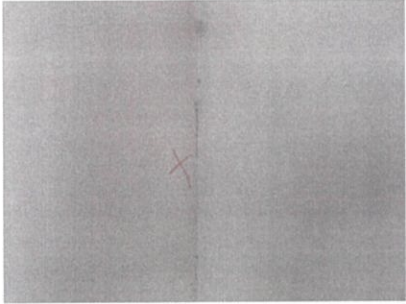
<p data-bbox="831 1052 1318 1086"><i>Figure 7.3.1: Hairline crack on edges of wall</i></p>
3.	Cracking at the corner of door frame

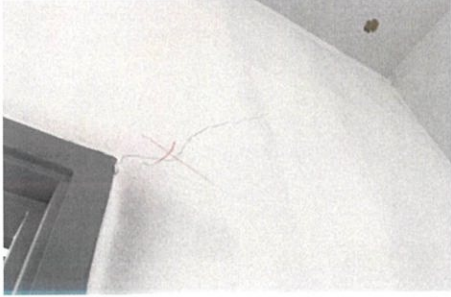
<p data-bbox="802 1482 1350 1543"><i>Figure 8.3.1: Hairline crack on the corner of door frame</i></p>
4.	Shear crack are inclined at 45° of crack with the horizontal

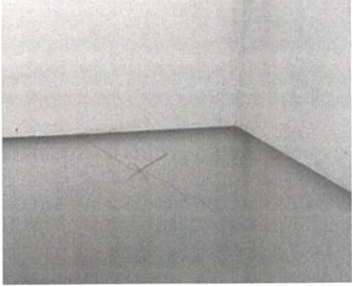
<p data-bbox="882 1930 1275 1964"><i>Figure 9.3.1: Shear cracks of beams</i></p>

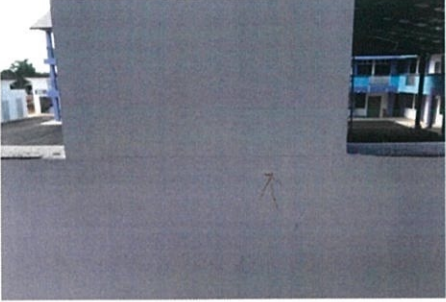
5.	Cracking along column and end of coping.

<p data-bbox="820 539 1310 568"><i>Figure 10.3.1: Hairline cracks along column</i></p>
6.	Jointing cracks in concrete beam.

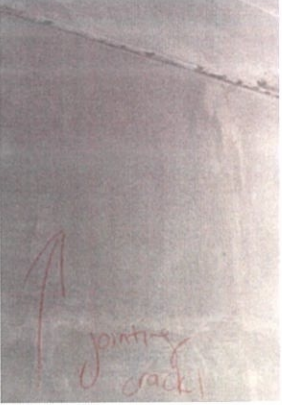
<p data-bbox="904 1059 1233 1088"><i>Figure 11.3.1: Jointing cracks</i></p>
7.	A hairline crack on concrete floor in classroom.

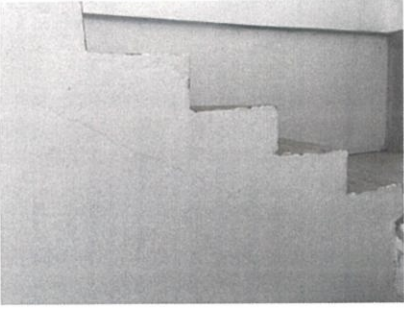
<p data-bbox="861 1897 1283 1926"><i>Figure 13.3.1: Cracking on stairs wall</i></p>

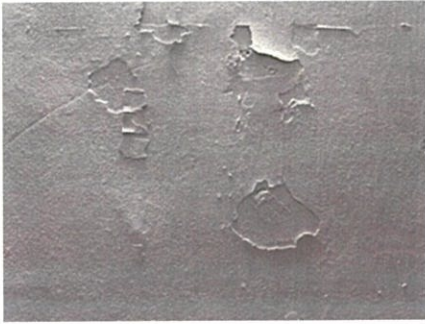
Peeling usually occurs on building facades, mainly on plastered wall, columns and other areas which are exposed to excessive rain and great dampness.

Figure 14.3.1: Peeling paint.

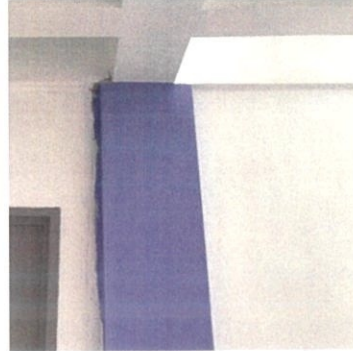
Figure 15.3.1: Excessive paint to the sides of wall.

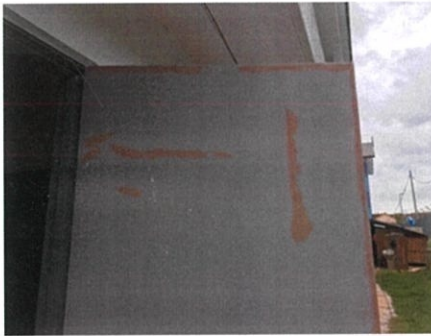
Figure 16.3.1: Improper painting on door panels.

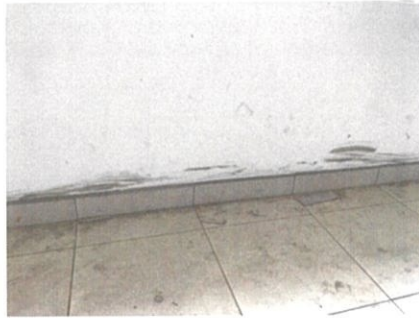
Figure 17.3.1: Stains on walls

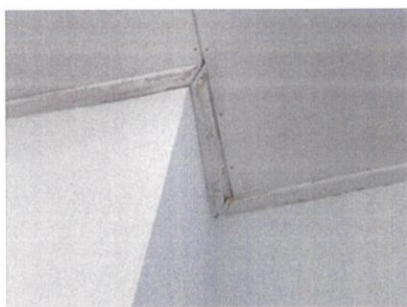
Figure 18.3.1: Dampness on ceiling.

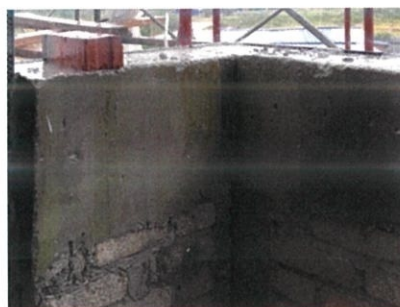
Figure 19.3.1: Dampness on plaster brickworks.

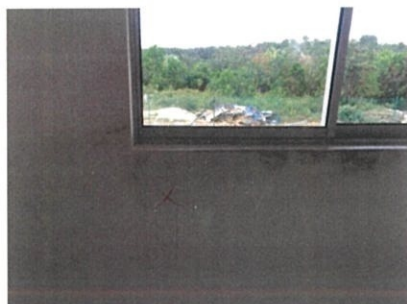
Figure 20.3.1: Dampness on wall.

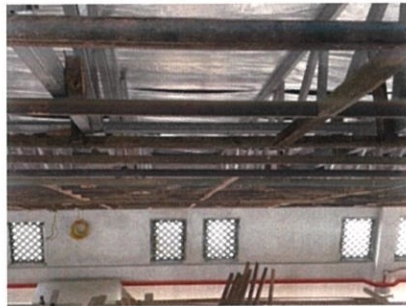
Figure 21.3.1: Timber panel of roofing structure decay

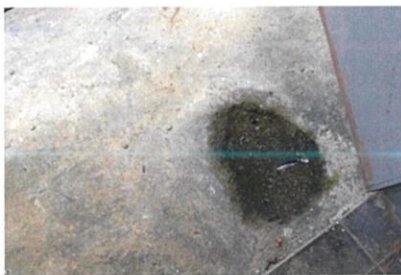
Figure 22.3.1: Mould on concrete

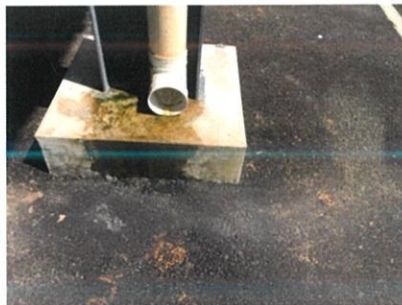
Figure 23.3.1: Mould on column footing

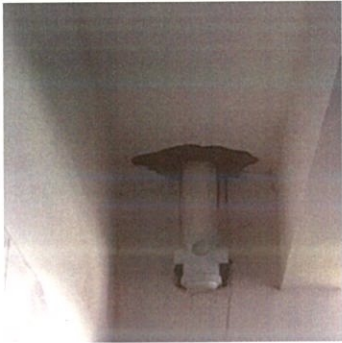
No.	Types	Items
1.	Wet plastering can be seen around the piping in toilet.

<p data-bbox="831 813 1158 846"><i>Figure 24.3.1: Wet plastering</i></p>
2.	The alignment of wall were not in straight line.

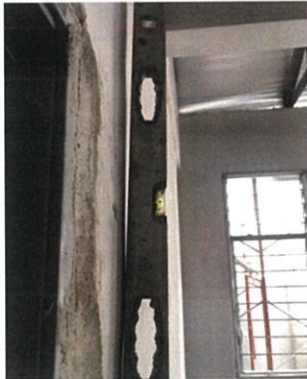
<p data-bbox="791 1294 1206 1328"><i>Figure 25.3.1: Non verticality on wall</i></p>
3.	Small hole can be seen between the fixed ceiling and beam

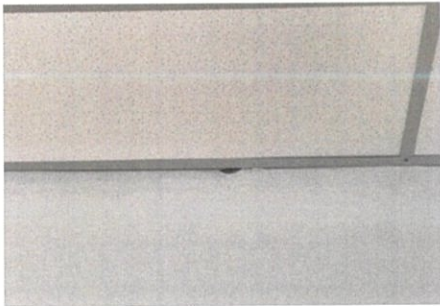
<p data-bbox="818 1704 1179 1738"><i>Figure 26.3.1: Lack of plastering</i></p>

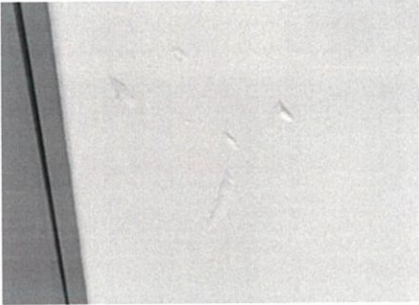
<p>4.</p>	<p>A few small hole or mark seen on the wall.</p>

<p><i>Figure 27.3.1: Improper plaster surfaces</i></p>
<p>5.</p>	<p>The beam was not in straight line and uneven form.</p>

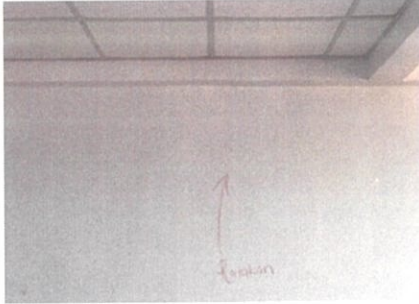
<p><i>Figure 28.3.1: Wavy beam</i></p>
<p>6.</p>	<p>Rough surfaces and smooth surfaces in a column.</p>

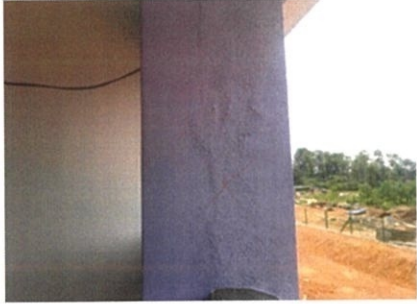
<p><i>Figure 29.3.1: Improper plaster on column</i></p>
<p>7.</p>	<p>The column are not in a straight line and wavy at the bottom of column.</p>

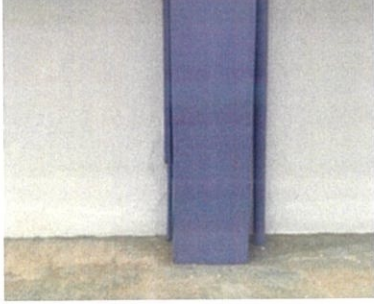
<p><i>Figure 30.3.1: Non alignment of column</i></p>

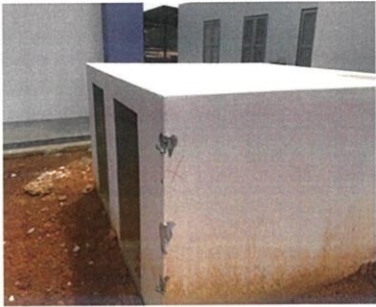
<p>8.</p>	<p>Drywall plaster on concrete platform of SPAII tank.</p>

<p><i>Figure 31.3.1: Peeling plaster</i></p>
<p>9.</p>	<p>The hole of wiring covered with improper plaster</p>

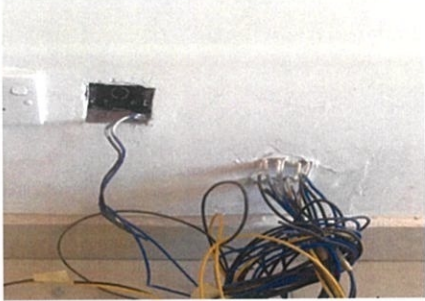
<p><i>Figure 32.3.1: Popping plaster on wall</i></p>
<p>10.</p>	<p>The hole are left uncovered with plaster.</p>

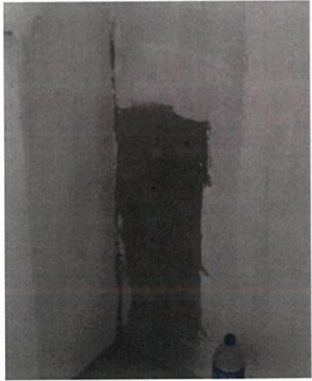
<p><i>Figure 33.3.1: Improper plaster surfaces</i></p>

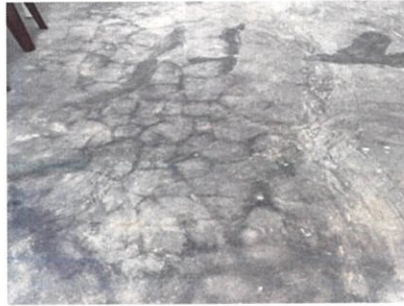
Figure 34.3.1: Crazeing on concrete floor

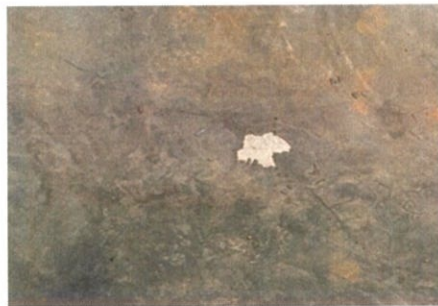
Figure 35.3.1: Delamination of concrete

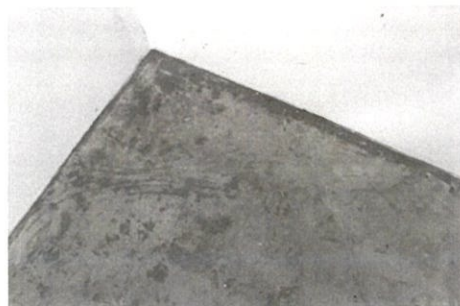
Figure 36.3.1: Dusting of concrete

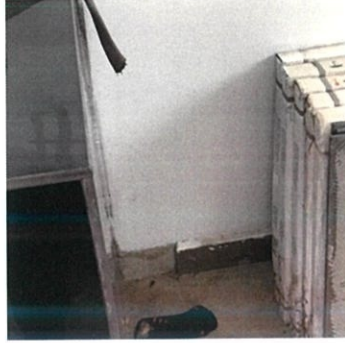
The tiles alignment between wall and other wall was not in a straight line.

Figure 37.3.1: Improper arrangement of tiles skirting

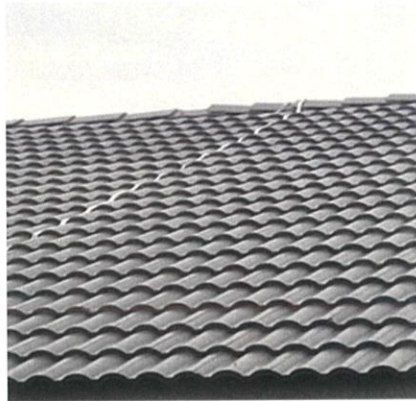
Figure 38.3.1: Poor arrangement of roof tiles

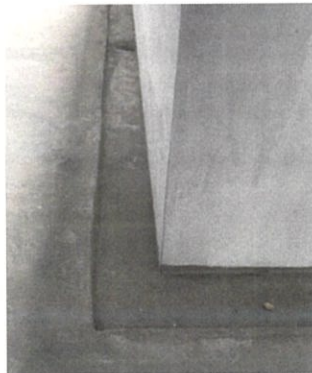
Figure 39.3.1: Non alignment of scupper drain

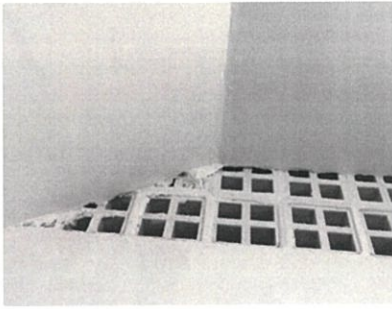
Figure 40.3.1: Cement residue on hollow block

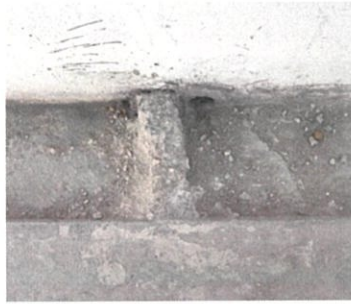
Figure 41.3.1: Excessive cement in scupper drain

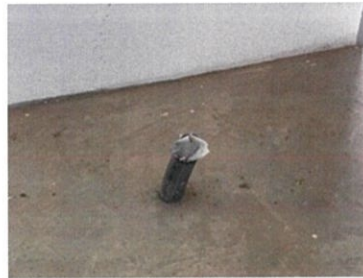
Figure 43.3.1: Exposed pipe on floor

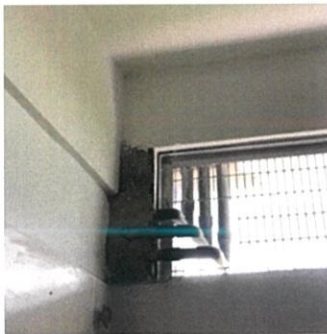
Figure 44.3.1: Improper installation of pipes in toilet

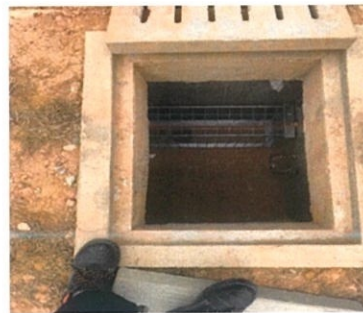
Figure 45.3.1: Wrong design of trash grill

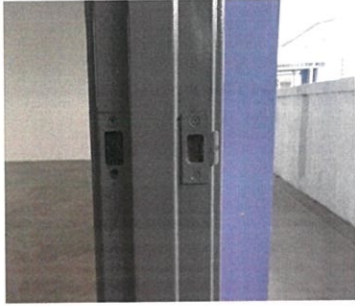
Figure 46.3.1: Improper installation of ironmongeries

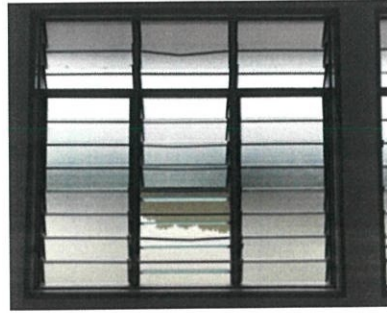
Figure 47.3.1: Window rods bend

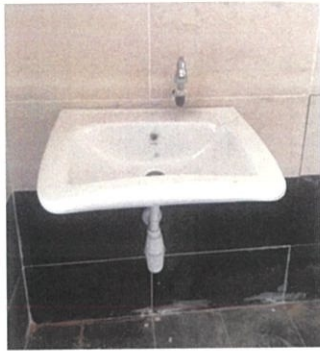
Figure 48.3.1: Non-alignment of tap pipe and sink

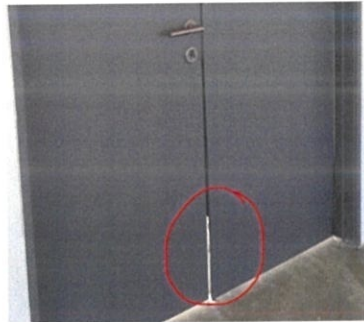
Figure 49.3.1: Broken door

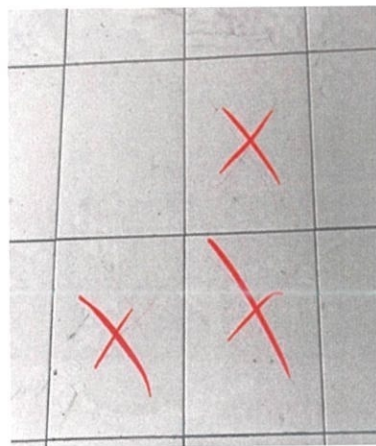
Figure 50.3.1: Hollow tiles in canteen

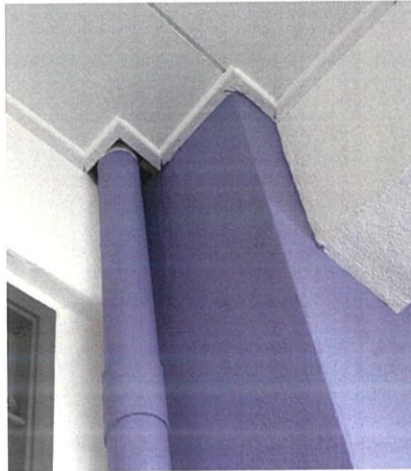
- i. Gap between floor tiles and column

Figure 51.3.1: Gap between piping and column

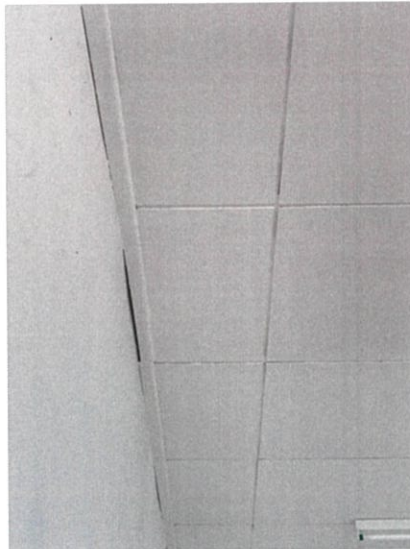
- ii. False ceiling – Gap between ceiling and wall

Figure 52.3.1: Gap between fixed ceiling and wall
