**THE CONSTRUCTION DEFECT ISSUE
INVOLVING METHOD OF RECTIFIED OF
DOUBLE STOREY HOUSE**

**PREPARED BY
AMIR FAKHRULLAH BIN AHMAD ASMADI
(2017206594)**

**2019
DEPARTMENT OF BUILDING**

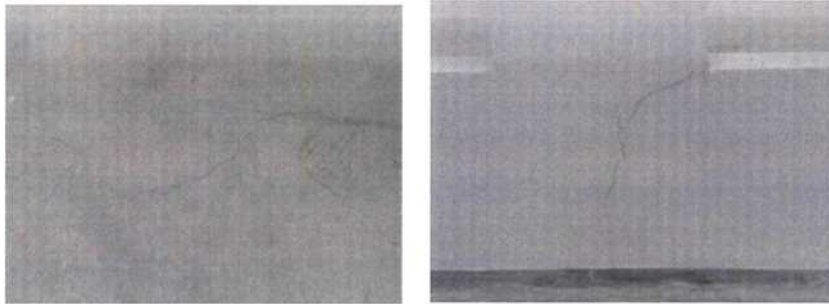
A plastering crack is a non-structural cracking where it formed on the plastered surfaces. Usually in a hexagon pattern, typically the measure only between 5 mm and 75 mm across the hexagon. They do not extend through the whole depth the plaster because it usually very fine and shallow. This crack can be hairlines crack which are difficult to notice, or it can wider crack which are easily seen. It is because plaster is very thin component made of mortar. The development of a series of hair crack on the finished plaster surfaces knows as map grazing. When it forms a haphazard pattern over the wall surfaces affected. For example, crack are detect at lot unsold shop at Meru Perdana 2.

Figure 10 Plastering Crack on Cement Rendering floor and outside wall partition

The full thickness of plaster has come away to the background. Loose areas sound hollow which tapped, and crack will often be evident. The plaster may bulge or sag, and in extreme cause will have fallen away. Plaster has failed to adhere to a dense concrete background, probably due to the use of an unsuitable undercoat. Remove all loose plaster, clean up laths and re-plaster. If deterioration is extensive it may be preferable to replace the old lath and plaster work entirely with new construction, for example using plasterboard.

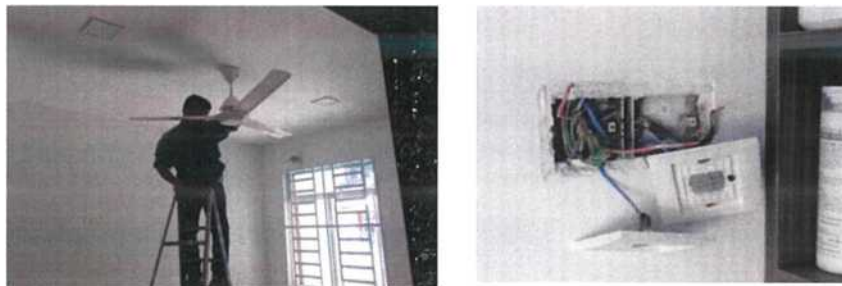
Electrical and wiring is a very complicated component. Every single wire have their own function and detailing. If not properly installed, it will cause the defect. These will lead to switch of light and fan is not working, flickering light, tripping circuit breaker and electric shock. In an electric power system, a fault or fault current is any abnormal electric current. For example, a short circuit is a fault in which current bypasses the normal load. An opencircuit fault occurs if a circuit is interrupted by some failure.

Figure 11 Defect at Azalea where the fan is not working and the problem of switch

The defective electrical can be anywhere indoor. The appliances fails to work when switch on. It will cause by loose wire, fuse has blown, faulty appliances and insulation breakdown. The way to rectified is first, reconnect the wire, replaces fuse with the correct size and try again. If still faulty refer to electrician. Instruct replacement of light flexes if in poor condition, but for any other failing instruct electrician to carry out inspection. Particularly if property was not rewired on conversion.

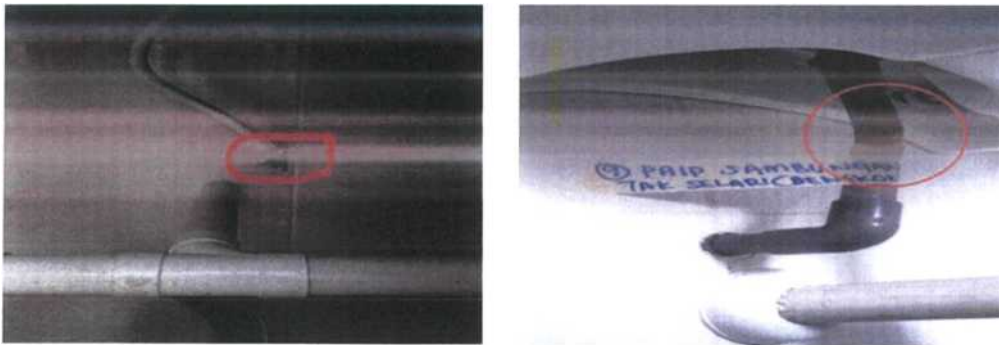
In many cases, piping defect happen when it changes in water pressure and water flow. Some case about water pressure slow, leaking and clogged. Many of the complaint about leaking of pipe. When pipe corrode, they leak and cause endless problems. Leak can be small as a drip, but they also prove to be something must most disastrous to the buildings and belonging. If the owner ignore leaking pipe enough they can wreak havoc on their entire house. For example, it will cause other defect problem like poor water quality, wrapped and stained wall, invasive black mold, and flooding. When the pipe have a bad smell from rotting food or other debris, maybe something was wrong. It maybe because of pipe clogged

Figure 12 Stop cock leaking at master bedroom and pipe crooked at kitchen

When water does not run away to waste, this is most frequently associated with kitchen sink. Internal corrosion causing restricted flow and hence blockage by normal household waste. Clear by rodding or flushing with safety precaution necessary or by drain clearing specialist in cases of persistence

blockage. Replaced corroded section with more suitable material. Relay waste pipe to proper fall. If the drain was blocked, attempt clearances using normal cleansing equipment and expertise. Identify fungal growth so that the food source can be identified and removed. Provides the deformation is temporary, releasing the blockage should return the pipes to its original shape. Ascertain the reason for breakage and replaces broken pipes.

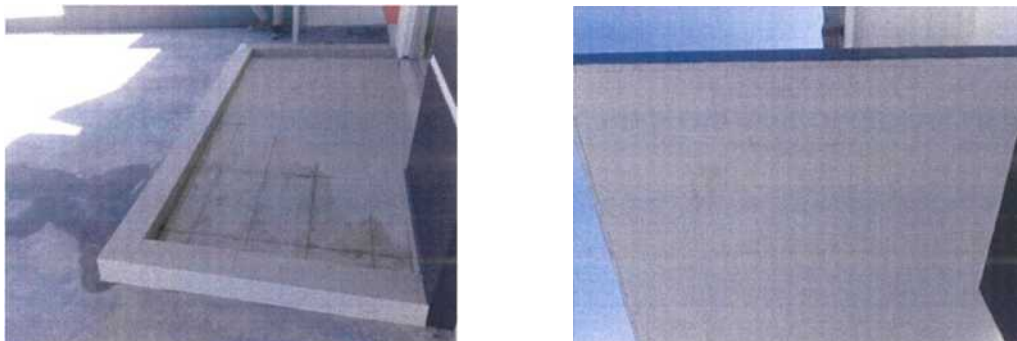
Dampness and leaking are common problem faced by home owner and it can be a serious matter. Moreover, when it comes to rainy season. Dampness happened when water entering a building through different routes. Water penetration occurs commonly through walls exposed to prevailing wet wind or rain. Many complaint according to customer services department says, car porch and balcony is mostly area that effect to the dampness and leaking. The water absorbs from the roof directly down to slab. This also will affect the wiring of balcony and car porch lighting. Water may also drive further up the wall to emerge at a higher level. This happens due to poor quality construction and lack of waterproofing measures during construction of the building. Dampness also occurs in walls due to other factors such as leaking gutters or down pipes, defective drains, burst plumbing and condensation due to inadequate ventilation.

Figure 13 Dampness at car porch roof and balcony

Damp is visible on the internal plaster of the upper parts of external walls of the building. Damp patches are visible also after rain and in more severe cases water may drip from them for sometimes afterwards. Such patches may be brownish in colour and water may drip from crack to the electric light fitting. This is because condensation of water and direct rain penetration, although possible, is much rarer than might be thought. Where water does enter, it may travel horizontally between layers of roof felt before appearing as damp. To remedies, provide an efficient water proofing on the surfaces of the ceiling and ventilated any air spaces in flat roof. It will improve insulation. Drain off trapped moisture by drilling or hack the roof for temporary drainage holes and insert ventilation units. Repair defect at roof surfaces and at edges, whether contributing to the damp or not.
