**BUILDING DEFECT MANAGEMENT : A CASE STUDY AT THE
HAVRE BUKIT JALIL**

PREPARED BY :
MUHAMAD AFIQ HAKIM BIN SHAMSUL ANUAR
2016614386

**HIGH-RISE BUILDING UNIT DEFECTS MANGEMENT PHASE 2A, THE HAVRE
BUKIT JALIL**

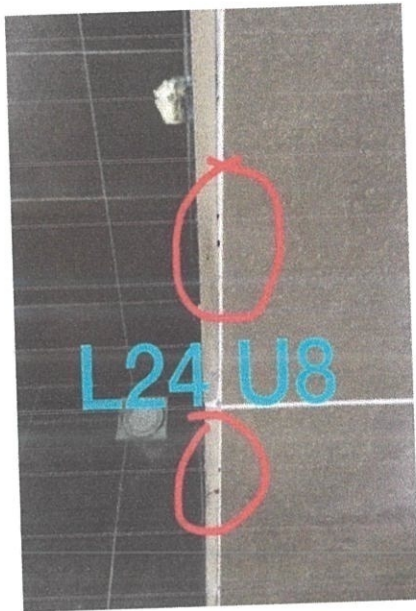
Figure 3.8 : Bathroom 'Grouting' defect

Figure 3.8 shows the grouting defects which is caused by the mortar not being applied evenly by the workers. If it was not applied evenly, the grout thickness is not the same where some of them are extremely thick and some of them were thin. Which then cause it to be crack and a hole is present from the cracks in time at the thin part of the grout. The defect was identified by using the sense of touch where we gently slide our finger along the grout to make sure that the grout is firm and to checked whether holes are present during the touch.

The bathroom defects are grouting, chipping of tiles and holes on the ceiling. For grouting and chipping of tiles, the sub-con needs to immediately come to the bathroom to see the defects. After a few discussion was made, all of us came up with the solution which are grout for grouting defects and welding for chipping tiles defect.

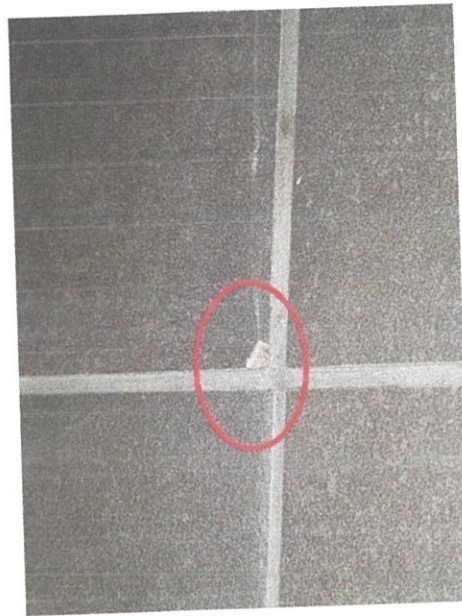
Figure 3.9 : Bathroom 'Chipping' defect

Chipping is another term of peel off of the tiles edges as shown on figure 3.9. It was cause by an impact or a collision with a hard material. It also could happened during grouting works where the sharp edge of the scrapper hits the tiles edge ad causes it to chipped. The defect was identified by the critical sense of observation. The bathroom needs to be critically inspected by the help of a flashlight in order to spot the chipping defect because it is micro in size.

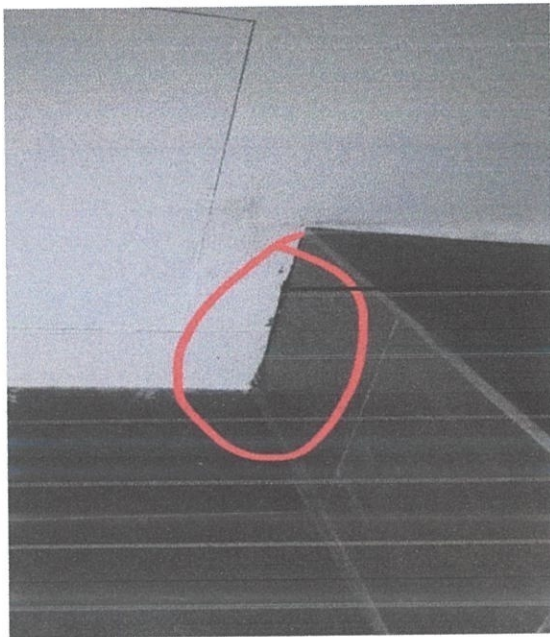
Hole in the ceiling is present. Due to human errors.

Figure 3.10 : Bathroom 'Ceiling' Defect

The defect is caused by untidy workmanship or it occurs during housekeeping progress where at first the ceiling was intact until a worker accidentally poke it and cause a hole by using a scrapper when they are trying to clean up the tiles outline. This defect was identified by using the sense of touch and the sense of observation. The holes came in different sizes where some of them were extremely tiny and some of them were tremendously large. Firstly a staircase is used to climb up to the ceiling. Then, gently touch the ceiling with the index finger along the edges of the ceiling. Bear in mind that the edges are extremely fragile because stopping compound is used to cover up the gaps in between the suspended ceiling slab and the tiles. After it have been touched, observe the ceiling by using a flashlight closely to spot holes.

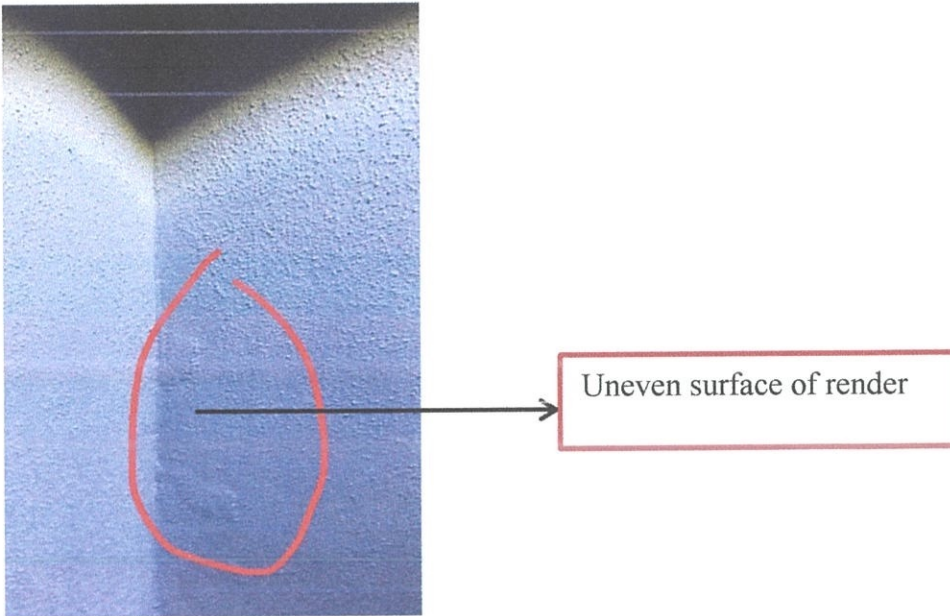
Figure 3.11 : Yard Defects

The uneven surface of render is due to the uneven amount of overlapping of render coats to the parts of the wall. The defect was identified by using a specific flashlight which is in a rectangular shape. It was very comfortable to use due to its size as big as our palm. Level the flashlight against the wall. Then, slightly move it around the surface of the yard wall to spot uneven surface as seen on figure 3.11. A shadow will appear at the edge of the wall if the surface is uneven. Besides that, Level is also used to determine whether the rendered wall is evenly coated or not. After it had been spotted, captured the photo as reference.

Yard defects are rectified by apply back the cement render to the defect. That is the only way to rectify it.

The yard render started with mixing of the cement render with water. Then, apply it on the defect part of the yard wall. Spread the render evenly as the first layer. 'Tatai' is the term use on site. Then, use sponge to make the surface become hard by rubbing it evenly until a micro stones is formed at the surface.

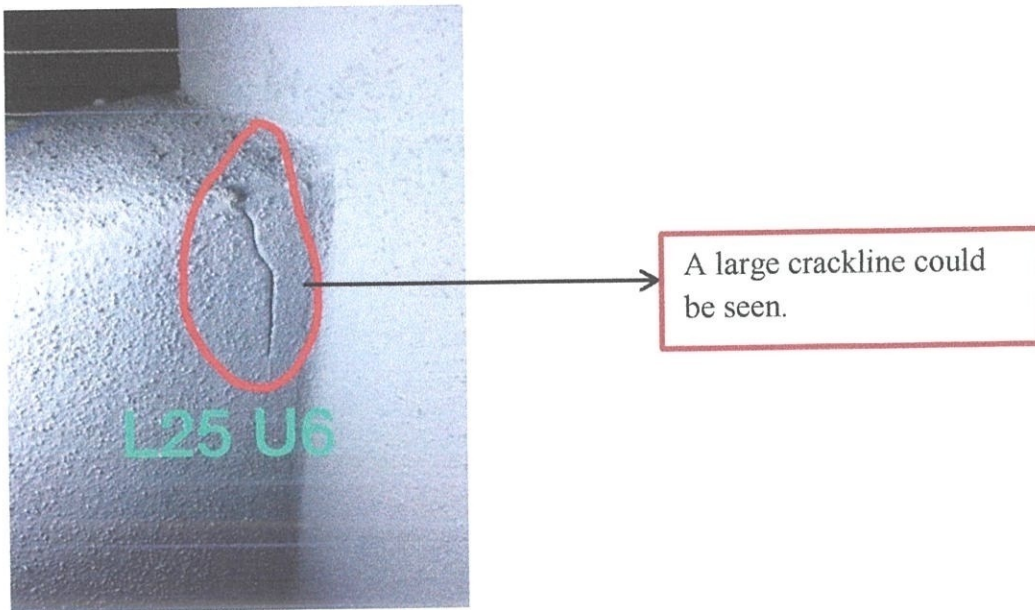
Figure 3.12 : Yard Defects

Figure 3.12 shows a large crackline on the surface of the yard wall which is caused by colliding with an when it was still not yet hardened. Identified by using a flashlight.

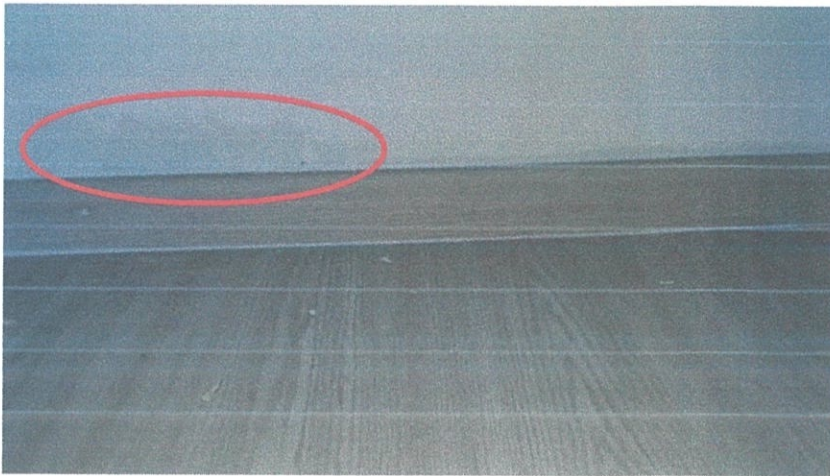
Figure 3.13 : Bedroom 'Skim' defect

The figure above shows skim defects in the bedroom. After the laminated parquet skirting have been installed, some of the places were damage during the process. Skim is the undercoat for the wall by using Asian Gympsum Compound/(ASG). After the undercoat layer of skim is applied, only then painting works could be done. The defect is identified by using a flashlight and the sense of observation.

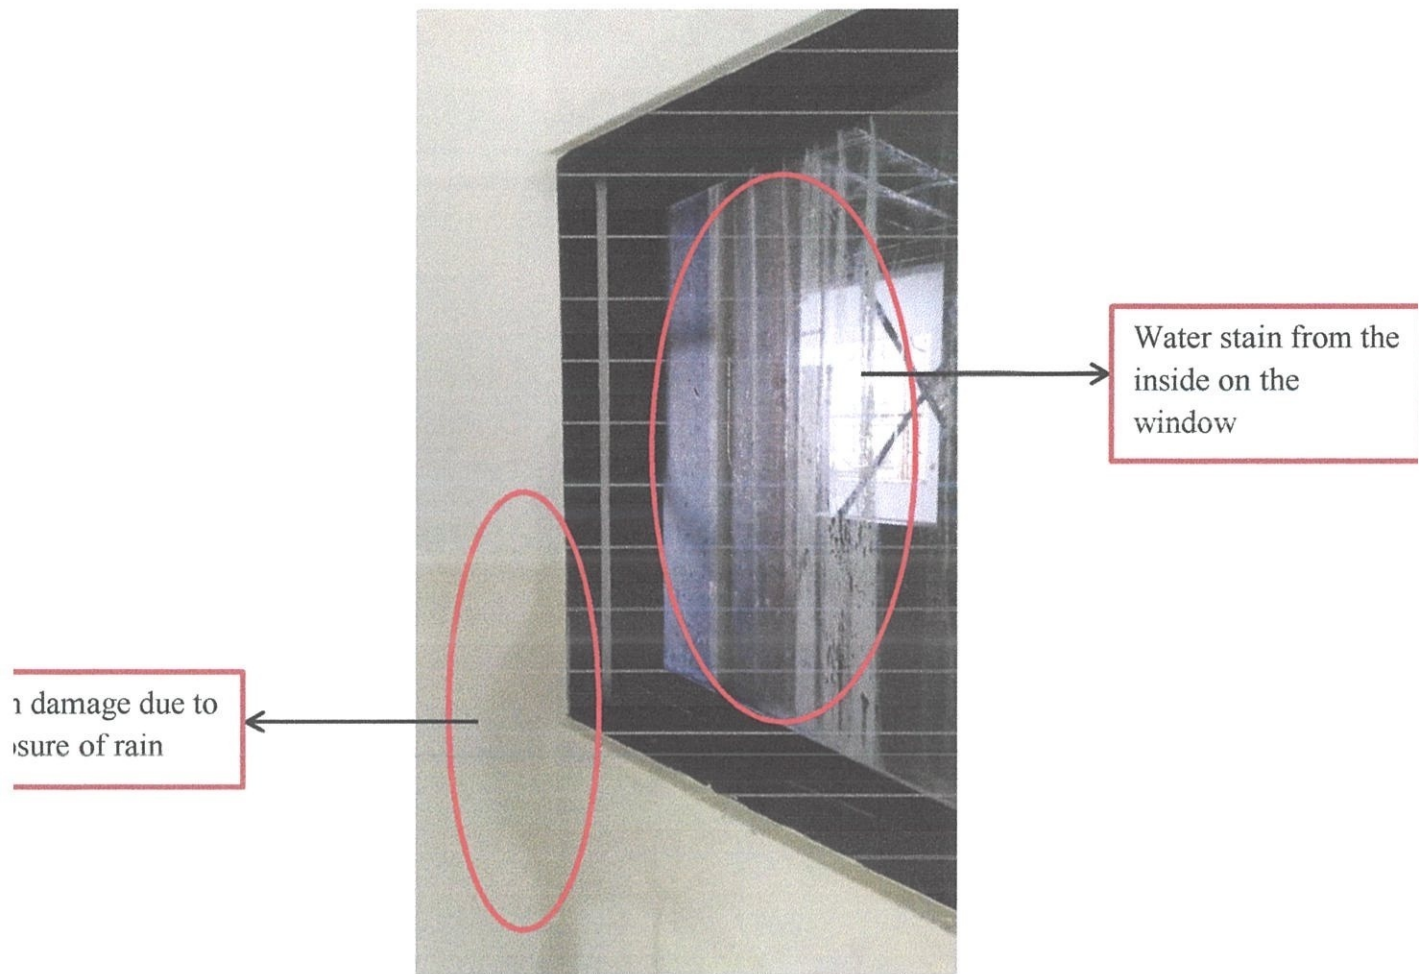
Figure 3.14 : Bedroom window and skim defect

The figure above is a combination of 3 defects which are window defect, laminated parquet floor defect and skim defect. It all started with the window defect, where water can pass through it due to the window being unable to close. The way to identify this defect is by conducting a functionality test towards the window. Firstly, check whether it can be fully open without any friction occurred. Then, proceed to test the handle of the window by twist it downwards to locked it. If it was unable to be locked, or to be twisted, than that is a defect. Window defects needed to be taken seriously. This is because, if the window can't be closed rainwater could pass through it and make a puddle in the bedroom on top of the laminated floor. If that happens, a disaster would occur.

The bedroom defects consist of more than one parties involve. So, it's a bit complicated in solving the defects. For example the window defects. Being unable to close, shattered glaze, water being able to pass through are the defects that could produce more defects in the bedroom specifically. Rainwater is the bedrooms greatest enemy. If rainwater passes through the bedroom, thus a few more defects are produced. A window defect could produced, skim defect from which the rainwater hits the internal wall of the bedroom Besides that,with exposure towards excessive water , It can cause the parquet to be infected by fungus, to peel off from the floor and to become bloated on the surface of the laminated floor.

So, the solution is to repair the window defect as soon as the defect is identified to avoid other defects from producing. If water passed through the window, there is only two methods that could be use to rectify the defect. Firstly, checked the external wall whether it is already coated with render or not. If render is applied, that means the problem is the window. But, if its otherwise, then the outer part of the window needs to be rendered properly and coat it with a specific paint to make it more effective in avoiding water from entering the window.

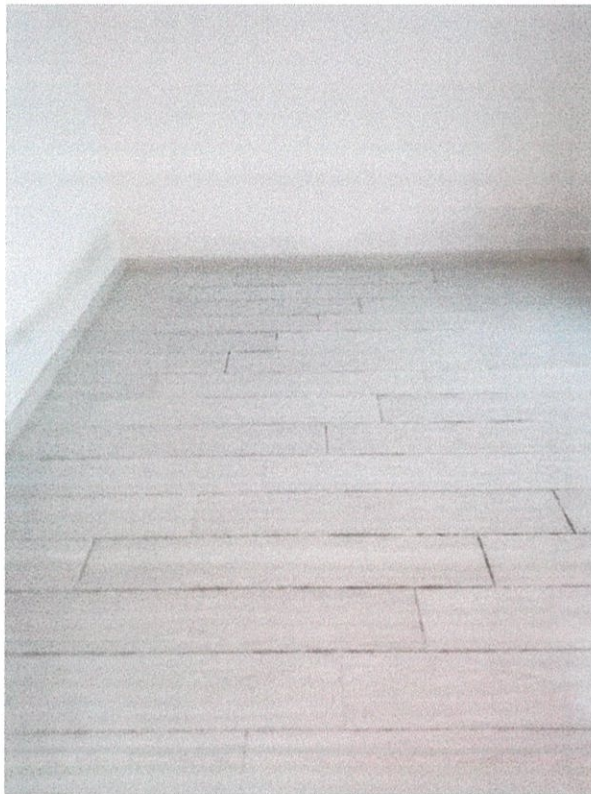
Figure 3. 15 : Laminated Parquet floor defect

The laminated parquet floor can't be expose towards water. It could damage the parquet by the growth of fungus and the parquet would peel off after a week. The way to identify this defect is by using the motion test. Where we step on the required with one foot and jogs it at the same place with the other foot. By doing so, if water is present we could felt the surface is bloated by stepping on it a few times. The motion test is only applied to laminated floor.

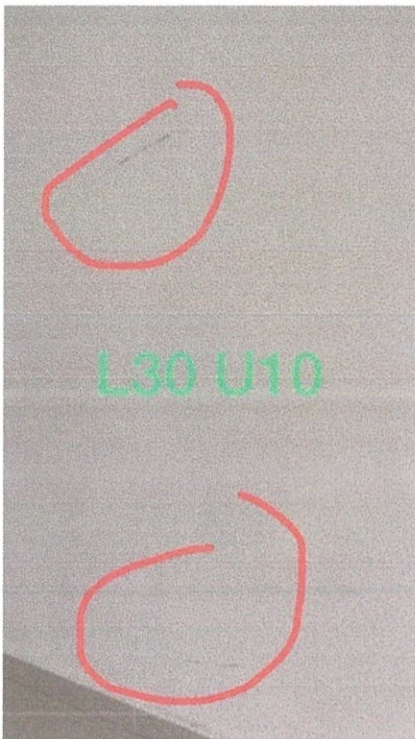
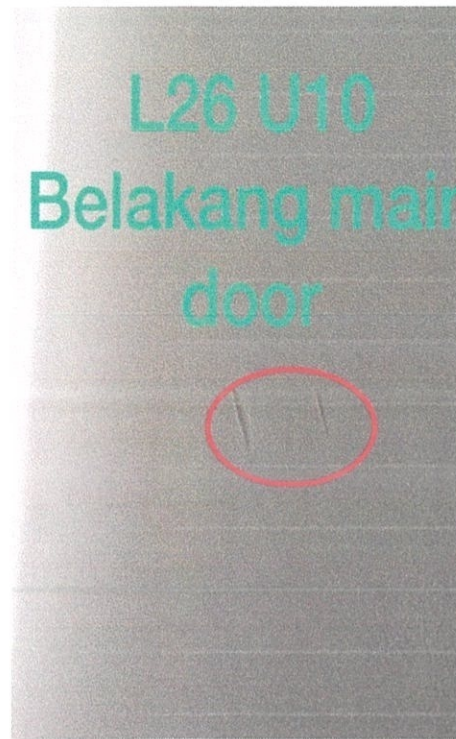
Figure 3.16 : Living room defect

Figure 3.17 : Living room defect

Figure 3.16 and 3.17 shows the same type of defects which are skim defects. But, the cause of the defects are different. Figure 3.14 defect is caused by colliding of materials such as scaffolds. While figure 3.15 is cause by human error. The workers did not plaster the wall to fill in the gaps as shown before skim coat is applied. Thus, gaps are present on the surface of the wall. In order to identify the defects, observation is used to spot the defects.

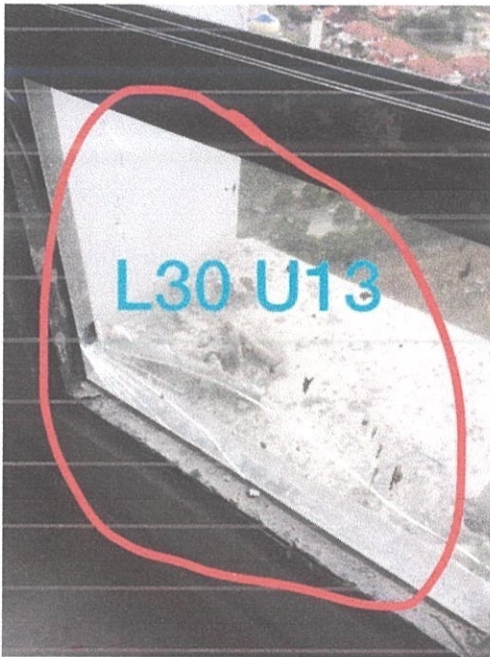
Figure 3.18 :Living room 'Window' defect

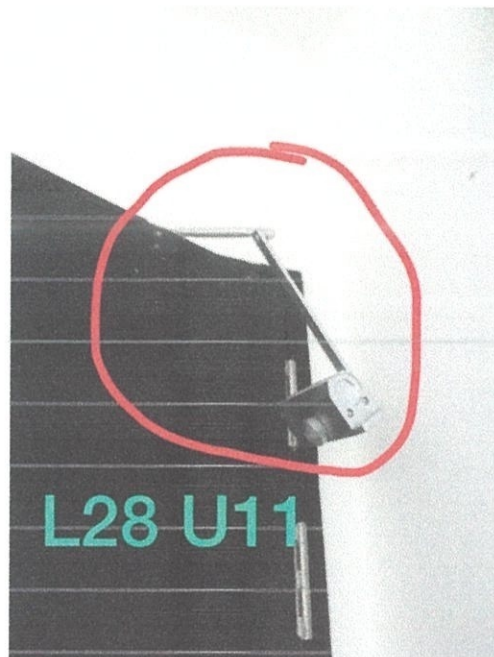
Figure 3.19 :Main Door 'stopper' defect

Material defects needed to be specified in quantity available on site. The only way to solve the defect is by replacing them. But, not all material defects could be rectified. For instance, door frames that are damaged needed to be ordered right after the defect have been spotted. In this matter, we would be working with the contract department and also sub-contractors on the quantity materials on site and the amount of material that needed to be come out with a delivery order(D.O) on the defected material that could not be rectified.

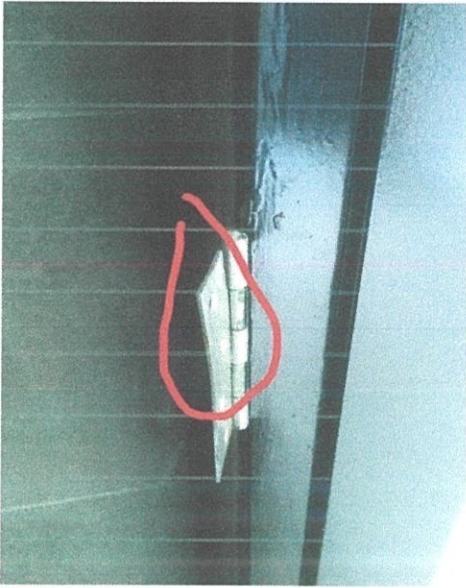
Figure 3.20 : Door frame 'Hinge' defect

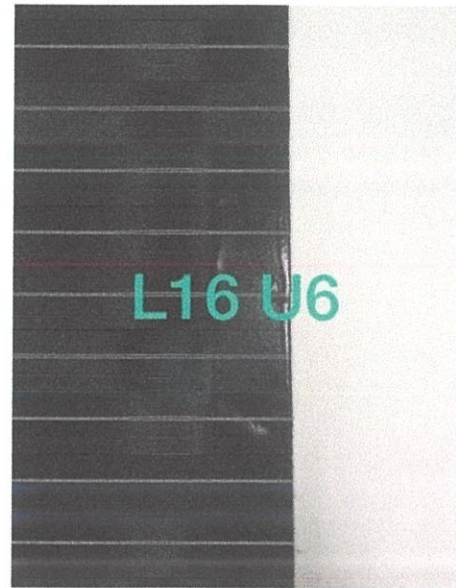
Figure 3. 21 : Door frame 'Crooked' defect

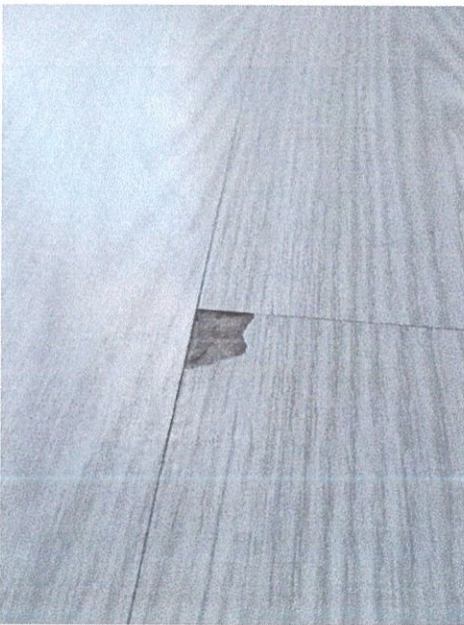
Figure 3.22 : 'Chipping' of laminated floor

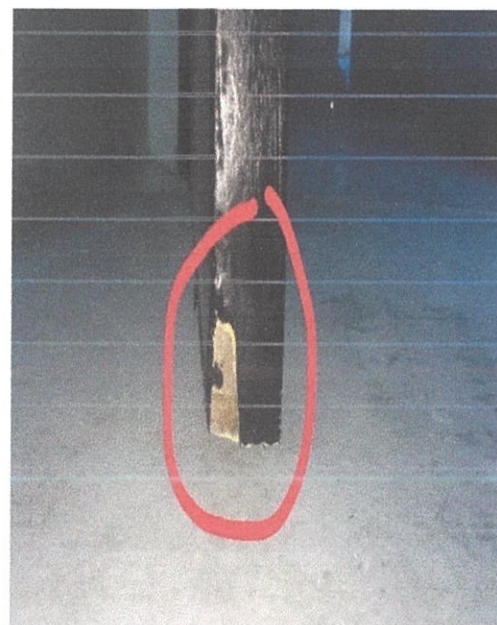
Figure 3.23 : 'Door leaf' defect
