DEPARTMENT OF BUILDING
UNIVERSITI TEKNOLOGI MARA
(PERAK)

FAILURE IN CONSTRUCTION AND ITS RECTIFICATION AT
RIANA SOUTH CONDOMINIUM

DECEMBER 2018

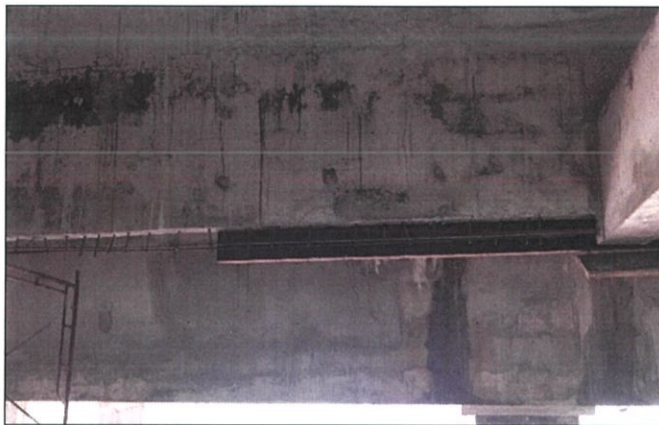
“Dinosaur teeth” is known as post-installed reinforcement which a process of reinforcement bar inserted into borehole filled with Hilti HIT in reinforced concrete structure. In this project, it is happened when sub beam (horizontal beam) and king beam (main beam) are not a line that affect the aesthetic of the building. Dinosaur teeth is named as the characteristic or the figure of the exposed reinforcement bar that were plant into concrete. This failure happened because of the architecture design errors as it is not careful design during design building.

Figure 3.6: Dinosaur teeth.

1. Scaffold were installed along the sub beam which act as an access for the worker to do their works and safe for use.

2. The position of "U" bar to be plant is identified by Scanning the reinforcing bars and other embedded elements with a Hilti GPR scanner or Scanners that locate ferrous materials using magnetic fields. Beam surface were Drilled with driller to require depth of 20mm d. There is two type of driller which is hammer drilling and diamond coring drilling. In this case, Hammer drilling were used in this process.

3. Next, drill hole is cleaned by blower before planting of rebar. Bond between adhesive and concrete is directly influenced by the condition of the hole wall at the time of adhesive injection. The concrete in which the post-installed reinforcing bar is to be installed may be dry, saturated or even partially or completely submerged at the time of installation. Hole cleaning generally involves a water-cleaning process, followed by sequential blowing out the hole with compressed air to remove debris and water, and the use of a wire brush to mechanically scour the hole wall. Approved epoxy Hilti RE-500 is applied into the drill hole and "U" bar details to be T 10-200 were plant into the beam.

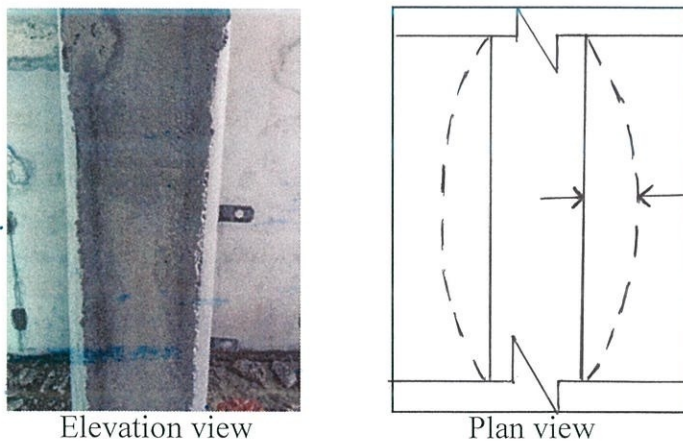
Bulging occur because of the form failure or misalignment of formwork that cause uneven surface on the reinforce concrete wall. Mostly happened because of the loose or missing bolts or fixing pins. Bulging also known as blister which are hollow, low profile bumps on concrete surface. Blister occur whenever the surface does not allow water/air to escape into the atmosphere. It can be repaired with surface grinding or hacking to maintain the verticality of the structure. Bulging can be prevented by a proper verticality inspection on the formwork by using plum bob technique, and a proper supervision on the installation of the formwork must be taken.

Figure 3.8 : Example of Bulging.

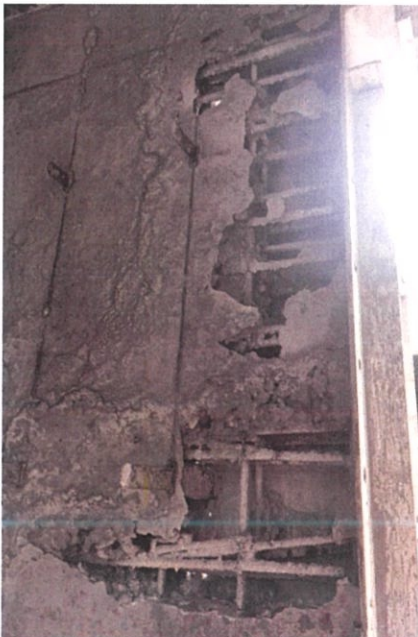
Segregation are also known as honeycombs. Honeycomb are hollow spaces and cavities left in concrete mass on surface or inside the concrete mass where the concrete could not reach. It is called honeycomb because of its characteristic that look like honey bees' nest which appears on concrete surface where voids are left due to failure of cement mortar to fill spaces around and among coarse aggregate. Honeycomb is always an aesthetic problem and depending on the depth and extent may reduce both the durability performance and the structural strength of the member. This happened because of poor concrete compaction due to ineffective vibration or rebars congestion, low cement content or improper mix design. This problem will damage the concrete and more serious attack the reinforcement bar in concrete.

Figure 3.9 : Example of Major segregation

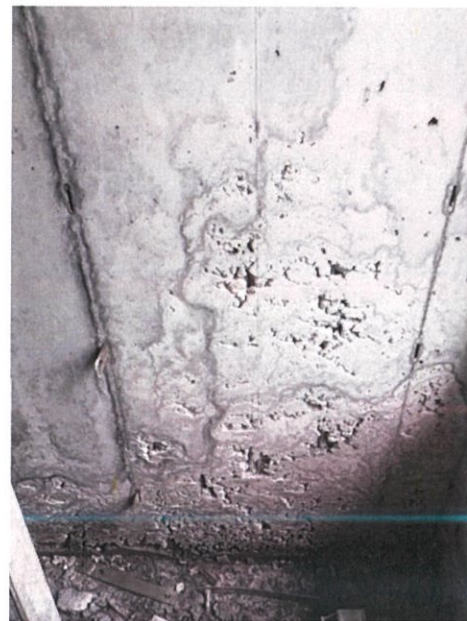
Figure 3.10: Example of Minor segregation

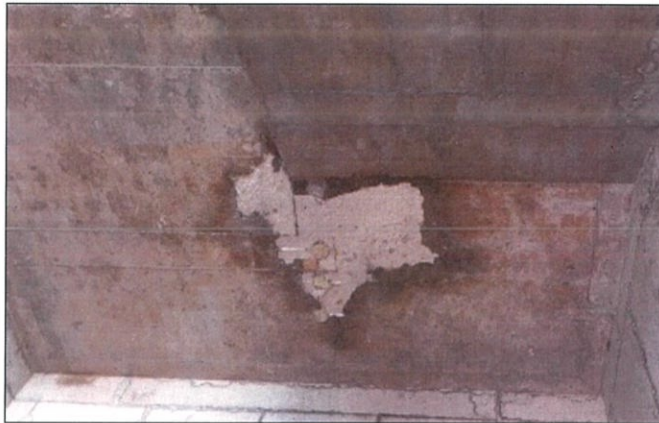
Finishing errors in concrete structure can involve over finishing of the concrete surface or addition of more water or cement to the surface during finishing of the concrete. This result in the porous surface which make the concrete permeable resulting in less durable concrete. Poor finishing of concrete results in the spalling of concrete from surface early in their service life. Repair of spalling involves removal of defective concrete and replacement with epoxy bonded concrete.

Figure 3.11 : Example of finishing Error.

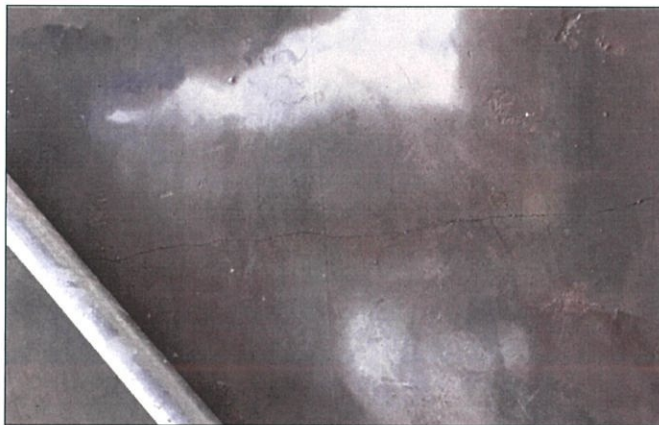
Crack are formed in concrete due to many reasons such as improper mix design, insufficient curing, omission of expansion and contraction joints, use of high slump concrete mix. Excessive movement of the building structure and serious overloading are also one of the reasons. To prevent cracking, low water cement ratio are used and maximize the coarse aggregate in concrete mix, avoid admixture that containing calcium chloride. Surface should be prevented against rapid evaporation of moisture content. Load must be applied on the concrete surface only after gaining its maximum strength

Figure 3.12: Example of crack.

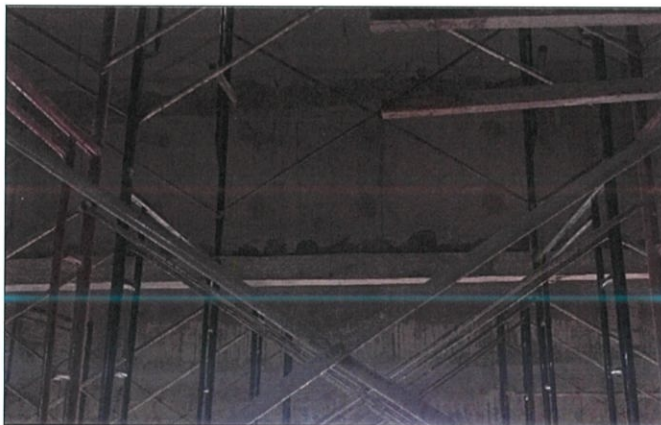
Figure 3.24: beam after formwork dismantled

6. After 3 days, formwork was carefully dismantled by carpenter without vibration as would damage the concrete.

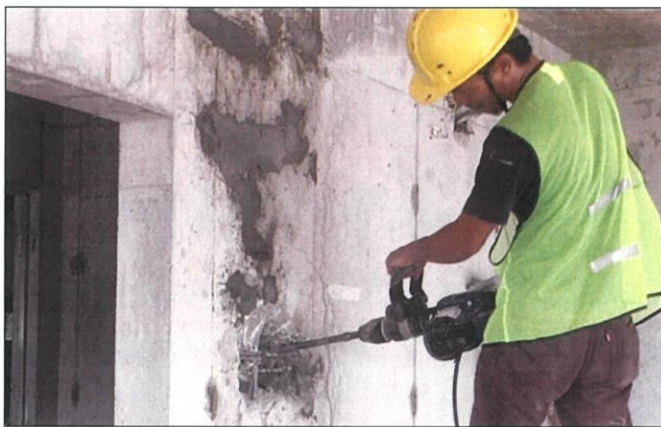
Figure 3.25: Hacking wall in process

1. RC wall is hacked to remove loose concrete in RC structure until sound concrete by using pneumatic or electric breaker. All laitance, loose dirt or dust on the hacked concrete substrate were removed by using electric air blower. The substrate surface was structurally sound, free from oil grease or any loosely adherent material. In addition, the substrate surface was presoaked with water to assist in the formation of bond between substrate and grout.

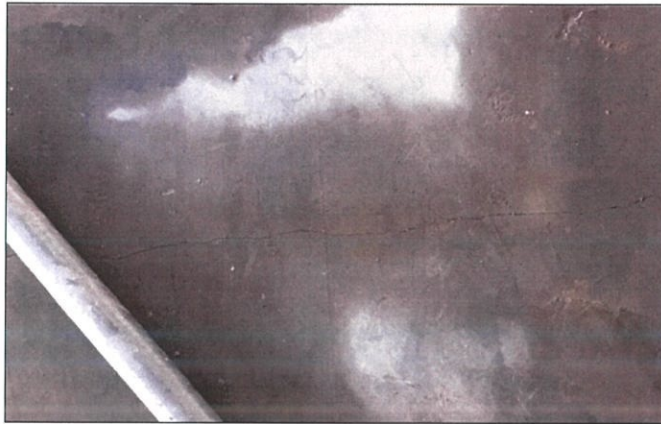
Figure 3.37: crack line at carpark RC slab

1. 20mm deep x 20mm wide were saw cut include 10mm on both sides of the RC slab crack lines by using diamond concrete cutter. Next, Slab is hacked by using electrical breakers along the pre-cut cracks to form 20mm x 20mm U' grooves to receive epoxy resin grout. All Losses materials, dust and laitance in prehacked grooves are cleaned and removed by using electrical blower or vacuum cleaner. Make sure the substrate is sound, dry, clean and free from oil and grease.

3. By gravity pouring method, the premixed StoPox EPG epoxy resin grout is poured in thickness of 0.5cm-4 cm into the pre hacked crack lines. Grout were poured from one side or from the corner when underfilling base plate. It was poured continuously until the cavity is completely filled. Next, the epoxy grout surface is smoothed by using steel trowel before gel time. The finish level of the epoxy resin grout shall be the same level with the existing RC floor slab. Lastly, the epoxy resin grout are settled for at least 6 hours.

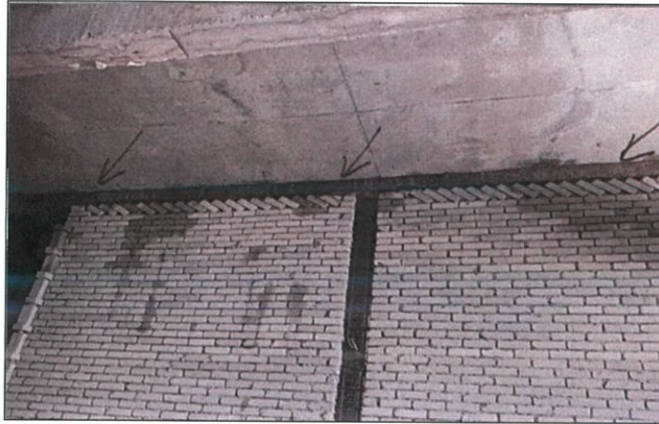
Figure 3.41: water leakage

1. Holes of 16mm diameter at 50mm deep was drilled into crake lines at 150 mmm intervals along the side of leaking cracks or construction joints or 75mm interval void in reinforced concrete by using electrical breaker either in diaphragm or retaining wall, rc wall, slab or beam.
2. Holes were drilled 20mm away from the existing crack lines or construction joint or around the localised concrete void areas, and to be at 45 degrees into the crack profile or construction joint of thy reinforced concrete or section. The distance between holes depended upon the width of crack or void is to be filled. After that, the mechanical packer was installed and secured tightly into the predrilled holes where pressure grouting is to be carried out.

- Next, Maxxeal PU Xeal one-part polyurethane grout were poured into holding drum attached on top of the grouting equip Commence application by using motorised / airless hydraulic pressure grouting equipment, ensuring crack or void is filled from one port hole to another. The Maxxeal PU Xeal polyurethane grout reacts almost immediately with the water Due to the expansion of Pentens PU 300 polyurethane grout, it forms a "fluid wedge" and block the leakage. The polyurethane grout is yellowish in colour in the form of expanding foam at initial set stage. Upon completion of the operation, all mechanical packers and plug holes were removed with non-shrink grout. All exposed solidified polyurethane grout or foam on the surface of the concrete were also removed.

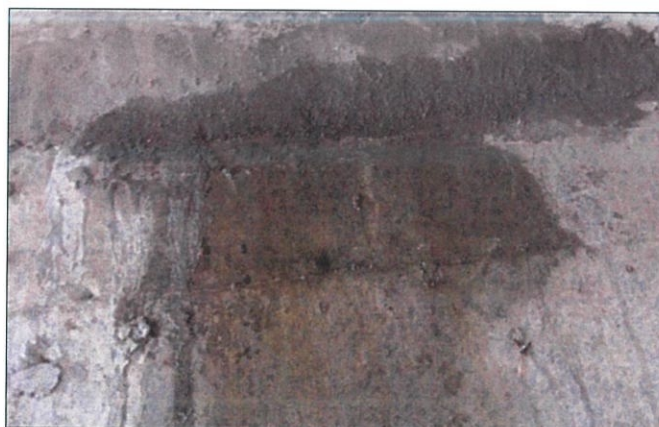
Figure 3.43: crack leakage at rc wall
