Study of Breakdown Occurrence on the 11kV Sewerage Plant Substation in UiTM Shah Alam

Abstract – This paper describes the characteristics of environment of 11kV outdoor distribution substation that was affected to underground cable supply. There is some visual checking and site testing to detect breakdown on the cable and calculated cost involve comparing to suggested solution. Details inspection and testing are usually perform if any tripping or fault occur. In this case, breakdown of insulation cable was studied on how it could be solve with less cost spend. First, inspection and testing was performed in order to find point of fault. Then analysis of data and information was estimated that moisture is the main cause contributes to this case of fault. The affected part was identified so that repairing work could be done. It was confirmed that gear involved in switchgear truck, interconnected bus-bar and insulation of cable was affected and will not be able to operate. Repairing work cost was studied by comparing it with the suggested solution. The suggested solution is to eliminate Sewerage Plant substation from operation supported by availability considered.

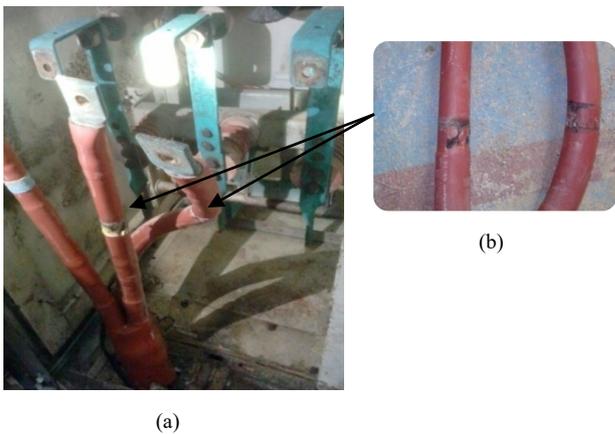
“to DATC substation (Dewan Agung Tengku Censelor)”. This case caused facility to make an observation to the site and it was observed that Sewerage substation was out of electric supply. It was observed that fault was occurred at interconnector cable connected to VCB at Sewerage Plant in UiTM Shah Alam caused of explosion. It was caused VCB which protect circuit of incoming supply from DATC building was trip. Bus bar which connect incoming cable from circuit of protection was observed change in color from silver to greenish [10]. The problem is the bus-bar will not be able to be maintaining during routine or preventive maintenance. The bus-bar supposes to be maintained in chrome colour during its entire operation. Another problem is about a breakdown cable supply observed. The figure 1 below shows the bus-bar which changed in colour and the point of fault on the incoming underground cable.

Fig 1: (a) Bus-bar shows Change in Colour. (b) Cable Fault at Phase Yellow and Blue

After all the equipment found having good condition of insulation, inspection was made on the termination of supply cable to the bus-bar. Faulty cable was identified on the phase cable terminate to bus-bar. The figure 4.2 shows that black mark that indicates broken insulation of the supply cable. The mark occurred was confirming the insulation breakdown and its need to be replaced. Insulation type which using polyethylene was proved that will subject to a condition of treeing. Based on the environment condition discussed early the presence of water containing contaminants caused unwanted moisture. This unwanted

moisture is proven caused oxidation and it is become serious when react to electrical stress caused growth of trees within the material. Based on the data collected, the cable that interconnected between DATC substation and Sewerage Plant substation was in operating since year 2008. There was 6 years of operation is enough for treeing phenomenon to occur with the irregular condition observed. To be more clear comparisons was made with another case study that was studied on the growing of tree in polyethylene material. The comparison was rearranged in table 4.6.

The breakdown occur caused fire and flashing at that point of fault. The breakdown strength of the cable might be reduced and usually faulty cable need to be change to restore its service. Finally, repairing work was decided to maintain continuous electrical supply by changing the oxidized interconnected bus-bar and that fault cable.

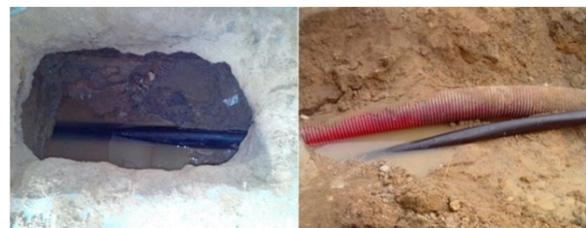
The main cause of oxidation that occur is the presence of moisture that make a direct or indirect contact with the power equipment. In this study, the moisture is developed based on the water stagnant at the around underground power cable. Figure 4.1 shows water has been pump out to doing maintenance work.

Fig 4: Underground Cable 11 kV (XLPE SWA) Immerge in Water.
