Assessing the Building Condition of Historic Timber Mosques in Kelantan

Keywords: Building Condition Assessment, historic timber mosque, timber defect, timber conservation

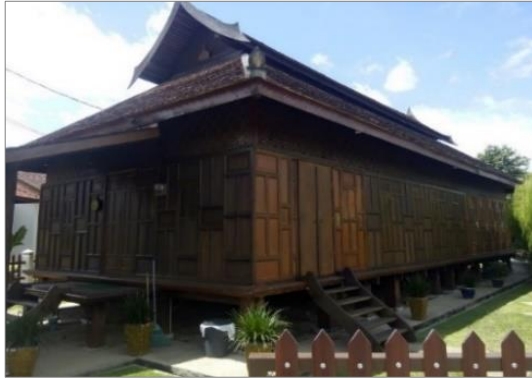
Figure 1: Mulong Old Mosque
Source: (Author, 2022)

The Mulong Old Mosque, currently named the Ar-Rahman Mosque, was built in 1900 as the Balairung Seri and refurbished into a mosque in 1958. Widely known as Masjid Kedai Mulong and Masjid Pameran, it is in Ketereh, Kota Bahru District, within 20x60 square feet. The mosque was built with 100% timber as the material, where the main structure was made with *chengal*, and the roof was made with *singgora* and *pemeleh*. Conservation work was done in 2009 to make good and replace the wall timber and restore the original roof material. The National Heritage Department (JWN) currently designated the mosque as the Heritage.

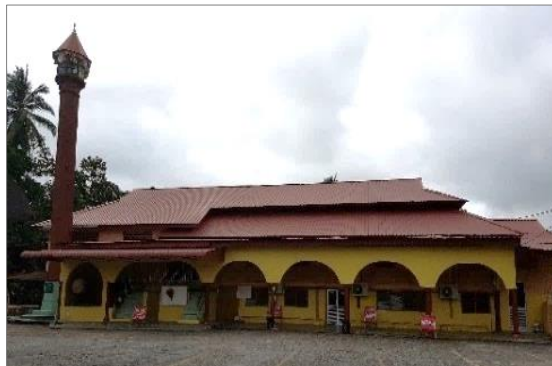
Figure 2: Tok Pulai Chondong Mosque
Source: (Author, 2022)

Categorized as the Mukim Mosque, the Tok Pulai Chondong Mosque is well known for its 57 feet of leaning minaret, which resembles the Leaning Tower of Pisa in Italy. It was built in 1856; however, it burnt down in a fire incident in 1857 and was reconstructed with the same timber structure in the same year. Located in Pulai Chondong, Machang District, it was built within 40x70 square feet with 80% to 90% timber with a 10% mix of concrete. The main mosque was built with wood logs, while other parts are made of *chengal*.

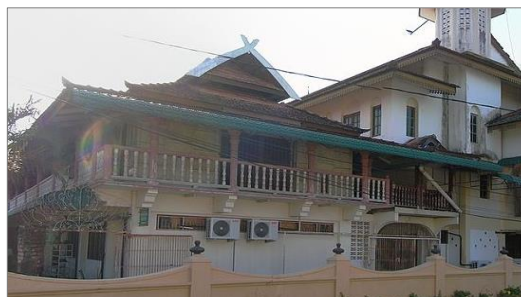
Figure 3: D'Raja Long Yunus Mosque
Source: (Author, 2022)

Meanwhile, the D'Raja Long Yunus Mosque, categorized as the Urban and Colonial Mosque, was built in 1871 and refurbished with an extension of a three-storey concrete building in 1985. It is widely known as Masjid Sultan because it is next to the Kelantan Royal Mausoleum (also known as the Langgar Royal Mausoleum). Built within 95x78 square feet, the original part (70% to 80% of the whole mosque) remains a timber structure, mostly built with *chengal*, *pemeleh* as the roof, and *kayu panjang* as the column.

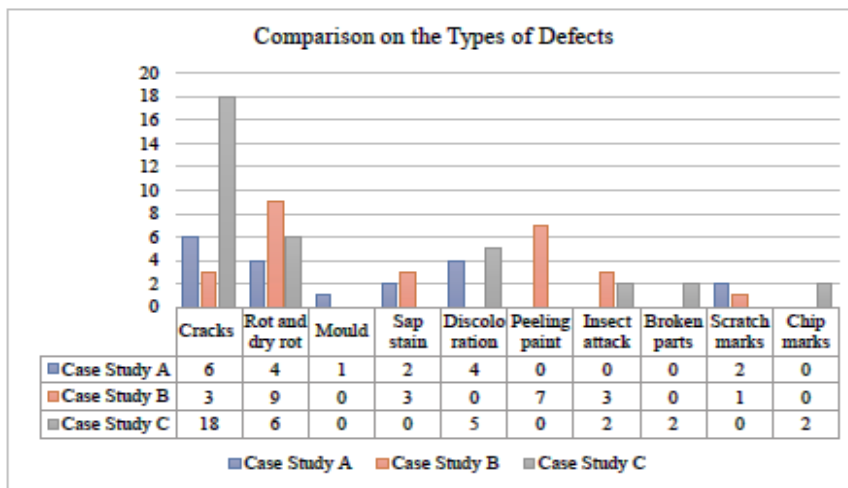
Figure 4: Comparison on types of defects
Source: (Author, 2022)

Defects Analysis based on the type of defects and elements of mosques is summarized and shown in Figure 4 and Figure 5. The most found defect was crack, which can be separated into the hairline, split, and checked cracks. Similar results were recorded at Perak heritage mosques as cracks are major defects found (Alauddin et al., 2018). Frequent changes in weather and the surrounding environment are the possible causes of this defect. Meanwhile, the highest number of defects were found on the external wall, where the parts are mostly exposed to outside weather as the outermost layer of the building.
