## PROCEEDING OF 3<sup>rd</sup> INTERNATIONAL CONFERENCE ON REBUILDING PLACE (ICRP) 2018

# THE HISTORIC TIMBER STRUCTURE CONSERVATION OF MADRASAH IDRISIAH BUILDING, KUALA KANGSAR, PERAK

Afzanizam Muhammad<sup>1</sup>, Siti Norlizaiha Harun<sup>2</sup>, Mohd Nurfaizal Baharuddin<sup>3</sup>

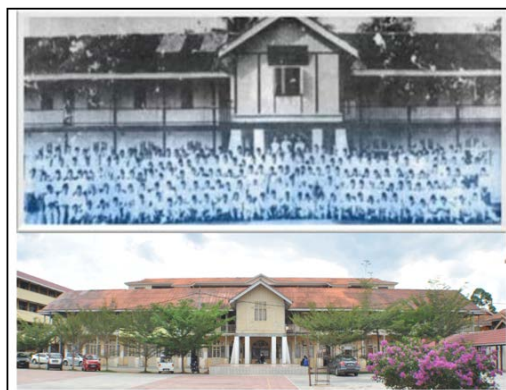
Figure 1 Top: Archive picture of Madrasah Idrisiah building with the students (Source: Madrasah Idrisiah) and below: Front view of Madrasah Idrisiah right before the conservation work started in 2017 (Source: Conservator)

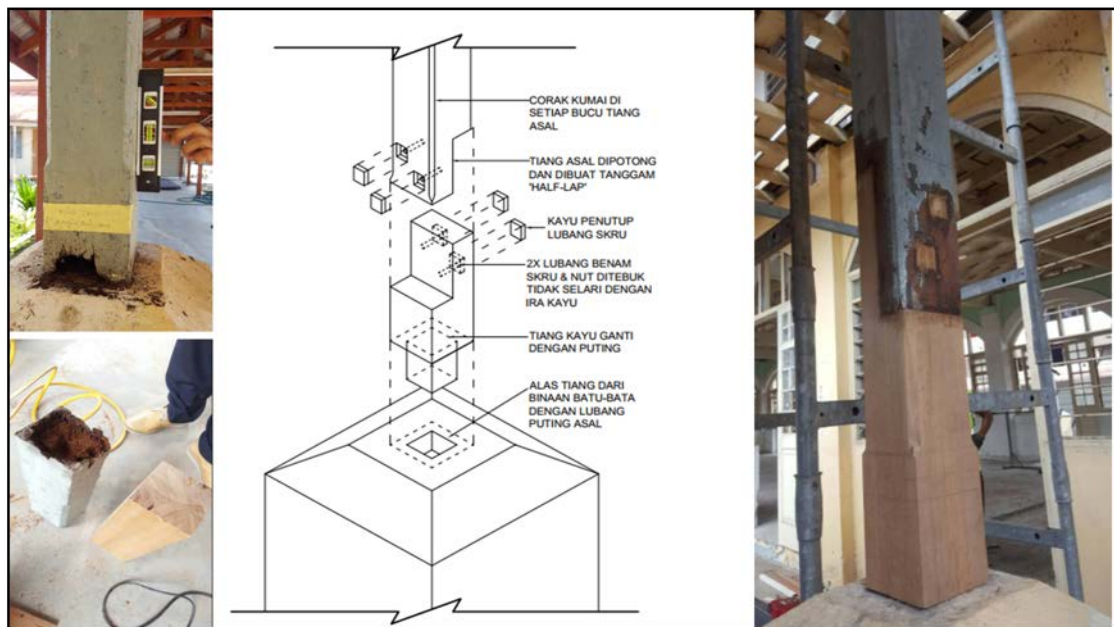
A total of 11 pillars was identified to have decayed on the jointing between masonry stumps. The cause of decaying is due to humidity and pest attack. The tenon of the pillars on stumps has been decayed and lost. See Figure 2. The consequence of this decaying causes the pillars to lean and become unstable to support the beams and joists of the first floor corridor.

Figure 2 Timber pillar defect due to deterioration. Right; timber pillars have been fragile due to pest attack. Middle; Exploded view on 'cut and joint' method and left; Complete timber pillar restoration

The pillars that have been cut is replaced with the new component that is duplicated according to the original, which has the same properties in terms of strength and size. The new timber is needed to dry enough and free from defects such as cracks and knots. The new pair of timber pillars are the same

as the original timber species or at least from the species that are close in mechanical properties. The original species of timber pillars used for this building are from Merbau (*Intsia palembanica*) which is classified as a hardwood (Malaysian Timber Council, 2009) (Malaysian Timber Industry Board, 2017). The jointing between the original timber pillar and the new ones was done by using the 'half-lap' jointing and tied with screws and nuts, see Figure 3. The screw holes need to be drilled not parallel to the timber grain (diagonal) to prevent split pole along the grain line. The screw and nut connections are concealed and patched with the same timber species of the original poles. The profile pattern on the new pillar edgings is duplicated to the original pillars. The purpose is to get uniformity in design. At the last stage, after the glue has dried, the surface of the jointing is smoothen by planing and sanding the surface. The gap between the timber and the masonry stump will be inserted with waterproof glue to prevent the absorption of water in the future.

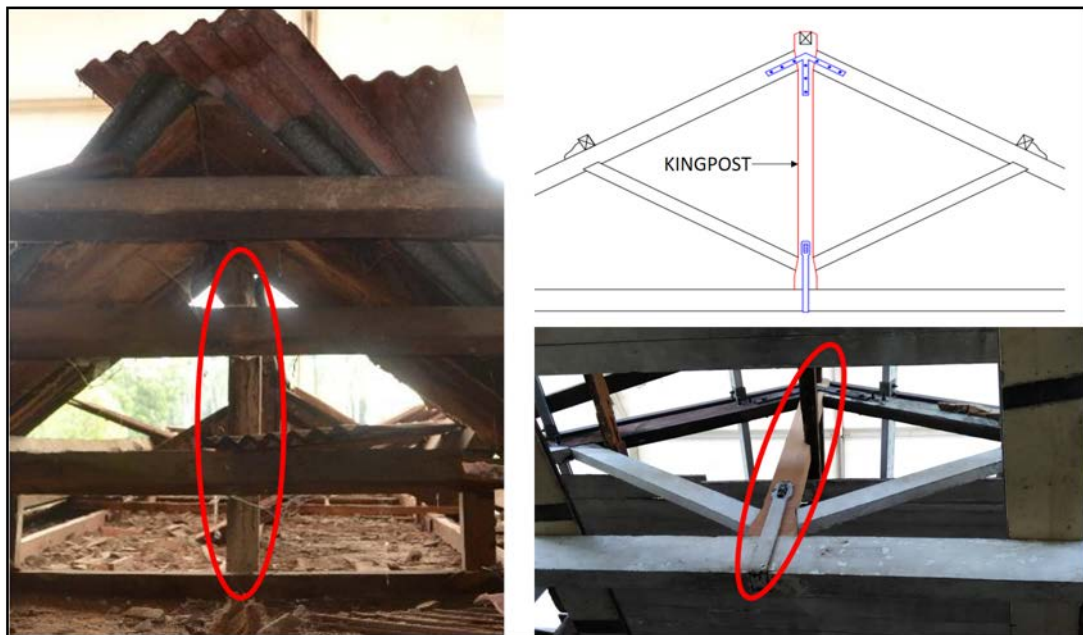
Most of the roof trusses of this building are in good condition except one of the kingposts was found deteriorating, due to roof leakage which has exposed the component with moisture. Kingpost is one of the timber members of the roof structure that stand in the middle of the truss which holds the ridge (see figure 3). All the roof truss members are tightened with its special ironmongeries. According to the 'method statement' that was prepared, the deteriorated kingpost should be detached from its members in order to conduct the duplication work. All the connected roof truss members are clamped accordingly before the removing deteriorated kingpost and replaced with a new one. The removed original kingpost is measured precisely to duplicate the new kingpost. The duplication work is not conducted on-site due to the custom made work. The new kingpost is made from the same grade of timber to ensure the structure authenticity is remained.

Figure 3 Left; Deteriorated kingpost. Right Top; Kingpost position on roof truss members. Right below; Restored Roof truss with duplicated kingpost tighten with original ironmongeries.

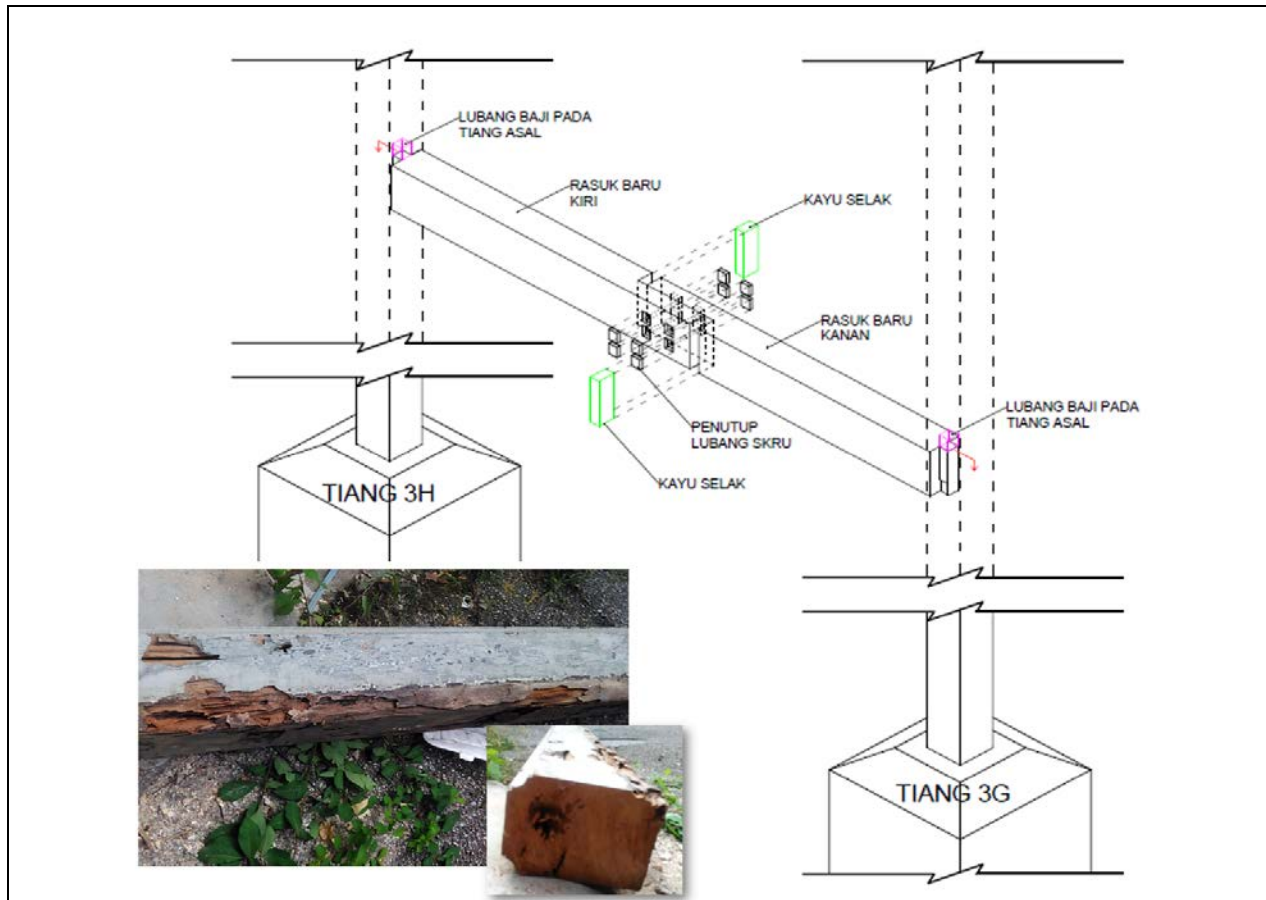
It can be considered as permanent structure and it is impossible to dismantle part by part to reach the defected component. One of the beams in the Madrasah building has experienced decay on both ends of the connection. The 'tenon and mortise' joints have serious decay on both of the beam ends (tenon). Whereas, the beam that are located between the two pillars is attached to the mortise on the pillars. Both pillars are still in good condition and stand firm. Technically, this beam replacement process needs to shift one of these pillars. These pillars are also attached together with roof and floor systems. In order to minimize intervention on the building as advised by ICOMOS and National Heritage Department (2017), the conservator has come out with modification on the replacing beam without changing its original appearance. Special jointing on the middle of the beam has been designed in order not to shift the existing pillars as shown in Figure 4 below:

Figure 4 Diagram shows the new beam with proposed jointing in the middle in order to minimize the intervention on both pillars during restoration work. The left-below pictures show the decay of the original beam.

Therefore, in certain cases, the problematic timber structure should be restored on-site without dismantling the other structural members that are connected. Dismantling and removing any of the existing components will bring risks to new damage. The modification of the jointing or component design itself should be necessary due to some timber restoration process that is different from the original installation process.

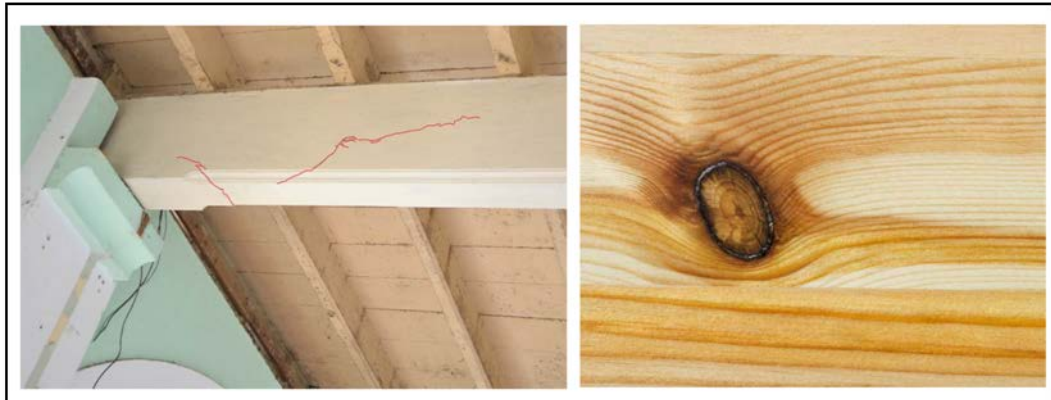
A part of the timber defects that are due to moisture, pest attacks, timber aging problems and the deterioration of durability. There is a timber defect due to their natural growth such as splits and crack on timber knots (spiral grain) or wavy grain, interlocking grain, hollow timber and high dense timber. The timbers that have natural defects, should not be used in construction. There is a beam in the Madrasah building that has experienced natural defect caused fractures on knots. The timber beam

Figure 5 The beam number 18 has cracked due to timber knots. There are knots and crack that suspected can cause the beam to bend and will eventually break. Right: example of timber knots (<https://www.woodworkingnetwork.com/best-practices-guide>, 2017)

The proposed conservation method is by straightening and raising beam no. 18 to its original position with an additional steel plate. This method is intended to reinforce the first floor structure by using a custom steel plate. For security purposes and structural strengthening, the temporary steel prop is installed to transfer the beam's loads directly to the ground. The dropped beam is slowly jacked up until it reaches its original position without damaging the other original components. The temporary steel prop will remain in use until the iron plate installation is completed. The surface of the beam is slightly cut and planed according to the shape of the steel plate. The width and length of the steel plate must have covered the cracked area. The holes are drilled through the beam matched with holes on the custom steel plate. The holes are avoided from being drilled on critical parts (cracks and knots). The steel plate shapes and thicknesses, as well as the size of the screws, are according to the engineer's recommendations. The steel plate should have located above the masonry column to help send the loads directly through it. After the installation of the steel plate, the plywood is cut according to the same shape that was originally used to cover the exposed plate screws. The direction of the woodgrain of the plywood board should be in line with the original timber beam grain direction. Plywood attached with glue and wood putty/filler are used before applying the proposed finishing.

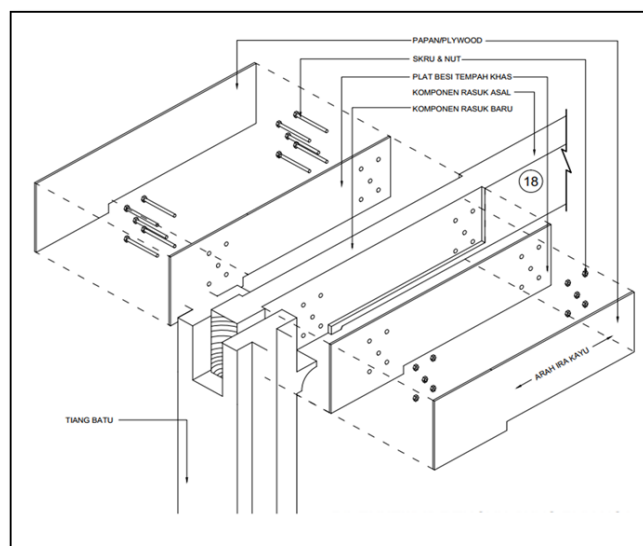
Figure 6 The Installation method of steel plate on beam no.18

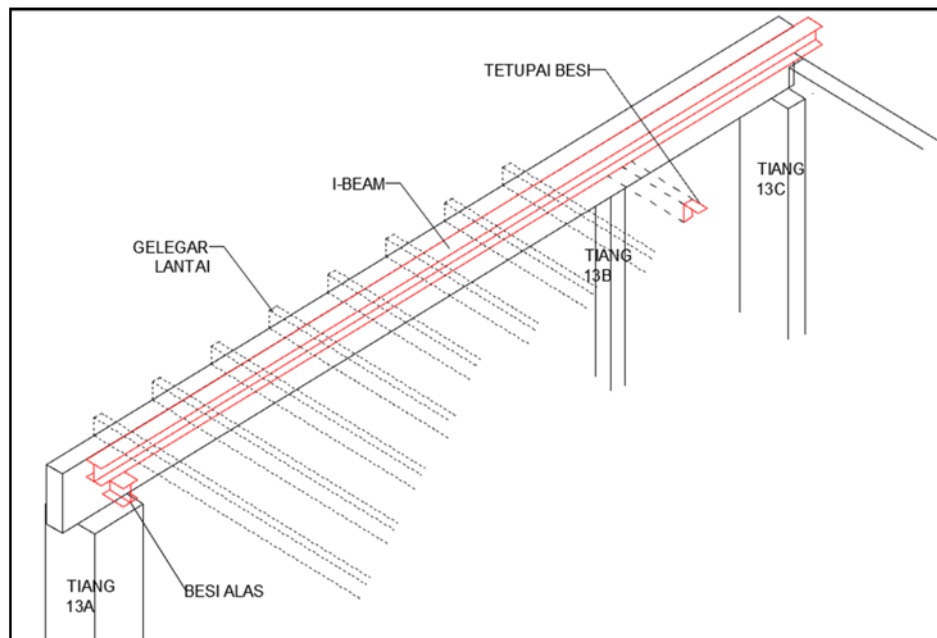
A beam in the building structure transfers its load laterally along its length to its supports which mostly are columns. Due to the nonconcurrent pattern of forces, a beam is subject to bending (Ching, 2014). One of the timber beam Madrasah Idrisiah had fractured due to 'bending stress'. This occurs due to 1 from 3 columns that support the beam which is in the middle had failed to support its loads due to natural ground movement. While in the meantime, there are 'live loads' stored above it during the roof repair work. Removing the fractured beam will give serious intervention to the structure of the building. The conservator of the project has taken an approach to ensure the fractured beam remain since the crack effect can be vanished by the putty and finishing. However, the loads which are supported by the fractured beam need to be transferred to the new structure. The new structure should not obviously change the original appearance of the building in order to remain the design authenticity. The conservator had proposed steel I-beam as the additional structure member. The proposed position of the additional I-beam is almost concealed from the outside view (see figure 7). The additional I-beam function is to support the loads from the floor joists that are supported by the existing timber beams earlier. The I-beam directly transfer the loads to both masonry columns and the middle timber pillar.

Figure 7 The new I-beam takes over the original timber beam by transferring the floor joist loads. The original exposed timber beam is preserved for aesthetic authenticity.
