**BUILDING CONDITION SURVEY AT ETIQA TWINS, JALAN PENANG, 50450
KUALA LUMPUR.**

**MUHAMMAD AZIM ASYRAF BIN MOHD LIZAH
2010969471
DIPLOMA IN BUILDING SURVEY**

**PRACTICAL TRAINING REPORT
JUNE 2013 – OCTOBER 2013**

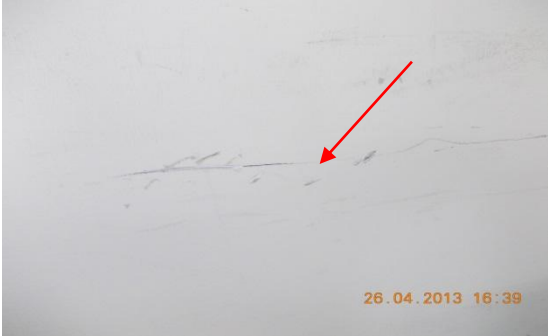
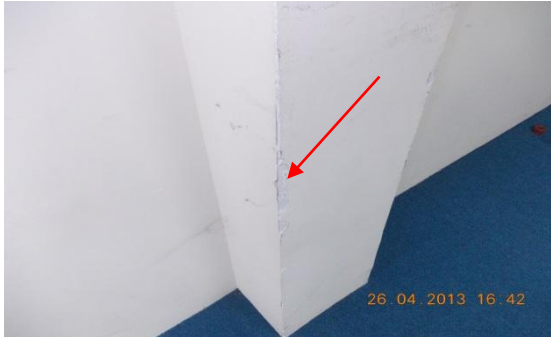
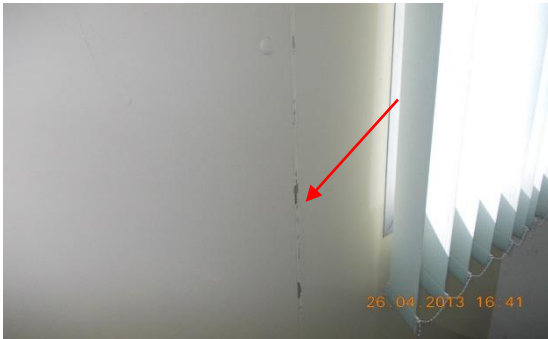
Defect: i. Peeling off paint on wall			
Symptom: i. Peel of paint			
Factor i. Human activity ii. Exposed to hard object			
Causes: i. Human activity ii. Exposed to hard object			
Suggestion: i. Repaint			
Quantity : 2	Cost	Overall Cost	Priority

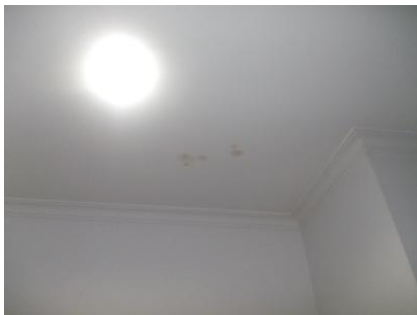
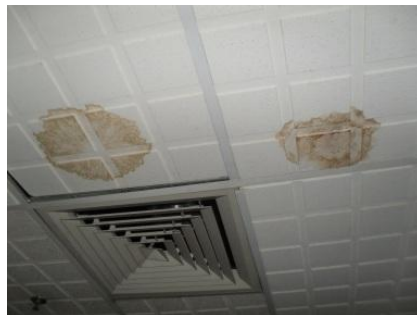
Table 4.6: Shows the defect checklist at Etika Twins.(Copyright AMAS FM Report)

Building Etika Twins	Element	System	Asset	Date 30.7.13-23.8.13
	Ceiling	Architecture	Gypsum board & plaster ceiling	
Location : Etika Twins/Level 1/Podium/Podium Ground Etika Twins/Level 1/Podium/Podium Ground Etika Twins/Level 2/Podium/Podium Level 2 Etika Twins/Level 2/Podium/Food Court Etika Twins/Level 26, 27/Tower 1/Office Area Etika Twins/Level 6/Tower 2 /Office Area		Ref. No AR/ET/L1/DSCN0996, AR/ET/L1/DSCN0997 AR/ET/L1/DSCN1002, AR/ET/L1/DSCN1003, AR/ET/L1/DSCN1004, AR/ET/L1/DSCN1005 AR/ET/L1/DSCN1025, AR/ET/L1/DSCN1026 AR/ET/L2/DSCN1055, AR/ET/L2/DSCN1056, AR/ET/L2/DSCN1060, AR/ET/L2/DSCN1061, AR/ET/L2/DSCN1062, AR/ET/L2/DSCN1082, AR/ET/L2/DSCN1083, AR/ET/L2/DSCN1134,

Defect: Water mark on ceiling surface				
Remarks: <ul style="list-style-type: none">• Stain• Watermark				
Condition	3	Priority	1	Condition Priority Index 3
Recommendation: <ul style="list-style-type: none">• Check piping air cond piping system• Repair piping air cond piping system• Replace new ceiling

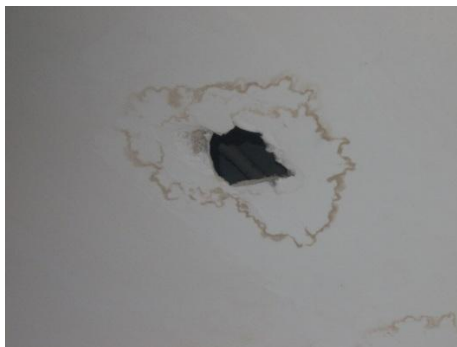
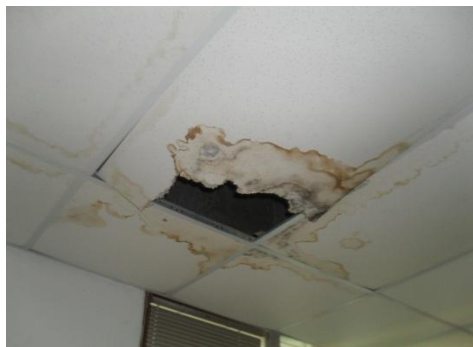
Table 4.7: Shows the defect checklist at Etika Twins.(Copyright AMAS FM Report)

Etika Twins	Element	System	Asset	Date 30.7.13-23.8.13	
	Ceiling	Architecture	Gypsum board and Plaster Ceiling		
Location : Etika Twins/Level 1/Podium/Podium Ground Etika Twins/Level 2/Podium/Podium Level 2 Etika Twins/Level 3/Podium/Podium Level 3 Etika Twins/Level 27/Tower 1/Office Area Etika Twins/Level 14/Tower/Corridor 1 Etika Twins/Level 26/Tower 2/Office Area		Ref. No AR/ET/L1/DSCN1007, AR/ET/L1/DSCN1008, AR/ET/L1/DSCN1011,AR/ET/L2/DSCN1139, AR/ET/L2/DSCN1140,AR/ET/L3/DSCN1236, AR/ET/L3/DSCN1237, AR/ET/L3/DSCN1238, AR/ET/L3/DSCN1239,AR/ET/L27/SDC15638, AR/ET/L27/SDC15639,AR/ET/L27/SDC15657, AR/ET/L27/SDC15680, AR/ET/L27/SDC15681, AR/ET/L27/SDC15682, AR/ET/L27/SDC15683 AR/ET/L14/DSCN1459, AR/ET/L14/DSCN1460 AR/ET/L26/DSCN1637, AR/ET/L26/DSCN1638 , AR/ET/L12/SDC15519, AR/ET/L12/SDC15520

Defect: Water mark on ceiling surface,Water mark and broken on ceiling surface, Broken on ceiling surface

Remarks: <ul style="list-style-type: none">• Stain• Watermark					
Condition	5	Priority	1	Condition Priority Index	5
Recommendation: <ul style="list-style-type: none">• Check piping / air cond piping system• Repair piping / air cond piping system• Replace new ceiling					
Quantity : 8	Estimated Cost		RM8,000

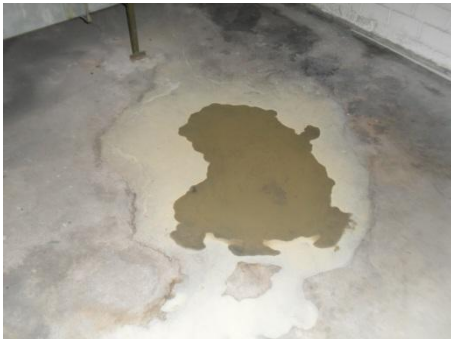
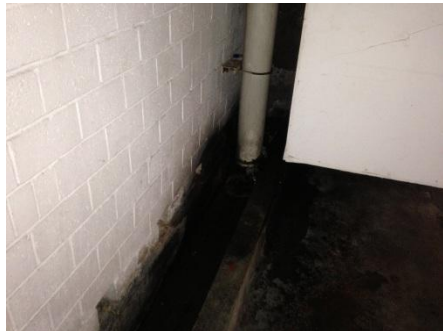
Table 4.8: Shows the defect checklist at Etiqa Twins.(Copyright AMAS FM Report)

Building Etiqa Twins	Element	System	Asset	Date 30.7.13-23.8.13
	Floor	Structure and architecture	Cement screed, floor trap	
Location : Etiqa Twins/B4 A Basement 4 A/Fan room 3 (DB B4-1 FR2) Etiqa Twins/B5 A/Basement 5 A/ Parking Lot Etiqa Twins/Level 1/Podium/Podium Ground Etiqa Twin/Level 1/Podium/Rumah Sampah Etiqa Twins/Level 28/Roof top/Corridor		Ref. No AR/ET/B4A/SDC15165 AR/ET/B5A/IMG_0529, AR/ET/B5A/IMG_0530, AR/ET/L1/DSCN0999, AR/ET/L1/DSCN1000 AR/ET/L1/DSCN1014, AR/ET/L1/DSCN1015, AR/ET/L1/DSCN1016, AR/ET/L1/DSCN1017, AR/ET/L1/DSCN1018,AR/ET/L28/DSCN1858, AR/ET/L28/DSCN1859,

Defect: Water ponding ,Clogged floor trap,Crack on floor tiles Crack on floor surface				
Remarks: <ul style="list-style-type: none">Water leakage from plumbing system				
Condition	3	Priority	1	Condition Priority Index
Recommendation: <ul style="list-style-type: none">Check plumbing systemRepair Plumbing systemReplace new floor tilesFill the crack with new cement screed

There are fine cracks can be found at the parking area and in fan room. The reasons of these problems are probably due to the insufficient water content during the construction curing process. We also noted that there are water ponding in fan room's floor at the basement. This happens from the water that comes from the wall or ceiling. The Visual Condition Assessment show that the floor trap needs a well maintenance to prevent any serious defects happens in the future.

Quantity : 5	Estimated Cost		RM3,400

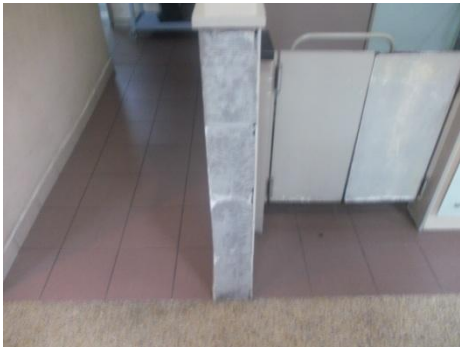
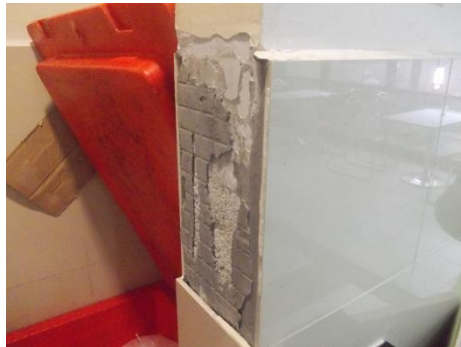
Table 4.9: Shows the defect checklist at Etika Twins.(Copyright AMAS FM Report)

Etika Twins	Element	System	Asset	Date 30.7.13-23.8.13	
	Wall	Architecture	Wall finishes		
Location : Etika Twins/Level 2/Podium/Food Court Etika Twins/Level 2/Podium/Podium Level 2 Etika Twins/Level 3/Podium/Podium Level 3 Etika Twins/Level 4/Podium/Podium Level 4 Etika Twins/Level 14/Tower 2/Corridor 1		Ref. No AR/ET/L2/DSCN1074, AR/ET/L2/DSCN1075, AR/ET/L2/DSCN1076, AR/ET/L2/DSCN1080, AR/ET/L2/DSCN1081, AR/ET/L2/DSCN1091, AR/ET/L2/DSCN1092, AR/ET/L2/DSCN1151, AR/ET/L2/DSCN1156, AR/ET/L2/DSCN1157, AR/ET/L3/DSCN1252, AR/ET/L3/DSCN1254 AR/ET/L4/DSCN1293, AR/ET/L4/DSCN1294 AR/ET/L14/DSCN1455, AR/ET/L14/DSCN1456, AR/ET/L14/DSCN1457

Defect: Peeling off wall tiles					
Remarks: <ul style="list-style-type: none"> Wear and tear Human activity 					
Condition	5	Priority	1	Condition Priority Index	5
Recommendation: <ul style="list-style-type: none"> Replace new wall tile 					
Quantity : 6	Estimated Cost		RM3,600
