**TITLE:
BUILDING CONDITION ASSESSMENT AT DATARAN MAYBANK, JALAN
MAAROF, BANGSAR**

**MUHAMMAD FALIHIN B. ABDUL MALLEK
2010997235
DIPLOMA IN BUILDING SURVEYING**

**PRACTICAL TRAINING REPORT
JUN 2013 – SEPTEMBER 2013**

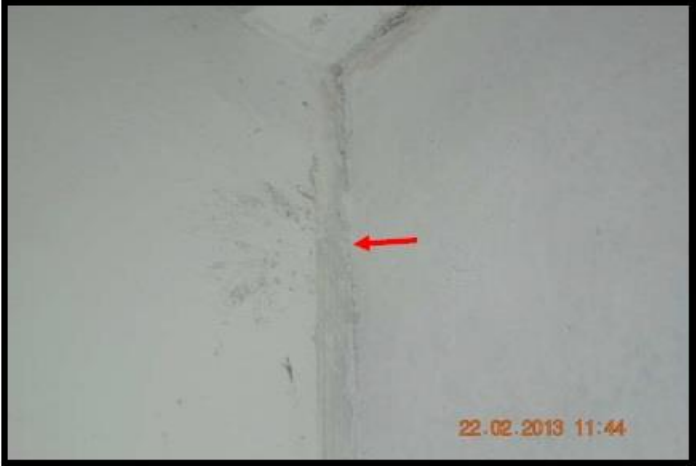
Photo.MP.LB3.I 3

Description: Close up view of fine vertical crack line on joint between wall and beam.	
Location/grid: B3,1C	CPI: Condition 2, Priority 1, Index 2.

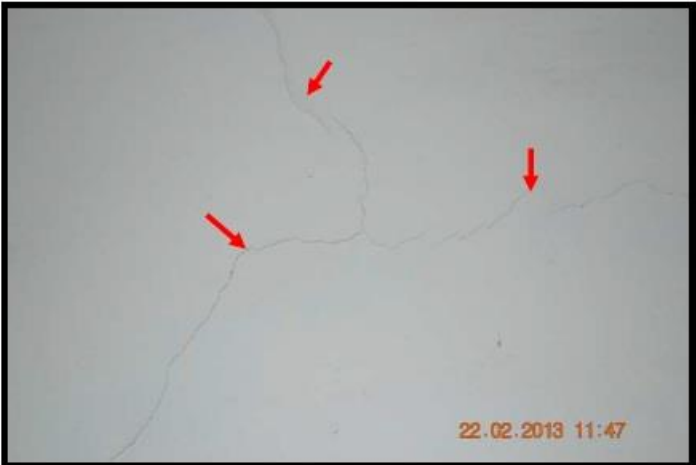
Photo.MP.LB3.I 4

Description: Fine diagonal crack lines on wall surfaces.	
Location/grid: B1,14B	CPI: Condition 2, Priority 1, Index 2.

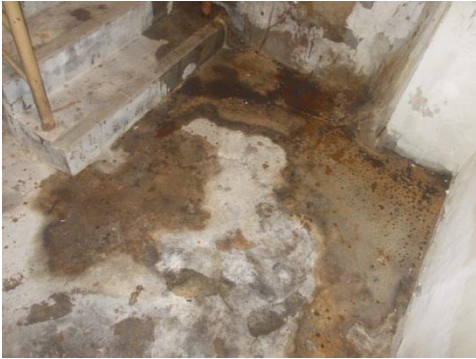
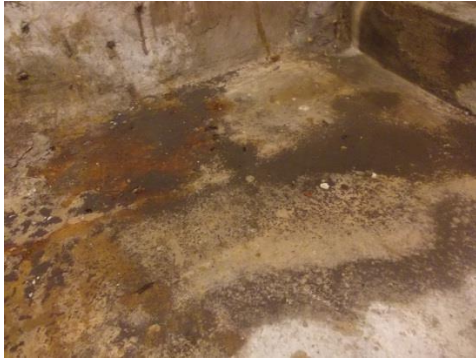
Building: DataranMaybank	System	Element	Asset	Date 30.7.13- 23.8.13	
	Architecture	Floor	Floor Slab		
Location : DataranMaybank/Basement 5/Staircase 16/Tower c		Ref. No: AR/DM/B5/DSCN0703, AR/DM/B5/DSCN0704

Defect: Water mark on floor surface					
Remarks:					
<ul style="list-style-type: none"> Leaking from plumbing system at basement 2 (Staircase 16) 					
Condition	3	Priority	2	Condition Priority Index	6
Recommendation:					
<ul style="list-style-type: none"> Check and Repair plumbing system Construct new cement screed Clarification from professional engineer are required to determine integrity of the structure (Wall and Floor) 					
Quantity : 1	Estimated Cost		RM3500

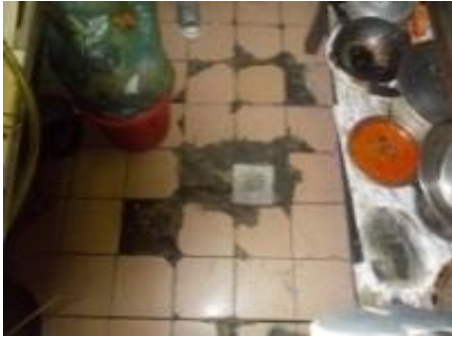
Defect: Peeling off floor finishes					
Remarks:					
<ul style="list-style-type: none"> • Wear and tear • Deteriorated 					
Condition	3	Priority	1	Condition Priority Index	3
Recommendation:					
<ul style="list-style-type: none"> ○ Replace floor tiles 					
Quantity :3	Estimated Cost		RM 1100

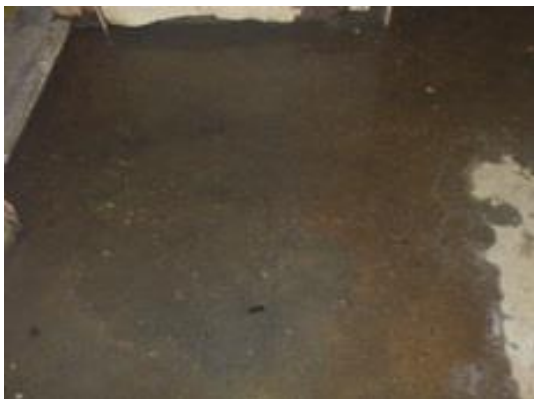
Building DataranMaybank	Element	System	Asset	Date: 30.7.13- 23.8.13	
	Structural	Floor	Floor Slab		
Location : DataranMaybank /B2B / Basement (Bilik Ejector 2)		Ref. No. AR/DM/B2B/DSCN0900, DSCN0901

Defect: Dampness on floor surface					
Remarks:					
<ul style="list-style-type: none"> • Water leakage from plumbing system 					
Condition	4	Priority	4	Condition Priority Index	16
Recomendation:					
<ul style="list-style-type: none"> ○ Check plumbing system ○ Repair Plumbing system ○ To pump out all the water 					
Quantity : 1	Estimated Cost		RM 3000

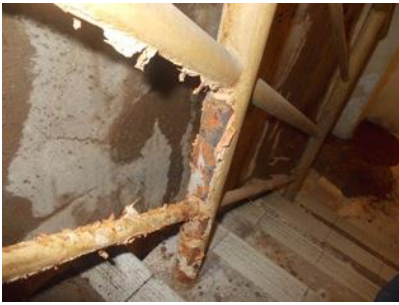
Building: DataranMaybank	Element	System	Asset	Date : 23/7/2013- 30/8/2013	
	Railing	Architecture	Painted railing		
Location : Tower C / Level B3 / Staircase 16		Ref. No.:AR/DM/B3/DSCN0855

Defect: Peeling off painted railing					
Remarks:					
<ul style="list-style-type: none"> • Rusted railing steel • Water mark on the railing • The moisture of the room basement 					
Condition	4	Priority	1	Condition Priority Index	4
Recomendation:					
<ul style="list-style-type: none"> • Repaint the railing • Check plumbing system 					
Quantity : 1	Estimated Cost		RM 700

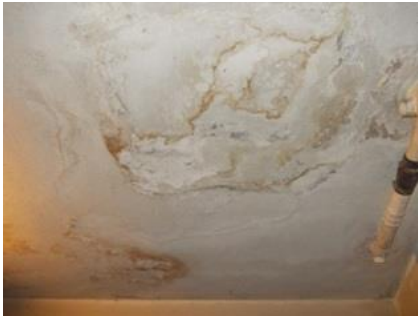
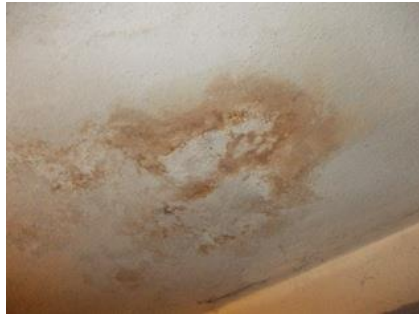
Building DataranMaybank	Element	System	Asset	Date: 23/7/2013- 30/8/2013	
	Ceiling	Architecture	Soffit slab		
Location : Tower C / Level B2 / Staircase 16		Ref. No.: AR/DM/B2/DSCN0943, AR/DM/B2/DSCN0944

Defect: Water mark on soffit slab surface					
Remarks:					
<ul style="list-style-type: none"> The moisture of the room basement 					
Condition	4	Priority	1	Condition Priority Index	4
Recomendation:					
<ul style="list-style-type: none"> Remove stain Repaint the soffit slab Check plumbing system 					
Quantity : 1	Estimated Cost		RM1500

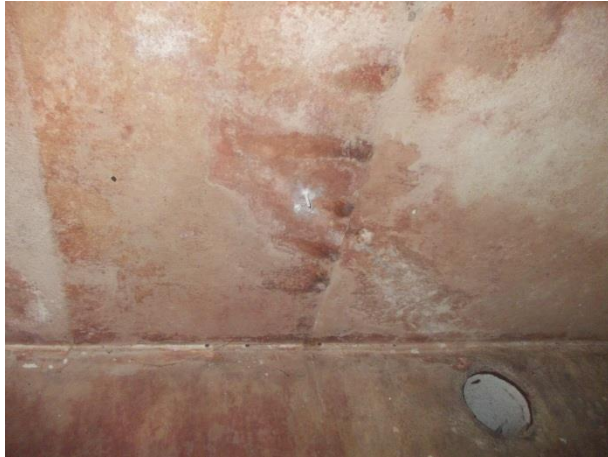
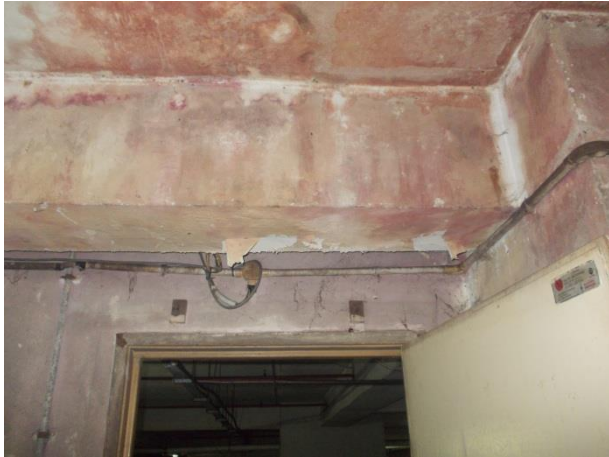
Building DataranMaybank	Element	System	Asset	Date 30.7.13-23.8.13	
	Ceiling	Structure	Soffit Slab		
Location : DataranMaybank / B2B (2) / Basement 2 / Bilik ejector 2 (Back)		Ref. No AR/DM/B2B/DSCN0904, AR/DM/B2B/DSCN0905, AR/DM/B2B/DSCN0906, AR/DM/B2B/DSCN0907, AR/DM/B2B/DSCN0908,

Defect: Water mark and crack on soffit slab					
Remarks: <ul style="list-style-type: none"> • Watermark • Water seep through • Water proofing failure 					
Condition	3	Priority	2	Condition Priority Index	6
Recommendation: <ul style="list-style-type: none"> • Check piping system • Concrete surface must be cleaned from any foreign particles. • Crack on soffit slab must be stabilized using epoxy injection. • To apply concrete repair product to the affected area • Clarification from Professional Engineer are needed to determine the integrity of the structure 					
Quantity : 1	Estimated Cost		RM1,200

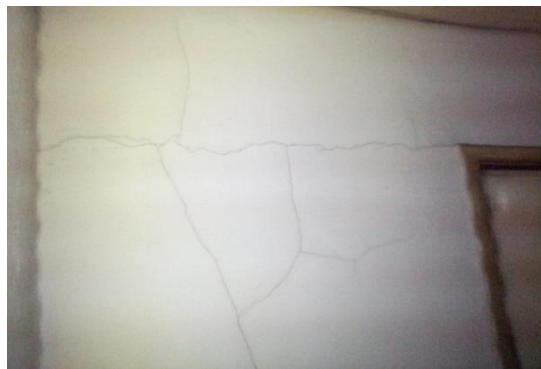
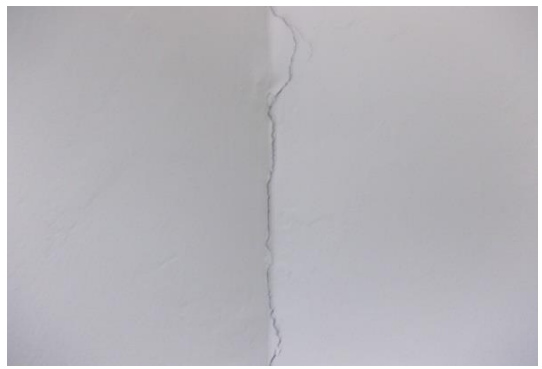
Defect: Crack on wall surface, Crack on wall corner, Crack on wall edge, Crack on wall tile					
Remarks: <ul style="list-style-type: none"> • Hair crack start to show • Cause by traffic movement at parking area • Mostly on mechanical room (Pump room, electrical) 					
Condition	3	Priority	1	Condition Priority Index	3
Recommendation: <ul style="list-style-type: none"> • Fill the crack with plaster • Replace new tile 					
Quantity : 33	Estimated Cost		RM14,900

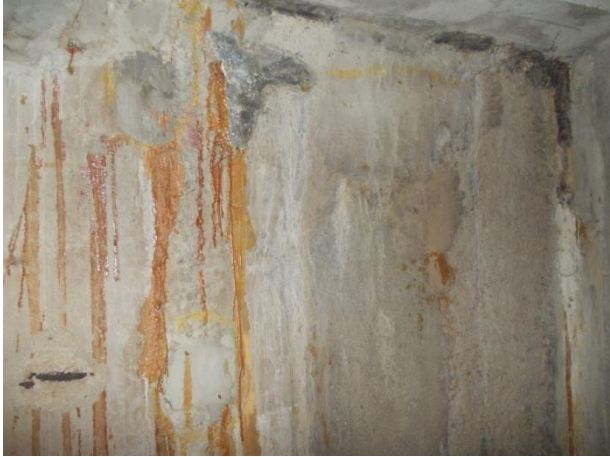
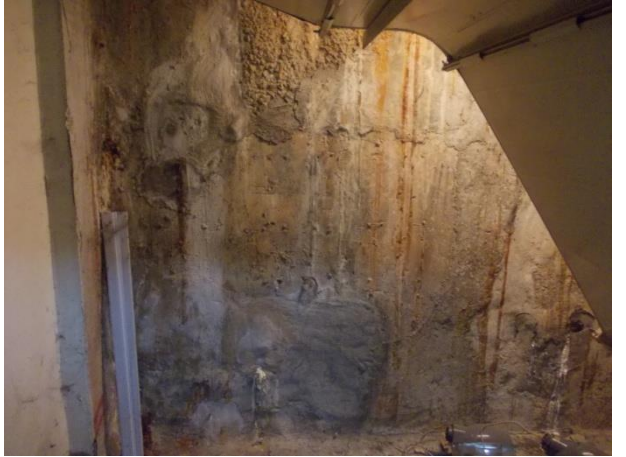
Defect: Water mark on wall surface, Peeling off paint on wall surface, Crack on wall surface, Leaking on wall surface					
Remarks: <ul style="list-style-type: none"> • Water proofing failure • Water seep through

Condition	3	Priority	1	Condition Priority Index	3
Recommendation: <ul style="list-style-type: none"> • Cracks on RC wall to be stabilized using epoxy injection • To apply Concrete Repair product to affected area (product to be proposed by the awarded contractor) • Clarification from Professional Engineer are needed to determine the integrity of the structure 					
Quantity : 7	Estimated Cost		RM35,000

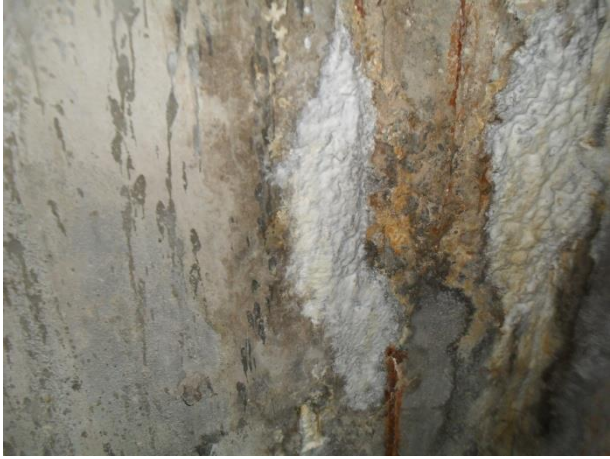
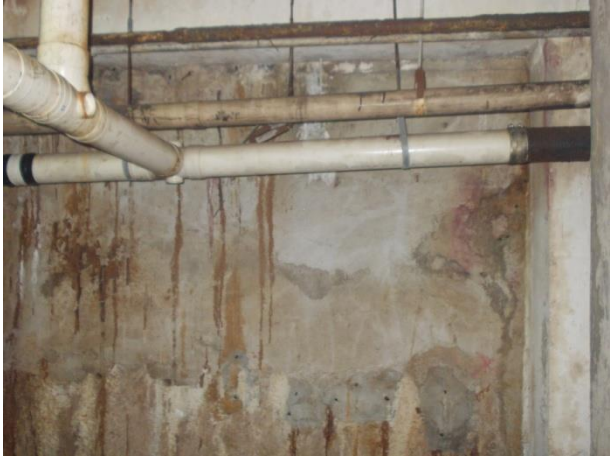
<p>Defect: Exposes reinforcement bar, Water mark on wall surface,</p>					
<p>Remarks:</p> <ul style="list-style-type: none"> • Water proofing failure • Water seep through • Concrete cancer 					
Condition	4	Priority	3	Condition Priority Index	12

<p>Recommendation:</p> <ul style="list-style-type: none"> • Cracks on RC wall to be stabilized using epoxy injection • To apply Concrete Repair product to affected area (product to be proposed by the awarded contractor • Clarification from Professional Engineer are needed to determine the integrity of the structure 					
Quantity : 23	Estimated Cost		RM104,000
