**BUILDING QUALITY INSPECTION FOR VACANT POSSESSION  
(COMPLETE)**

**SYABIL ARISSA BINTI AZIZI  
(2015890332)  
DIPLOMA IN BUILDING SURVEYING**

**PRACTICAL TRAINING REPORT  
MARCH -JULY 2018**

### 3.1 INTRODUCTION TO CASE STUDY OF THE BUILDING QUALITY INSPECTION FOR VACANT POSSESSION

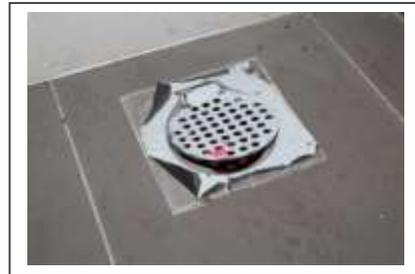
Floor trap cover found dented

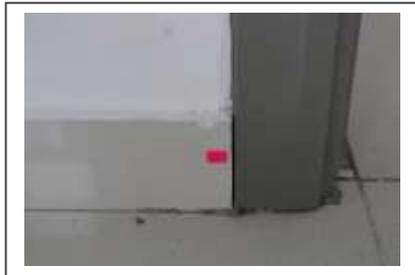
Gap sighted between architrave and skirting tiles

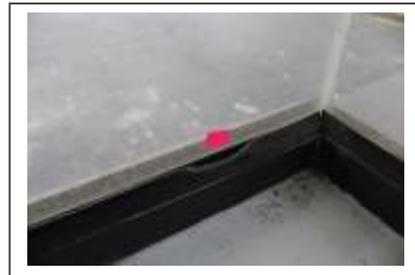
Rubber gasket at glass found not installed properly

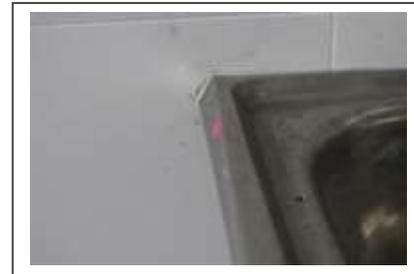
Kitchen sink found

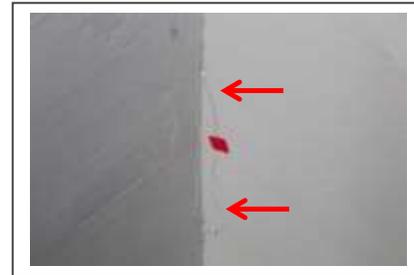
Cracks sighted on wall

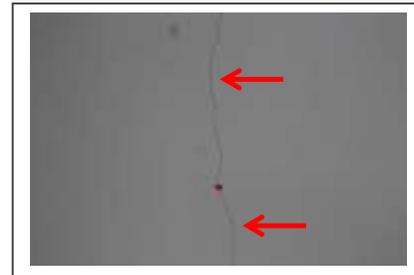
Cracks sighted on wall

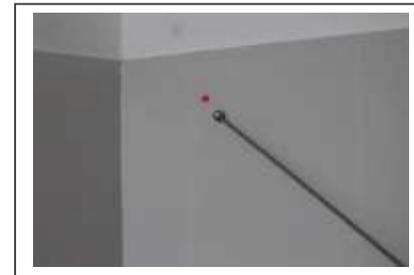
Hollowness found on wall tile

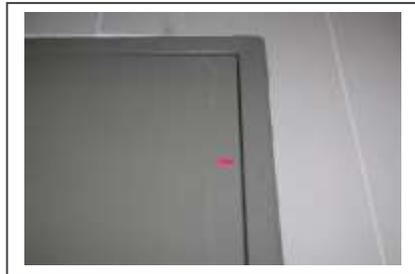
Inconsistent gap sighted between door panel and door frame

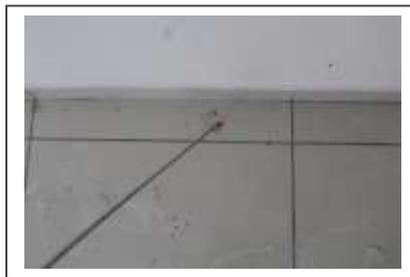
Hollowness found on floor tile

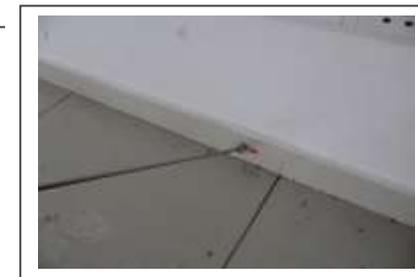
Hollowness found on skirting tile

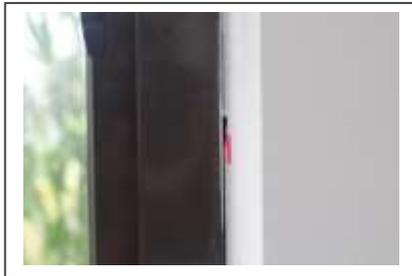
Gap sighted at window frame jointing

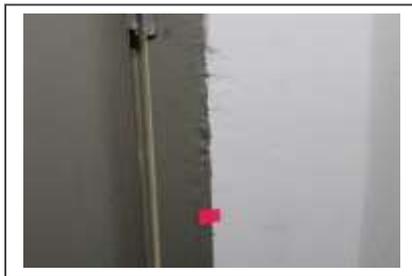
Door frame jointing and door finishing found rough

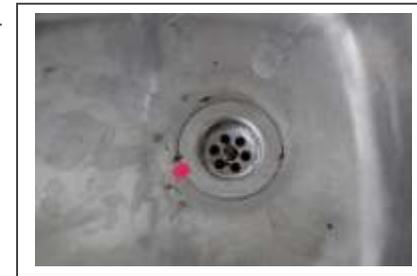
Kitchen sink found rusty

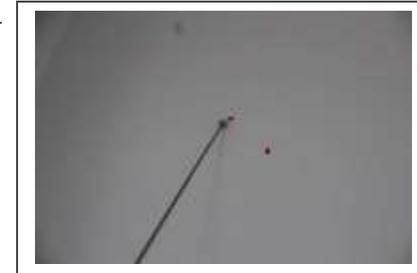
Hollowness and crack found on wall

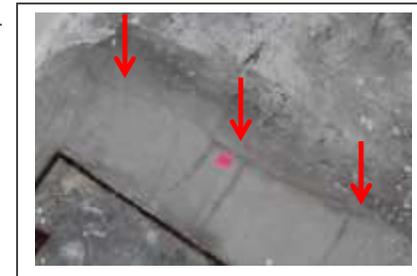
Cracks sighted on floor

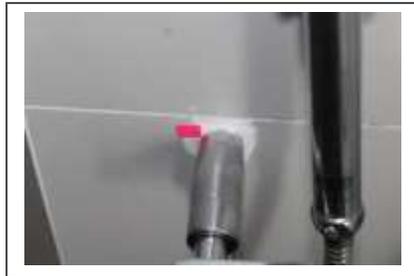
Bidet jointing found rough

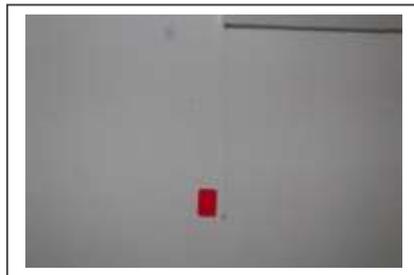
Paint dripping found on wall

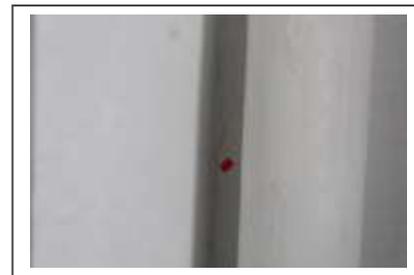
Crack sighted on wall

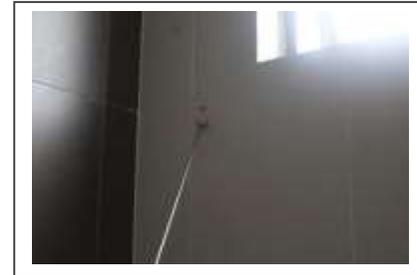
Hollowness found on wall tiles

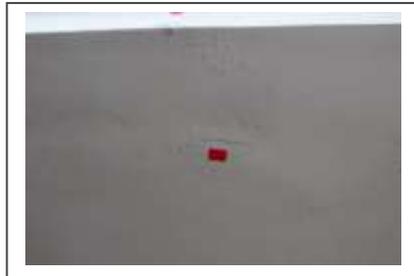
Scratches and blistering found on wall

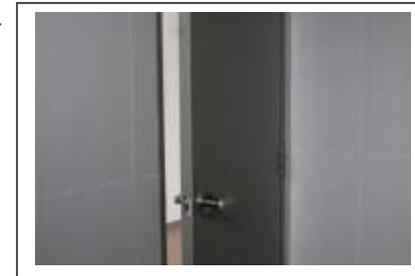
Door found squeaky

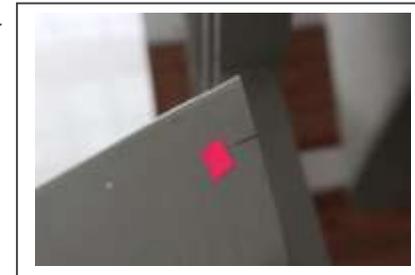
Scratches sighted on railing

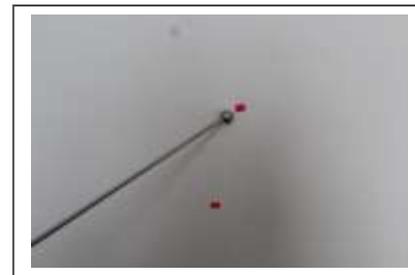
Hollowness found on wall

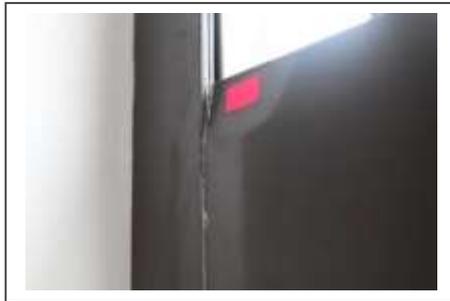
Window frame found dented

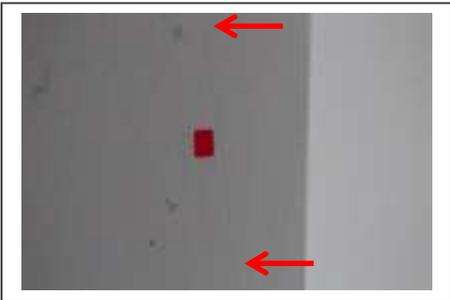
Crack sighted on wall

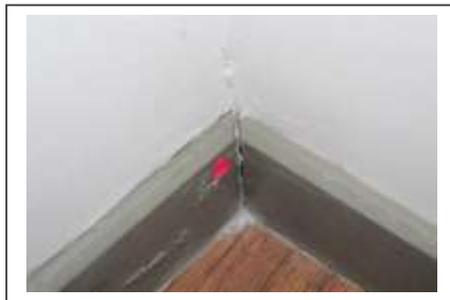
Gap sighted at timber skirting jointing

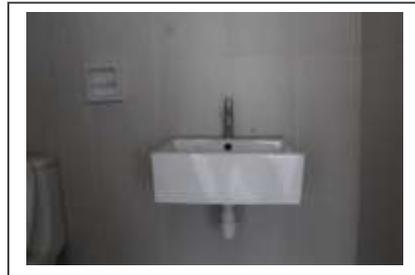
Wash basin found misaligned

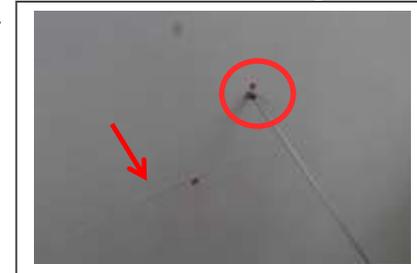
Crack and hollowness found on wall

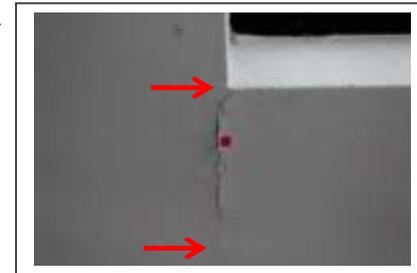
Crack sighted on wall

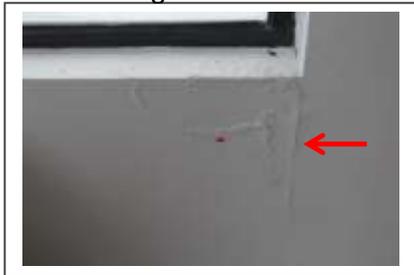
Blistering and crack sighted on wall

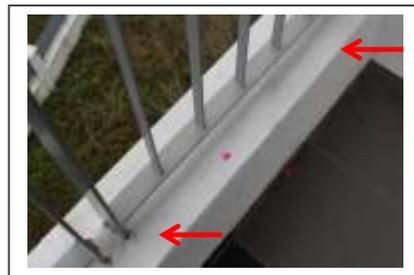
Crack sighted on up stand kerb

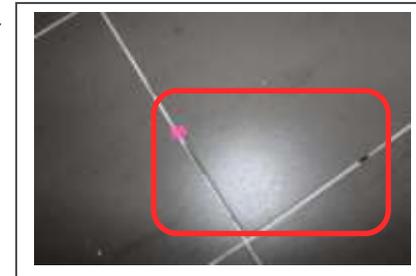
Under grouting found on floor tiles

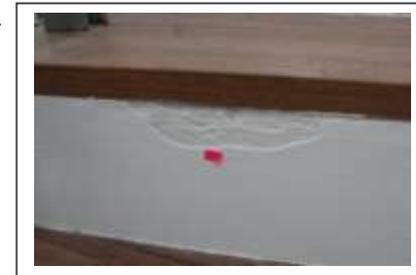
Skim coat at staircase edges found peeled off

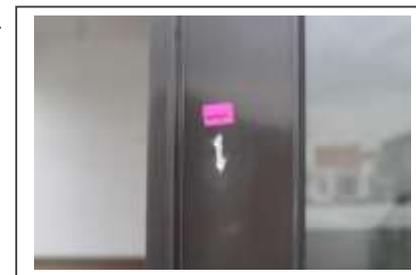
Door outer frame found damaged

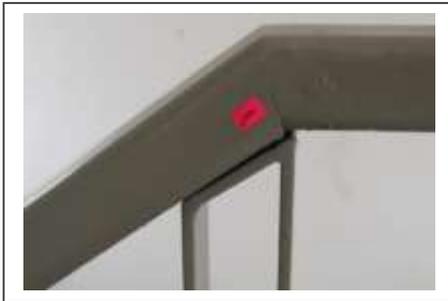
Gap sighted at staircase railing jointing

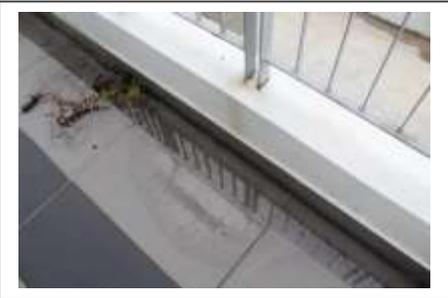
Water ponding found on floor tiles

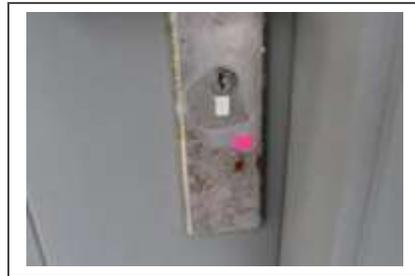
Door lockset found rusty

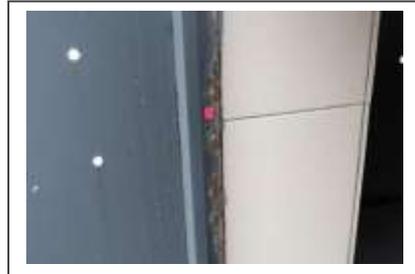
Refuse chamber's door frame found rusty

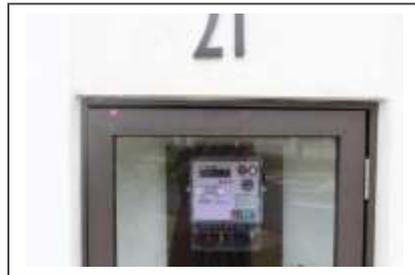
Electrical meter compartment's door found misaligned

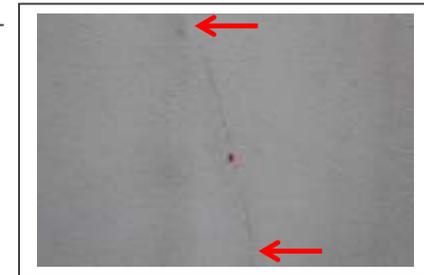
Diagonal crack sighted on perimeter fencing wall

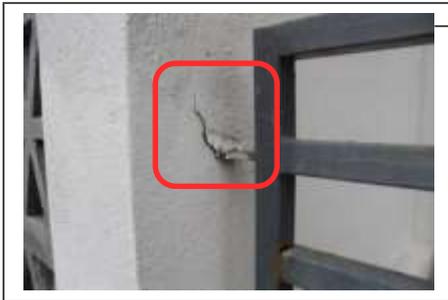
Damages sighted at perimeter fencing wall

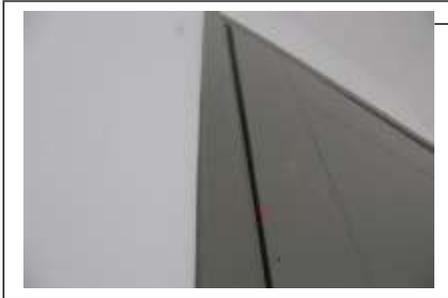
Door panel found misaligned (door panel not flush with door frame)

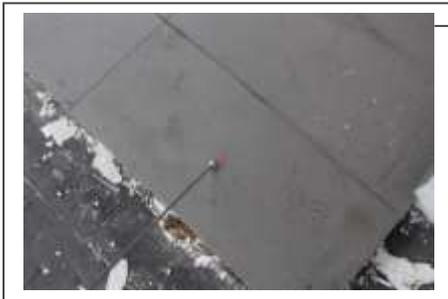
Hollowness found on floor tile

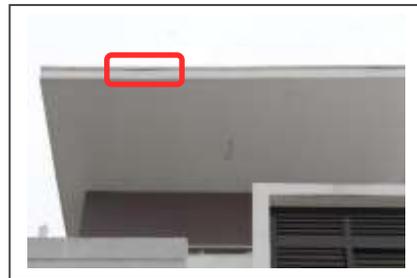
Diagonal crack sighted on fascia board

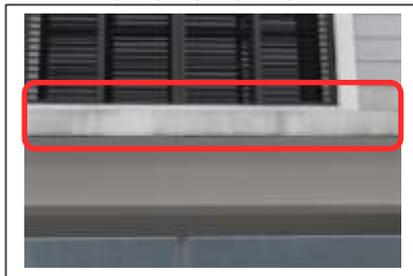
Stain marks sighted on coping

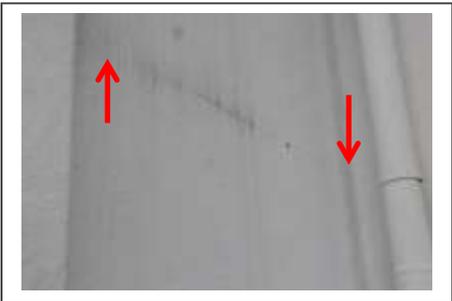
Diagonal crack sighted on external wall

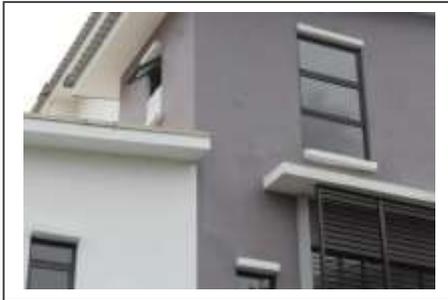
Patchiness found on external wall

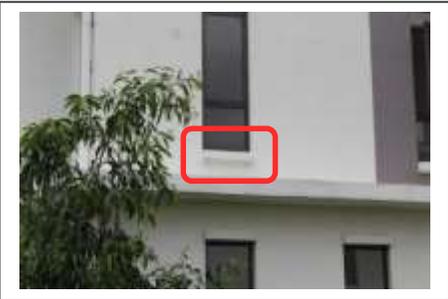
Water mark sighted on external wall
