**DEPARTMENT OF BUILDING
UNIVERSITI TEKNOLOGI MARA
(PERAK)**

**DILAPIDATION SURVEY FOR PROPOSED CONSTRUCTION
AT SUNGAI ARA**

**Prepared by:
LIYANA SAFIAH BINTI ZMAN
2019281798**

AUGUST 2021 – JANUARY 2022

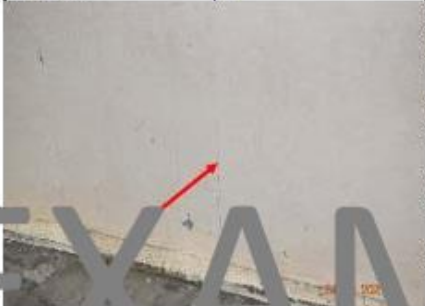
Photo No.	30	Location	Area	Element

External	Right elevation	Wall
	Crack/Gap	Fine crack line (<1mm width)		
	Water Seepage/ Leakage	-		
	Other Defects	-		
	Remarks	-

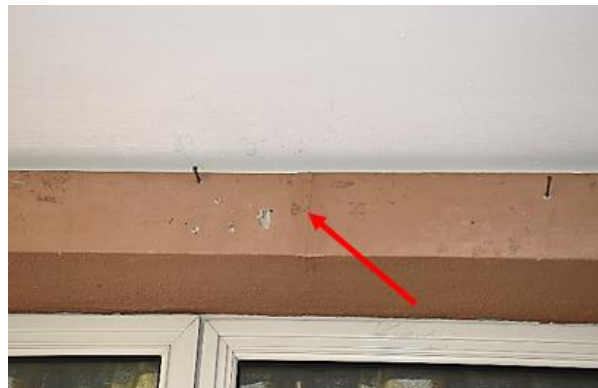
Figure 3.15 Fine crack line on the coping

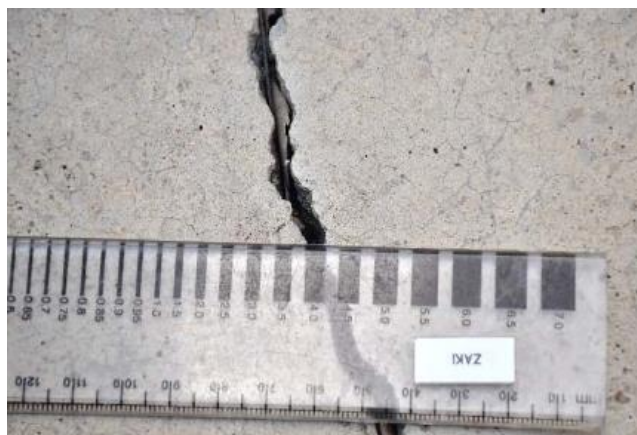
Figure 3.16 Width crack line on the apron using crack gauge

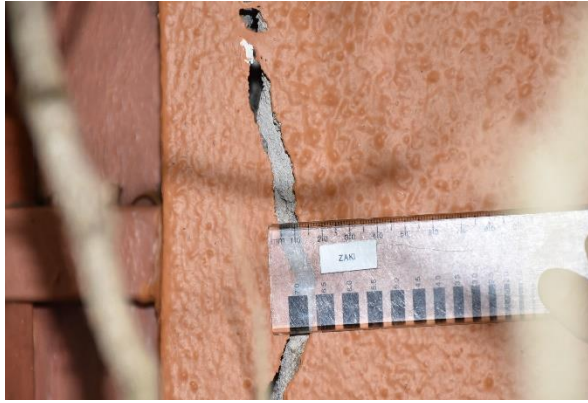
Figure 3.17 Wide crack on the wall using crack gauge

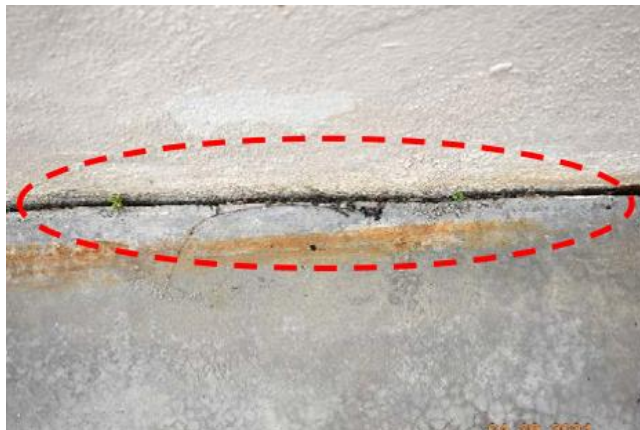
Figure 3.18 separation gap between apron and wall

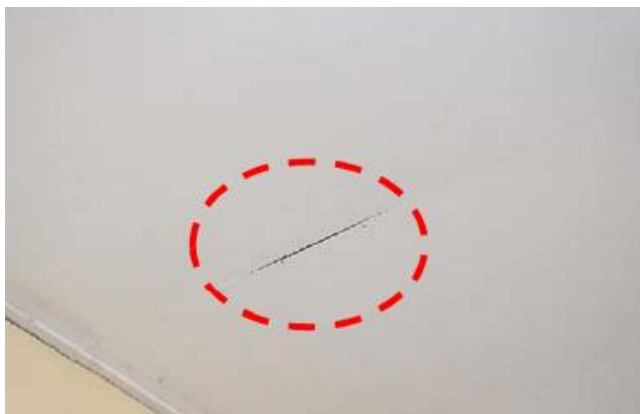
Figure 3.19 Separation gap between ceiling panel with other ceiling panel.

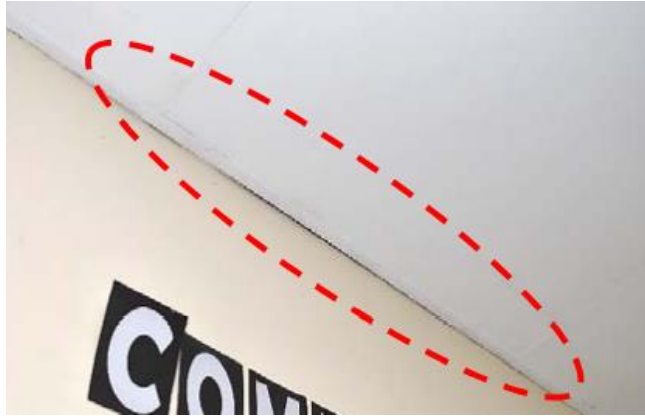
Figure 3.20 Separation gap between wall and ceiling.

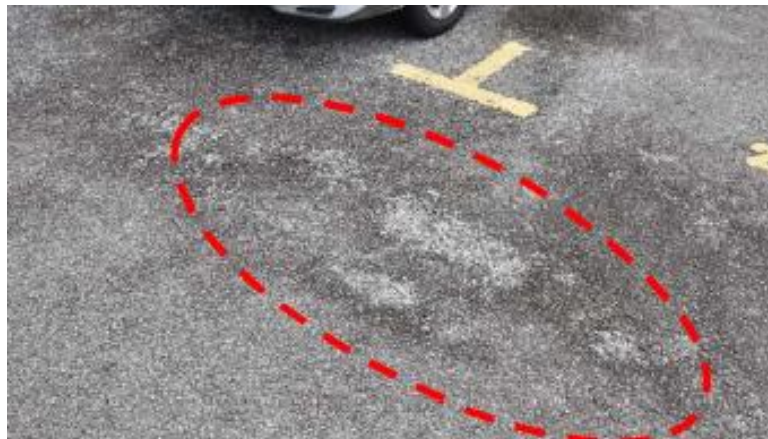
Figure 3.21 Example of uneven surfaces on the road.

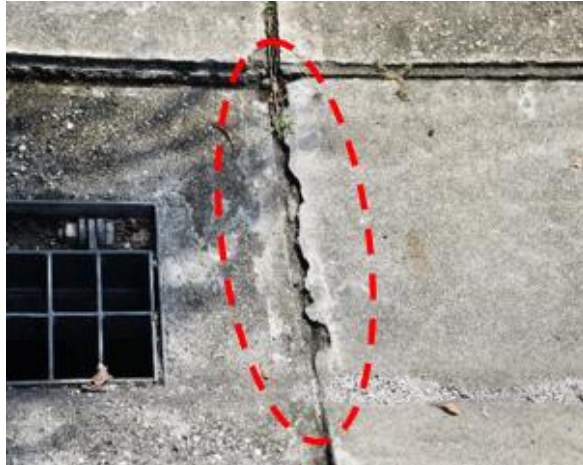
Figure 3.22 Chipped off cement screed on the road drain

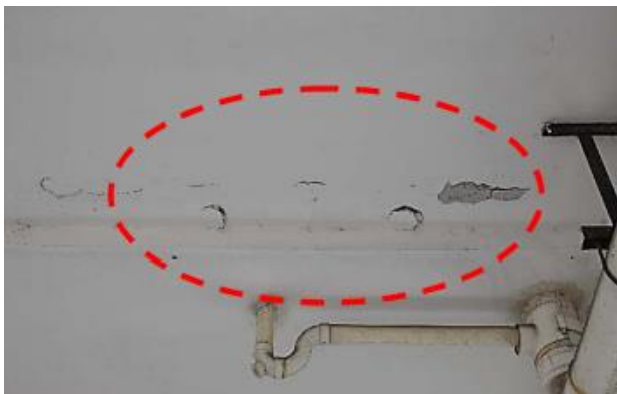
Figure 3.23 Chipped off plaster on the ceiling

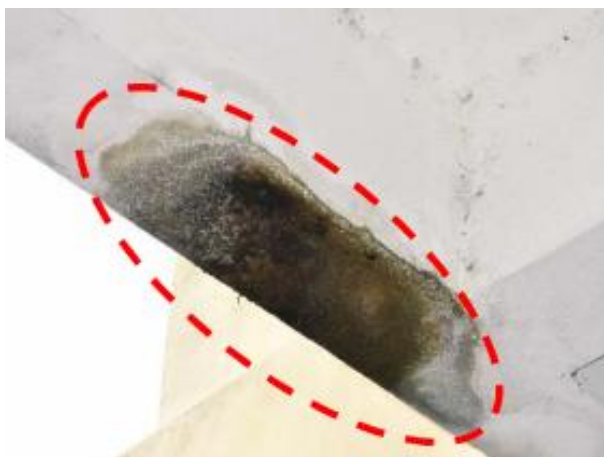
Water stain marks are caused by leakage water. It can be found on the wall, floor, beam and soffit slab but most of the time will be found on ceiling. The examples of water stain marks are shown in the figure 3.24.

Figure 3.24 Water stain marks on the beam

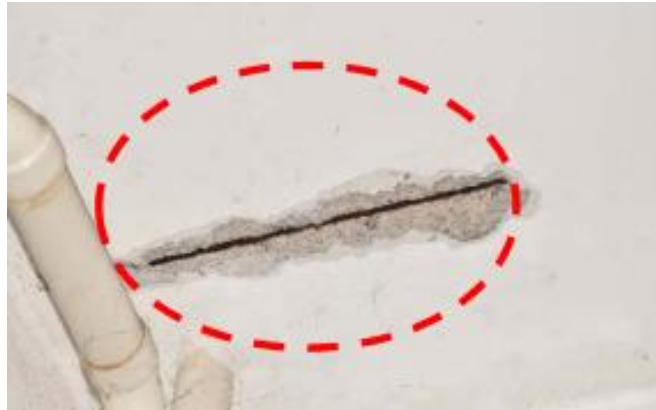
Figure 3.25 Spalled concrete on the soffit slab

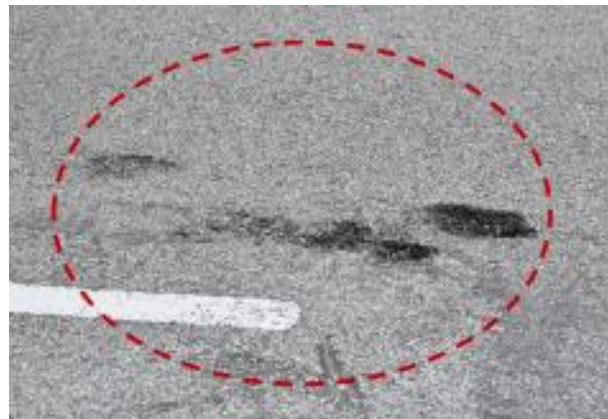
Figure 3.26 Spalled premix on the road surface
