**DEPARTMENT OF BUILDING  
FACULTY OF ARCHITECTURE, PLANNING AND SURVEYING  
UNIVERSITI TEKNOLOGI MARA  
(PERAK)**

**Building Defects And Repairing Work For Finishing**

In its report and review of defects in a building I have chosen a Taman Akasia Indah Phase 1 on the plot 20 and house no. 21, . Construction of the park is the kind of single storey semi-D house in the city in lots 1415 and lots 11562 Bandar Sungai Petani area Kuala Muda. Many factors influencing the plot is due to the effect of the disability on the house is different. This building was fully completed only some minor work such as sanitary uncompleted work and pipeing work. The number of houses available in the park of 40 units. Selection of the park for a review as I placed on the site and I was given the responsibility to oversee and organize the work on site. Making it easier for me to study or report on building defects and steps to be taken. Other than that, I was given guidance by the supervisor of another site for doing repair work disability

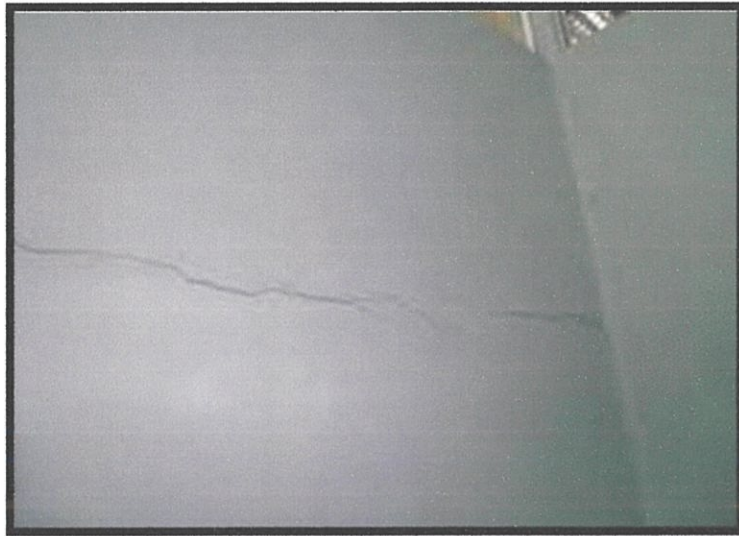
Photo 3.3 : Identifies Cracks

Cracking is the breakdown or cracks that occur in the walls. There are two types of cracks in the walls of plaster cracking or cracking plaster and brick. Before any action is cracking should be identified cracking level. Cracking occurs due to several factors such as the weather, the materials used, as well as plaster technique used. All of this will affect the situation aserta wall resistance. Cracks often occur in every construction it is often caused by carelessness during the work done.
