**DEPARTMENT OF BUILDING  
FACULTY OF ARCHITECTURE, PLANNING AND SURVEYING  
UNIVERSITI TEKNOLOGI MARA  
(PERAK)**

**SEPTEMBER 2015**

**CAUSES OF DEFECT ON WHARF RESIDENCE AND METHODS OF  
RECTIFICATION**

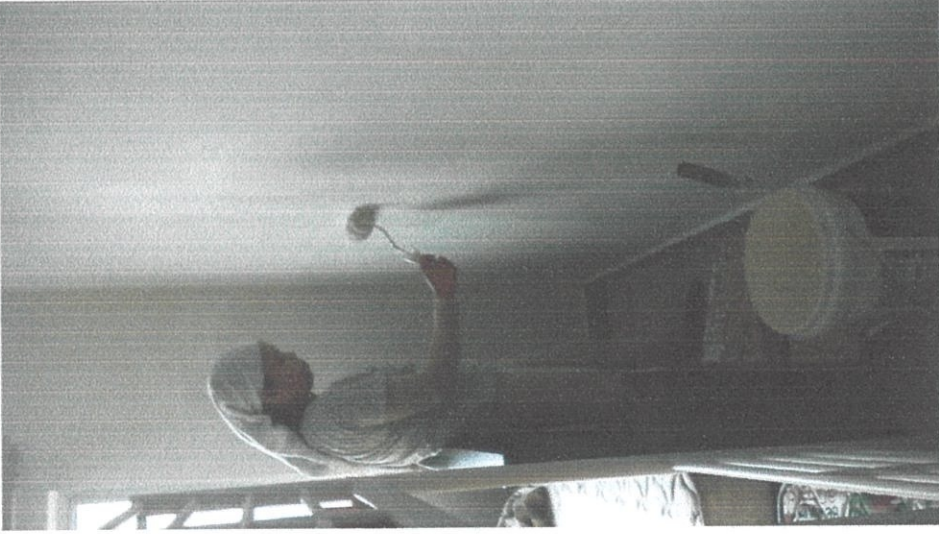
<p>Photo 3.3: Painting work</p>	<p>1. Supervisor 1. General worker</p>	2 days	
---	------	--	---	--	--------	--

2	coat	<p>Start the painting with the first coat. Then let it dry at least for 2 hours and continue with another coat until it reach 3 coat layer of paint.</p>

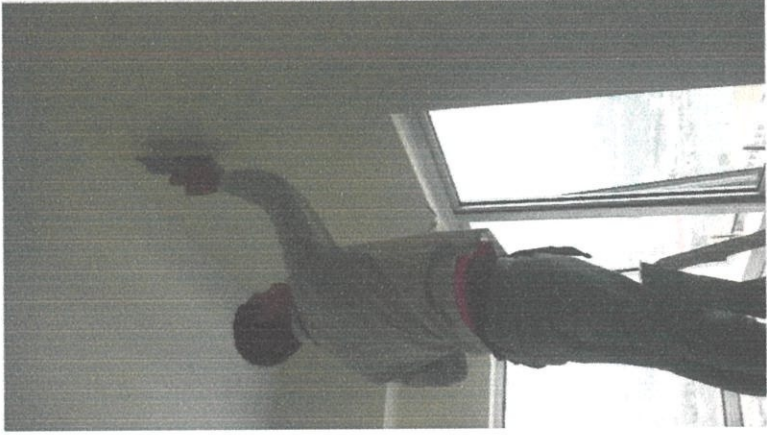
**COMPLAINT BY OWNER:** 'masterbedroom wall crack'

Photo 3.5: Applied skim coat

3	Covered with skim coat	<p>-The base coat shall be applied to a thickness of 2-3 mm per application to the wall.</p> <p>-It can be done by using spatula to level and smoothen the surface to form a layer of even fine particular size coating.</p> <p>-After that the coated area shall be left to dry until partial setting is achieved prior to application of finishing coat.</p>

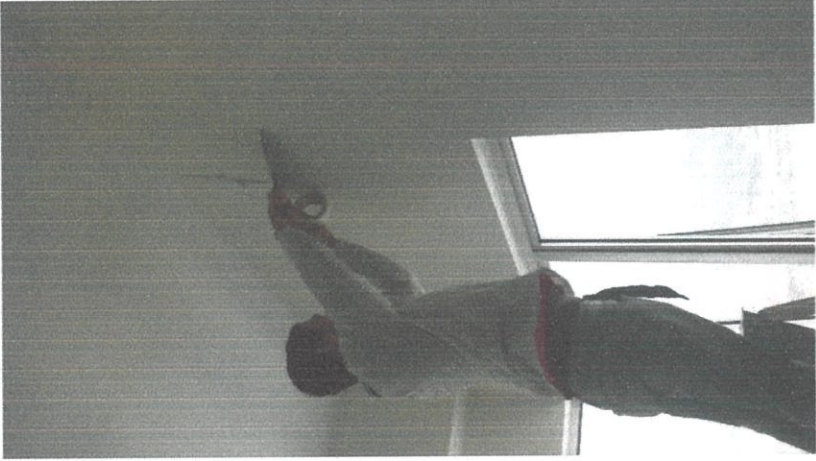
<p>Photo 3.6: place net as protection</p>	<p>1.Supervisor 1.Skilled worker</p>	15 minutes	<p>-The net that been use has their own glue on the back of the net.</p>
---	------------	--	---	--	------------	--

4	Protection	<p>-Place a net at the crack area to prevent the crack from happened again.</p> <p>- The net that been used must be suitable with the size of crack and the deep of the crack.</p>

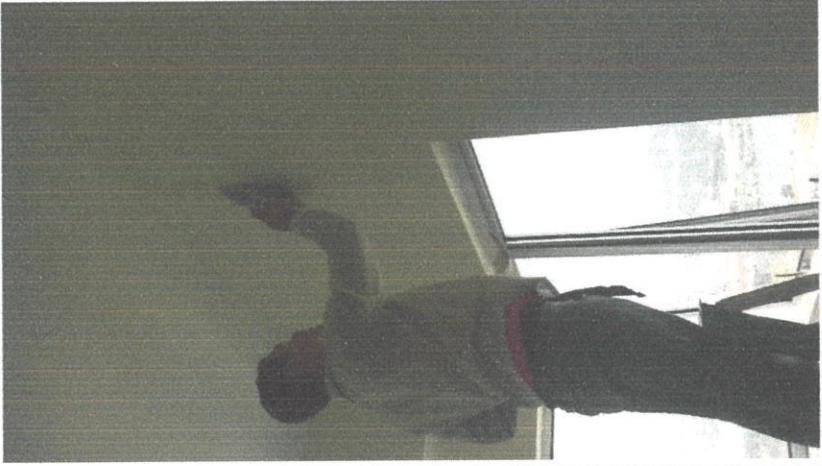
<p>Photo 3.7: Applied finishing coat</p>	<p>1.Supervisor 1.Skilled worker</p>	1 hour	
---	----------------	--	--	--	--------	--

5	Finishing coat	<p>-The finishing coat must be applied after the first coat had been dry correctly. The thickness of between 1-2 mm per application.</p>

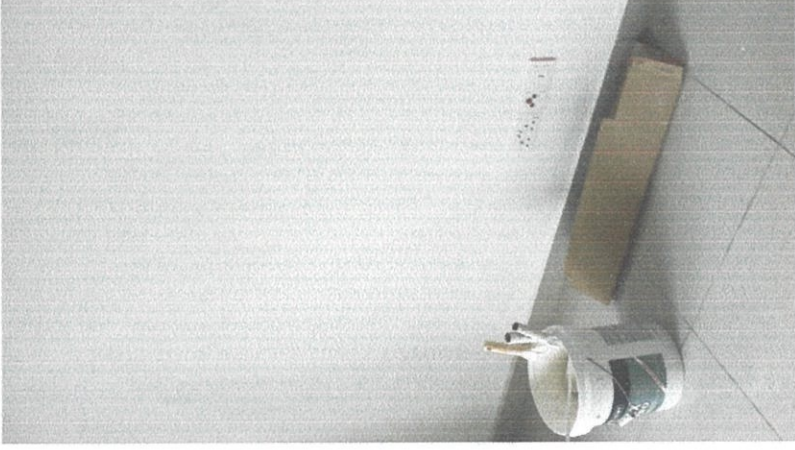
<p data-bbox="1118 994 1145 1232">Photo 3.8: Painting</p>	1. Supervisor 1. General Worker	1 hour	
---	----------	--	---	------------------------------------	--------	--

5	Painting	-After the skim coat had been dry, painting the area nicely.

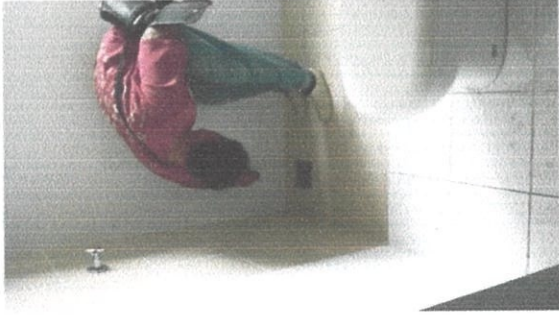
**COMPLAINT BY OWNER: 'tiles hollow and crack'**

Photo 3.9: Check tiling for hollow and crack

<p>crack was happened because of the renovation work by the contractor of the owner, the owner need to pay for the cost of the installation of the new tile.</p> <ul style="list-style-type: none"> <li>-for hollow tile, normally we will use key to check.</li> <li>-mark the tile that need to be change.</li> </ul>

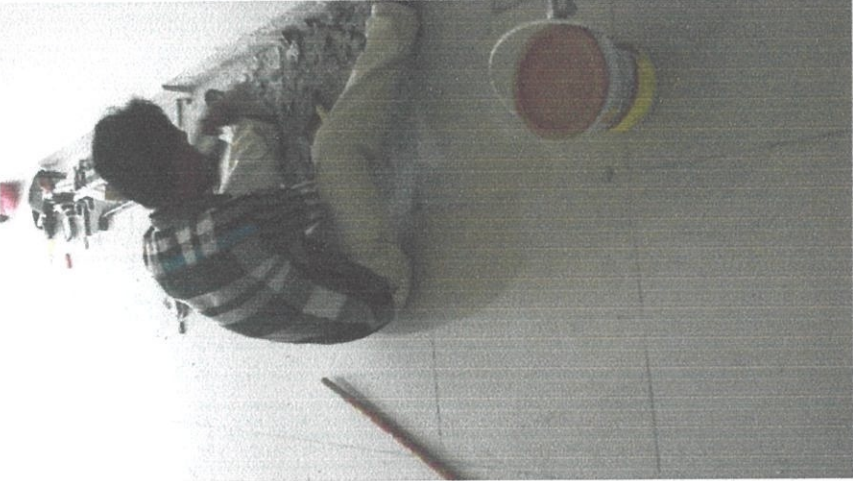
<p data-bbox="1062 891 1093 1478">Photo 3.10: move the entire crack and hollow</p>	1 .supervisor 3 .skilled workers	1 day	Move the entire crack and hollow tiles
---	----------------------------------	--	--	-------------------------------------	-------	--

2	Move the entire crack and hollow	-move all the crack and hollow tiles -the defects must install the new tile

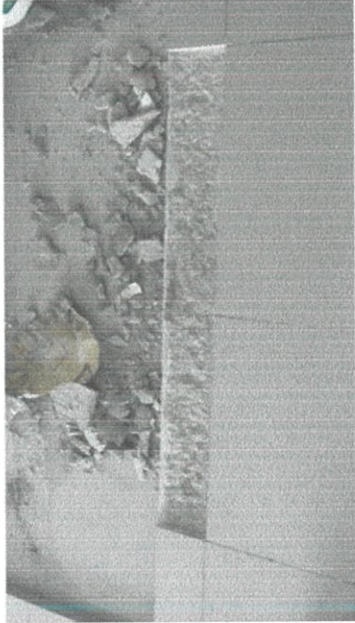
<p>Photo 3.11: move all the cement render</p>	1.supervisor 3.skilled workers	1 day	Move all the cement renders by scratcher
---	----------------------------	--	--	-----------------------------------	-------	--

3	Move all the cement render	<p>-move all the cement renders to provide the new installation of tiles.</p> <p>-the cement render need to be clearly done before we install another tile, if the cement render did not being move correctly, it will affect the thickness of the new installation of tile.</p>

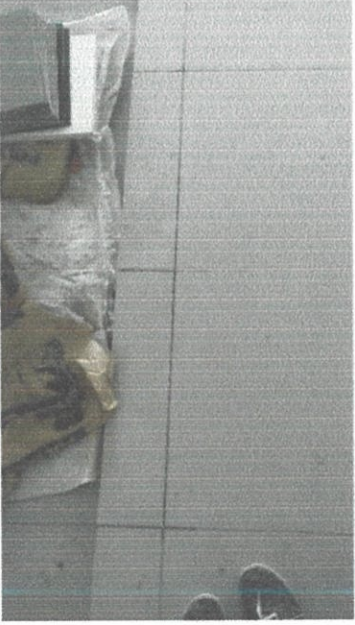
<p>Photo 3.13: grouting</p>	<p>1. supervisor 2. general worker</p>	<p><math>\frac{3}{4}</math> day</p>	
---	----------	---	--	--	-------------------------------------	--

5	Grouting	<p>-fill in grouting for all tiling. Make sure the grouting is consistent for all tile.</p>

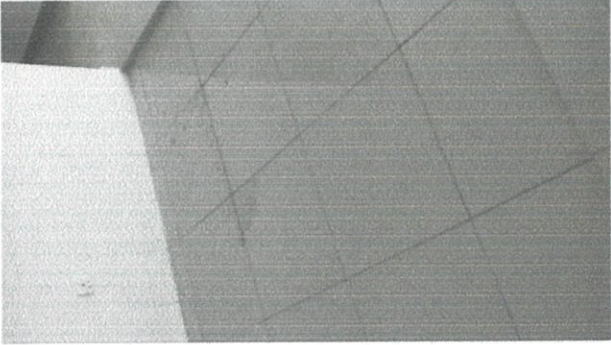
Photo 3.13: finishing and cleaning work

6	Finishing and cleaning work	<p>-ensure no more crack again</p> <p>-ensure there is no more hollow of tile again</p> <p>-clean the working area.</p>

<p>1. supervisor</p> <p>2. general worker</p>	1/2 day	<p>-ensure the finishing not have any defects. if the defects happen move the crack and install the new tiles.</p>
---	-----------------------------	---	---	---	---------	--
