**DEPARTMENT OF BUILDING
FACULTY OF ARCHITECTURE, PLANNING & SURVEYING
UNIVERSITI TEKNOLOGI MARA
(PERAK)**

DEFECT ON PLASTERING AND ITS METHOD OF RECTIFICATION

PROJECT	:Proposed Construction And Completion Of 2&3 Storey 35 Units Office Consist Of Four(4) Corner Units, Twenty Seven (27) Intermediate Units And Four(4) End Units, One Units Of Substation And One Unit Of Refuse Centre Phase 3, Temasya Glenmarie On Lot64333, Skesyen U1, 40150,Shah Alam,Selangor Darul Ehsan
EMPLOYER	:TEMASYA DEVELOPMENT CO SDN BHD
ARCHITECT	:S&A ARCHITECT SDN BHD
STRUCTURAL ENGINEER	:KEMASEPAKAT SDN BHD
M & E ENGINEER	:JURUTERA BUDIMAN SDN BHD
QUANTITY SURVEYOR	:PERUNDING NFL SDN BHD
LANDSCAPE ARCHITECT	:PUNT GARDEN SDN BHD
CIVIL ENGINEER	:MINCONSULT SDN BHD
MAIN CONTRACTOR	:MUTUAL PERMIUM SDN BHD
CONTRACT AMOUNT	:RM 18,182,030.07

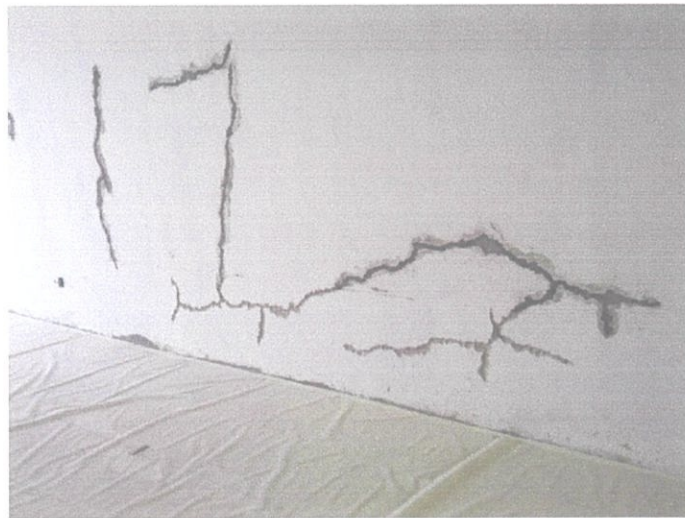
Crazing is a network of fine cracks, in a hexagon pattern, which are across hexagon. Craze cracks are fine and shallow and not extend to the whole depth of plaster. They are usually the result of overtrolling a rich mix which high cement content or using a sand that containing an excessive amount of dust. (www.cnci.org.za ,2009) Often occurs within few hours the plaster being applied to the wall and cracks may hardly be visible until dust or moisture makes them noticeable.

Photo 3.3.1.1 cracking at the wall

Craze cracks can be covered using reasonable quality paint. Map cracking is similar to crazing but it is deeper than craze cracks (sometimes going through plaster). This cracks happen because of high cement content and dry too quickly because the evaporation. The wall is not protected from sun and wind. (www.cnci.org.za ,2009)

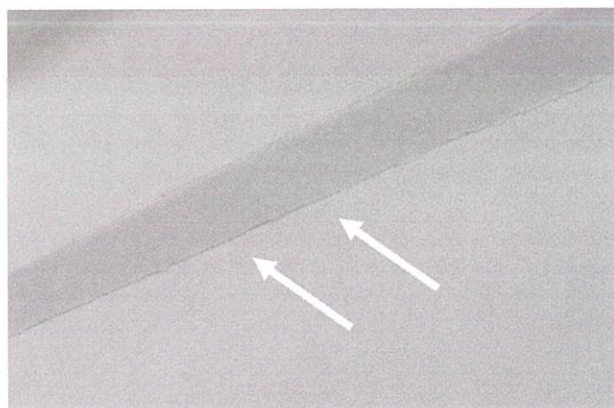
Some cracks visible in the plaster may result from cracking of the wall. It can be caused by different movement of the foundation, moisture expansion or drying shrinkage of the masonry units.(Azmi, 2012) This type of cracks often forms in straight vertical or horizontal line.

These cracks originate in the wall and not in plaster, repairing the plaster is ineffective to this cracks.

Photo 3.3.1.2 horizontal crack bellow the beam.

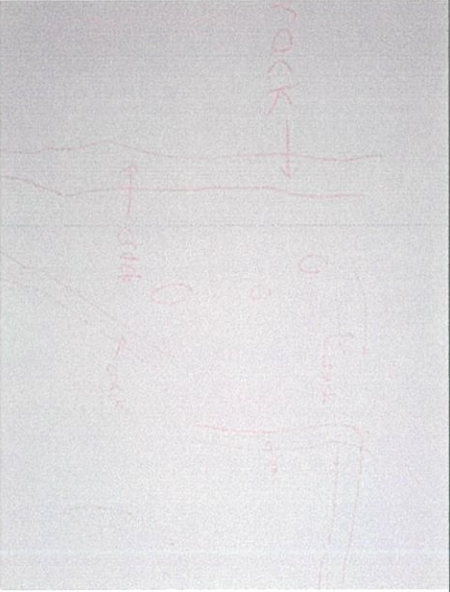
<p data-bbox="726 958 758 1444">Photo 3.3.2.1: wall that has been mark</p>	1 worker

No	Operation	Method	Diagram	worker
1	Identify the crack	Search at the wall surface that have crack

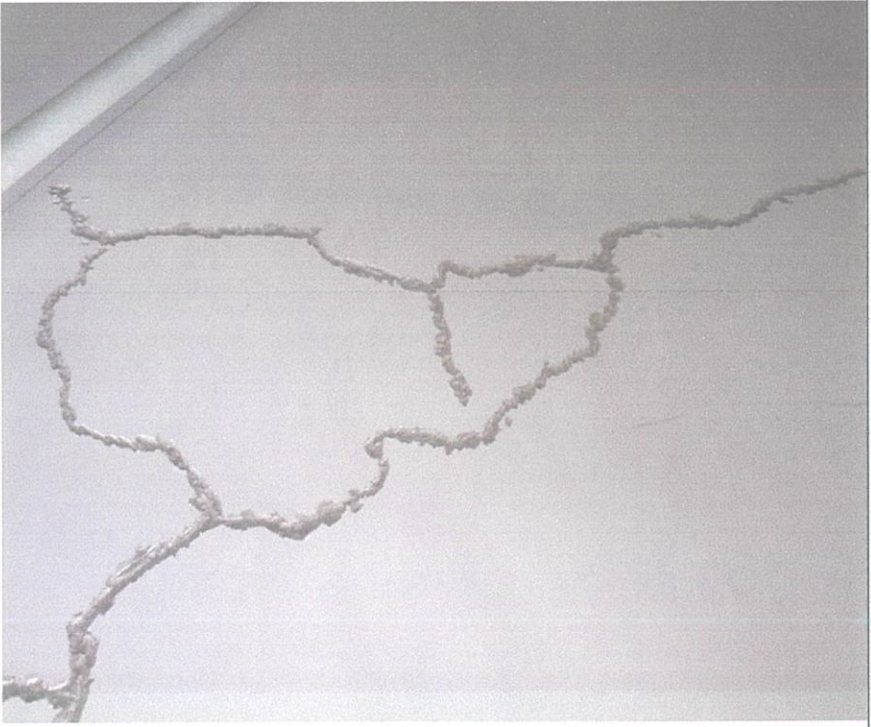
Photo 3.3.2.2: knock the wal that has been mark

2	Knocking the wall	Knocking the wall that has been mark

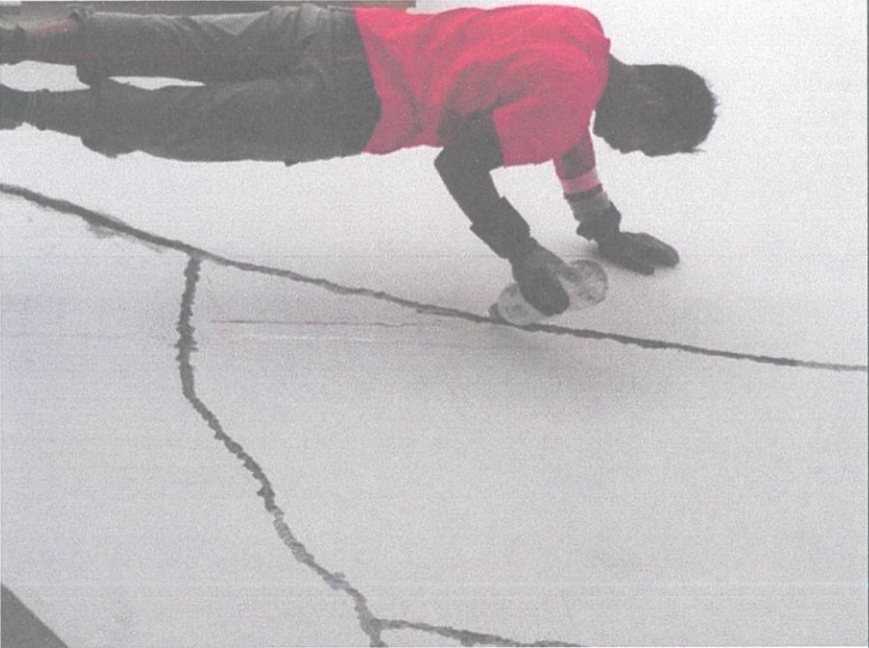
<p>Photo 3.3.2.3: clean the hole that has been knock</p>	1 worker
---	----------	---	--	----------

3	Cleaning	<p>Cleaning the dust by using water to make sure the plaster attach to the wall</p>

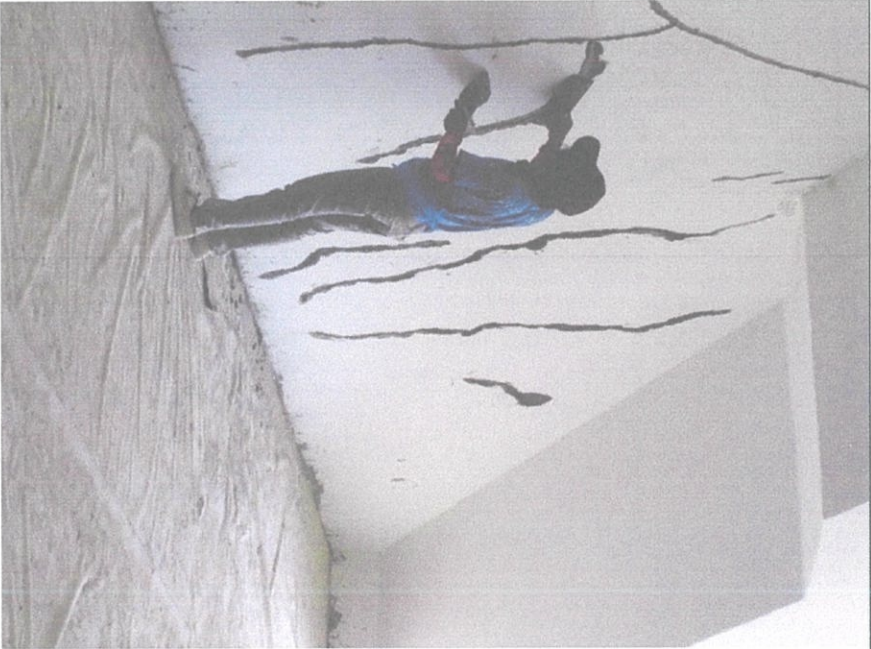
Photo 3.3.2.4: replaster the wall

4	Plastering	Plaster back the crack by using the mixture that have been perfectly mix

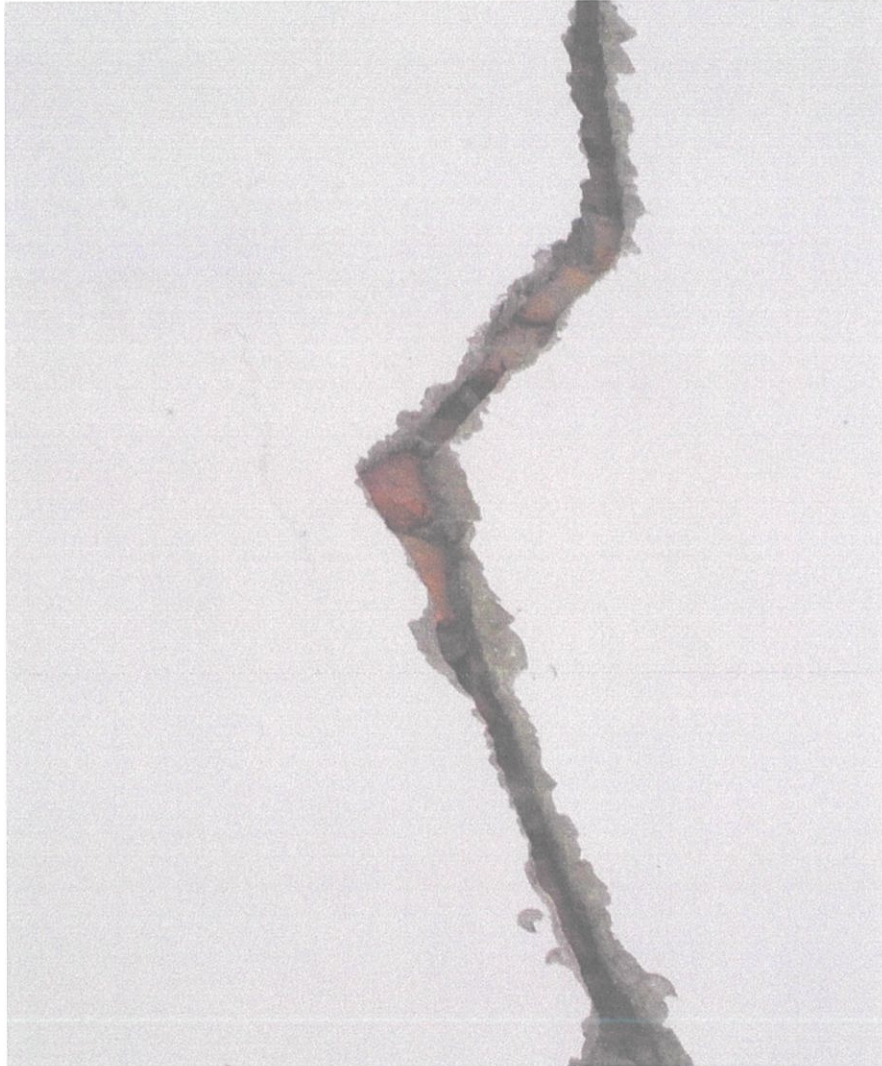
Appendix 1

Photo : After knocking the crack part.

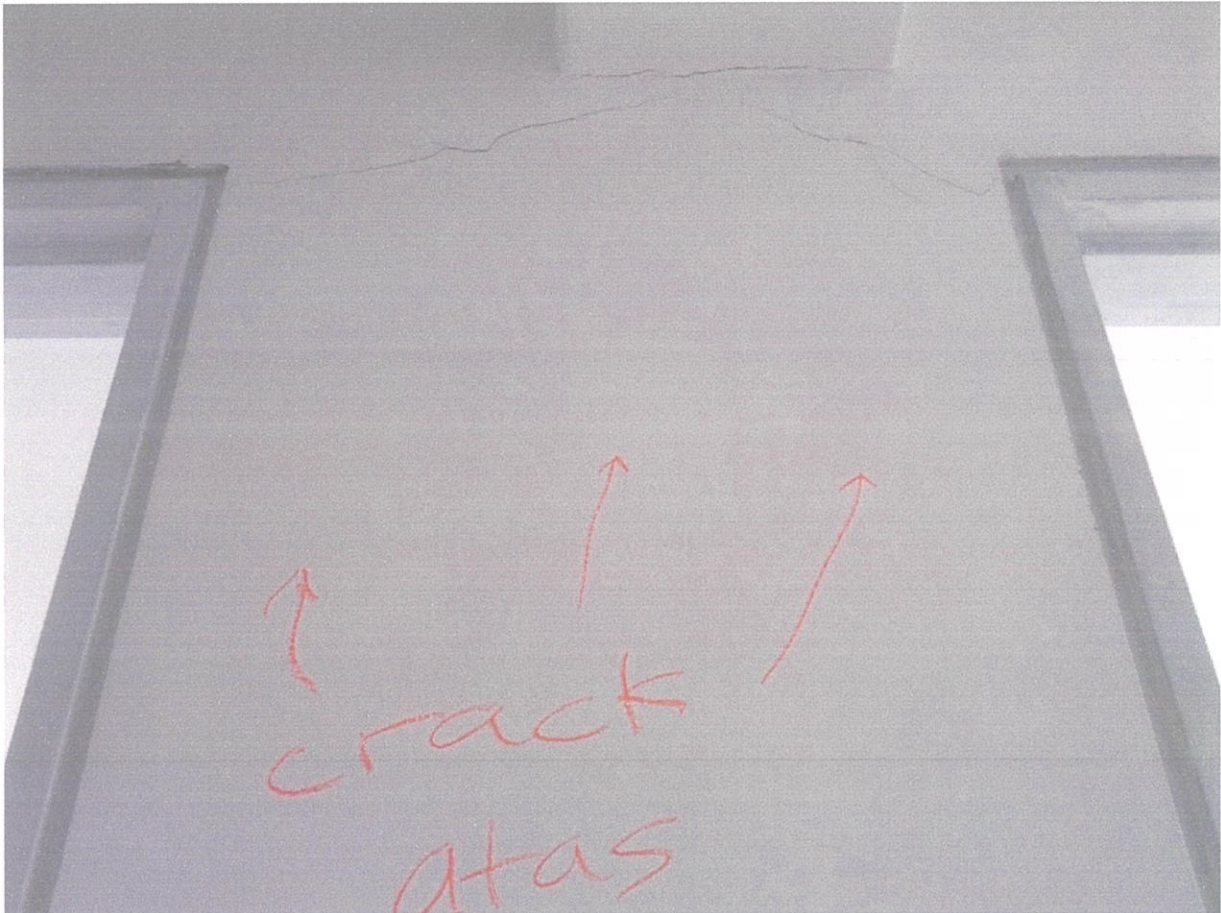
Appendix 8

Photo : The cracking plaster
