NATIONAL SEMINAR ON

30-31 May 2006

Swiss Garden Resort & Spa
Kuantan, Pahang

Failure Investigation of GFRP Water Storage Tank: A Case study at IKBN Jitra, Kedah

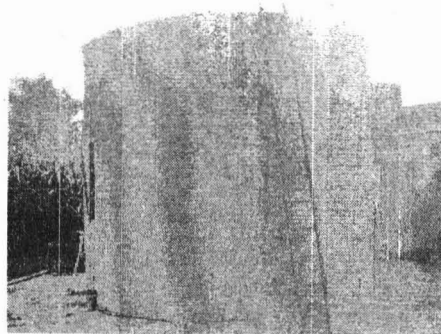
Fig. 1: Reconstructed Tank at Atostech Factory

On 1 August 2004, after two weeks after the tragedy, the failed tank has been reconstructed at Atostech Fibreglass Sdn. Bhd factory by the investigators to inspect and examine the cause of failure. Figure 1 shows the

reconstructed tank at the factory. However, the base of the tank was not brought from the site. From the inspection done, it can be seen that the source of the tank failure was the malfunction of its outlet flange hole. The analogy of the tank failure; how the tank failed and fell from the tower is also shown in Figure 2. This caused the tank wall to crack vertically upward from the hole to the top of the tank and downward to the corner of the wall at the bottom of tank as shown in Figure 3.

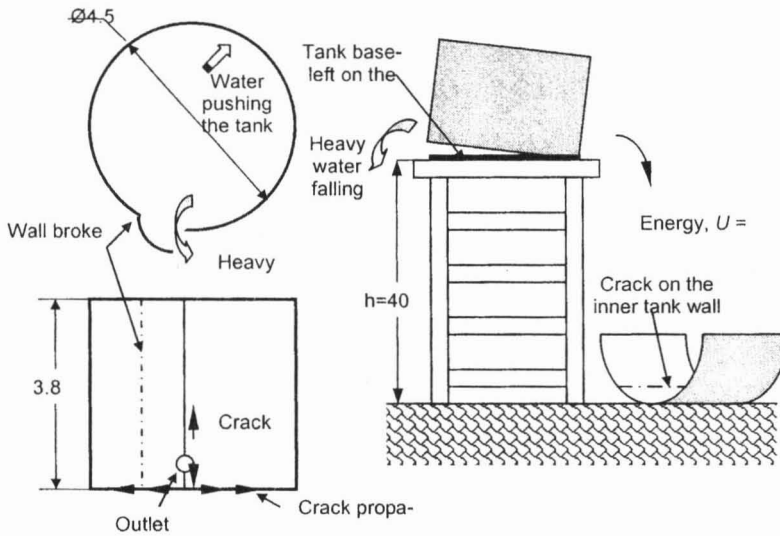
Fig. 2: Analogy of Tank Failure

As the outlet flange hole crack vertically, upward and downward, the hydrostatic pressure of the water caused the cracks to spread quickly. This continued until the high pressure fractured the tank wall vertically. At the same time, the crack spread to the corner of the tank floor because it became the tank's highest concentration point. This causes the thrust force of the tank to exist, with opposite direction from the water flow, thus causing the wall to fall from the tower, leaving the base on the tower.

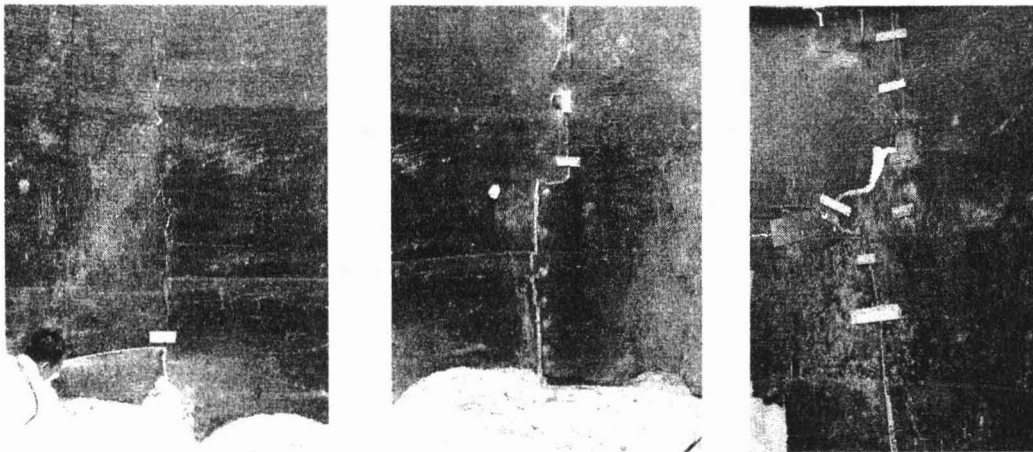
Fig. 3: (a) Net Section Failure, (b) Inner Wall Fracture, and (c) Failure Caused by the Crash from Falling.

The wall experienced a massive crash and cracked the inner wall of the tank. This is due to its rounded shape, plus the weight on the whole tank wall. Net Section Failure refers to tensile failure of a holed material. Crack until disconnected on the tangent hole occurred in the direction perpendicular to the tensile stress on the material. This phenomenon is shown in Figure 4.

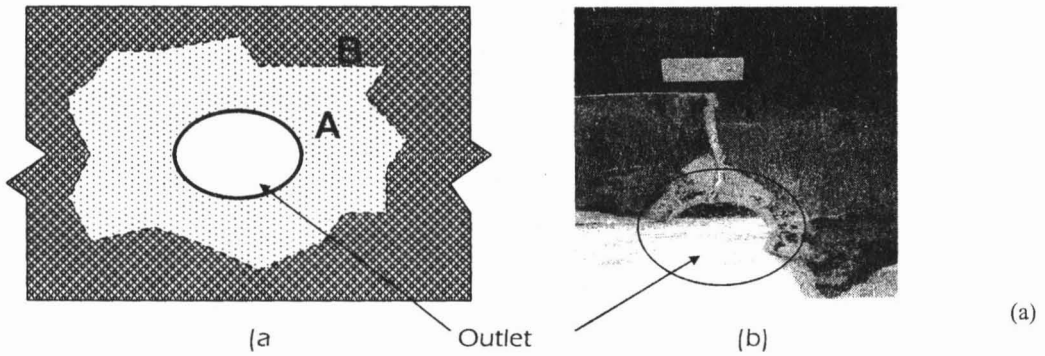
Since outlet flange hole is the cause of whole tank failure, detailed examination is done on the hole. The result showed that the cutting section was not treated properly to avoid moisture effects. Thus, the cutting section was exposed to water and moisture. Because composite materials are made up of glass fibre, delamination occurred when raisin reacted with water. Slowly, this process caused the area around the tank hole became weak and the strength to hold load decreasing. Figure 7(a) shows evidence of delamination around the outlet flange hole.

Delamination around the Outlet Flange Hole (b) Unsmooth Cutting of the Outlet Fange

Water and moisture that penetrated and spread through fibre glass quickened the delamination process, thus making it not able to hold the stress concentrated around the hole, especially on the tangent. Figure 7(b) shows untreated hole surface after cutting was made. In addition to that, messy cutting, and unsmooth surface becomes the factor encouraging the cracks.

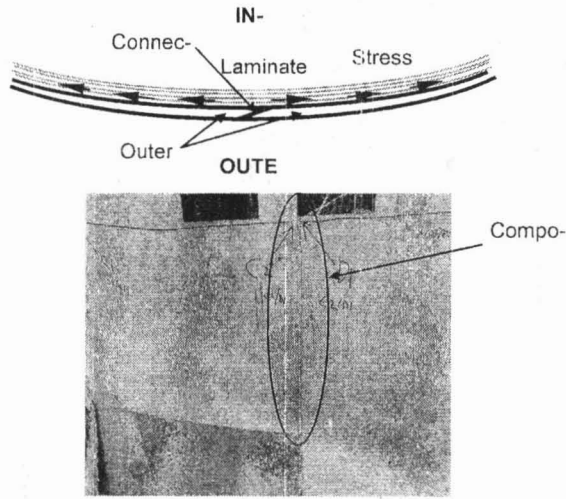
From observations, assembling between tank components was not laminated again on the outside for whole tank structure integrity. Lamination on the outside of connection ensures stress brought inside tank wall by hydrostatic pressure is withstand by inside lamination. Stress is transform from shear strength properties between laminate on the connection. Without lamination on outside of the tank wall, the water hydrostatic pressure was only withstand by laminate inside the tank wall. Therefore, it is very important to make sure the whole tank structure integrity is not affected because water tank is a structure that always withstand continuous load. Every part plays role to withstand stresses that exist in tank structure. Figure 8 shows assembling method between tank components on the outer side of a tank.

Fig. 8: Assembling Method of Outer Tank Components that are Not Laminated

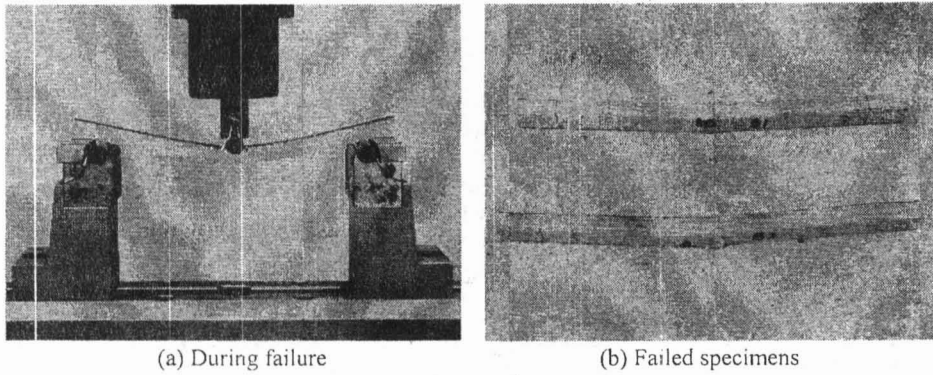
Fig. 11: Bending Test and Failed Specimens

From output of the INSTRON machine, the data in Table 3 was obtained. It can be seen that failure happened to the lower part of the specimen that suffered tensile and on the upper part of the specimen that suffered compression. Maximum bending strength obtained was higher than minimum bending strength value specified by SIRIM, with averaged value 125.23 MPa, compared to 10 MPa, while modulus value was 6091 MPa compared to 4830 MPa. Overall, laminate of tank wall was in good condition with strength higher than the minimum value specified by SIRIM.

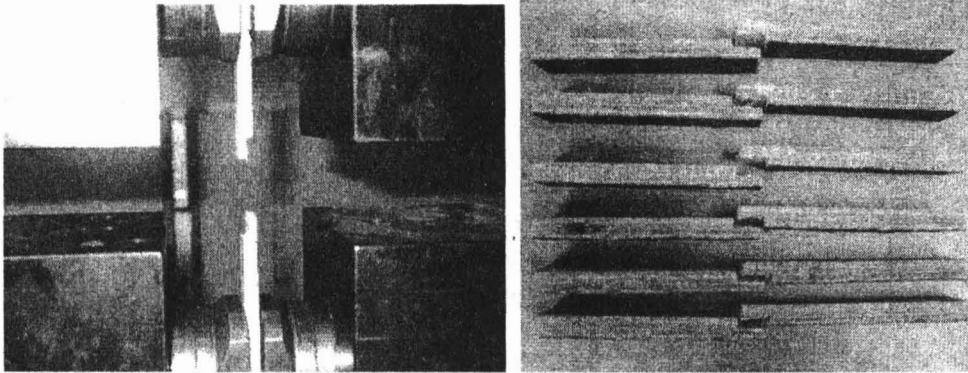
From output of the DARTEC Universal Testing Machine, the data in Table 3 was obtained. It can be seen that failure occurred at laminate between WR and CSM because these layers are in between the cuttings. Maximum shear strength obtained was higher than minimum shear strength value specified in BS 4994: 1987, which is 12.78 MPa compared to 7 MPa. Overall, laminate of tank wall has good shear strength between WR and CSM surface.

Fig.12: (a) Lap Shear Test using DARTEC, (b) Failure Specimen by Lap Shear Test

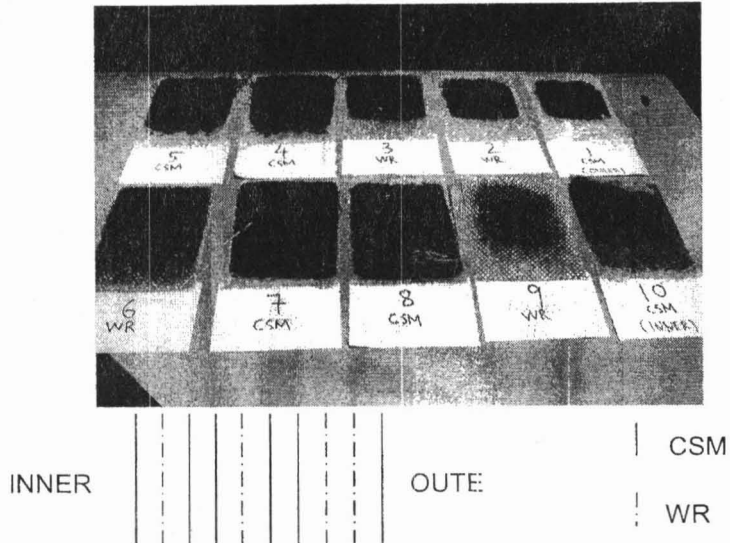
discovered that there are 6 layers of CSM and 4 layers of WR, making the total of 10 laminate layers.

Fig. 14: Laminate Arrangements can be seen after Burn-out Test

From the burn-out test conducted, the composition of matrix and resin was identified. More over, the arrangement of woven roving (WR) and chopped strand mat (CSM) type glass fibre layers can be observed. After comparing it with original laminate arrangement from the manufacturer, the total amount of laminate are the same, which are 10 layers. However, from calculation based on BS 4994: 1981, the amount of laminate needed is 13 layers. Therefore, reducing the amount of laminate is risky as the safety factor is lower than the ideal safety design.
