DEPARTMENT OF BUILDING UNIVERSITI TEKNOLOGI MARA (PERAK)

MAINTENANCE WORK AT APARTMENT LAGUNA BIRU

MAC 2016

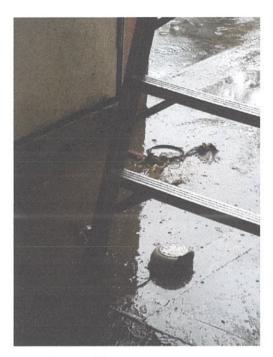
Photo 3.18: wastes

6. Photo 3.4.8 shows wastes that cause the sewage line to clog.
