**TRAINING MODULE FOR HOUSE DEFECT INSPECTION FOR  
RESIDENTIAL BUILDING: CASE STUDY AT TAMAN KOTA SERIBONG**

PRACTICAL TRAINING REPORT

(TRAINING MODULE FOR HOUSE DEFECT INSPECTION FOR  
RESIDENTIAL BUILDING: CASE STUDY AT TAMAN KOTA SERIBONG)

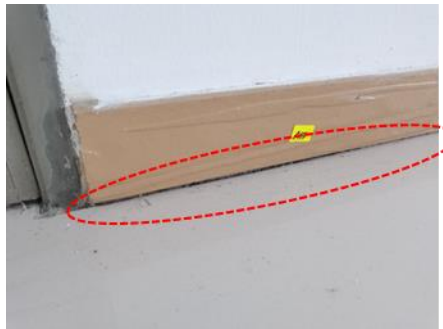
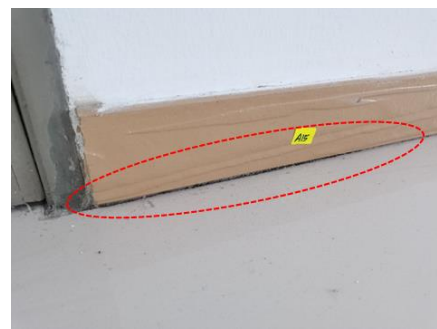
- a) Gap at floor tiles to skirting
  - Reference No : A15 (4 Locations)

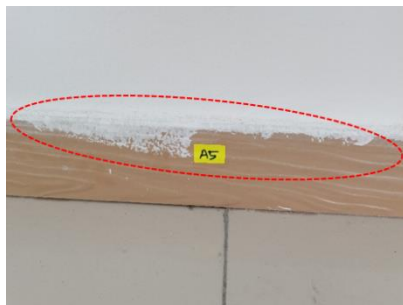
- a) Paint stain at skirting
  - Reference No : A5 (4 Locations)

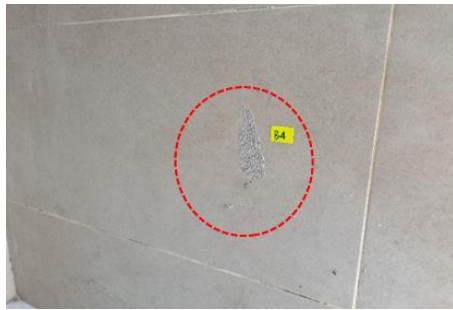
- a) Paint stain at wall tiles
  - Reference No: B4 (2 Locations)

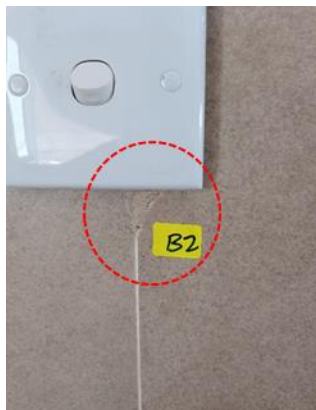
- a) Chipped wall tiles
  - Reference No: B2

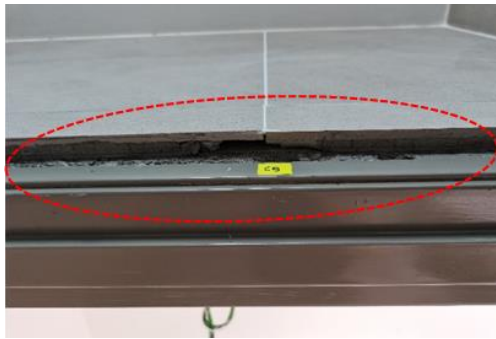
- a) Poor wall tiles assembly finishing
  - Reference No: C5

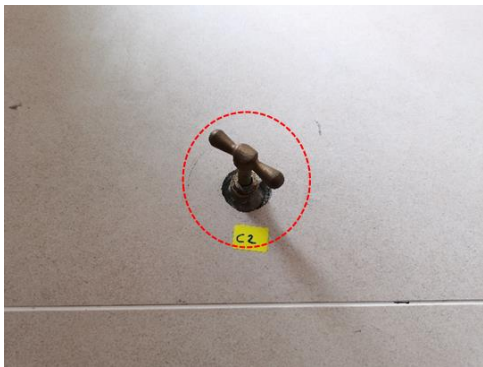
- a) No grouting finishing at stopcock & shower rose inlet area.
  - Reference No : C2 (2 Locations)

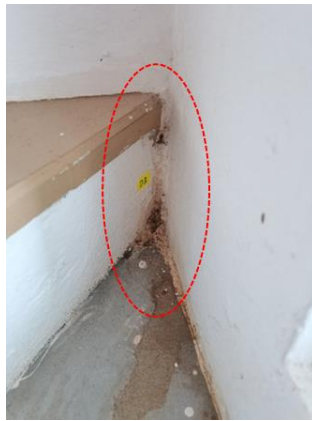
- a) Rough plaster finishing
  - Reference No : D3

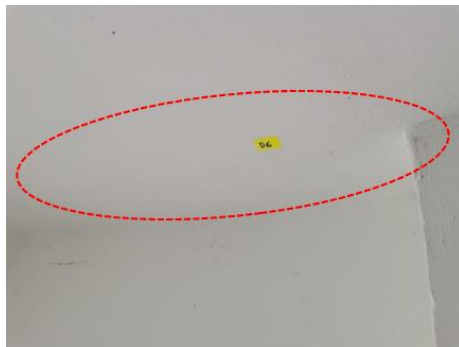
- a) Hairline crack at ceiling
  - Reference No : D6

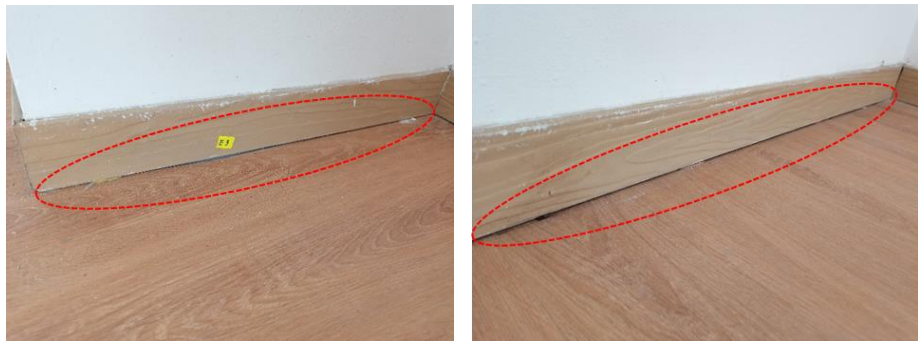
- a) Big gaps at lower floor skirting area.
  - Reference No : E3 (2 Locations)

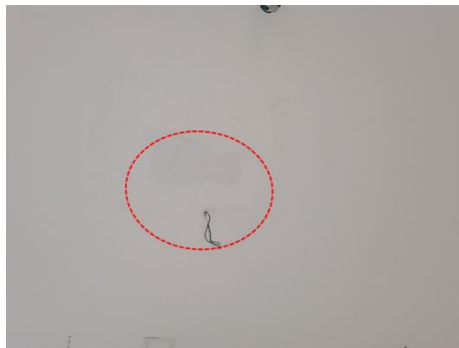
- a) Unpainted (after touch up) ceiling surface.
  - Reference No : E1

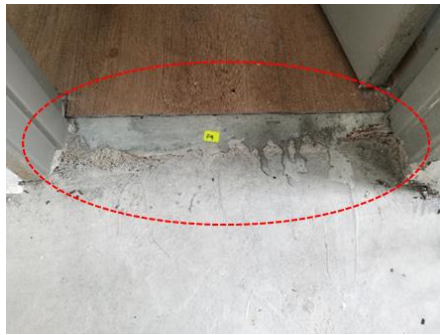
- a) Poor cement render finishing at 1<sup>st</sup> floor aircond compressor area.
  - Reference No : F9

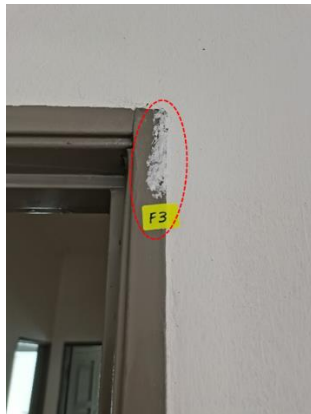
- a) Paint stain at door frame
  - Reference No : F3

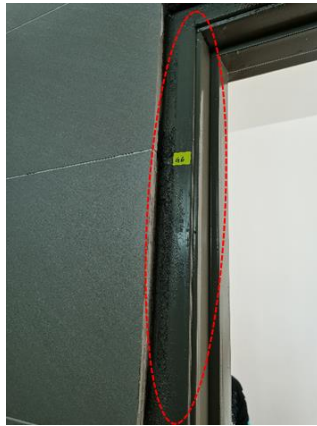
- a) Unfinished tiles installation at door frame
- Reference No : G6

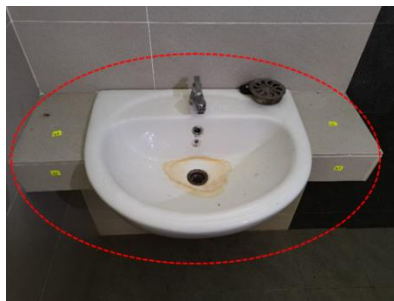
- a) Hollowness at sink table top
- Reference No : G3 (4 Locations)

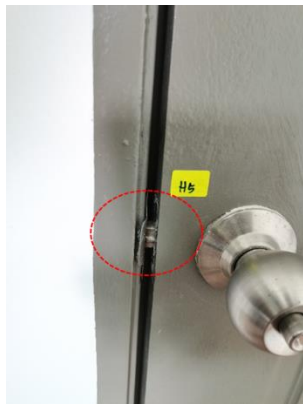
- a) Doorknob not locking when door fully closed.
  - Reference No : H5

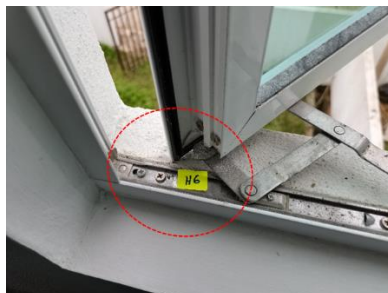
- a) Window frame touching to coping area
  - Reference No : H6

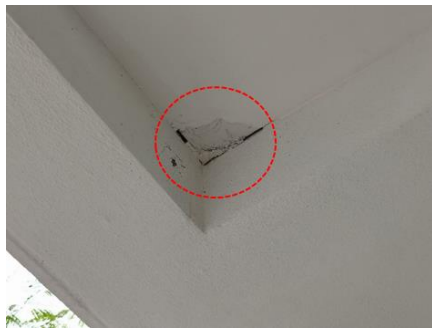
- a) Ceiling damage at joint area.
  - Reference No : K10
