**PROCESS OF HOUSE DEFECT INSPECTION DURING DLP FOR  
HIGH RISE BUILDING: CASE STUDY AT TROIKA RESIDENCE**

NURUL AQEESYA BINTI ABDUL AZIZ  
(2019893354)

PRACTICAL TRAINING REPORT

OCTOBER 2021

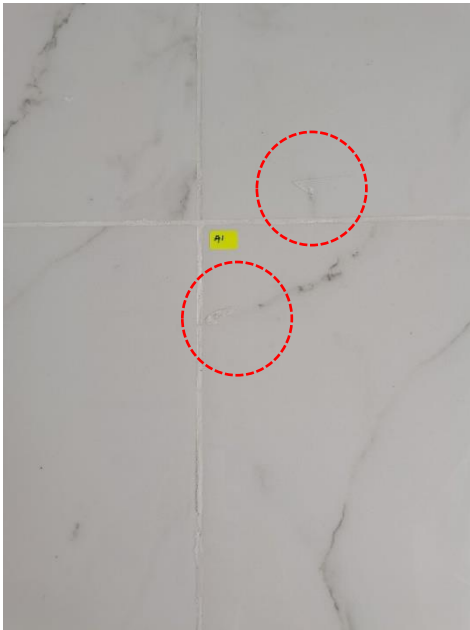
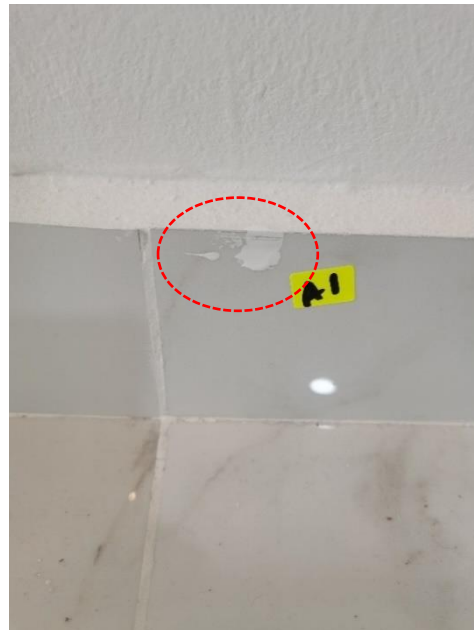
- a) Paint Stain.
  - Reference No : A1 (2 Locations)

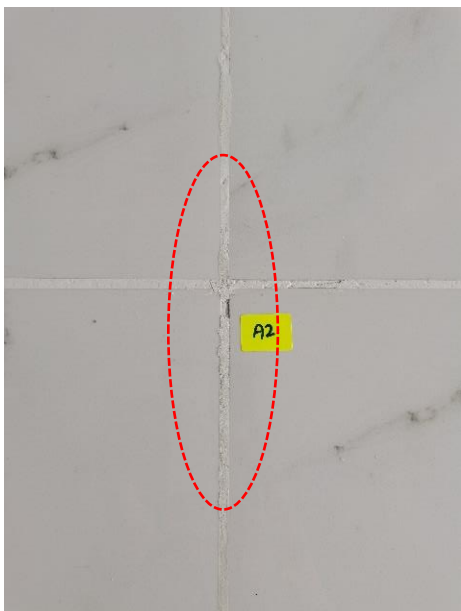
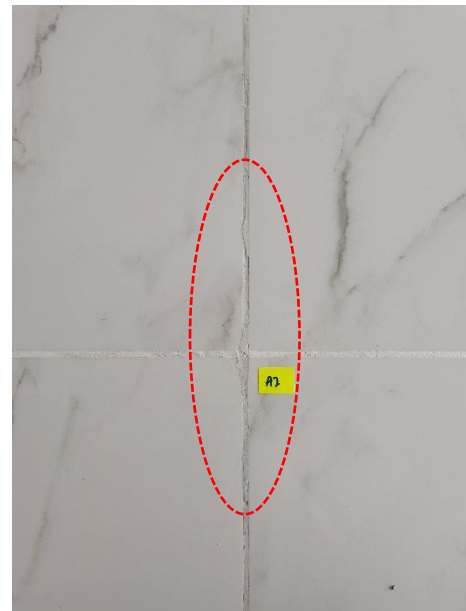
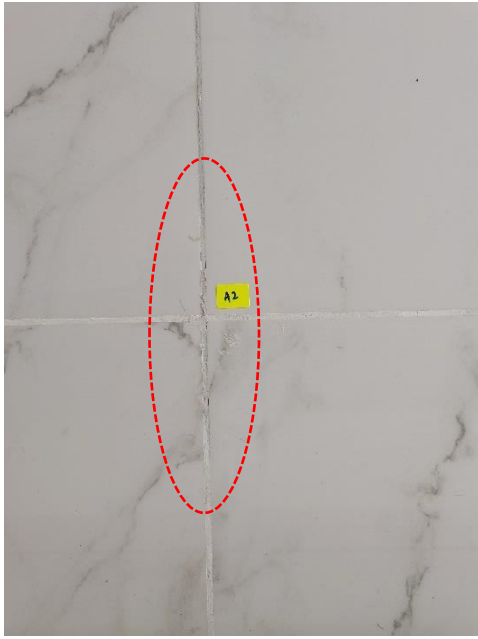
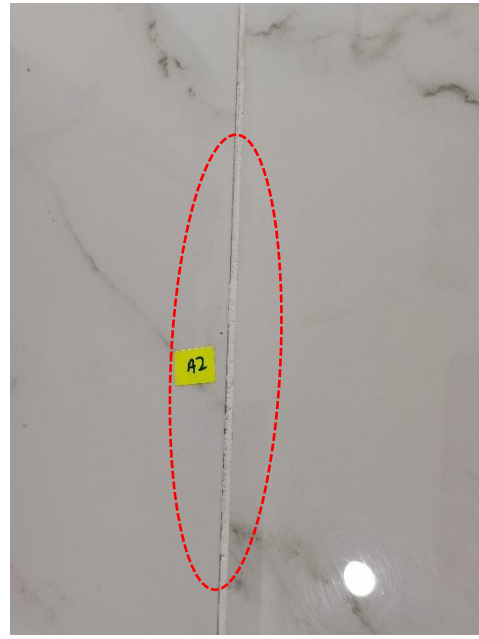
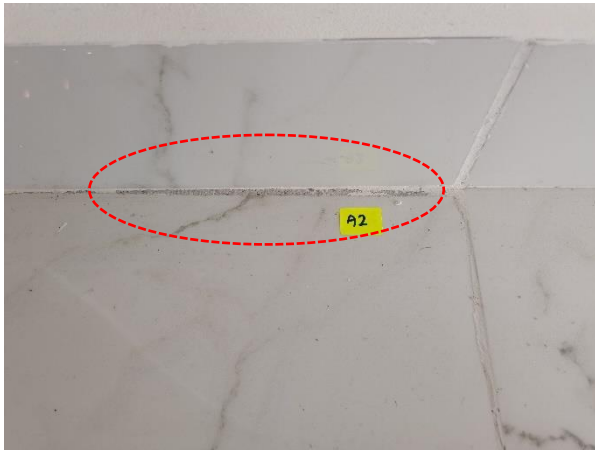
- b) Poor grouting.
  - Reference No : A2 (5 Locations)

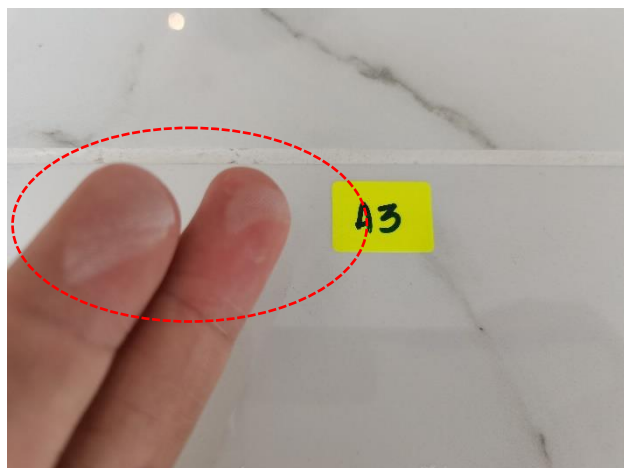
- Reference No : A3

c) Chalky Grouting.

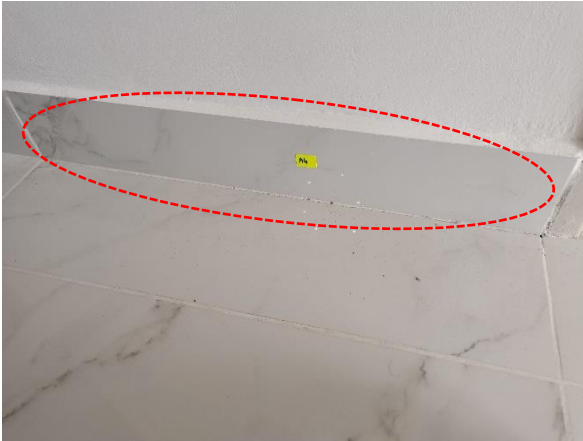
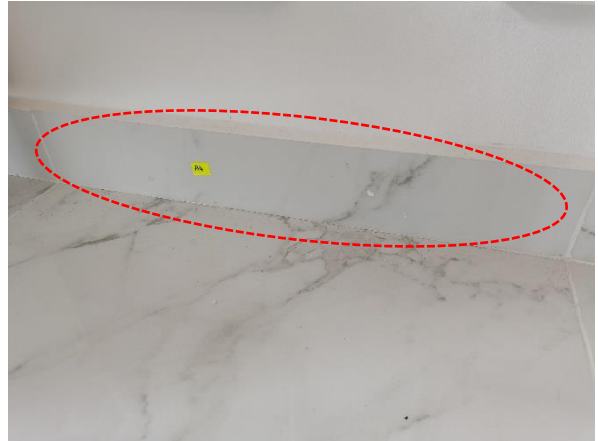
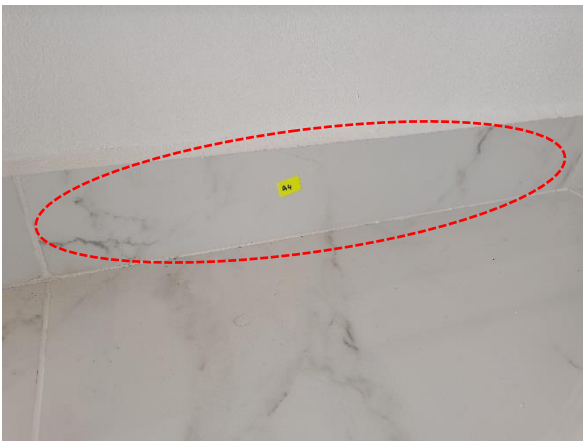
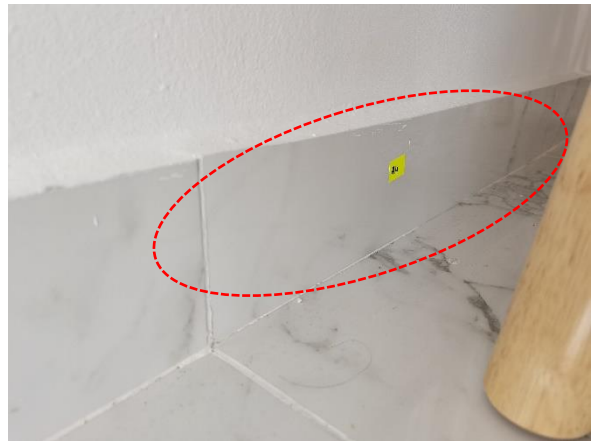
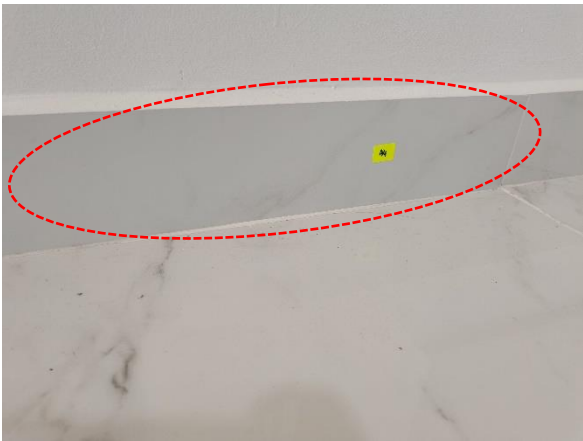
- Reference No : A4 (5 Locations)

a) Hollow sound detected at floor tiles skirting.
