**BUILDING INSPECTION FOR DEFECT LIABILITY PERIOD AT SETIA  
ECO GLADES CYBERJAYA**

PRACTICAL TRAINING REPORT

(BUILDING INSPECTION FOR DEFECT LIABILITY PERIOD AT SETIA  
ECO GLADES CYBERJAYA)

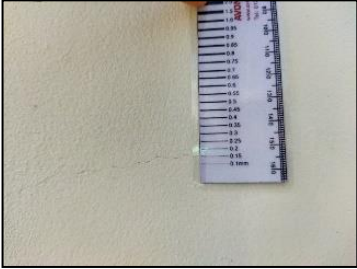
*Figure 3.9: close view*

<b>Defect Indication code</b>	A12	<b>Location</b>	Car Porch
<b>Element</b>	Column	<b>Type / Item</b>	Finishes (Paint)
<b>Defect</b>	Crack on column	<b>Quantity</b>	1

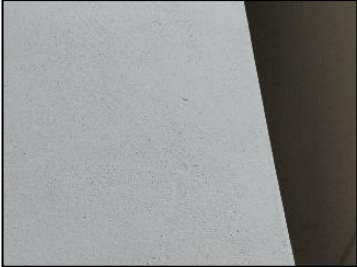
*Figure 3.10: close view*

<b>Defect Indication code</b>	A13	<b>Location</b>	Car Porch
<b>Element</b>	Column	<b>Type / Item</b>	Finishes (Paint)
<b>Defect</b>	Chipping on column	<b>Quantity</b>	1

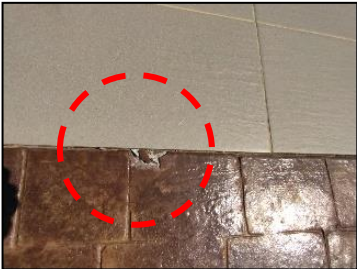
*Figure 3.11: close view*

<b>Defect Indication code</b>	A100	<b>Location</b>	Car Porch
<b>Element</b>	Floor	<b>Type / Item</b>	Pavement
<b>Defect</b>	Broken on floor	<b>Quantity</b>	1

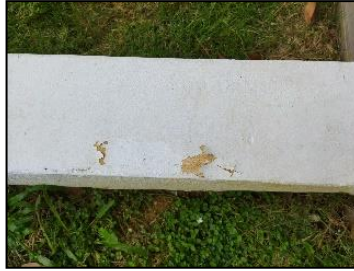
*Figure 3.12: close view*

<b>Defect Indication code</b>	A110	<b>Location</b>	Car Porch
<b>Element</b>	Base	<b>Type / Item</b>	Finishes (Paint)
<b>Defect</b>	Peeling of paint on base	<b>Quantity</b>	1

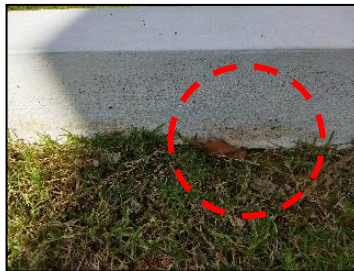
*Figure 3.13: close view*

<b>Defect Indication code</b>	A113	<b>Location</b>	Car Porch
<b>Element</b>	Base	<b>Type / Item</b>	Finishes (Paint)
<b>Defect</b>	Dirt stain on base	<b>Quantity</b>	1

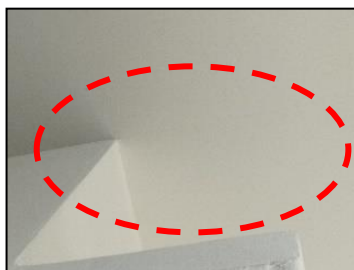
*Figure 3.14: close view*

<b>Defect Indication code</b>	A120	<b>Location</b>	Car Porch
<b>Element</b>	Base	<b>Type / Item</b>	Finishes (Paint)
<b>Defect</b>	Crack on base	<b>Quantity</b>	1

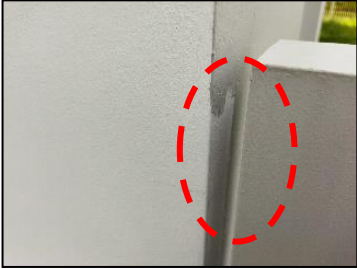
*Figure 3.15: close view*

<b>Defect Indication code</b>	A18	<b>Location</b>	Terrace
<b>Element</b>	Wall	<b>Type / Item</b>	Finishes (Paint)
<b>Defect</b>	Uneven paint on wall	<b>Quantity</b>	1

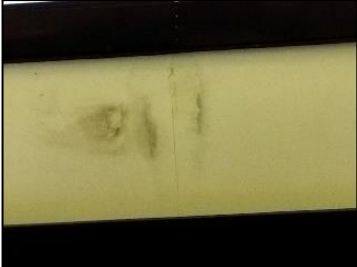
*Figure 3.16: close view*

<b>Defect Indication code</b>	A29	<b>Location</b>	Terrace
<b>Element</b>	Roof	<b>Type / Item</b>	Soffit
<b>Defect</b>	Dirt stain on soffit	<b>Quantity</b>	1

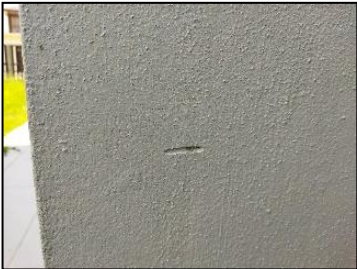
*Figure 3.17: close view*

<b>Defect Indication code</b>	A33	<b>Location</b>	Terrace
<b>Element</b>	Wall	<b>Type / Item</b>	Finishes (Paint)
<b>Defect</b>	Chipping on wall	<b>Quantity</b>	1

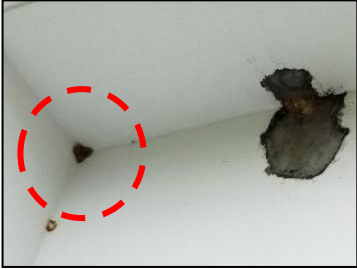
*Figure 3.18: close view*

<b>Defect Indication code</b>	A57	<b>Location</b>	Patio
<b>Element</b>	Wall	<b>Type / Item</b>	Finishes (Paint)
<b>Defect</b>	Insect nest on wall	<b>Quantity</b>	1

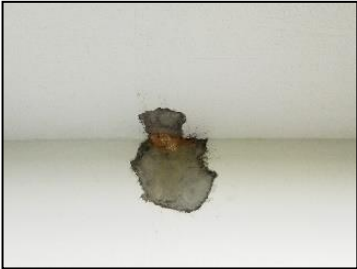
*Figure 3.19: close view*

<b>Defect Indication code</b>	A58	<b>Location</b>	Patio
<b>Element</b>	Wall	<b>Type / Item</b>	Finishes (Paint)
<b>Defect</b>	Improper plaster and paint work on wall	<b>Quantity</b>	1

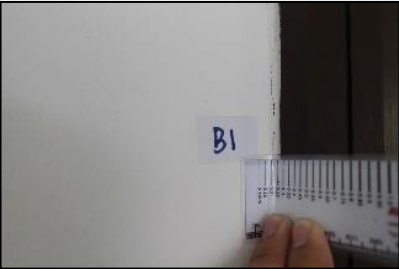
*Figure 3.120: close view*

<b>Defect Indication code</b>	B1	<b>Location</b>	Dining
<b>Element</b>	Wall	<b>Type / Item</b>	Finishes (paint)
<b>Defect</b>	Crack on the wall	<b>Quantity</b>	1

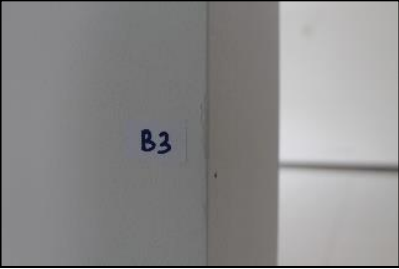
*Figure 3.21: close view*

<b>Defect Indication code</b>	B3	<b>Location</b>	Dining
<b>Element</b>	Wall	<b>Type / Item</b>	Finishes (paint)
<b>Defect</b>	Chipping on the wall	<b>Quantity</b>	1

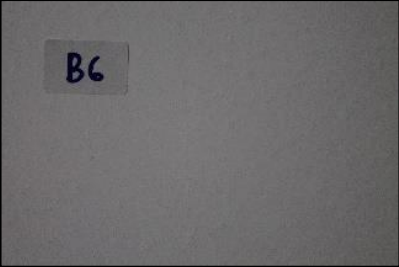
*Figure 3.22: close view*

<b>Defect Indication code</b>	B6	<b>Location</b>	Dining
<b>Element</b>	Wall	<b>Type / Item</b>	Finishes (paint)
<b>Defect</b>	Paint problems on wall	<b>Quantity</b>	1

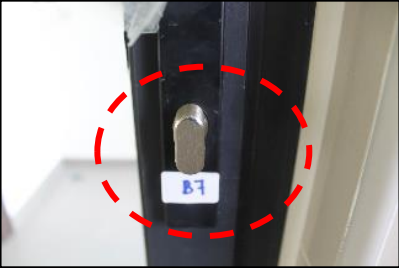
*Figure 3.23: close view*

<b>Defect Indication code</b>	B7	<b>Location</b>	Kitchen
<b>Element</b>	Door	<b>Type / Item</b>	Lock set
<b>Defect</b>	Scratch mark on lock set	<b>Quantity</b>	1

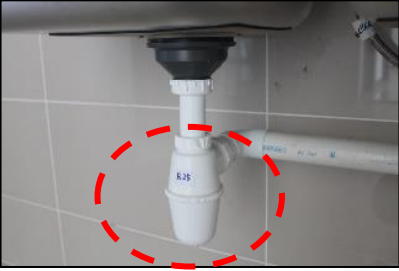
*Figure 3.24: close view*

<b>Defect Indication code</b>	B25	<b>Location</b>	Kitchen
<b>Element</b>	Sanitary and plumbing	<b>Type / Item</b>	Bottle trap
<b>Defect</b>	Leaking bottle trap	<b>Quantity</b>	1

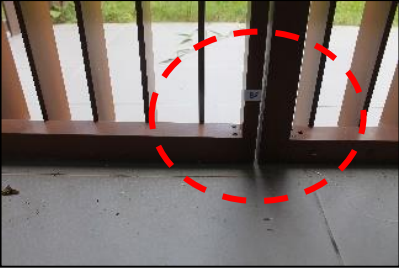
*Figure 3.25: close view*

<b>Defect Indication code</b>	B8	<b>Location</b>	Yard
<b>Element</b>	Door	<b>Type / Item</b>	Grille
<b>Defect</b>	The grille tilt	<b>Quantity</b>	1

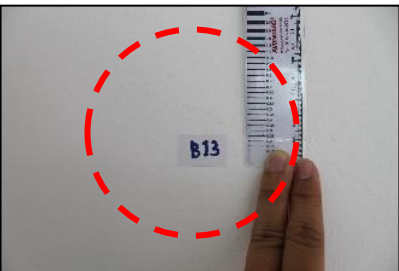
*Figure 3.26: close view*

<b>Defect Indication code</b>	B13	<b>Location</b>	Guest room
<b>Element</b>	Wall	<b>Type / Item</b>	Finishes (Paint)
<b>Defect</b>	Crack and paint problem on wall	<b>Quantity</b>	1

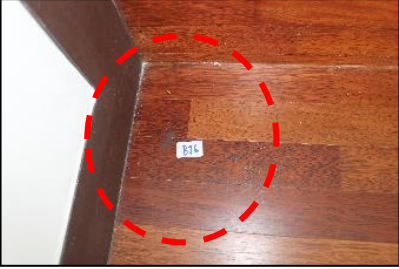
<p><i>Figure 3.27: close view</i></p>

<b>Defect Indication code</b>	B16	<b>Location</b>	Staircase
<b>Element</b>	Staircase	<b>Type / Item</b>	Finishes (Timber Strip)
<b>Defect</b>	Dirt stain on staircase	<b>Quantity</b>	1

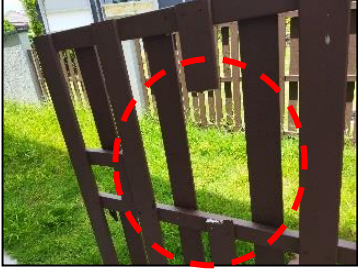
<p><i>Figure 3.28: close view</i></p>

<b>Defect Indication code</b>	A19	<b>Location</b>	Right Elevation
<b>Element</b>	Gate	<b>Type / Item</b>	Timber Strip
<b>Defect</b>	Broken timber strip	<b>Quantity</b>	1

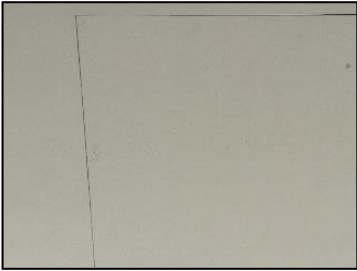
*Figure 3.33: close view*

<b>Defect Indication code</b>	C78	<b>Location</b>	Family Area
<b>Element</b>	Ceiling	<b>Type / Item</b>	Finishes (Paint)
<b>Defect</b>	Dirt stain on ceiling	<b>Quantity</b>	1

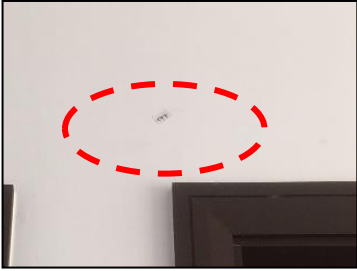
*Figure 3.34: close view*

<b>Defect Indication code</b>	C99	<b>Location</b>	Family Area
<b>Element</b>	Wall	<b>Type / Item</b>	Finishes (Paint)
<b>Defect</b>	Crack on wall	<b>Quantity</b>	1

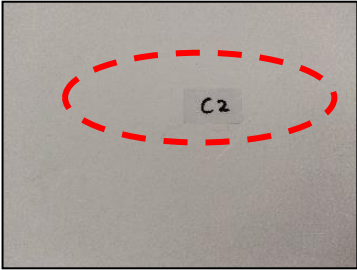
*Figure 3.35: close view*

<b>Defect Indication code</b>	C2	<b>Location</b>	Bedroom 2
<b>Element</b>	Wall	<b>Type / Item</b>	Finishes (Paint)
<b>Defect</b>	Uneven paint on wall	<b>Quantity</b>	1

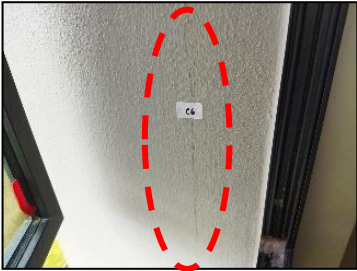
*Figure 3.36: close view*

<b>Defect Indication code</b>	C6	<b>Location</b>	Bedroom 2
<b>Element</b>	Wall	<b>Type / Item</b>	Finishes (Paint)
<b>Defect</b>	Crack on wall	<b>Quantity</b>	1

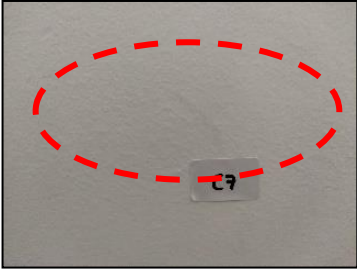
*Figure 3.37: close view*

<b>Defect Indication code</b>	C7	<b>Location</b>	Bedroom 2
<b>Element</b>	Wall	<b>Type / Item</b>	Finishes (Paint)
<b>Defect</b>	Dirt stain on wall	<b>Quantity</b>	1

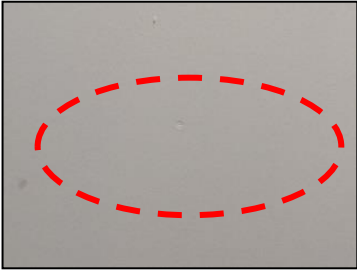
*Figure 3.38: close view*

<b>Defect Indication code</b>	C13	<b>Location</b>	Bath 2
<b>Element</b>	Ceiling	<b>Type / Item</b>	Finishes (Paint)
<b>Defect</b>	Chipping on ceiling	<b>Quantity</b>	1

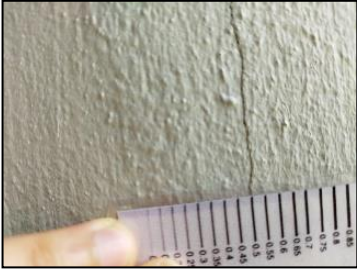
<p><i>Figure 3.40: close view</i></p>

<b>Defect Indication code</b>	C20	<b>Location</b>	Bedroom 1
<b>Element</b>	Wall	<b>Type / Item</b>	Finishes (Paint)
<b>Defect</b>	Crack on wall	<b>Quantity</b>	1

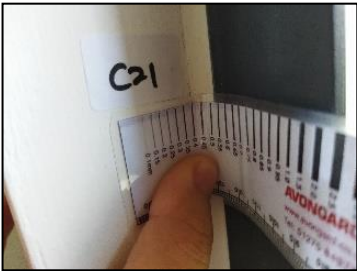
<p><i>Figure 3.41: close view</i></p>

<b>Defect Indication code</b>	C21	<b>Location</b>	Bedroom 1
<b>Element</b>	Wall	<b>Type / Item</b>	Finishes (Paint)
<b>Defect</b>	Open gap on wall between window frame	<b>Quantity</b>	1

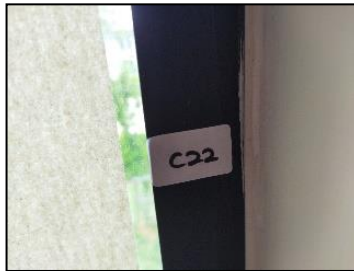
*Figure 3.42: close view*

<b>Defect Indication code</b>	C22	<b>Location</b>	Bedroom 1
<b>Element</b>	Window	<b>Type / Item</b>	Window frame
<b>Defect</b>	Dirt stain on window frame	<b>Quantity</b>	1

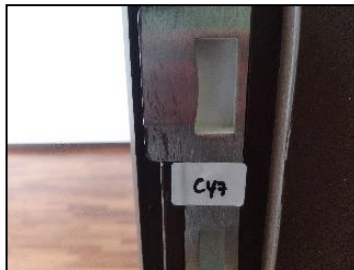
*Figure 3.43: close view*

<b>Defect Indication code</b>	C47	<b>Location</b>	Master Bedroom
<b>Element</b>	Door	<b>Type / Item</b>	Strike plate
<b>Defect</b>	Scratch mark on strike plate	<b>Quantity</b>	1

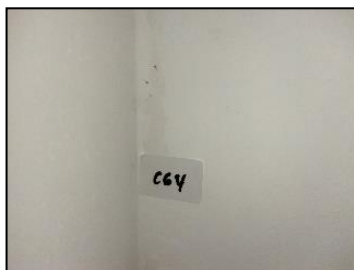
*Figure 3.44: close view*

<b>Defect Indication code</b>	C64	<b>Location</b>	WID
<b>Element</b>	Wall	<b>Type / Item</b>	Finishes (paint)
<b>Defect</b>	Uneven paint on wall	<b>Quantity</b>	1
