6th UNDERGRADUATE SEMINAR ON BUILT ENVIRONMENT AND TECHNOLOGY (USBET) 2023 SUSTAINABLE BUILT

# IMPLICATIONS OF DEFECTS IN BUILDING CONDITION OF HERITAGE MOSQUES IN PERAK

Ahmad Hafidzullah Zulkifli<sup>1</sup>, Nurhidayah Samsul Rijal<sup>1\*</sup>

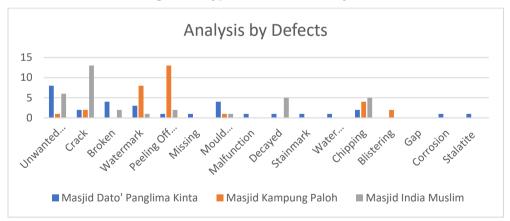
Figure 4: Types of Defects Analysis

As shown in the bar chart above, cracks are the most common type of defect found in the three mosques involved, which are as many as 18 defects related to cracks. The highest number of cracks are found in the India Muslim Mosque which totals to 14. For Dato' Panglima Kinta Mosque, there is at least one defect found related to missing, malfunction, stain mark, water penetration, corrosion and also stalactite found in the mosque. The second highest number of defects is from the peeling off of paint defect, which totals to 17 defects found for the three mosques, with the highest number found in Kampung Paloh Mosque.

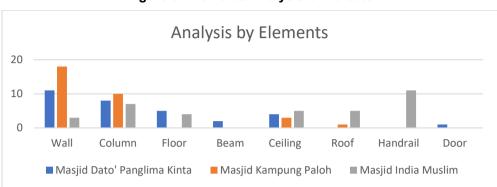
Figure 5: Elements Analysis of Defects

The elements associated with each defect found in each of the selected mosques were analysed and shown through the bar chart above. For the three mosques examined, a total of 34 walls were discovered to be defective. Kampung Paloh Mosque had the most defects, with 18 walls found to be defective. The door is the component with the fewest defects, with one defective door found in Dato' Panglima Kinta Mosque. As many as 25 defects were found in the column element, which is the second-highest type of defective element after walls. Each of the three mosques have between seven and 10 defects related to their columns.

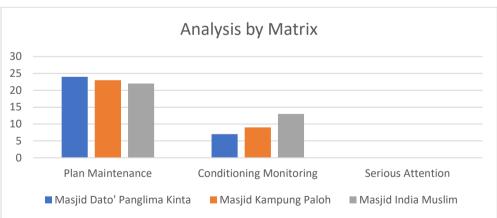
#### Figure 6: Matrix Analysis of Defects

As seen in the bar graph above, the three mosques which are Dato' Panglima Kinta Mosque, Kampung Paloh Mosque, and India Muslim Mosque have nearly identical readings. The highest number of defects is from matrix plan maintenance, ranging between 22 and 24, while none of the three mosques had defects with the lowest matrix requiring serious attention. The India Muslim Mosque has the most matrix for

condition monitoring, with a total of 13, and the Dato' Panglima Kinta Mosque has the fewest defects with a total of seven, according to matrix condition monitoring. Kampung Paloh Mosque has a total of nine defects as determined by matrix condition monitoring.
