**A CASE STUDY OF BUILDING DEFECTS AT BANK NEGARA
MALAYSIA (LOWER GROUND 1)**

NUR SYAMIRA BINTI ZAMRI

DEPARTMENT OF BUILDING
FACULTY OF ARCHITECTURE, PLANNING AND SURVEYING
UNIVERSITI TEKNOLOGI MARA

DECEMBER 2018

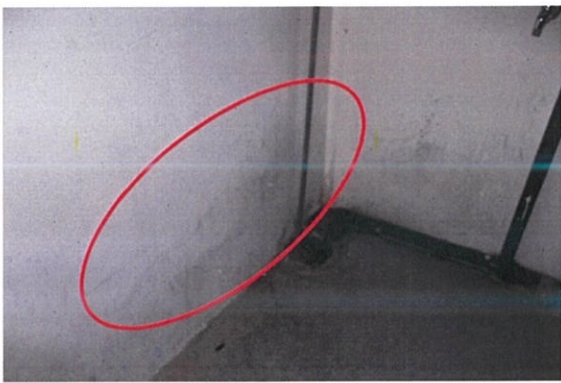
Table 3.1: Peeling paint on the wall

<p>Figure 3.1 Peeling paint at LG1 Source: SGS (M) Sdn Bhd</p>	Defect No:	CSA-0529			
	Element:	Wall plaster			
	Location:	LG1-West-AHU-Near Female Surau			
	Description of Defect:	Sign of peel off paint on the wall.			
	Category:	A	B	C	D
				✓

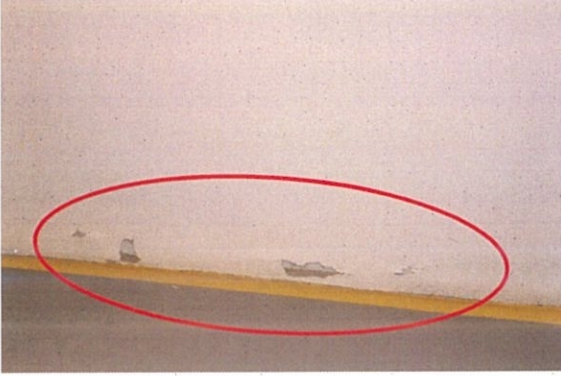
Table 3.2: Peeling paint on the wall

<p>Figure 3.2 Peeling paint at LG1 Source: SGS (M) Sdn Bhd</p>	Defect No:	CSA-0617			
	Element:	Wall plaster			
	Location:	LG1-East-Exhaust Air Shaft			
	Description of Defect:	Sign of peel off paint on the wall.			
	Category:	A	B	C	D
				✓

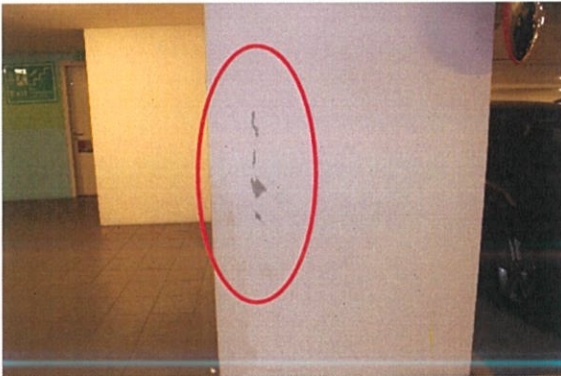
Table 3.3: Peeling paint on the wall

<p>Figure 3.3 Peeling paint at LG1 Source: SGS (M) Sdn Bhd</p>	Defect No:	CSA-0640			
	Element:	Wall plaster			
	Location:	LG1-East-Near Gelung Hos			
	Description of Defect:	Sign of peel off paint on the wall.			
	Category:	A	B	C	D
				✓

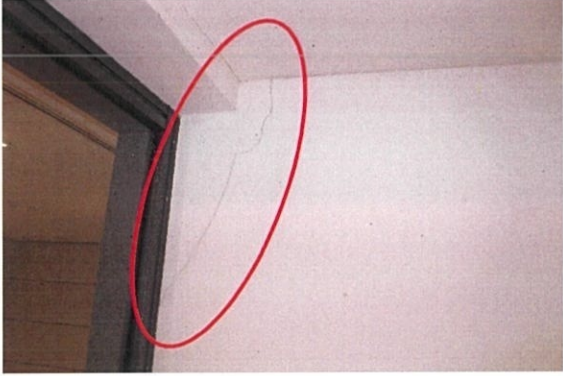
Table 3.4: Diagonal crack on the wall

<p>Figure 3.4: Diagonal crack at LG1 Source: SGS (M) Sdn Bhd</p>	Defect No:	CSA-0510			
	Element:	Wall plaster			
	Location:	LG1-Lift Lobby			
	Description of Defect:	Diagonal crack on the wall.			
	Category:	A	B	C	D
				✓

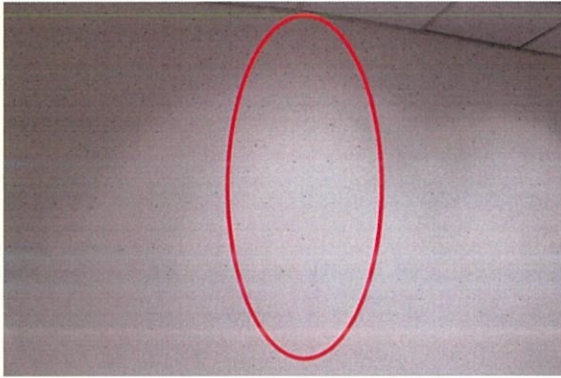
Table 3.5: Vertical crack on the wall

<p>Figure 3.5: Vertical crack at LG1 Source: SGS (M) Sdn Bhd</p>	Defect No:	CSA-0519			
	Element:	Wall plaster			
	Location:	LG1-West-Corridor			
	Description of Defect:	Vertical crack on the wall.			
	Category:	A	B	C	D
				✓

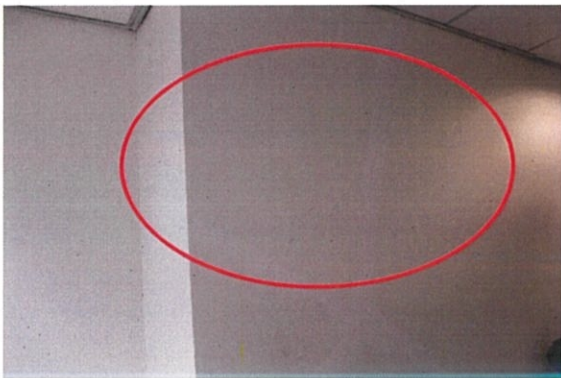
Table 3.6: Random crack on the wall

<p>Figure 3.6: Random crack at LG1 Source: SGS (M) Sdn Bhd</p>	Defect No:	CSA-0521			
	Element:	Wall plaster			
	Location:	LG1-West-Corridor			
	Description of Defect:	Random crack on the wall.			
	Category:	A	B	C	D
				✓

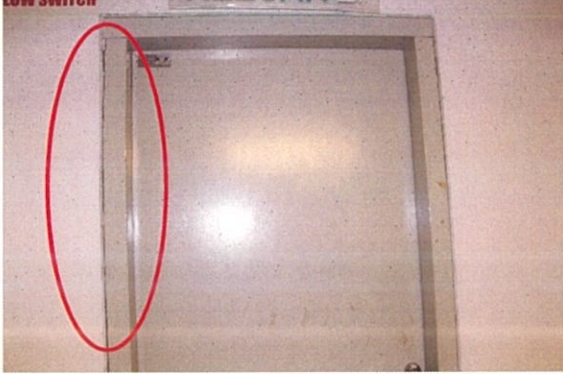
Table 3.7: Gap Jointing on door frame

<p>Figure 3.7: Gap jointing at LG1 Source: SGS (M) Sdn Bhd</p>	Defect No:	CSA-0545			
	Element:	Door frame			
	Location:	LG1- West- Staircase 7			
	Description of Defect:	Sign of gap jointing between door frame and wall.			
Category:	A	B	C	D	
					✓

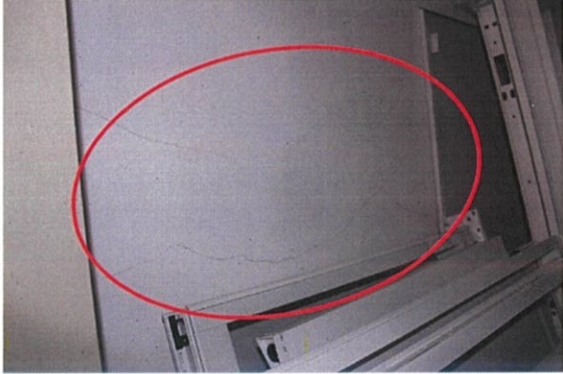
Table 3.8: Horizontal crack on the wall

<p>Figure 3.8: Horizontal crack at LG1 Source: SGS (M) Sdn Bhd</p>	Defect No:	CSA-0556			
	Element:	Wall plaster			
	Location:	LG1- West- CL16- Lot 17			
	Description of Defect:	Horizontal crack on the wall.			
Category:	A	B	C	D	
					✓

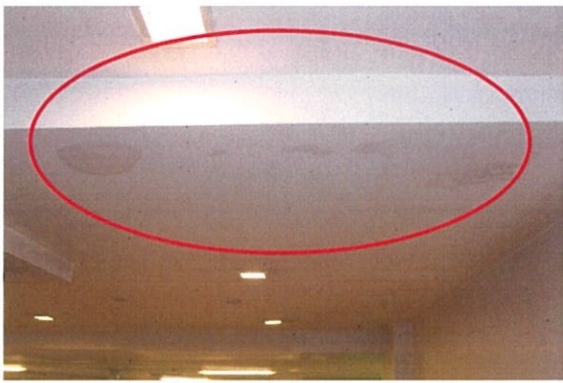
Table 3.9: Water mark on the ceiling

<p>Figure 3.9: Water mark at LG1 Source: SGS (M) Sdn Bhd</p>	Defect No:	CSA-0511			
	Element:	Ceiling			
	Location:	LG1- Lift Lobby			
	Description of Defect:	Sign of water mark. Suspected due to leakage from above ceiling/ pipe leaks.			
Category:	A	B	C	D	
			√

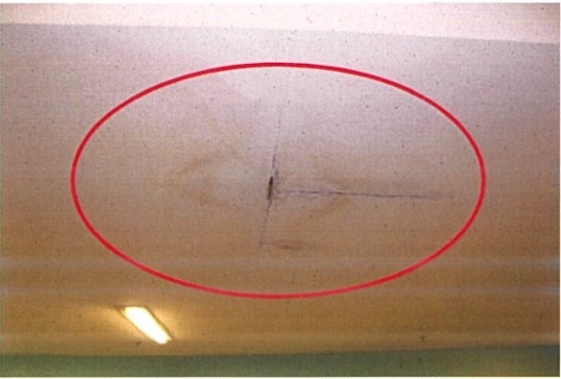
Table 3.10: Water mark on the ceiling

<p>Figure 3.10: Water mark at LG1 Source: SGS (M) Sdn Bhd</p>	Defect No:	CSA-0512			
	Element:	Ceiling			
	Location:	LG1- West- CL26- Lot 62			
	Description of Defect:	Sign of water mark. Suspected due to leakage from above ceiling/ pipe leaks.			
Category:	A	B	C	D	
			√

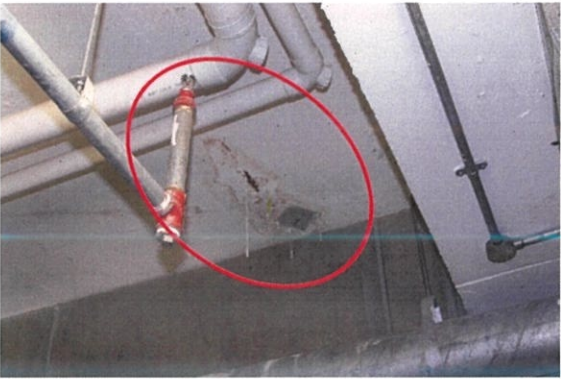
Table 3.11: Dampness and stalactite on the ceiling

<p>Figure 3.11: Dampness and stalactite at LG1 Source: SGS (M) Sdn Bhd</p>	Defect No:	CSA-0538			
	Element:	Ceiling			
	Location:	LG1-West- AHU Room (foyer)			
	Description of Defect:	Sign of dampness and stalactite.			
Category:	A	B	C	D	
			√

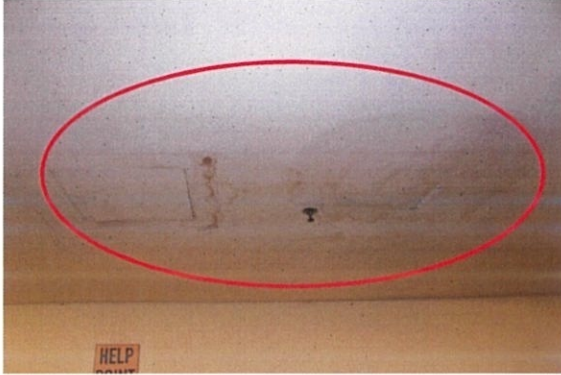
Table 3.12: Water mark on the ceiling

<p>Figure 3.12: Water mark at LG1 Source: SGS (M) Sdn Bhd</p>	Defect No:	CSA-0543			
	Element:	Ceiling			
	Location:	LG1- West- CL24- Lot 35			
	Description of Defect:	Sign of water mark. Suspected due to leakage from above ceiling/ pipe leaks.			
	Category:	A	B	C	D
			√

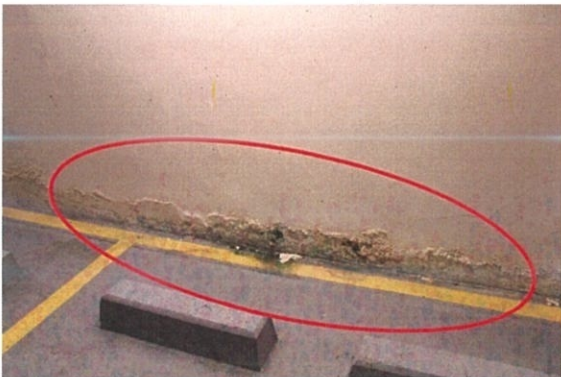
Table 3.13: Dampness on the wall

<p>Figure 3.13: Dampness at LG1 Source: SGS (M) Sdn Bhd</p>	Defect No:	CSA-0551			
	Element:	Wall plaster			
	Location:	LG1- West- Water Tank and Pump Room			
	Description of Defect:	Sign of dampness on the wall.			
	Category:	A	B	C	D
			√

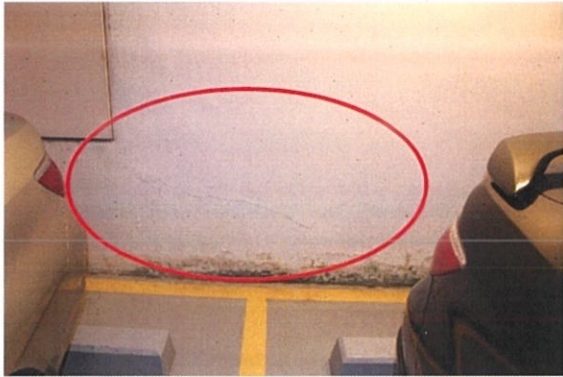
Table 3.14: Random crack on the wall

<p>Figure 3.14: Random crack at LG1 Source: SGS (M) Sdn Bhd</p>	Defect No:	CSA-0553
	Element:	Wall plaster
	Location:	LG1- West- CL15- Lot 14
	Description of Defect:	Random crack on the wall.
	Recommendation:	Repair the affected areas with cement based grout. For application of cementitious grout generally some form of routing and surface preparation, such as removal of loose debris are needed. Repair the affected surface with suitable coating.

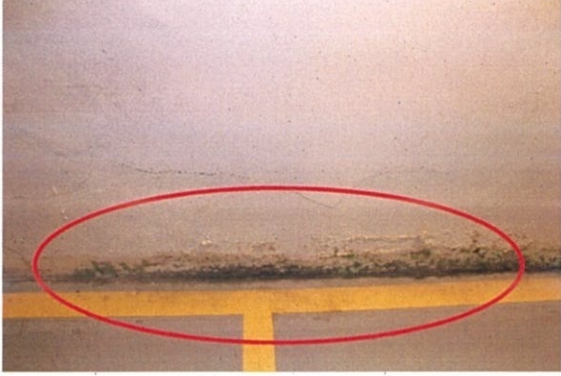
Table 3.15: Dampness on the wall

<p>Figure 3.15: Dampness at LG1 Source: SGS (M) Sdn Bhd</p>	Defect No:	CSA-0554
	Element:	Wall plaster
	Location:	LG1- West- CL15- Lot 14
	Description of Defect:	Sign of dampness on the wall.
	Recommendation:	Perform detail investigation and rectify the dampness problems before repair and refurbish affected area. Scrap and clean defective area. Refurbish the affected areas with cement based paint or textured wall coating. Repaint the affected area by using appropriate paint system.

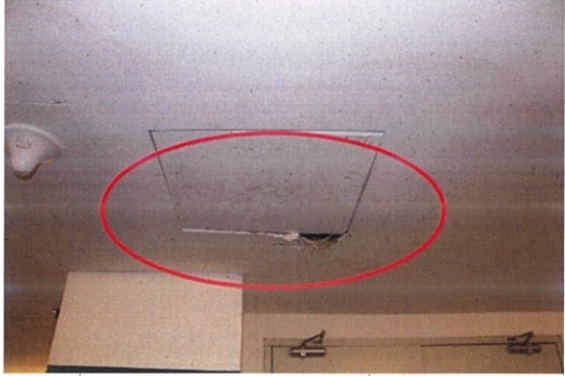
Table 3.16: Damage of ceiling

<p>Figure 3.16: Damage of ceiling at LG1 Source: SGS (M) Sdn Bhd</p>	Defect No:	CSA-0555
	Element:	Ceiling
	Location:	LG1- West- CL16- Lot 17
	Description of Defect:	Damage of ceiling.
	Recommendation:	Rectify and install with the new ceiling at the affected area.

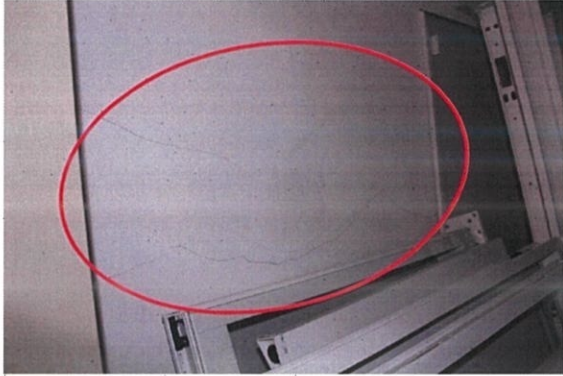
Table 3.17: Horizontal crack on the wall

<p>Figure 3.17: Horizontal crack at LG1 Source: SGS (M) Sdn Bhd</p>	Defect No:	CSA-0556
	Element:	Wall plaster
	Location:	LG1- West- CL16- Lot 17
	Description of Defect:	Horizontal crack on the wall.
	Recommendation:	Repair the affected areas with cement based grout. For application of cementitious grout generally some form of routing and surface preparation, such as removal of loose debris are needed. Repair the affected surface with suitable coating.

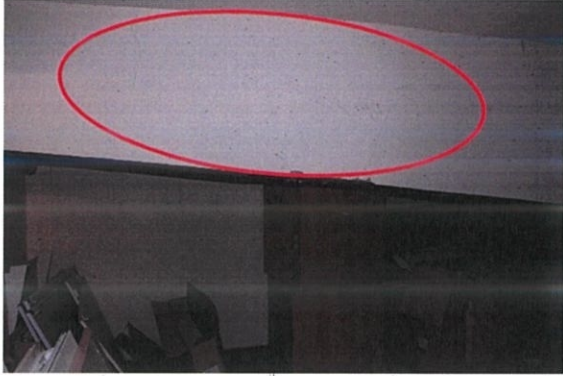
Table 3.18: Random crack on the wall

<p>Figure 3.18: Random crack at LG1 Source: SGS (M) Sdn Bhd</p>	Defect No:	CSA-0557
	Element:	Wall plaster
	Location:	LG1- West- CL16
	Description of Defect:	Random crack on the wall.
	Recommendation:	Repair the affected areas with cement based grout. For application of cementitious grout generally some form of routing and surface preparation, such as removal of loose debris are needed. Repair the affected surface with suitable coating.

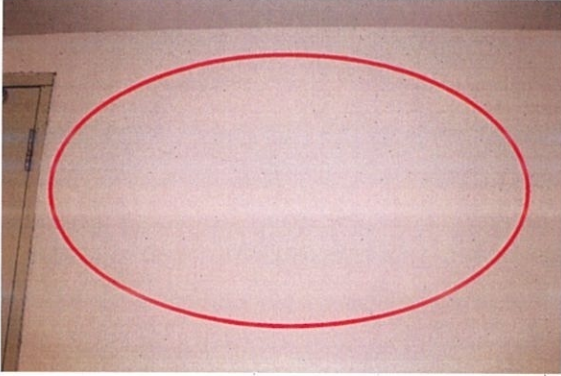
Table 3.19: Random crack on the wall

<p>Figure 3.19: Random crack at LG1 Source: SGS (M) Sdn Bhd</p>	Defect No:	CSA-0558
	Element:	Wall plaster
	Location:	LG1- West- CL16
	Description of Defect:	Random crack on the wall.
	Recommendation:	Repair the affected areas with cement based grout. For application of cementitious grout generally some form of routing and surface preparation, such as removal of loose debris are needed. Repair the affected surface with suitable coating.

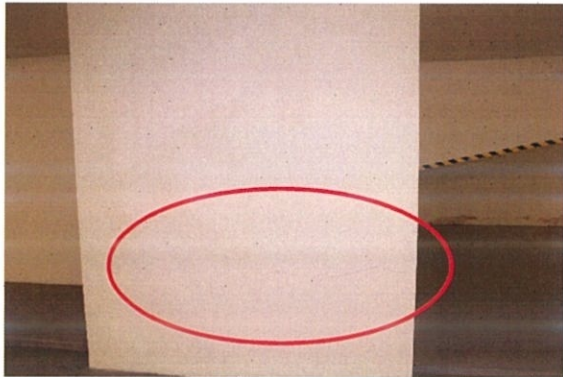
Table 3.20: Horizontal crack on the wall

<p>Figure 3.20: Horizontal crack at LG1 Source: SGS (M) Sdn Bhd</p>	Defect No:	CSA-0559
	Element:	Wall plaster
	Location:	LG1- West- CL 16
	Description of Defect:	Horizontal crack on the wall.
	Recommendation:	Repair the affected areas with cement based grout. For application of cementitious grout generally some form of routing and surface preparation, such as removal of loose debris are needed. Repair the affected surface with suitable coating.

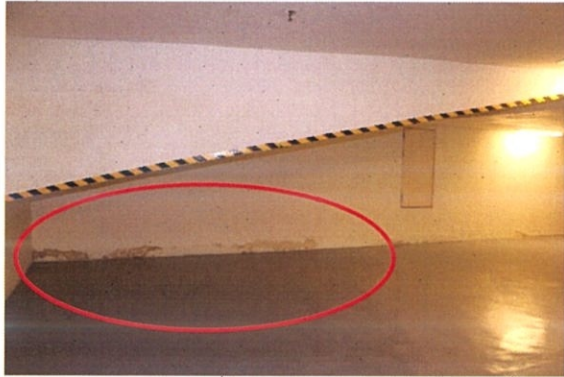
Table 3.21: Dampness on the wall

<p>Figure 3.21: Dampness on wall at LG1 Source: SGS (M) Sdn Bhd</p>	Defect No:	CSA-0560
	Element:	Wall plaster
	Location:	LG1- West- CL16
	Description of Defect:	Sign of dampness on the wall.
	Recommendation:	Perform detail investigation and rectify the dampness problems before repair and refurbish affected area. Scrap and clean defective area. Refurbish the affected areas with cement based paint or textured wall coating. Repaint the affected area by using appropriate paint system.

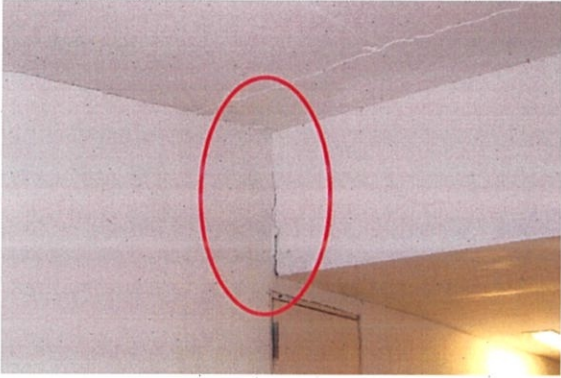
3.22: Sign of gap jointing on the wall

<p>Figure 3.22: Sign of gap jointing at LG1 Source: SGS (M) Sdn Bhd</p>	Defect No:	CSA-0561
	Element:	Wall plaster
	Location:	LG1- West- CL16
	Description of Defect:	Sign of gap jointing between wall and beam.
	Recommendation:	Repair and close the joint or gap with crack filler, joint sealant or similar product.

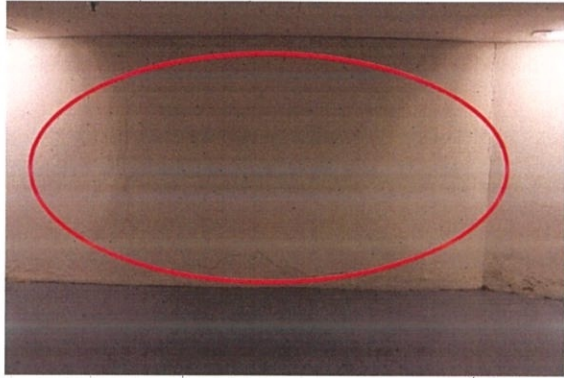
Table 3.23: Random crack on the wall

<p>Figure 3.23: Random crack at LG1 Source: SGS (M) Sdn Bhd</p>	Defect No:	CSA-0562
	Element:	Wall plaster
	Location:	LG1- West- CL16
	Description of Defect:	Random crack on the wall.
	Recommendation:	Repair the affected areas with cement based grout. For application of cementitious grout generally some form of routing and surface preparation, such as removal of loose debris are needed. Repair the affected surface with suitable coating.

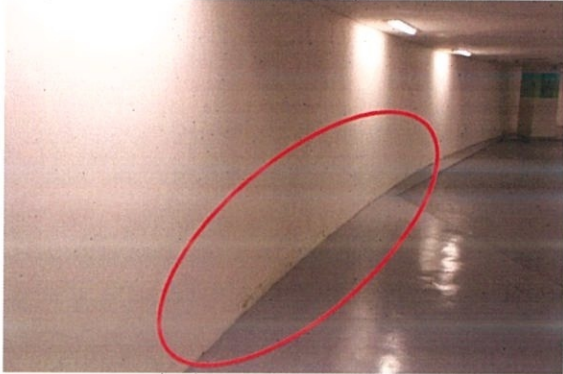
Table 3.24: Dampness on the wall

<p>Figure 3.24: Dampness on wall at LG1 Source: SGS (M) Sdn Bhd</p>	Defect No:	CSA-0563
	Element:	Wall plaster
	Location:	LG1- West- CL16
	Description of Defect:	Sign of dampness on the wall.
	Recommendation:	Perform detail investigation and rectify the dampness problems before repair and refurbish affected area. Scrap and clean defective area. Refurbish the affected areas with cement based paint or textured wall coating. Repaint the affected area by using appropriate paint system.

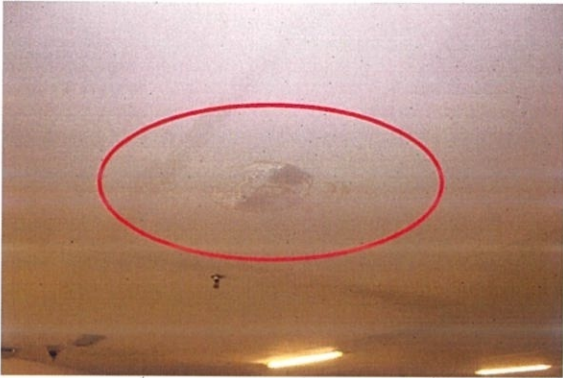
Table 3.25: Water mark on the wall

<p>Figure 3.25: Water mark at LG1 Source: SGS (M) Sdn Bhd</p>	Defect No:	CSA-0564
	Element:	Ceiling plaster
	Location:	LG1- West- Lot 18
	Description of Defect:	Sign of water mark. Suspected due to leakage from above ceiling/ pipe leaks.
	Recommendation:	Perform detail investigation and rectify the leakages problems before repair and refurbish affected area. Rectify and install with the new ceiling at the affected area.

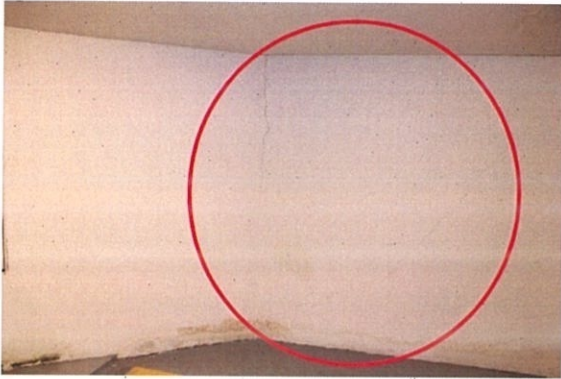
Table 3.26: Random crack on the wall

<p>Figure 3.26: Random crack at LG1 Source: SGS (M) Sdn Bhd</p>	Defect No:	CSA-0565
	Element:	Wall plaster
	Location:	LG1- West- Lot 18
	Description of Defect:	Random crack on the wall.
	Recommendation:	Repair the affected areas with cement based grout. For application of cementitious grout generally some form of routing and surface preparation, such as removal of loose debris are needed. Repair the affected surface with suitable coating.

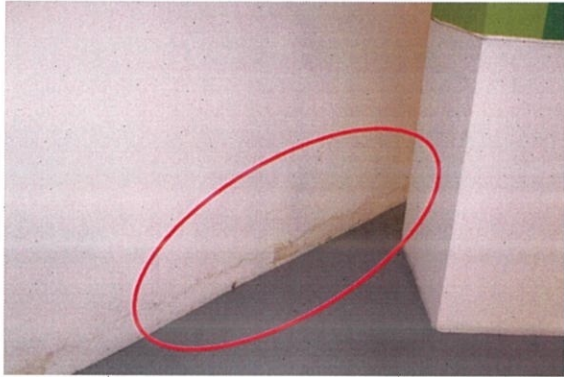
Table 3.27: Dampness on the wall

<p>Figure 3.27: Dampness on the wall at LG1 Source: SGS (M) Sdn Bhd</p>	Defect No:	CSA-0566
	Element:	Wall plaster
	Location:	LG1- West- Lot 18
	Description of Defect:	Sign of dampness on the wall.
	Recommendation:	Perform detail investigation and rectify the dampness problems before repair and refurbish affected area. Scrap and clean defective area. Refurbish the affected areas with cement based paint or textured wall coating. Repaint the affected area by using appropriate paint system.

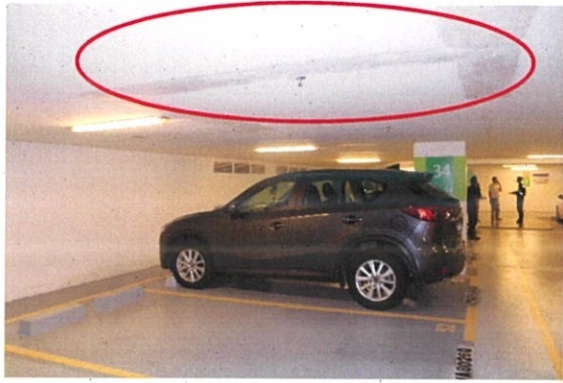
Table 3.28: Unevenness of paint on the ceiling

<p>Figure 3.28: Unevenness of paint at LG1 Source: SGS (M) Sdn Bhd</p>	Defect No:	CSA-0567
	Element:	Ceiling plaster
	Location:	LG1- West- Lot 18
	Description of Defect:	Unevenness of paint on the ceiling.
	Recommendation:	Refurbish the affected area with cement based paint or textured wall coating. Repaint the affected area by using appropriate paint system.

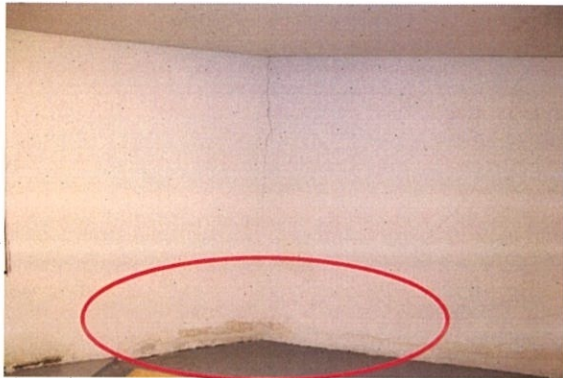
Table3.29: Dampness on the wall

<p>Figure 3.29: Dampness on the wall at LG1 Source: SGS (M) Sdn Bhd</p>	Defect No:	CSA-0568
	Element:	Wall plaster
	Location:	LG1- West- CL17- Lot 52
	Description of Defect:	Sign of dampness on the wall.
	Recommendation:	Perform detail investigation and rectify the dampness problems before repair and refurbish affected area. Scrap and clean defective area. Refurbish the affected areas with cement based paint or textured wall coating. Repaint the affected area by using appropriate paint system.

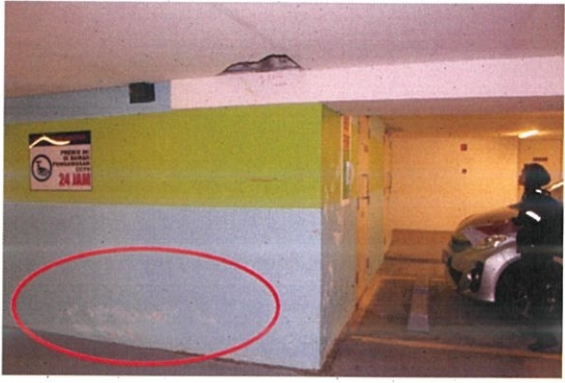
Table 3.30: Dampness on the wall

<p>Figure 3.30: Dampness on the wall at LG1</p> <p>Source: SGS (M) Sdn Bhd</p>	Defect No:	CSA-0569
	Element:	Wall plaster
	Location:	LG1- West- CL34- Lot 53
	Description of Defect:	Sign of dampness on the wall.
	Recommendation:	Perform detail investigation and rectify the dampness problems before repair and refurbish affected area. Scrap and clean defective area. Refurbish the affected areas with cement based paint or textured wall coating. Repaint the affected area by using appropriate paint system.

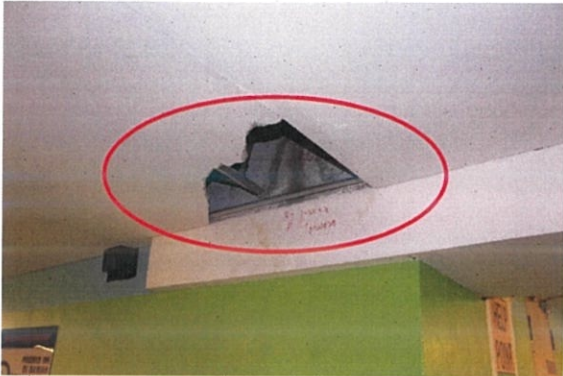
Table 3.31: Damage of ceiling

<p>Figure 3.31: Damage of ceiling at LG1 Source: SGS (M) Sdn Bhd</p>	Defect No:	CSA-0570
	Element:	Ceiling
	Location:	LG1- West- Telco and ICT Room
	Description of Defect:	Damage of ceiling.
	Recommendation:	Rectify and install with the new ceiling at the affected area.

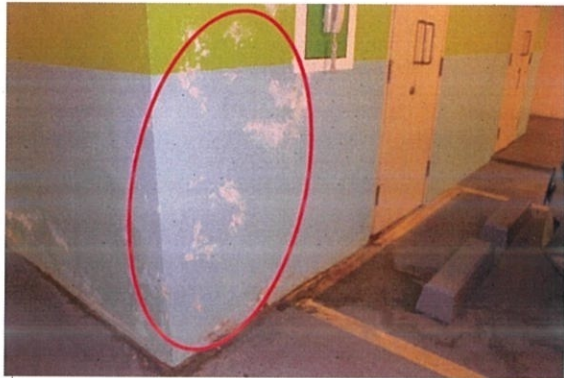
Table 3.32: Blistering of paint on the wall

<p>Figure 3.32: Blistering of paint at LG1 Source: SGS (M) Sdn Bhd</p>	Defect No:	CSA-0571
	Element:	Wall plaster
	Location:	LG1- West- Telco and ICT Room
	Description of Defect:	Sign of blistering paint on the wall.
	Recommendation:	Perform detail investigation and rectify the dampness problems before repair and refurbish affected area. Scrap and clean defective area. Refurbish the affected areas with cement based paint or textured wall coating. Repaint the affected area by using appropriate paint system.

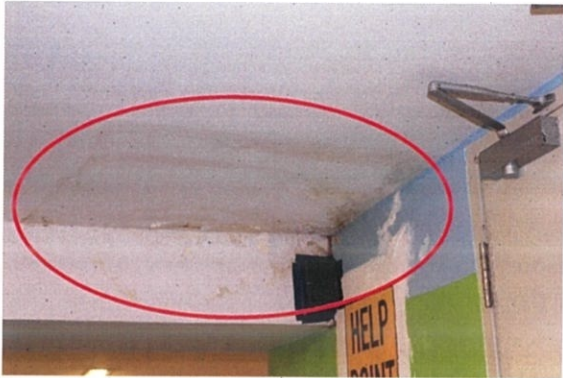
Table 3.33: Dampness on the ceiling

<p>Figure 3.33: Dampness on ceiling at LG1 Source: SGS (M) Sdn Bhd</p>	Defect No:	CSA-0572
	Element:	Concrete slab (ceiling)
	Location:	LG1- West- Telco and ICT Room
	Description of Defect:	Sign of dampness on the concrete slab (ceiling).
	Recommendation:	Perform detail investigation and rectify the dampness problems before repair and refurbish affected area. Scrap and clean the defective area. Refurbish the affected area with protective seal coat.

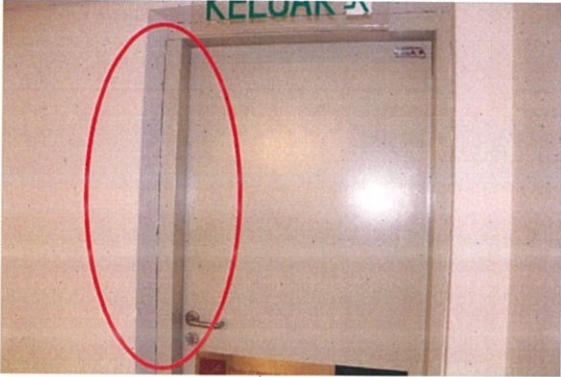
Table 3.34: Sign of gap jointing on door frame

<p>Figure 3.34: Sign of gap jointing at LG1</p> <p>Source: SGS (M) Sdn Bhd</p>	Defect No:	CSA-0573
	Element:	Door frame
	Location:	LG1- West- Staircase 8
	Description of Defect:	Sign of gap jointing between door frame and wall.
	Recommendation:	Repair and close the joint or gap with crack filler, joint sealant or similar product.

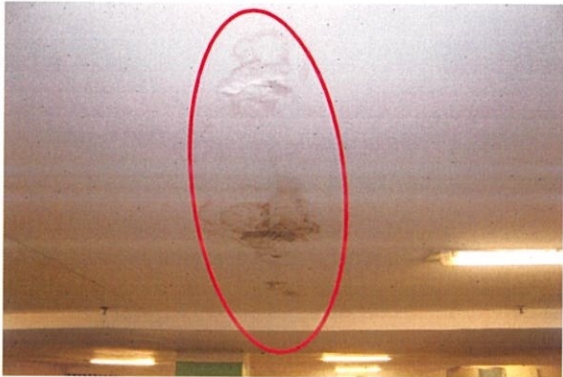
Table 3.35: Water mark on the ceiling

<p>Figure 3.35: Water mark at LG1 Source: SGS (M) Sdn Bhd</p>	Defect No:	CSA-0574
	Element:	Ceiling
	Location:	LG1- West- CL34- Lot 55
	Description of Defect:	Sign of water mark. Suspected due to leakage from above ceiling/ pipe leaks.
	Recommendation:	Perform detail investigation and rectify the leakages problems before repair and refurbish affected area. Rectify and install with the new ceiling at the affected area.

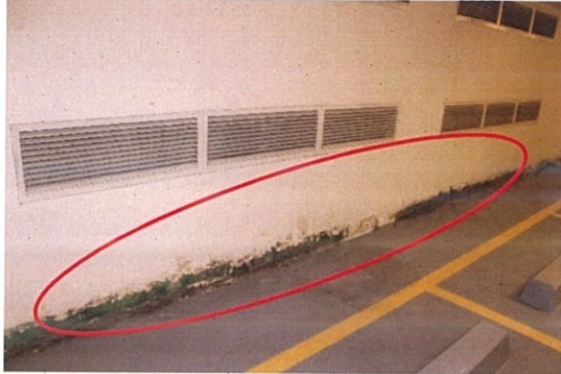
Table 3.36: Dampness on the wall

<p>Figure 3.36: Dampness on the wall at LG1 Source: SGS (M) Sdn Bhd</p>	Defect No:	CSA-0575
	Element:	Wall plaster
	Location:	LG1- West- CL34- Lot 55
	Description of Defect:	Sign of dampness on the wall.
	Recommendation:	Perform detail investigation and rectify the dampness problems before repair and refurbish affected area. Scrap and clean defective area. Refurbish the affected areas with cement based paint or textured wall coating. Repaint the affected area by using appropriate paint system.
