DEPARTMENT OF BUILDING UNIVERSITI TEKNOLOGI MARA (PERAK)

DEFECTS WORKS AT KL TRADERS SQUARE GOMBAK

Prepared by:
NOR NAJWA BINTI ABD RAHMAN
2016458592

DECEMBER 2018

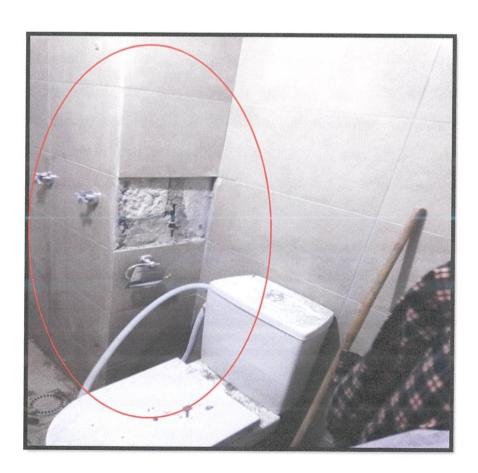
Most major pipe leaking usually this can be seen when the area of shower at bathroom get watery. This is because there is a rainwater downpipe installed in the shower area or also known as box up area. The first step is to inform the plumber about the watery area and call them for inspection. When the leaking area has been identified, the box up area need to be hacked. After the hacking work is done, usually the leak will be seen directly from the rainwater downpipe. Mostly cases of this leaking occur because of the loose of internal pipe connection. Then the plumber usually will use the proxing to seal back the loose area. For safety concerns, the plumber usually installs an additional pipe that also known as spot pipe. Spot pipe is a pipe that will be install in the box up area and the outlet will go through the floor trap outlet at shower area. The function of this pipe is to let flow any existing water in box up area through the floor trap to eliminate water ponding inside the box up again.

Photo 3. 9: Show the box up area that already been hack

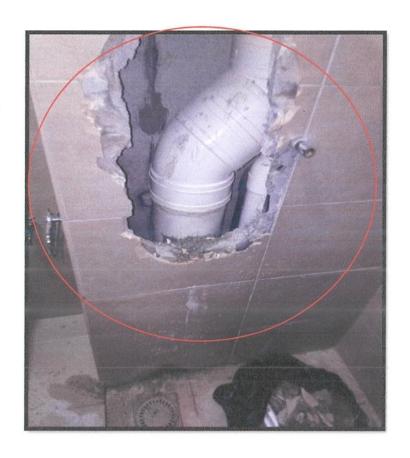
Photo 3. 10: Rainwater downpipe inside box up area

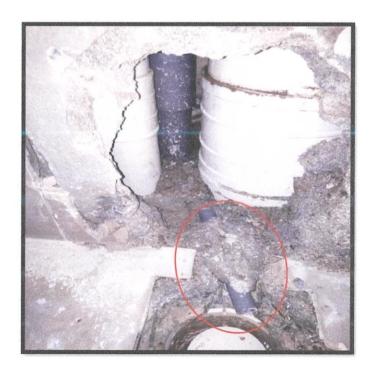
Photo 3. 11: Spot pipe

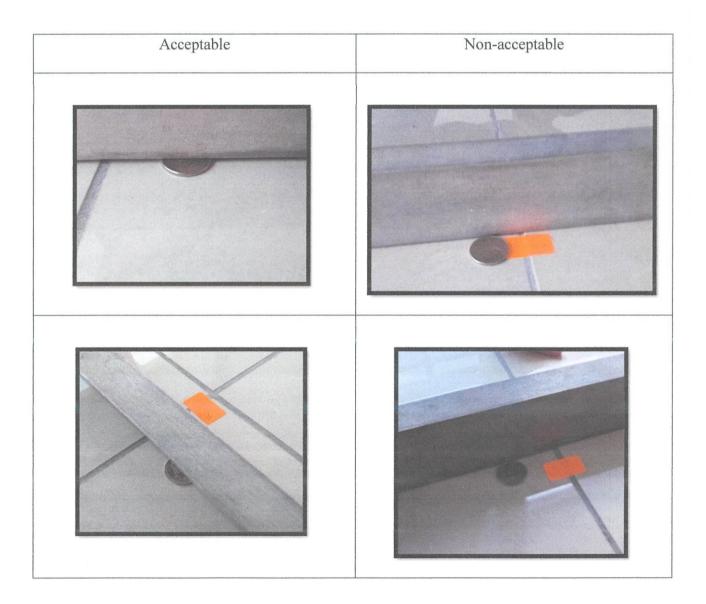
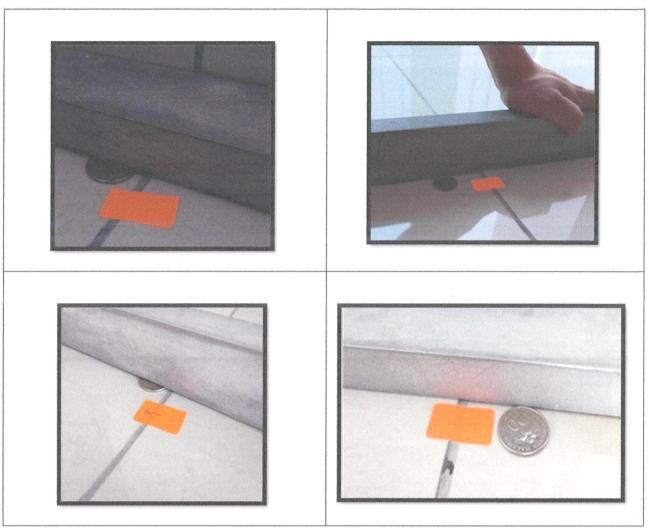
Table 3. 2: Photo of uneven tiles

Uneven tiles are the most major tiles defects for tiling works. This defects occur because of the poor workmanship and unbalance of levelling work during installation of the tiles. This defects can cause serious injury to the residence if the levelling tiles was not level based on the specific requirements.

The site supervisor first will determine which tiles is acceptable to rectify and which is unacceptable that did not require to rectify. Aluminium steel and a coin of 2mm thick is required to measure the level of the tiles. The process of identify the acceptable tiles is shown in the table below.

After the identifying of the tiles that need to rectify, the site supervisor will inform the tiling workers for the rectifying works. Usually it takes 2 or 3 days and 2 or 3 skilled workers to fully rectify the tiles works for a unit. The tiles first will be cut off carefully using grinder machine.

Then the tiles area then will fill back with cement and install back carefully using levelling instrument. Then let it dry for about one day before doing the finishing for the tiles.

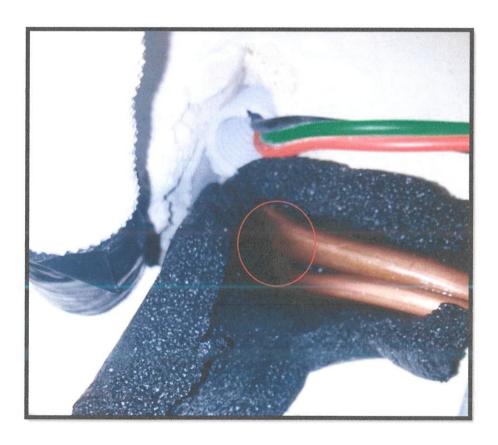
This defects consider as major defects because of the leak at copper pipe will cause the gas from the air-conditioner compressor leak through out the pipe. Site supervisor first need to check and inform the NSC invovled to inspection. Sri Cool as the company for air-conditioner will first identify whether the defects is originally from us or from the renovation workers. This step is important as it could avoid our side lossing money in rectifying works. Below images shown the owner submit the defect about his copper pipe is leaking at the bedroom 2. When the air-conditioner workers do the inspection, they identify that the leak is actually from the the owner's renovation workers as they make mistake during installion on copper pipe connection between our original pipe and their pipe. They bend the pipe so hard until the pipe got leak. So our workers will not rectify the defects as it not their initial fault.

Photo 3. 12: Bending of the copper pipe

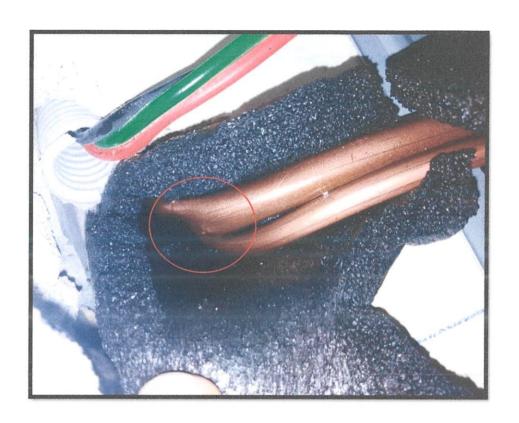
Photo 3. 13: Bending of the copper pipe
