DEPARTMENT OF BUILDING
FACULTY OF ARCHITECTURE, PLANNING AND SURVEYING
UNIVERSITI TEKNOLOGI MARA
(PERAK)
DECEMBER 2019

Defect Studies During Defect Liability Period

The project that I have been assigned to during the practical training was *Facility Management and Maintenance During Defect Liability Period For Cadangan Mereka Bentuk, Membina Dan Menyiapkan Hospital Pakar Wanita Dan Kanak-Kanak 140 Katil Di Precint 2.7, Seksyen 14, Shah Alam, Daerah Petaling, Selangor Darul Ehsan*. The cost for this project is strictly private and confidential due to several reasons. This contract has been signed for about 24 months starting from 1st March 2019 and estimated finished on 28th December 2021.

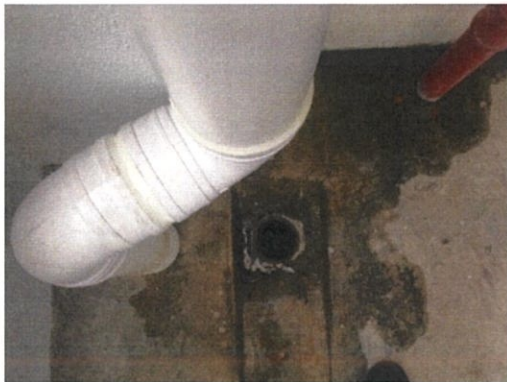
Figure 1.3: Clogged Trap

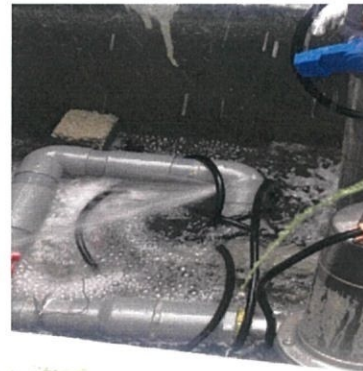
Figure 1.4: Broken Pipe

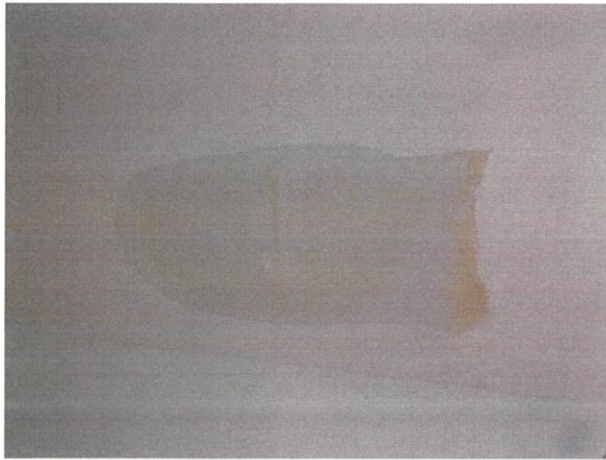
Figure 3.3: Watermark on ceiling

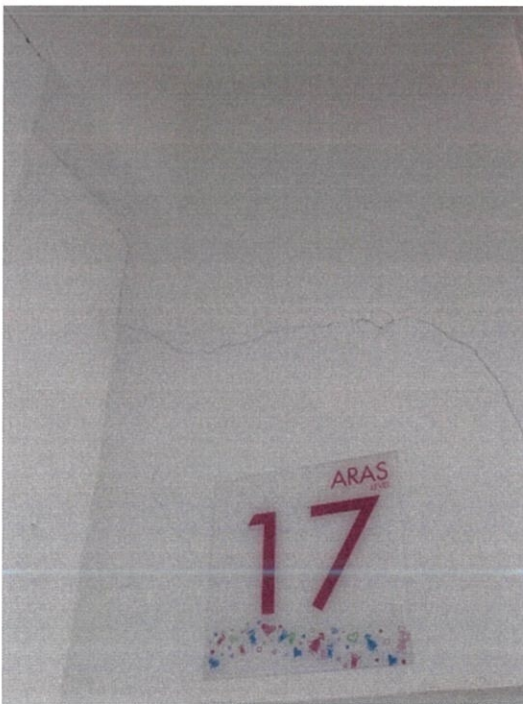
Figure 3.4: Wall crack

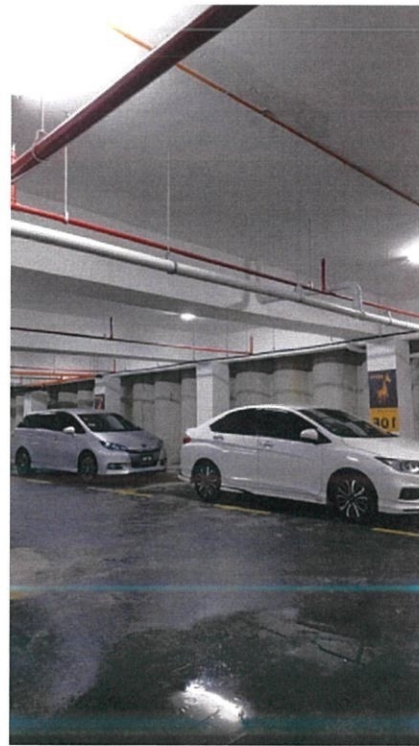
Figure 3.5: Water leaking from ceiling

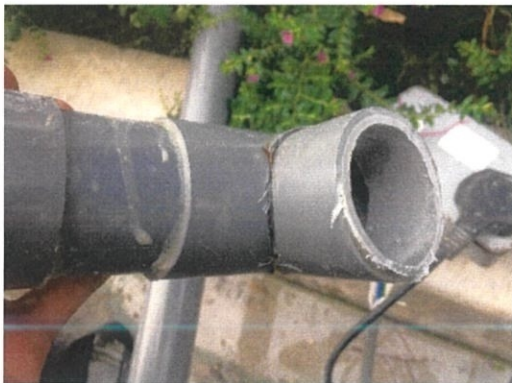
Figure 3.6: Broken Pipe

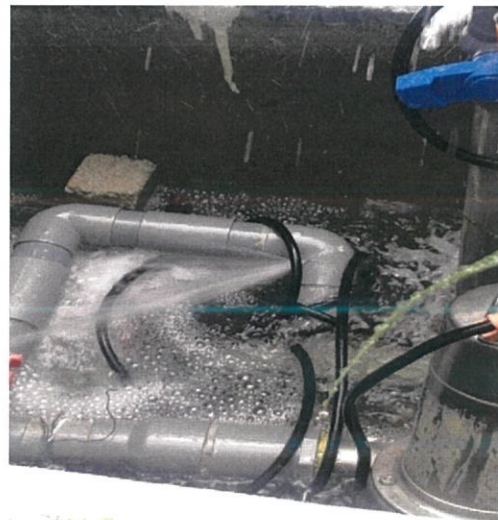
Figure 3.7: Water leaking from pipe

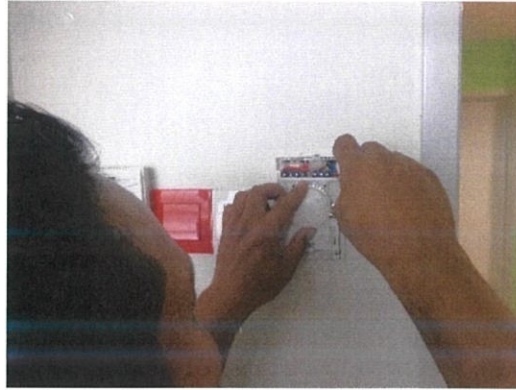
Figure 3.8: Thermostat wire trip

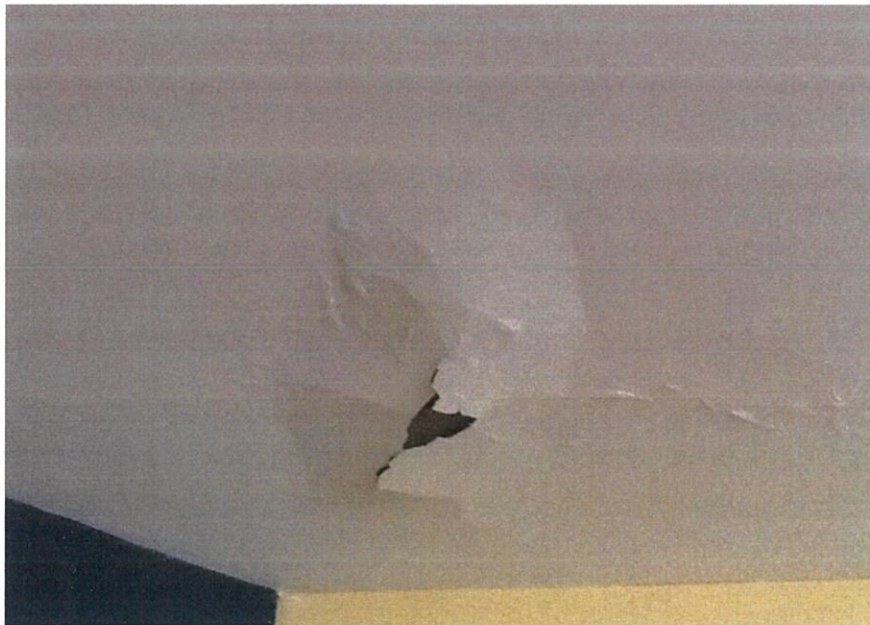
Figure 3.9: Plaster ceiling cracks

This problem is quite common in this building especially in a damp area such as toilet. Typically, plaster ceiling cracks have two causes either it is building settling and temperature or moisture fluctuations in an attic, which result in the expansion or contraction of framing members. Figure 3.9 shows the example of plaster ceiling cracks.

1. For the preparations, equipment and items that will needed are skim coat, emulsion paint, squeegee knife and paint roller. Figure 3.10 shows the emulsion paint. Skim coat is shown in Figure 3.11. Figure 3.12 shows the example of ladder and the canvas is shown in Figure 3.13

2. Firstly, prepare the surface to skim and cover the floor with canvas or plastic cloth to avoid skim coat spilled on the floor. Determine the damage to ceilings. If there is a large damage for example a big holes, repair the damage first. Figure 3.15 shows the area that was covered with canvas.

3. Clean through the ceiling. Dust first, then wash if necessary to remove any grease. Use a damp towel to wipe down the surface.
4. The essential part was preparing materials. Pre-mixed skim coat comes ready to apply to the surface. Water added to the pre-mixture skim coat for some quantity according to the size and area of cracks. Gather the tools and equipment before start skimming. Ladder or scaffolding are important for a high ceiling.

5. First skim coat applied. Thickness of coat to install has decided. Skimmer plate was held in left hand and squeegee knife in right hand. It may have to adjust the technique to get desired thickness and texture. It can always add more compound to the surface, but once it dry, it is messy and time-consuming to remove. The ceiling was painted right after the skim coat dried with white emulsion paint. Figure 3.15 shows the worker repaint the ceiling. Figure 3.16 shows the worker install the first skim coat layer.

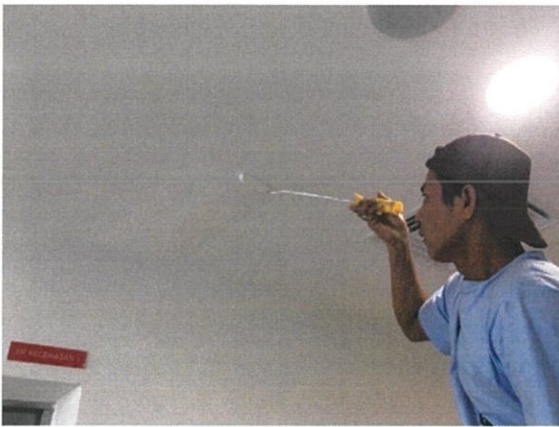
Figure 3.15: Worker repaint ceiling after skim coat dry

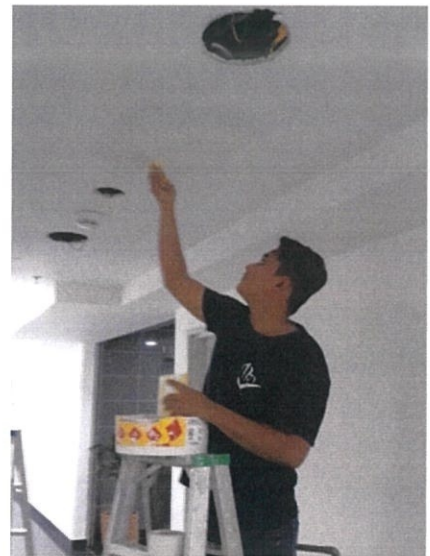
Figure 3.16: Worker install first skim coat layer

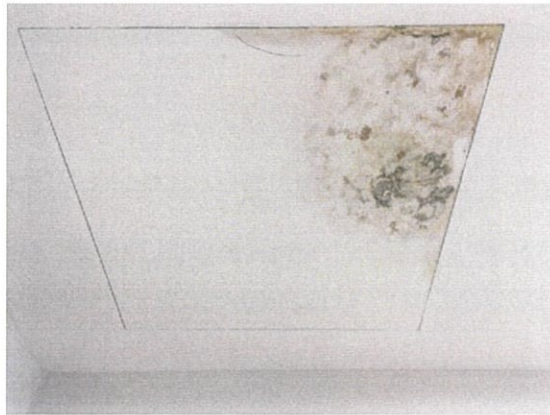
Figure 3.17: Fungus on ceiling plaster

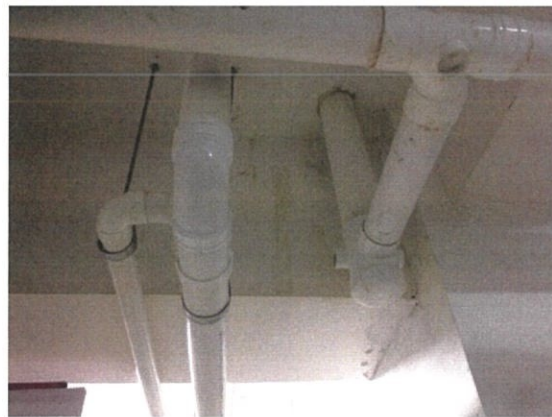
1. **High water pressure** - High water pressure leads to damaging wear and tear on pipes. Water zipping through the pipes at high speeds increases the risk of pipes bursting. The sudden changes to the direction of water flow can be too much for pipes to bear, eventually resulting a leaking.
2. **Temperature changes** - Extreme changes in temperature (generally from cold weather) can cause pipes to crack and begin leaking.

Figure 3.19: Leaking Pipes

1. Firstly, the water supply was shut off. Main water supply often located at near of the fittings. The valve was turned clockwise to shut off the water so the leak stops and does not cause more damages. Figure 3.20 shows the main water supply was located.

2. Then, the faucets that connected to the pipe was turned on to drain the water out until the pipe was completely empty.
3. The leaking area on the pipe was wiped using cleaning cloth to avoid slippery while trying to work on it.
4. The equipment and tools was prepared before the work started. Equipment such as bondite epoxy putty, white tape and rubber pipe connector. Figure 3.21 shows the bondite epoxy putty. White tape is shown in Figure 3.22

5. Bondite epoxy putty was mixed by hand to combine it. Small ball of epoxy putty was ripped off from the tube and knead it together between fingers. The darker epoxy will mix with lighter exterior to activate it. Once the epoxy has a consistent light grey color that means it was completely mixed and ready to use.
6. The epoxy putty was wrapped around the leaking area. The putty was molded around the leak on the pipe so it wraps completely around it. The putty forms a layer that is about 1.3 cm thick around the leak so it holds in place. Figure 3.23 shows the worker wrapped epoxy putty around the leaked area.

7. After finishing covered the leaking area, the putty was set for 5-10 minutes before turning the water on to let it becomes hard and solid. Once the putty solidify itself, the water can turn back on. But this is the temporary fix only. Change the pipe if the damage becomes worst. Figure 3.24 shows the condition of pipe after wrap the epoxy putty.

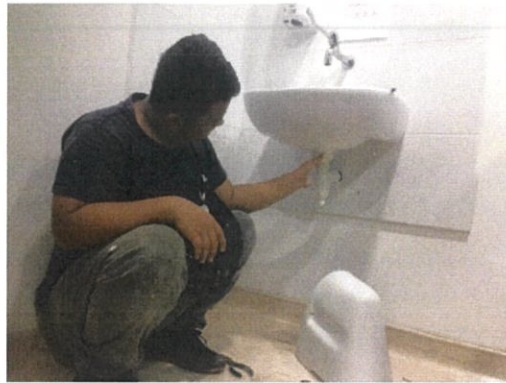
Figure 3.23: Worker wrapped putty around the leak area

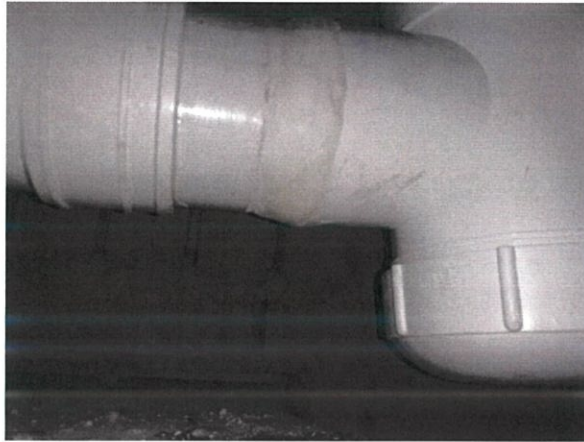
Figure 3.24: Condition of pipe after wrap the epoxy putty

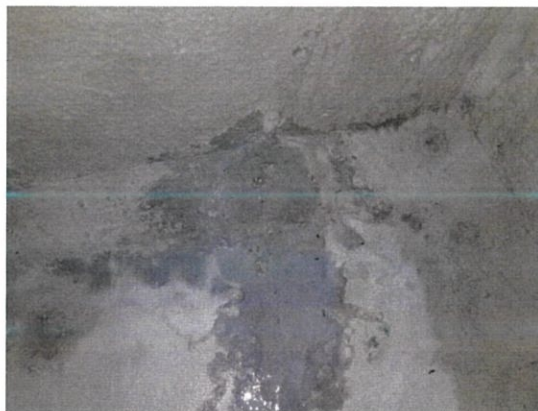
Water leaking from slabs is often clear water, rather than brown and dirty if a faulty plumbing pipe is the culprit. Leaking will usually be quite steady if the ceiling leak as plumbing-related. Especially if a water supply pipe is to blame, the water dripping from the slabs may be never-ending. Figure 3.25 shows the water leaked from soffit slab.

Figure 3.25: Water leaking on slabs

It is the one of suitable waterproofing method for some water leaking issues. This method applied chemical pressure into the defect area or specifically in the cracks. When the polyurethane touches the base with water, the chemical reacts and expands to seal the cracks. It is one of preferred method and easiest way than hacking. Just drill some holes on the slabs, and apply the PU injection in the holes. These are the steps during PU injection:

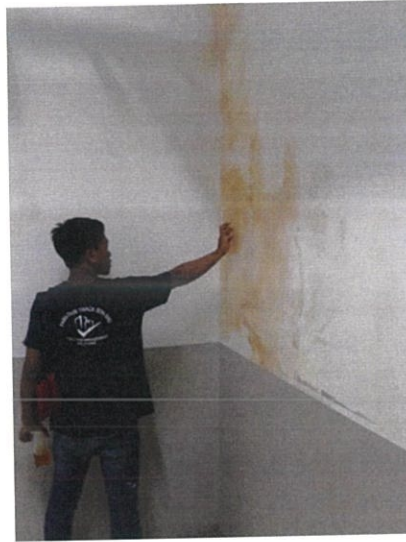
In addition, slabs and walls leaking can cause by many things such as thermal expansion and high water pressure in plumbing system, rainwater and failed insulations in the walls and slabs. Figure 3.26 shows the water leaked from wall.

Figure 3.26: Water leaks on wall

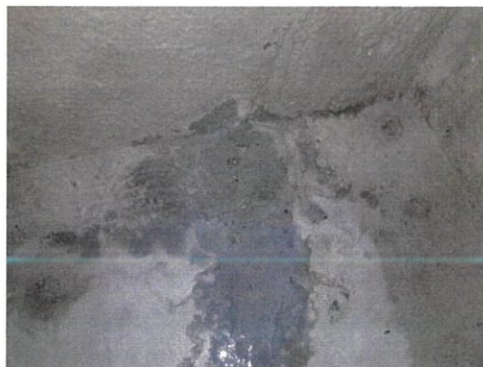
Figure 3.32: Watermarks on slabs

2. Firstly, the stains and watermarks was cleaned by cleaning cloth. The position to put the packer was marked. Figure 3.32 shows the watermarks on slab.

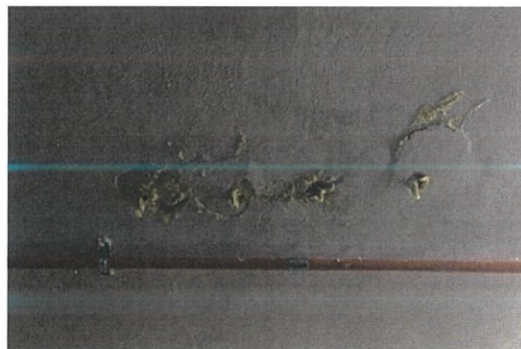
Figure 3.37: Condition of slab after injection

6. After 1-2 days of injection, the extravasation was removed. Figure 3.36 shows the extravasation was removed. Figure 3.38 shows the condition of slabs after injection.
