**DEPARTMENT OF BUILDING
UNIVERSITI TEKNOLOGI MARA
(PERAK)**

**METHOD OF RECTIFYING DEFECTS
(FLOORING, WALL CRACK AND WINDOW LEAKING)**

In my case study, I will explain how the rectifying process begins and completed for flooring defects, wall cracking and leaking. This process was carried out at The Havre, Block B as I was assigned to manage the defects from level 17 to 27 for this block.

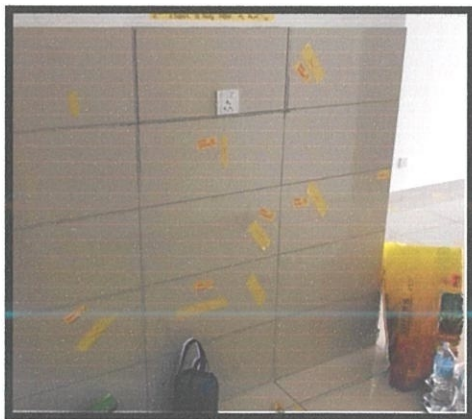
Figure 3.2
The owner put stickers on the tiles are hollow

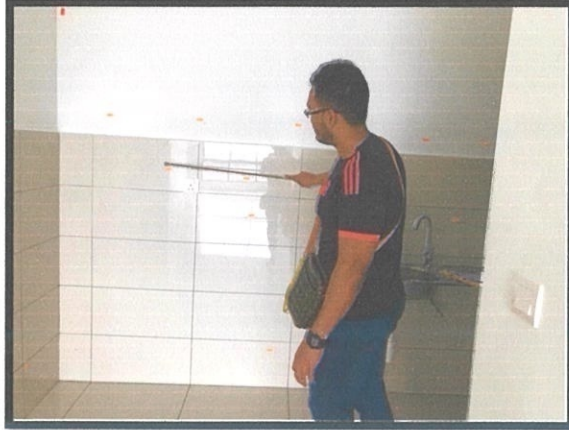
Figure 3.4
Supervisor check the hollow tiles
put sticker by the owner

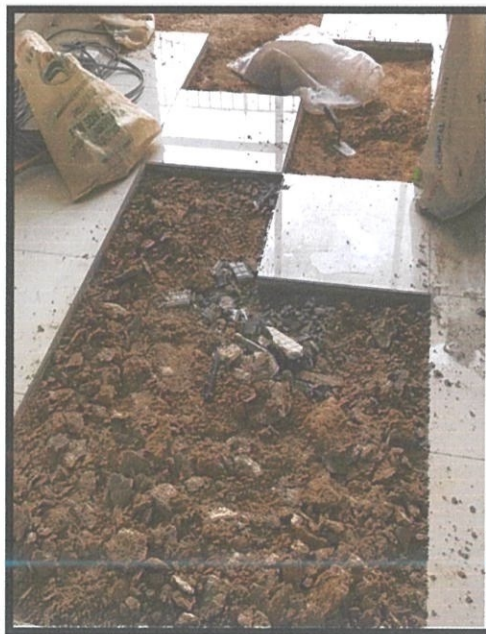
Figure 3.5
Deficiency of screeding

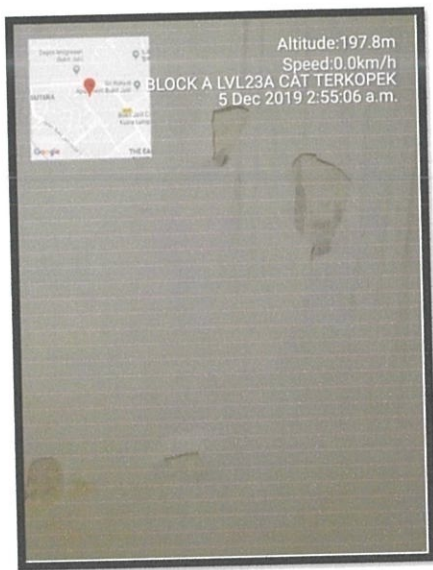
Cracks in the walls and ceiling of residential buildings can be a source of concern to homeowners, as cracking may indicate serious structural problems and give a building an unsightly look. For Havre project the commonly be reported by the owner or security is wall crack around corridor and inside their units as figure 3.6 and figure 3.7. There are few common reasons why the cracks can occur on walls. The reasons are because of contraction and expansion, weather forecast problem, low-quality paint, impatience during plasterwork and poor paint job. Here are a few methods of rectifying the wall cracks.

Photo 3.6
Crack wall (Corridor)

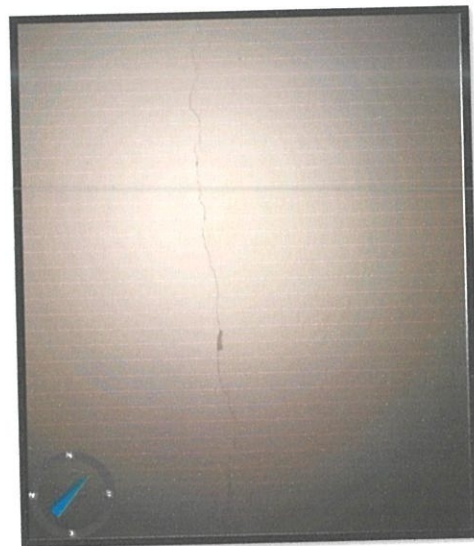
Photo 3.7
Crack wall (Owner unit)

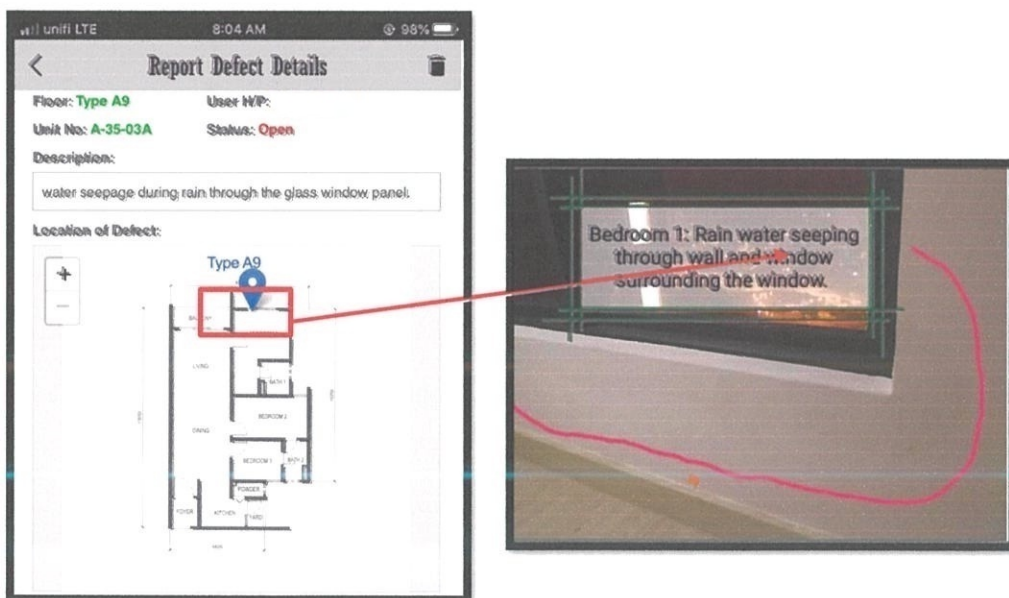
Figure 3.8

The owner complains water seepage during heavy rain

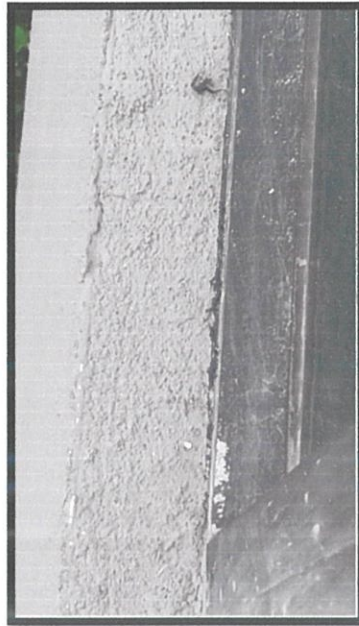
Figure 3.9
Crack/hole from the outside
of the window

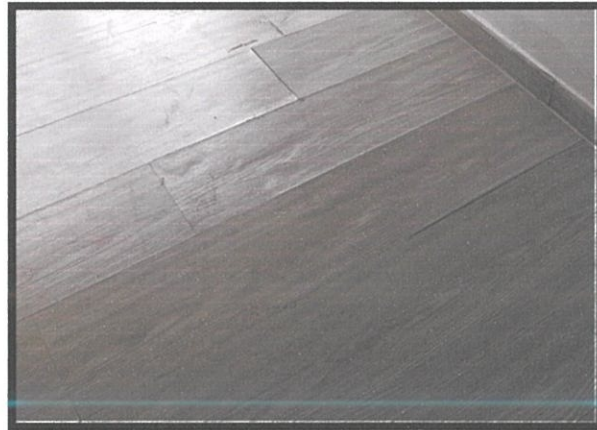
Figure 4.0
Timber floor damaged due water
stress in from window
