**DEPARTMENT OF BUILDING  
UNIVERSITI TEKNOLOGI MARA  
(PERAK)**

**LEAKING :- THE FAILURE OF DESIGN**

KL Trader Squares include of 97 unit of shoplots, over 1000 surface of parking bay, one floor for condo facilities and five blocks of 30-storey serviced apartment. Totally 95% of this project are completed and only common area left to be finish by end of this year. This building was located at the Gombak Batu 4 where 10 minutes about from Kuala Lumpur Center.

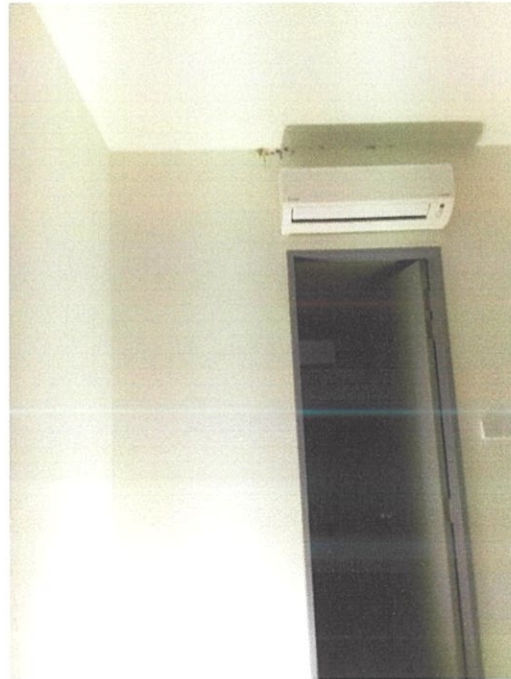
**Figure 3.2.1 :** Water mark on the top of air-conditioner.

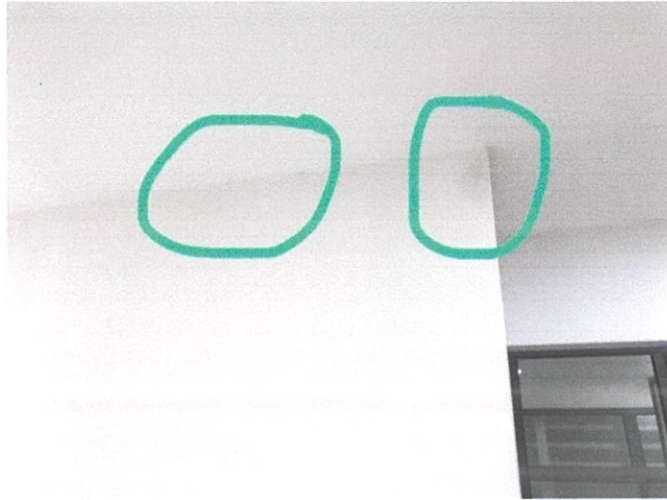
**Figure 3.2.2 :** Water mark at the edge of slab in dining area.

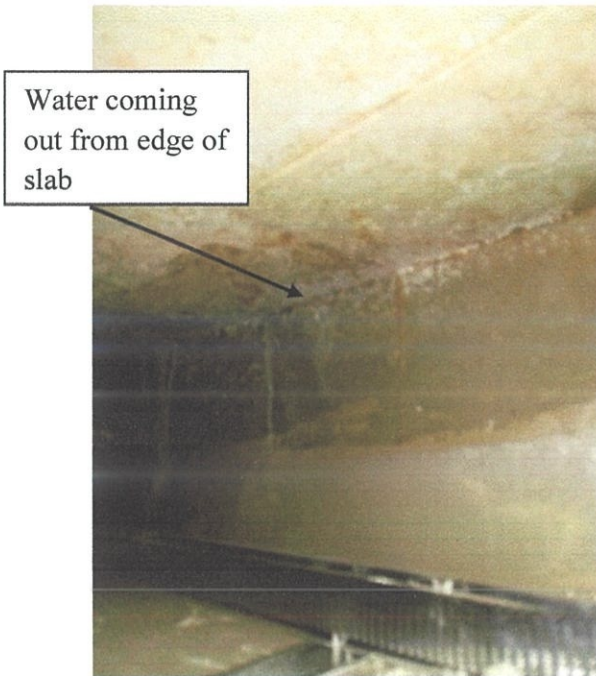
In addition, what makes the leaking worse is the failure of waterproofing. According to the submission defect regarding leaking, almost 75% of the leaking is from the slab, which means water penetrates inside the concrete slab when water is used on the unit above or when the pipe is damaged. This can be considered as a failure of waterproofing and a failure of design. The failure of design can be seen when the installation of the water flow out piping is inside the bathroom.

**Figure 3.3.1 :** The water from slab.

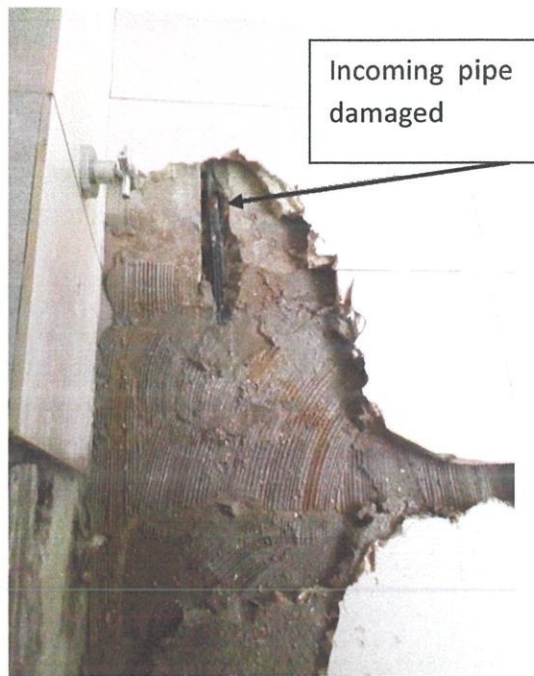
**Figure 3.3.2 :** Leaking from pipe.

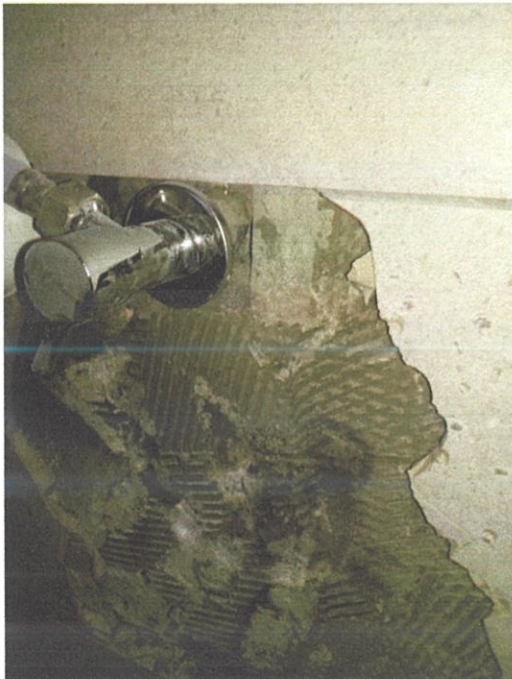
**Figure 3.3.3 :** Wall wet near angle valve.

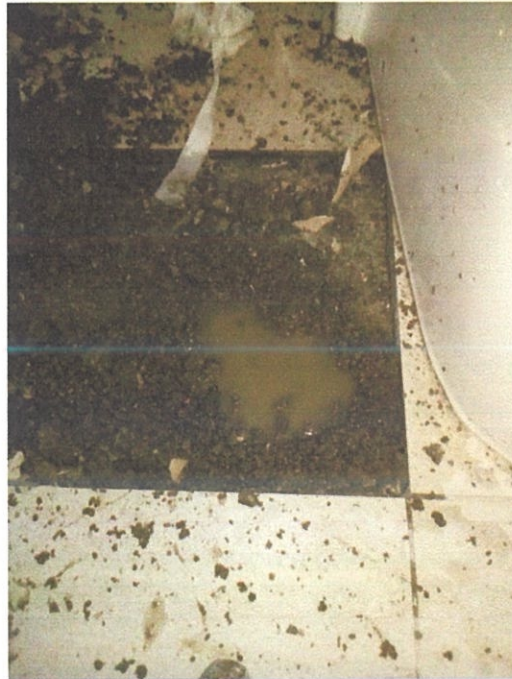
**Figure 3.3.4 :** Water coming out from floor.

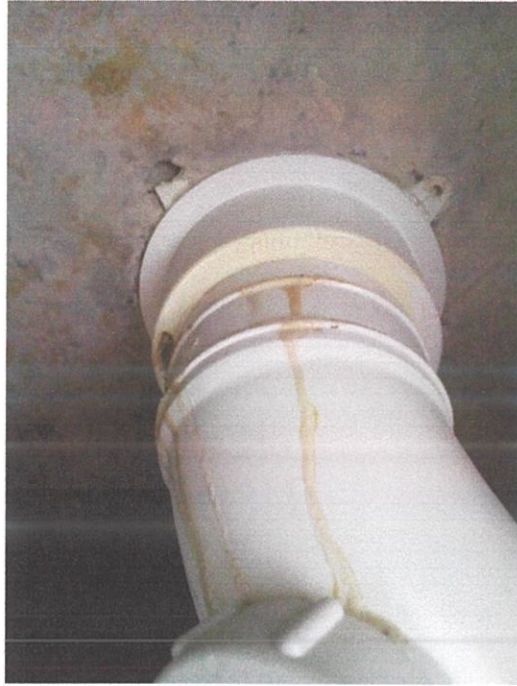
**Figure 3.3.5 :** Connection of pipe not sealed properly.

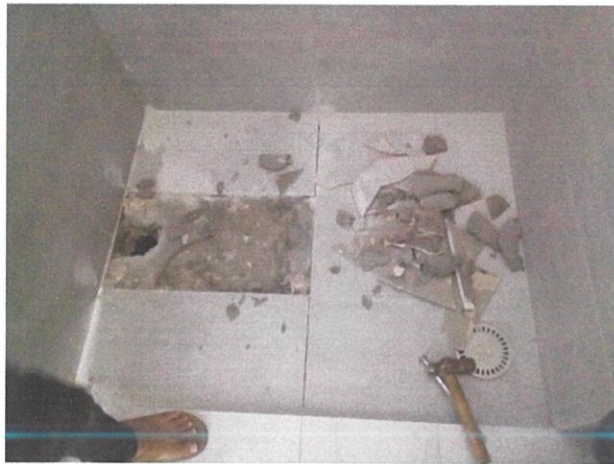
**Figure 3.3.5 :** Slab got a big hole.

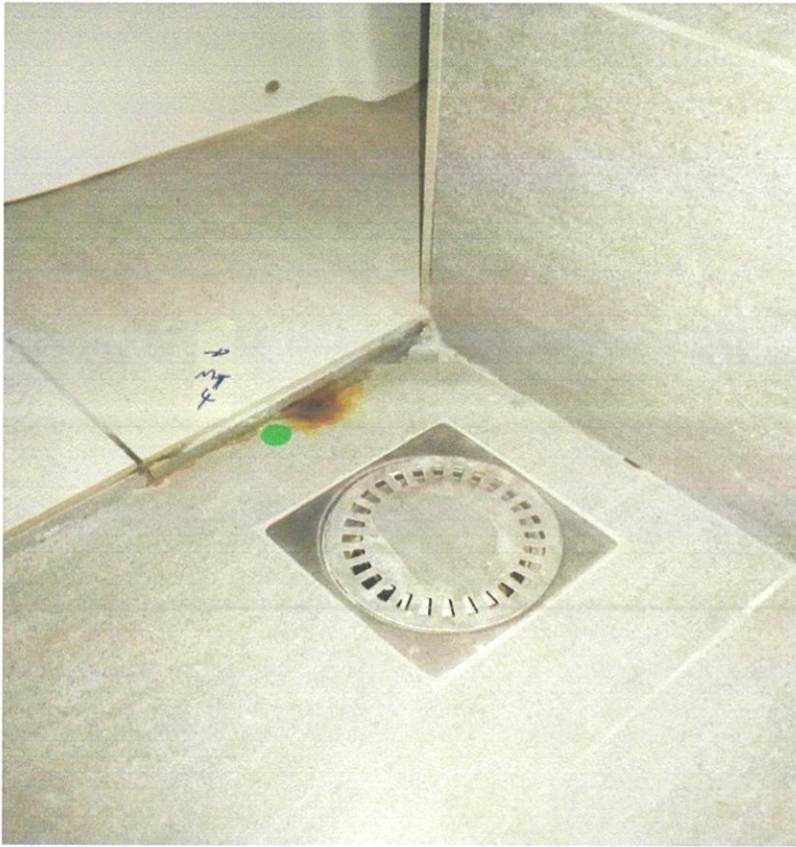
**Figure 3.4.1: An opening gap or grouting between tiles.**

So there is several method that can be use to rectify the leaking. First, all the grouting need to be fill properly. All the holes eventhough the smallest hole can be the reason of leaking. Second the installation of the tiles need to be alert. The vertical tiles need to be put on top of the horizontal tile. This shown that the water can go through cement but not through ceramic tile. Third is to rectify the gradient of the floor tile. Need to be sure that the water can flow smoothly into the floor trap and there is no ponding inside the bathroom. This is the simple way for repairing the leaking.

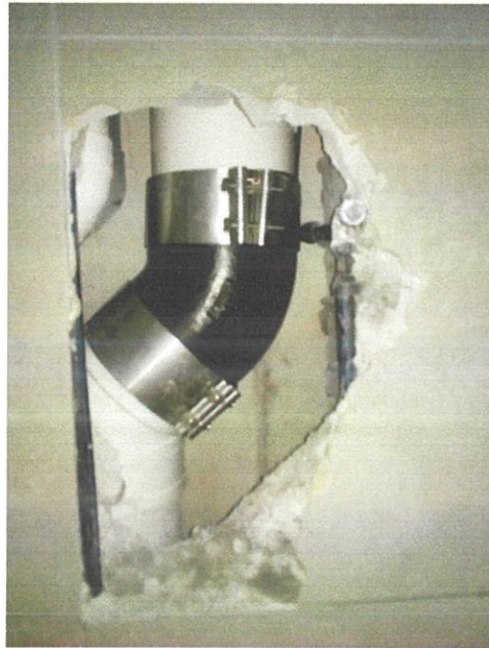
The first point to be hacking if there is leaking from boxup is at the 45 degree elbow pipe located. The most common problem is the 45 degree elbow pipe got leak around the connection or the elbow got crack at the bottom side due to the construction material inside such as skim and mortar waste. This happen because of the low quality of glue that connect the pipe and the low quality of elbow pipe. The solution decided by the plumber to rectify the problem is by replacing the pvc 45 degree elbow to metal material connected by aluminum clip as shown.

**Figure 3.4.4:** 45 degree elbow pipe rectify inside boxup

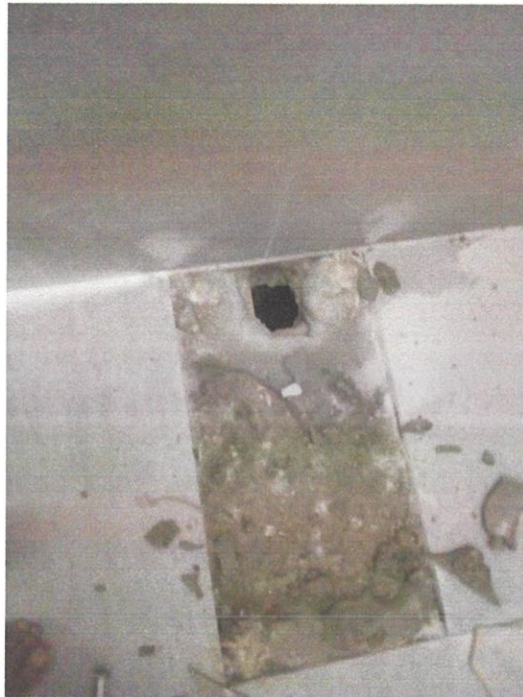
**Figure 3.4.5 :** Big hole on slab covered by tile.

This is the example of incomplete work done by labour. This hole was one of the reason there is leaking in below unit. This hole suspected to be point shower drainage but the point had to be change in some reason. During the installation the of tiling, the tiler did not inform the person in-charge regarding this problem and just laying the tile without casting the hole back.
