**STEEL STRUCTURES**

**DEPARTMENT OF BUILDING  
FACULTY OF ARCHITECTURE, PLANNING AND SURVEYING  
UNIVERSITI TEKNOLOGI MARA  
(PERAK)**

**DECEMBER 2019**

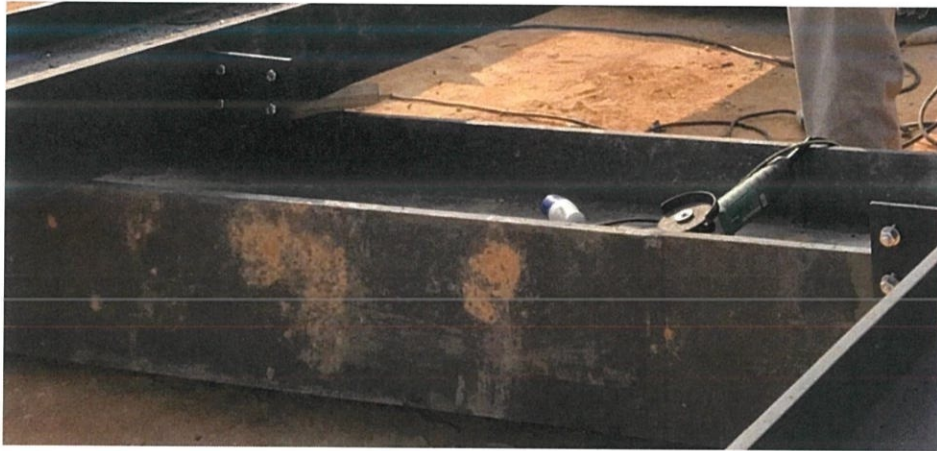
There were many problems during the installation of steel structure. The first one was defect on steel. The steel structure arrived at site with some defect on it such as faded colour (as shown in figure 3.25), faded metal roofs, bad scratches, and cracks.

Figure 3.25: Defect and faded colour on steel

The solution of the problems related for the first one was, the worker painted the steel again (as shown in figure 3.32) to cover the faded and defect on steels and the worker also repaired the defect (as shown in figure 3.33) on the steel. The steel was dried under the sun for rapid drying and continued the work immediately.

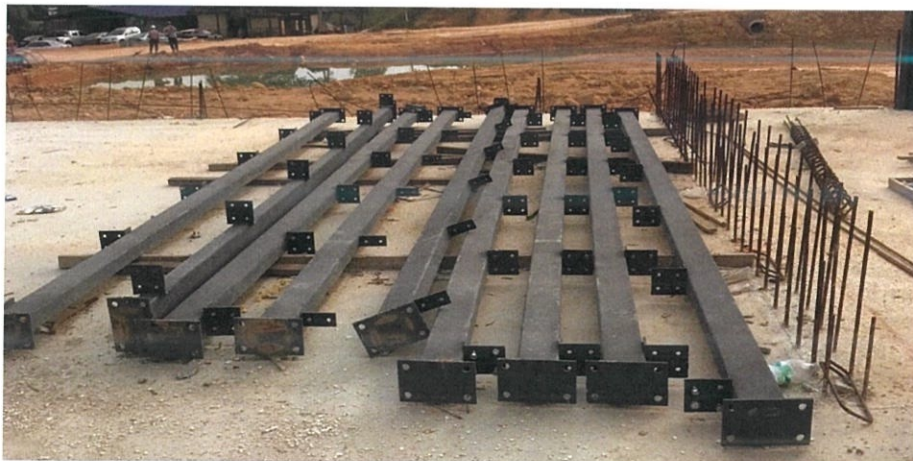
Second was the amount of steel. The lack of number of steel (as shown in figure 3.26) made the installation work had to be delayed while waiting for the other ordered to arrive. It was caused by the supplier that misunderstood and wrong calculated during the shipping process.

Figure 3.26: Steels had to be put aside and hold the progress of installation

Move to the second solution, the manager contacted the supplier of steel and informed about the misunderstood of amount of steel. The supplier took a few days to process the delivery and the steel safely arrived (as shown in figure 3.34) at site.

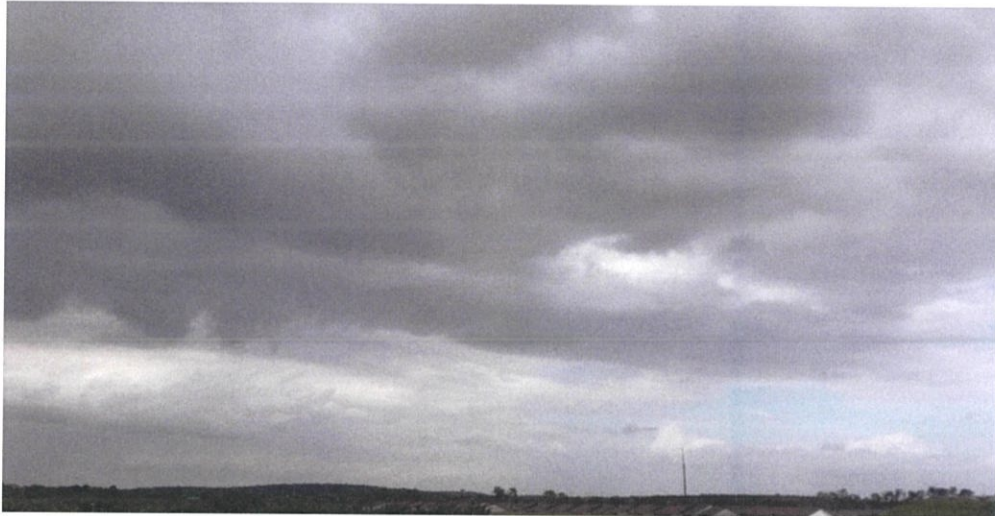
Next, the erratic weather during installation work (as shown in figure 3.27). Since it was the monsoon season, the workers can only work half a day each day. The unpredictable weather that a bit hard to continue the installation work which causes the work to be delayed over a given period.

Figure 3.27: The bad weather during installation day

Furthermore, after discussed, the construction manager and site supervisor had to reduce and maximize workers' rest time, from three break time to two break time a day. They also had to cut the overtime of worker's and they can go back to their shared home at 5 PM.

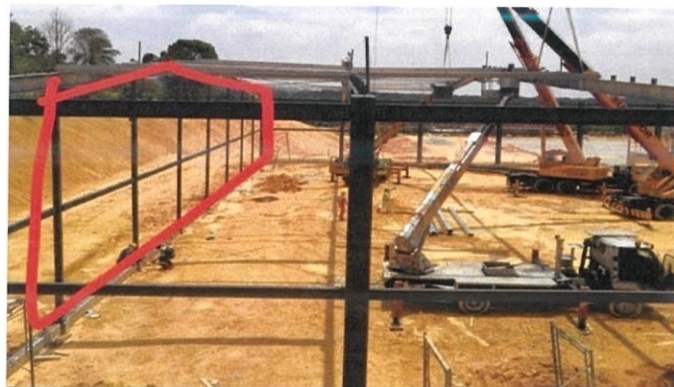
Furthermore, incorrect installation method. During the installation day, the workers were misplaced the steel and installation error (as shown in figure 3.28, 3.29 and 3.30) because they did not understand how to install the steel properly. The result was so bad that it caused many deflections.

Figure 3.28: Unstructured column at lawn bowl

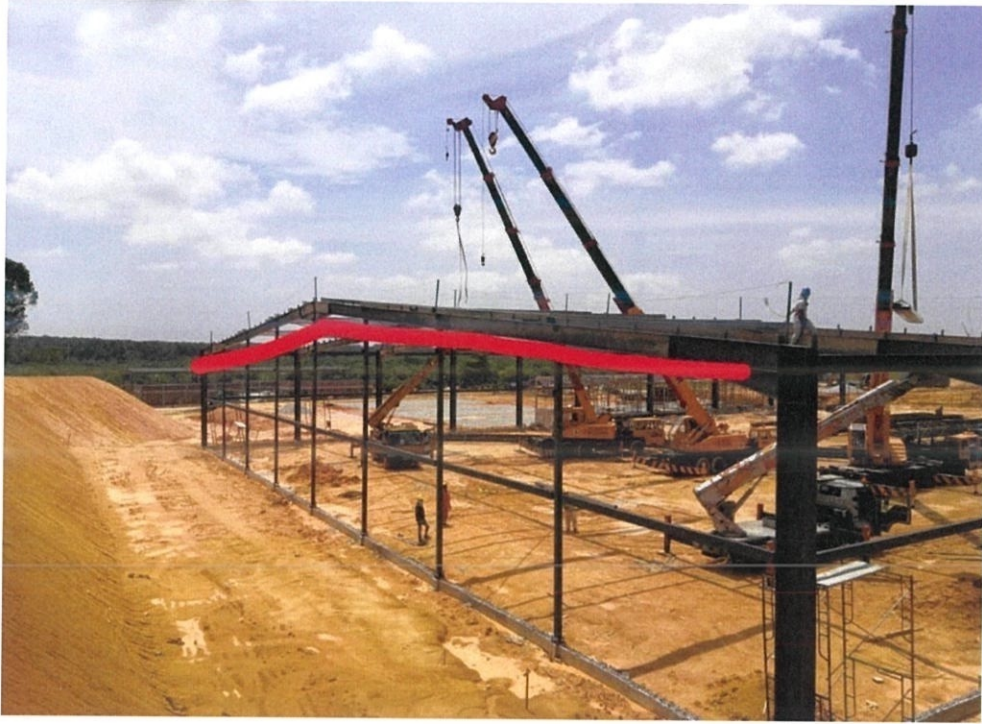
Figure 3.29: Unregulated purlin at lawn bowl

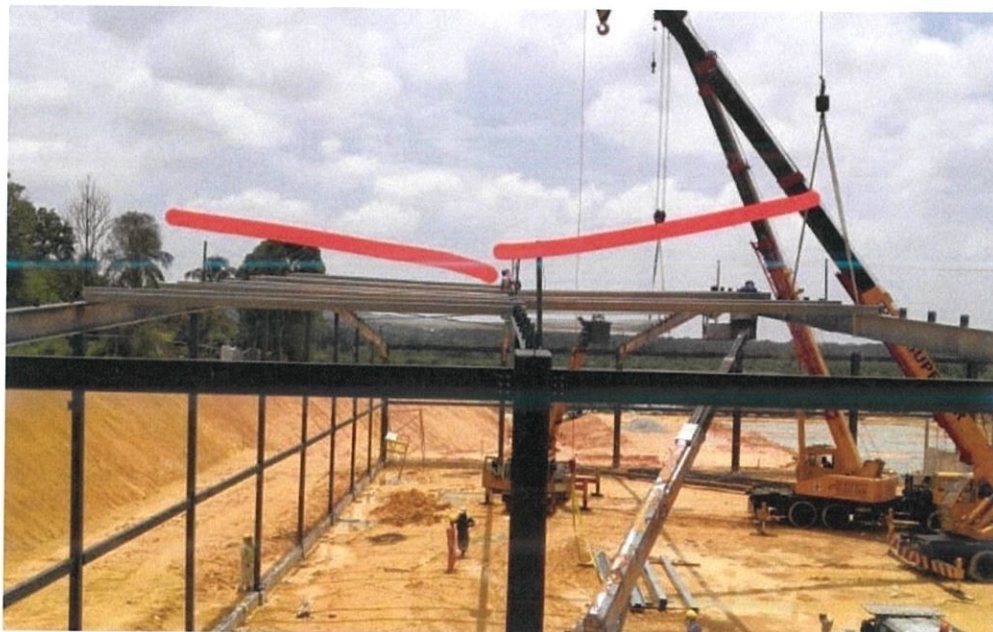
Figure 3.30: Unstructured portal frame at lawn bowl

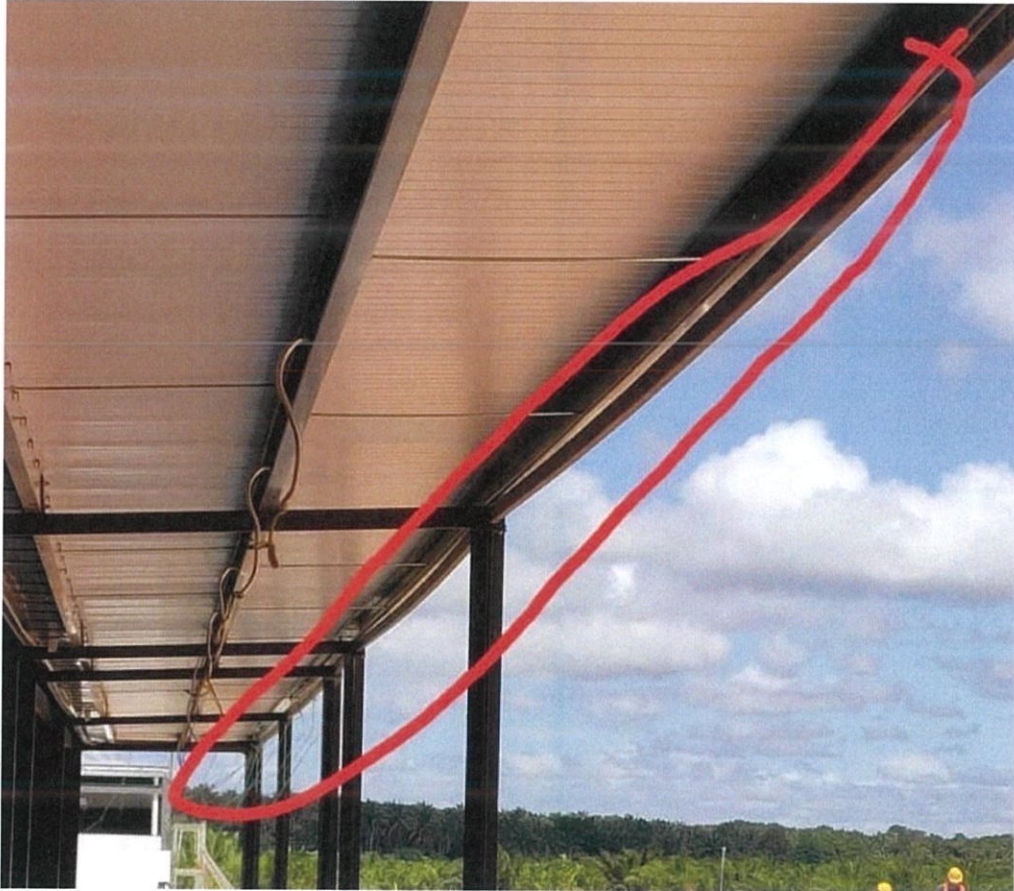
Lastly, the wrong size of span. The span arrived at site with the larger size than what had ordered. Due to time constraints, the installation work had to carry out by using the same span. Unfortunately, the result was unsatisfying because the thickness was very thick (as shown in figure 3.31), did not same as the drawing and the self-weight was very heavy.

Figure 3.31: The span at main pavillion and lawn bowl look bigger than the actual size

Last but not least, since the span was installed at few sport centre already, the Project Engineer asked the architect to change the thickness in the drawing. After one week we received the new drawing which the thickness of span has been edited according to the span thickness on the site.

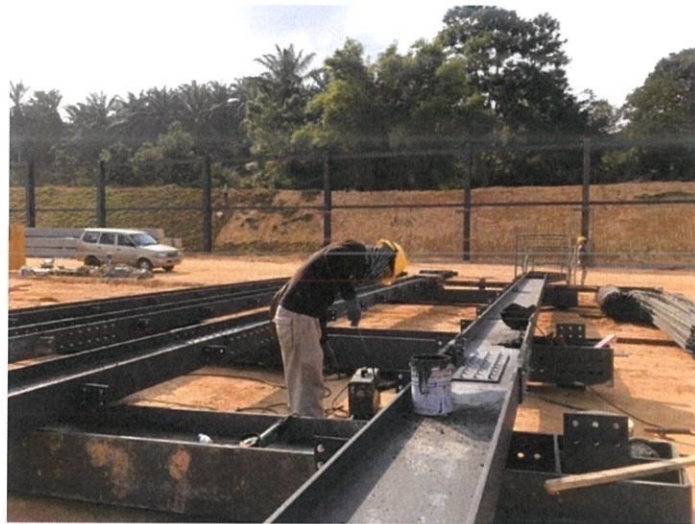
Figure 3.32: Worker is painting the steel to cover the faded colour

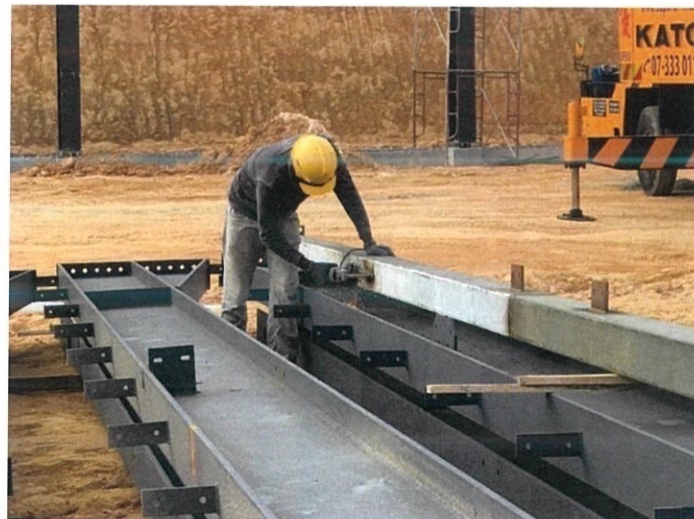
Figure 3.33: Worker is repairing the defect of steel

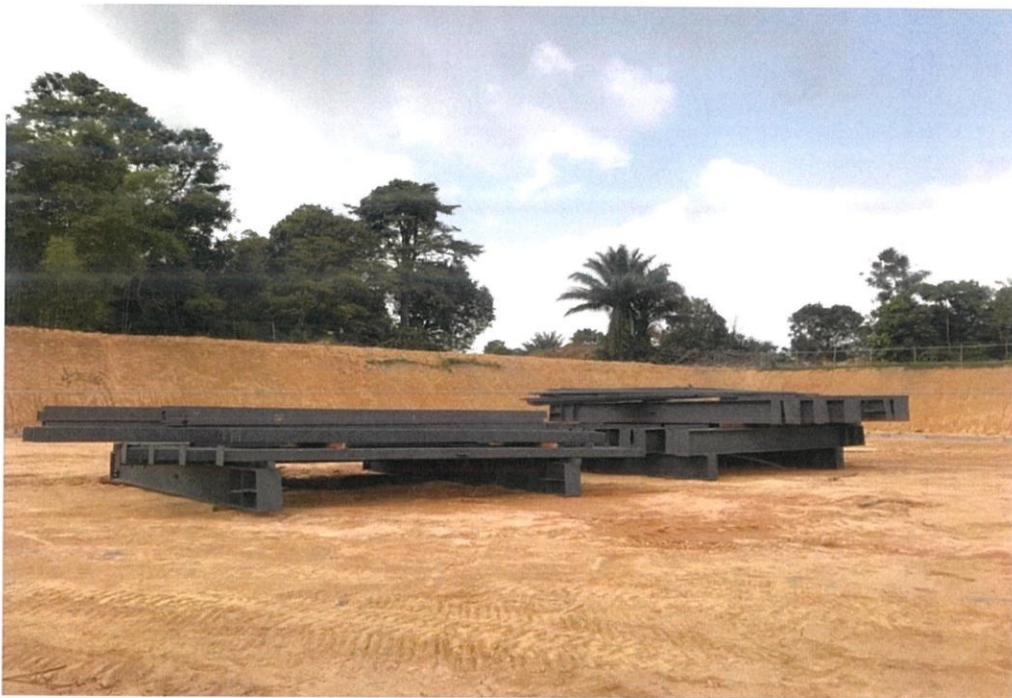
Figure 3.34: The steels arrived and placed on the lawn bowl arena
