**BUILDING FORENSIC INVESTIGATION OF COLLAPSE HALL
AT CURE & CARE REHABILITATION CENTER (CCRC),
PERLOP**

**PREPARED BY:
MUHAMMAD AIDIL QAYYUM BIN MOHAMMAD RUSLI
2019236012**

Practical Report

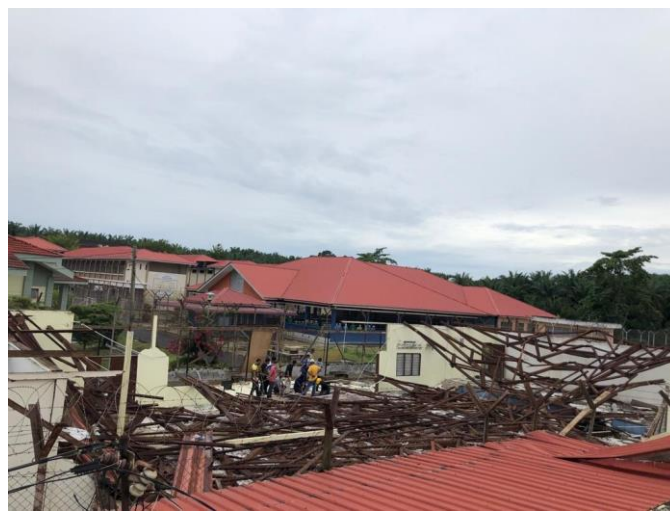
Figure 7 The overall view from the top of the collapsed hall building

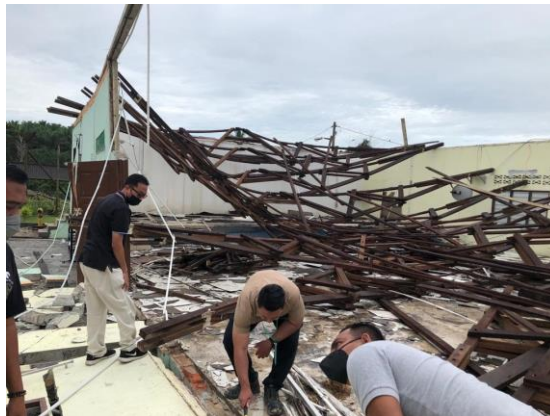
Figure 8 Inspection activities of the hall that have fallen and collapsed

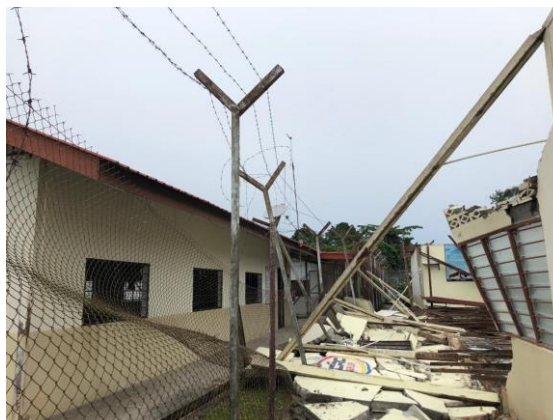
Figure 9 The condition of the fallen wall

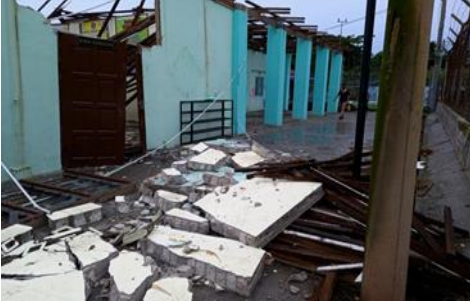
<p data-bbox="451 1478 842 1507"><i>Figure 11 The condition of collapse hall</i></p>	<p data-bbox="927 1133 1390 1274">There are some parts of the wall that do not collapse which is. at the front of the hall</p>
3

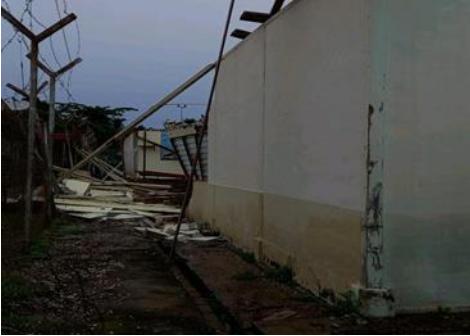
<p data-bbox="483 1915 810 1944"><i>Figure 12 Sloping wall condition</i></p>	<p data-bbox="927 1538 1390 1626">The condition of the wall that began to collapse on the left side of the hall</p>

Based on the investigation of the collapse of the hall that is damage to the roof components, the structure of the walls and columns can be summarized into several things or aspects. Firstly, the wall as one of the load-receiving parts of the roof component becomes weak when the roof truss fastener nails that are the strength holders to the left and right walls have been opened. An important aspect of the construction of any building is the connection between the roof and the walls. Trusses or rafters may be attached to walls. The roofing system is called the roof support structure, which is the basis for overcoming the impact and stability of the walls.

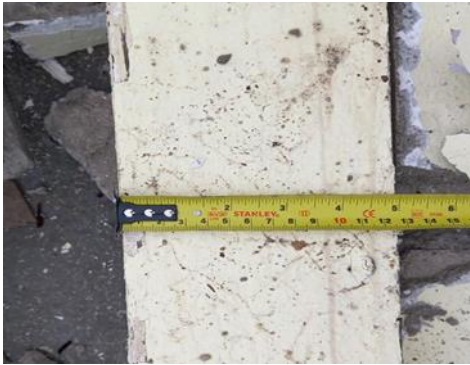
<p data-bbox="496 663 798 689"><i>Figure 13 Wooden column size</i></p>	<p data-bbox="927 255 1390 342">The size of the wooden column used for this building is 125mm</p>
5

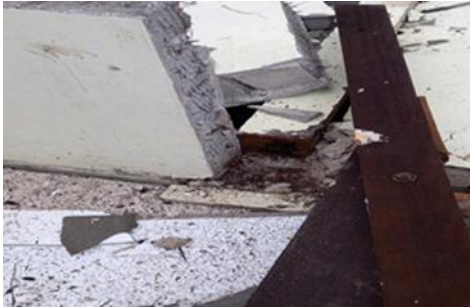
<p data-bbox="469 1072 823 1099"><i>Figure 14 Placed of wooden column</i></p>	<p data-bbox="927 721 1390 808">Wooden columns are placed only on top of the beam foundation</p>
6

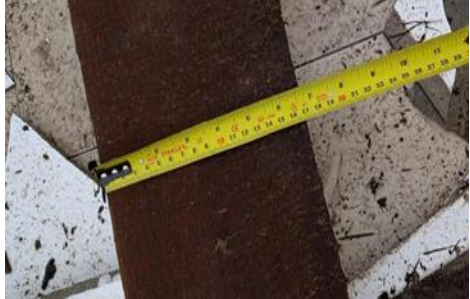
<p data-bbox="533 1476 759 1503"><i>Figure 15 Rafter's size</i></p>	<p data-bbox="927 1133 1390 1272">The size of the rafters was found to be larger than the size of the joists which was 170mm</p>
7

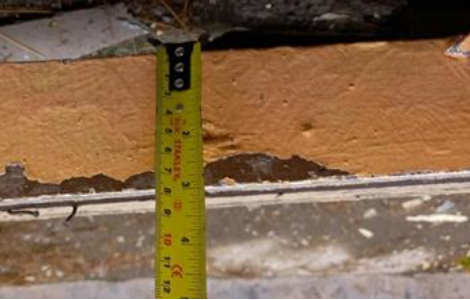
<p data-bbox="469 1879 823 1906"><i>Figure 16 Roof truss cladding's size</i></p>	<p data-bbox="927 1536 1390 1624">The size of the roof truss cladding over the brick wall ties is 78mm</p>

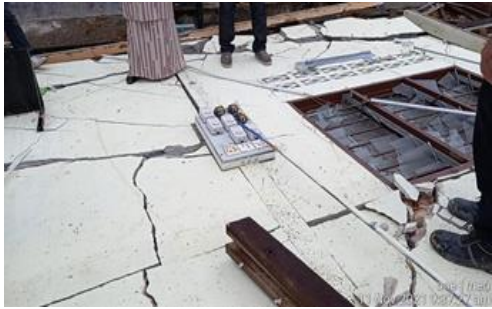
<p data-bbox="475 607 818 636"><i>Figure 16 Electrical wiring system</i></p>	Electrical wiring systems that are damaged due to wall collapse
9

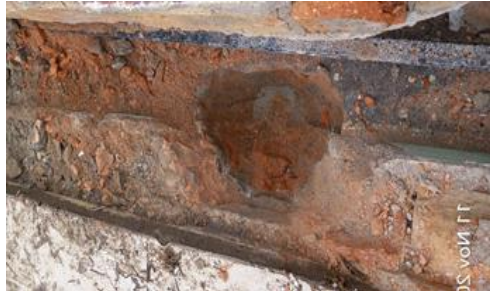
<p data-bbox="421 1003 873 1059"><i>Figure 17 The condition of the floor and beam foundation</i></p>	Excavated the floor and found the floor surface to be cement and a bond of beam foundation bricks made on it
10

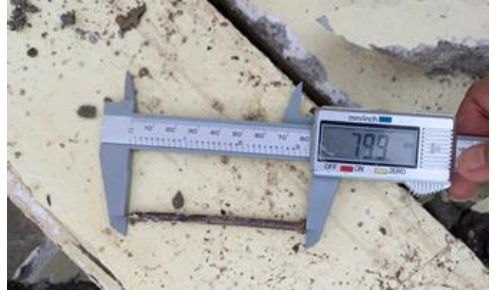
<p data-bbox="517 1426 777 1456"><i>Figure 18 The size of nails</i></p>	The size of the nails used as fasteners between columns and brick ties as well as fasteners for roof trusses
11

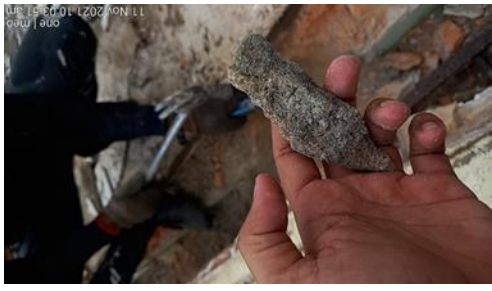
<p data-bbox="496 1818 799 1848"><i>Figure 19 Fragment of cement</i></p>	A mixture of cement and sand on the bottom layer of the bond used as the base beam layer

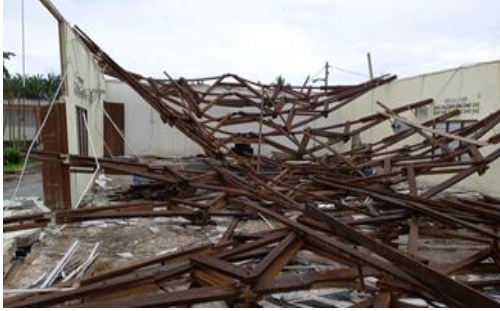
<p data-bbox="459 613 842 645"><i>Figure 20 The condition of roof trusses</i></p>	<p data-bbox="935 259 1428 344">The original roof truss suffered damage and collapse as a whole</p>
13

Secondly, the cause or aspect of the collapse of the hall is about the load borne by the wall. Prior to the collapse of the hall walls, the ongoing project was to repair the roof of the hall building. the contractor has found that the load borne by the wall panels through the upper components has long been detected when the joists have sagged before the roof repair work was carried out. Subsequent observations during the incident of the wall collapse are all the truss wood is wet.

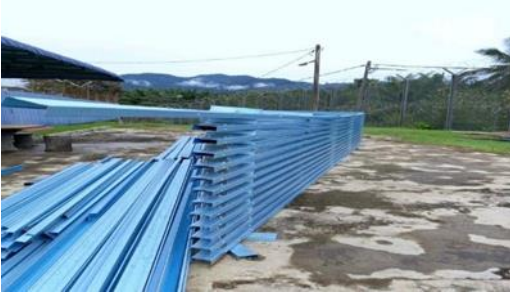
<p data-bbox="419 1043 882 1075"><i>Figure 21 The condition of the new roof trusses</i></p>	<p data-bbox="935 678 1428 815">New trusses where supposed roof truss fabrication work should be done by the contractor</p>

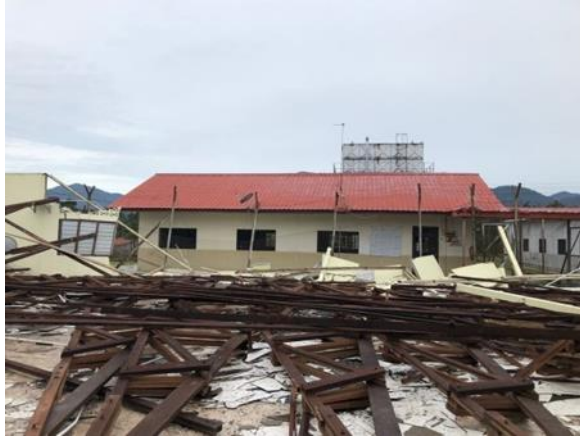
A joist is a structural member that spans horizontally between the foundations of a building or between walls or structural beams (as shown as figure 24). In combination with other joist, it provides support for a ceiling. In effect, a joist is a type of beam

Figure 24 The condition of the joist and trusses that have fallen

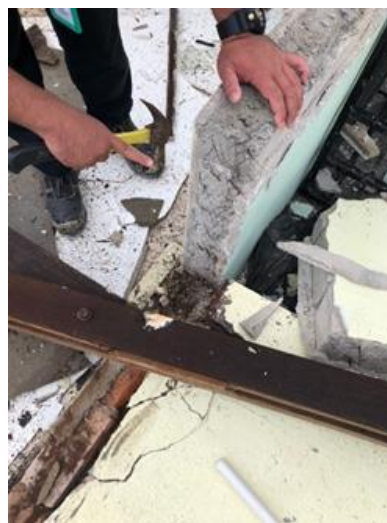
Thirdly, the cause or aspect of the collapse of the hall is the material for the beam foundation is a brick bond and there is just a mixture of cement and sand below it placed on the surface of the cement floor (as shown as figure 25). Fourth, the wooden poles are placed on a brick bond which is used as the beam foundation without planting even a small part of it. The strength of this loose wooden pole handle contributes to the collapsed wall because the brick bond that rests on it is not fastened with iron from the pole even when exmet application is applied.

Figure 25: Beam foundation condition

To overcome the increasingly critical damage to related components, priority repairs should immediately be carried out by dismantling, demolishing and removing as well as rebuilding the entire hall block. Firstly, dismantle or demolish the entire building and bring out of the site existing construction waste. It is because all components and parts of the hall can no longer be worn or replaced because they have been damaged such as beam foundation, columns, doors, windows, trusses, roof and so on.
