DEPARTMENT OF BUILDING
FACULTY OF ARCHITECTURE, PLANNING AND SURVEYING
UNIVERSITI TEKNOLOGI MARA
(PERAK)

DECEMBER 2019

Slope Stabilization

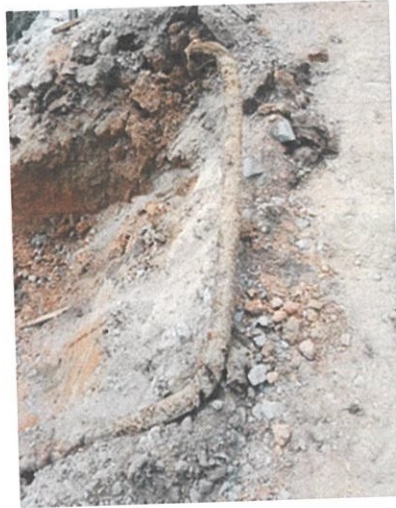
Figure 3.4 : Electric cable found beneath the ground

- iv. During the construction, there were electric cables found that were laid underground near the slopes which the contractor were not aware beforehand as shown in **Figure 3.4**. As the manpower on duty notice it, the contractor directly contacted with TNB authorities for further action to be taken as the villagers needed another alternative electrical supply. As for the next day, the contractor and workers on site were informed that the electrical supply were supplied through generator provided for the mean time.
- v. Other street furniture such as guardrails were dismantled and stored for re-use as required after the construction completed later. E.G.L. survey were carried out progressively with the clearing work, from ROW to ROW.

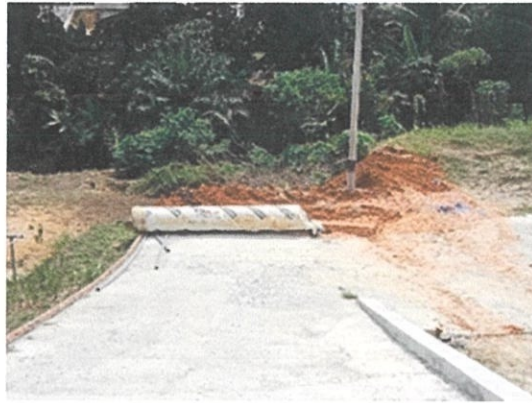
Figure 3.17 : Access road

For example, the slope instability at Felda Air Tawar 3 were due to the human modifications too. As from the observation on site, the condition of the slope were slightly shaken and instable was because of the modifications made to the parts of the slope to make an access road towards two houses located down the slope as shown in **Figure 3.17**. It makes more unbearable as the access road made on the slope was by unprofessional person.

As modifications were made there without specialize workmanship and further investigation on the slope, the rest of the soil of the slope received the impact too which resulting to the unstable slope. Nowadays, people will see a lot of excavation being done on slopes. In order to build more buildings in becoming one of the developed countries, more slope were excavated. Other than that, some of the error made from this modification could cause life in the future if there were no engineered fill on the slopes. If the slopes were to be modified, it could have further engineered fill. Take Highland Tower tragedy as example, one of the main reason of the landslide and slope failure was because of the soil creep due to the non-engineered fill on the slopes which were affecting the strength of the slope. (Kazmi 2017) In this stated that human modification can be done only if further matter were taken seriously, not only changing the soil composition and textures.

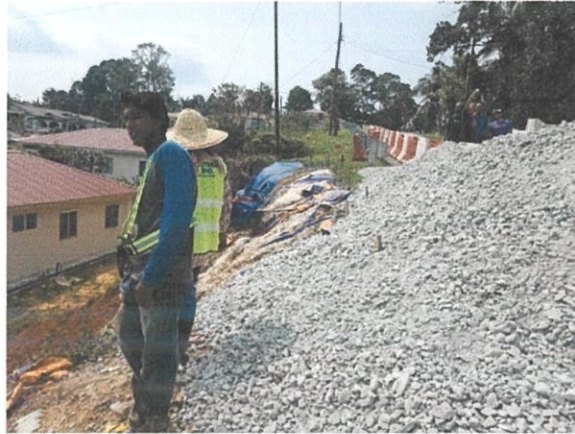
Figure 3.18 : Road above the slope

Soil composition becoming loose because of the frequent modifications. As different soil have different composition and durability, some of them might be loose and some might be tight. Different types of soil also have different characteristic when it comes to frictional resistance towards the erosion and cohesion between the grains. Loose composition soil will move downwards the ground in a form of smaller debris but it will slowly taken the soil from the slope. As the slope becoming loose, bigger debris will start moving downwards too. As example, from the site location at Felda Air Tawar 3, one of the cause was loose soil composition. As it was located right beside a residence house, when the condition get worse day by day, it could affect the house and the upper road as shown in **Figure 3.18**.

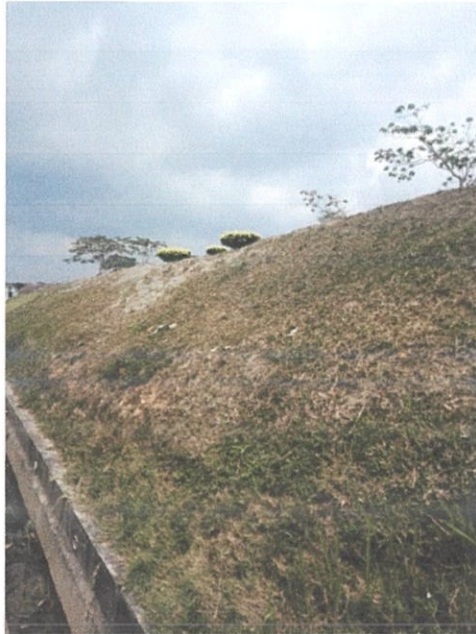
Figure 3.19 : Slope damage at SSTMI

Excessive water and inadequate drainage could cause big impact to the slope condition. For example, during this practical training, one of the location for slope stabilization works at Sekolah Sukan Tunku Mahkota Ismail, Bandar Penawar (SSTMI) were damaged because of the excessive water flow, specifically rainwater as shown in **Figure 3.19**. This is due to the improper drainage system which are making the water to overflow out of the shallow drain and went straight to the hockey field nearby. As the location was at sport school, the hockey field is one of the necessary facilities for the students there. Due to the damages from the water, the students and athletes could not do their training because of the damaged field. According to one of the school teachers, the condition could get worse when it was rainy season.

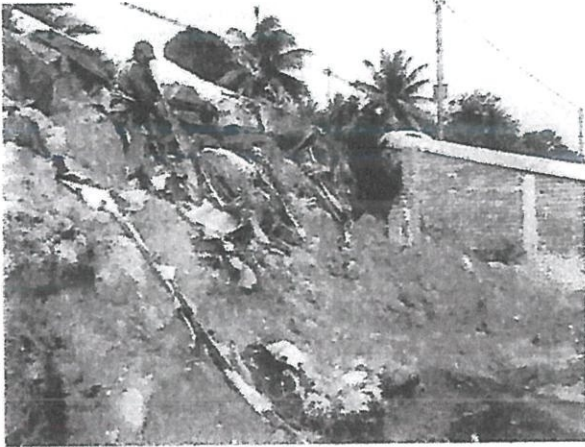
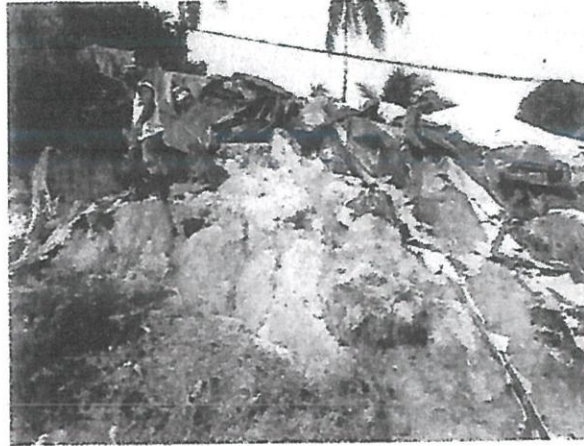
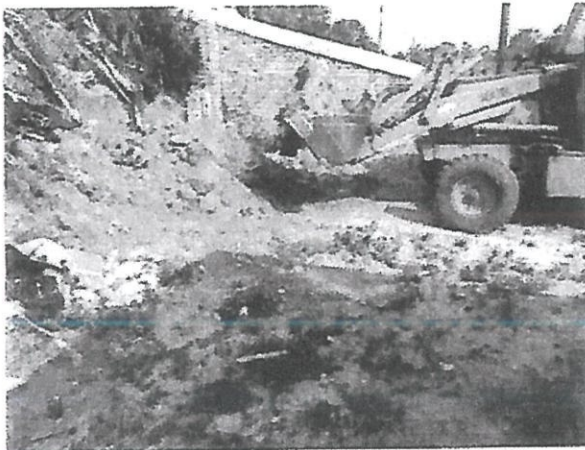
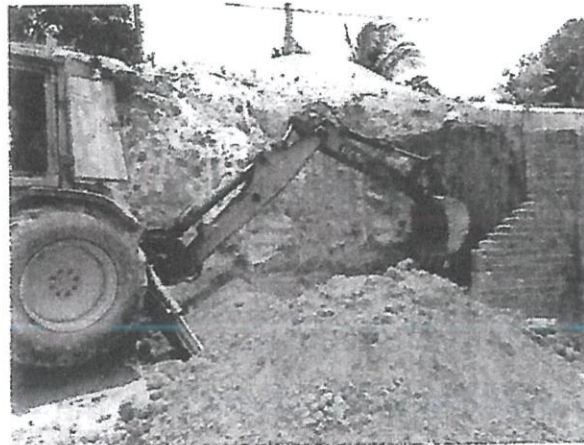
Site condition before start work
