DEPARTMENT OF BUILDING UNIVERSITI TEKNOLOGI MARA (PERAK)

REPAIRING THE RUBBLE OF THE RIVER BANK

JANUARY 2021

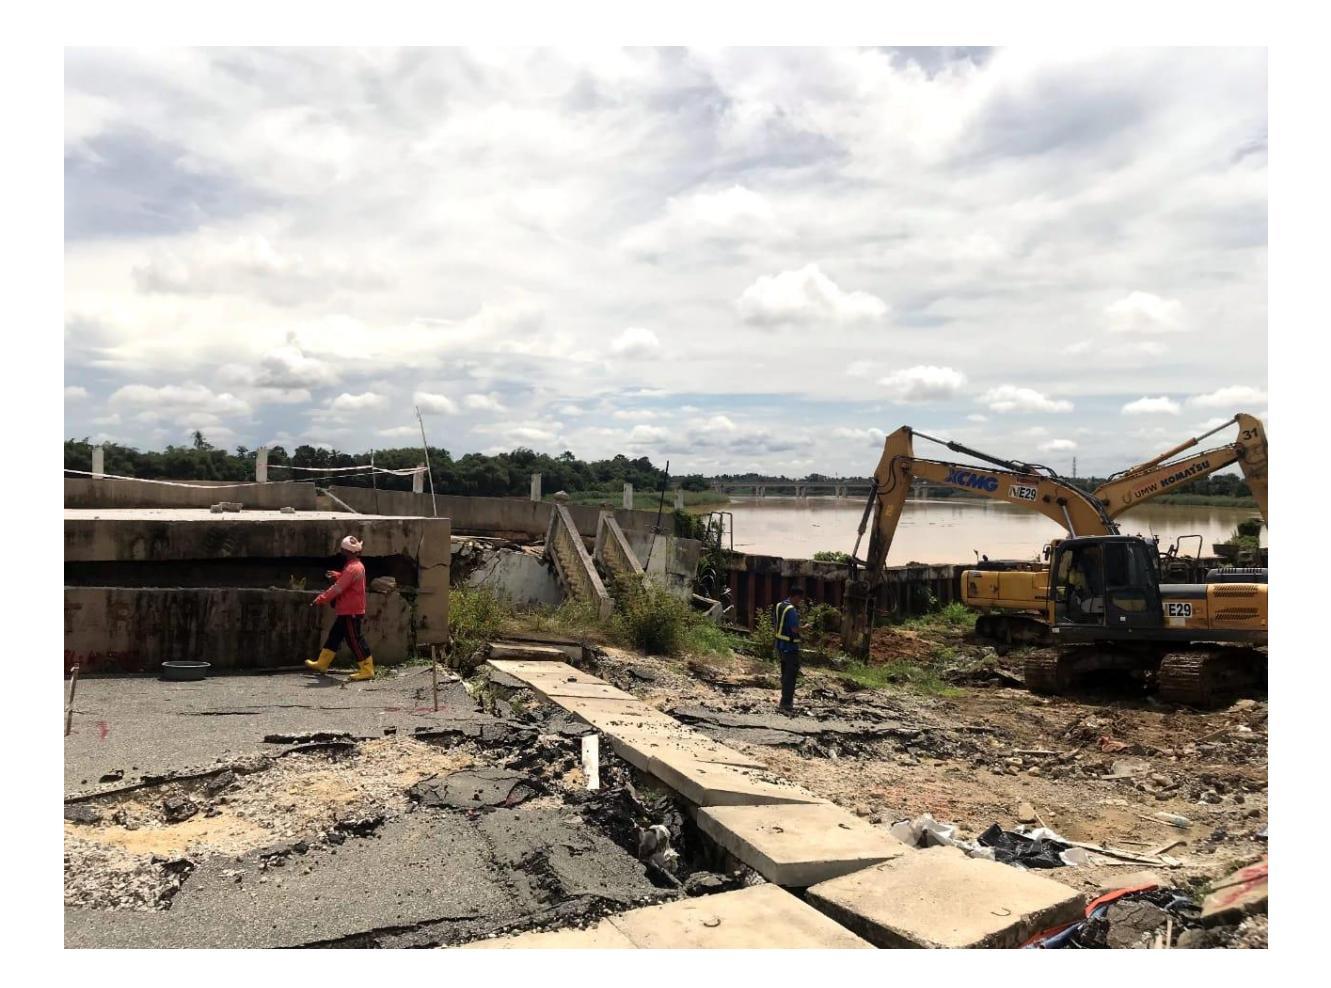
Figure 8: Excavation work

This project takes about 9 months which is began from August 2021 and will complete in May 2022 but this project may be delayed for reasons such as heavy rain or flooding. This is to avoid any problems and injuries that can occur at the site construction. This construction is handled by the skilled labourers and semi-skilled labourers to make sure that everyone can involve in this project construction. This project must be finish as soon as possible because this damage has caused some families at Kampung Pohon Celagi have lost their properties such as cars and houses.

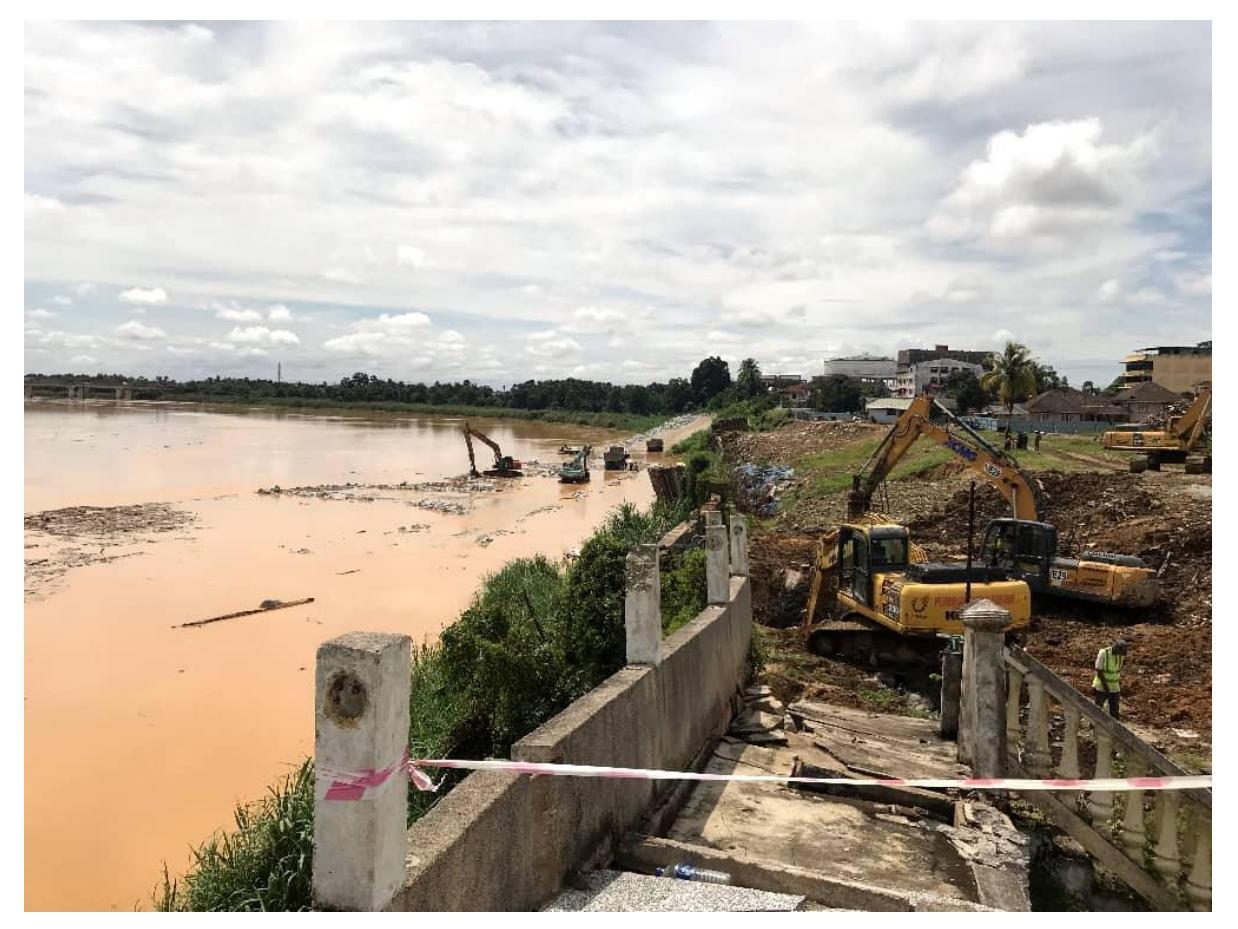
Figure 9: Excavation work

Excavation work is in progress to removal of earth, rock or other material area the riverbank that collapsed into the river. A few machines such as excavator are required to do some excavation work.
