RECOMMENDATIONS FOR IMPROVEMENT BASED ON FIRE INCIDENT CASE AT LOT NO. 4.18B (*RELYSIS COMPUTER*), LEVEL 4, PLAZA PELANGI, TAMAN PELANGI, JOHOR BAHRU, JOHOR

PRACTICAL TRAINING REPORT

FEBRUARY 2022

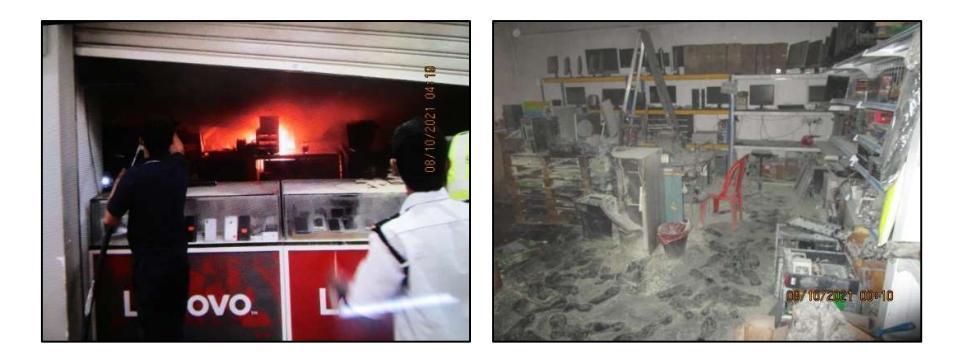
Figure 3.6: (Left) Fire as seen from the front of premise lot, (Right) Condition of premise after the fire has been extinguished.

On 7th of October 2021, at 2115 hrs, a fire incident occurred within the Plaza Pelangi, at Level 4, Lot No. 4.18B, with the premise's name *Relysis Computer*. The incident was first sighted by one of the maintenance departments staff that was patrolling in the area before closing the building for the day. The staff saw some smokes emerging from the fourth floor towards the open area. The staff called for assistance from the remaining other staff that were still at the building to quickly take actions for the sudden incidents. They then unlocked the roller shutter for the premise and saw fires within the premise. They hurriedly acted by extinguishing the fire using nearby fire extinguishers and fire hose reels available. Some of the fire sprinklers within the premise lot were also activated due to the high temperature. The fires were successfully extinguished around 2140 hrs.

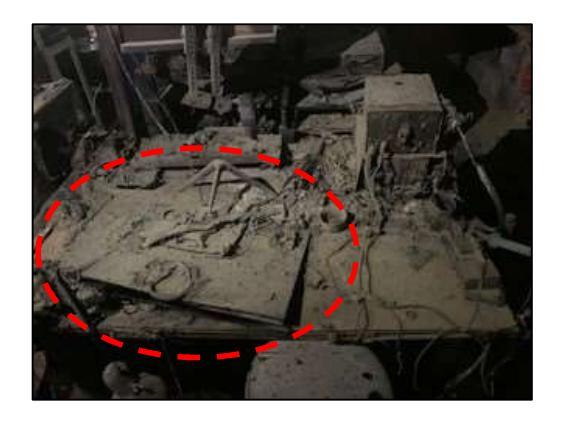
Figure 3.7: The laptop unit that has caused the sparks of the incident

After investigation has been done by the maintenance department and also the firefighter department, it was found that the cause of the incident is due to uncut power supply to one of the electronic items, a laptop, inside the lot that were left unattended for the night after closing the premise. This has caused the charging battery to overheat which led to the sparks of the fire incident.

Recommendation: To add routine reminder given from the building management such as daily or weekly reminder to the tenants to always turn off or cut supply to their electrical tools and equipment located within their premise to avoid or mitigate any possibilities for fire incident risks.

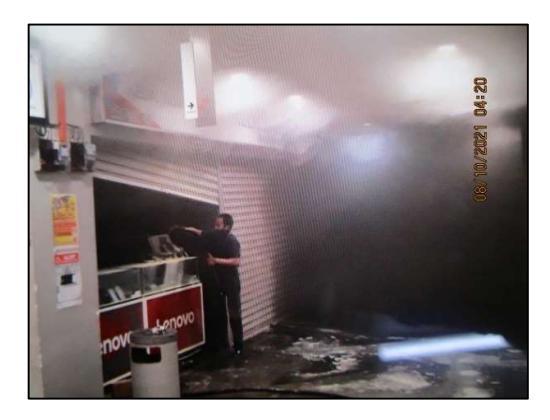
Figure 3.8: Maintenance staff using fire hose reel to extinguish fire

The first staff that sighted the smokes called for assistance and reported to the security department regarding the smokes emerging from the fourth floor. Since the premise has been closed for the day, the maintenance staff had to break open the lock for the roller shutter in order to enter the premise to further investigate on the origin of the smokes.

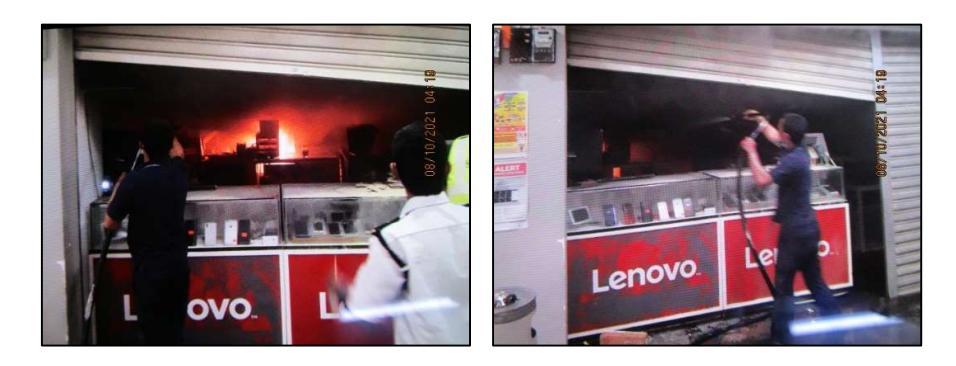
Figure 3.9: Maintenance staffs extinguishing the fire with hose reels

Right after the maintenance staff had opened the roller shutter, a fire was sighted in the back area of the premise lot. The maintenance staffs that had arrived on the scene took a total of five nearby fire extinguishers and another decided to use the closest fire hose reel located to the premise. The fire was completely extinguished after about 30 minutes.

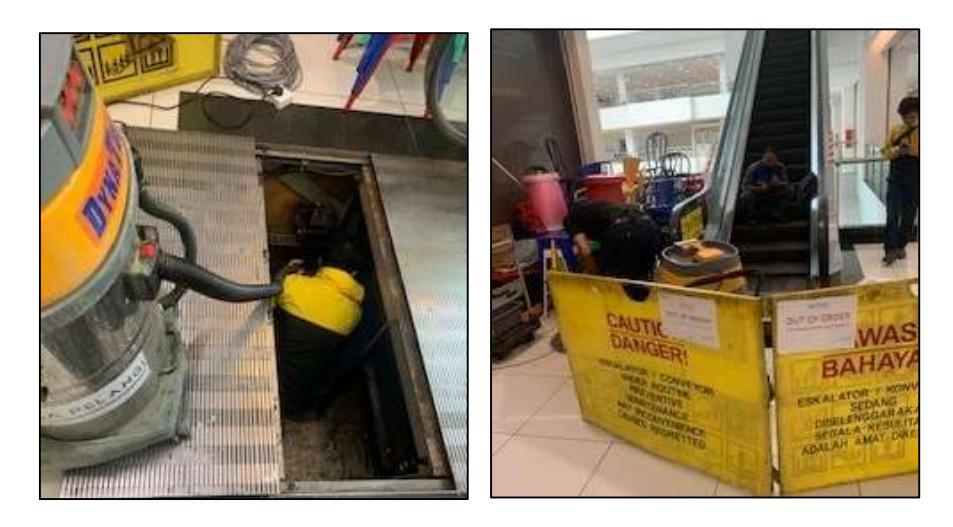
Figure 3.12: Maintenance staff servicing the affected escalator in front of the premise

Two escalators, one located right in front of the involved premise, and another located right below it, was immediately switched off due to water from the fire sprinkler overflowed and seeped into the chamber pit of the two escalators. One of the escalators was severely damaged due to the water and had to be shut down until further repair, meanwhile the other was still operable after servicing works were done upon it.

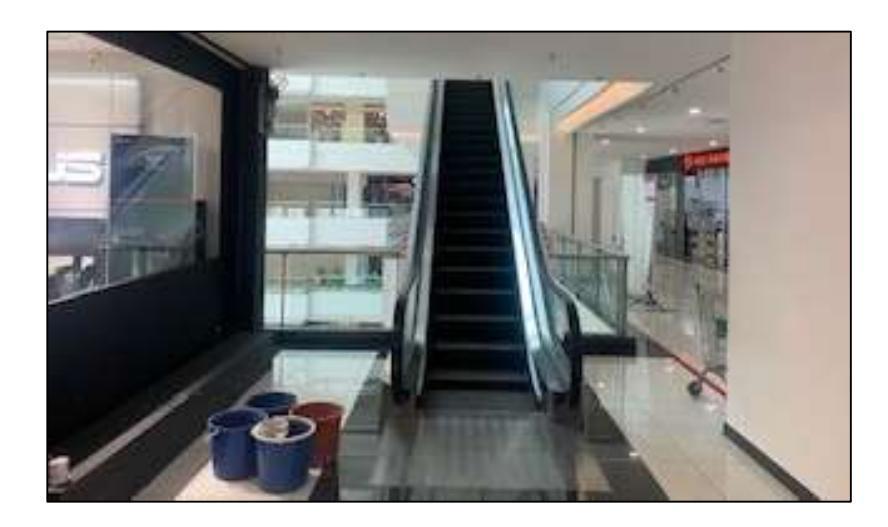
Figure 3.13: Another escalator that was affected but still operable after servicing works has been done

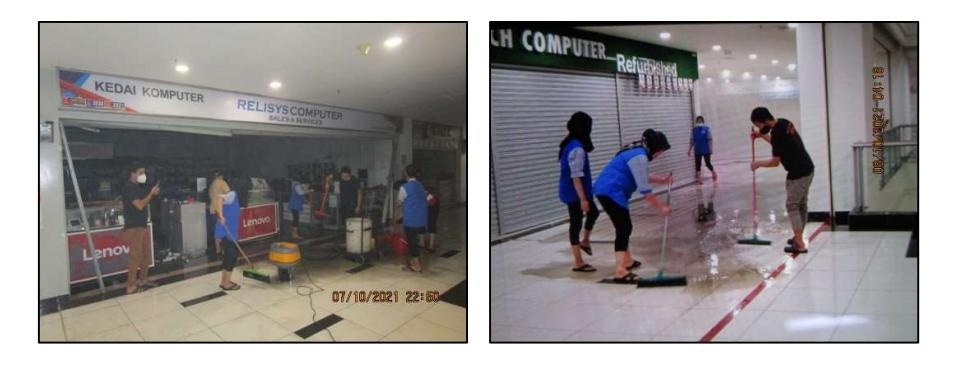
Figure 3.14: Cleaner staffs and maintenance staffs cleaning the corridor in front of premises involved in the incident

Right after the fire has been extinguished, cleaner workers that were still in the building has been tasked to immediately clean the corridor area of the involved premises from all the soot and dust that were mixed with the waters from the fire sprinklers. This is to avoid from the remains and debris to dried out and stain the corridor area such as on the floor tiles and the surrounding wall surfaces.

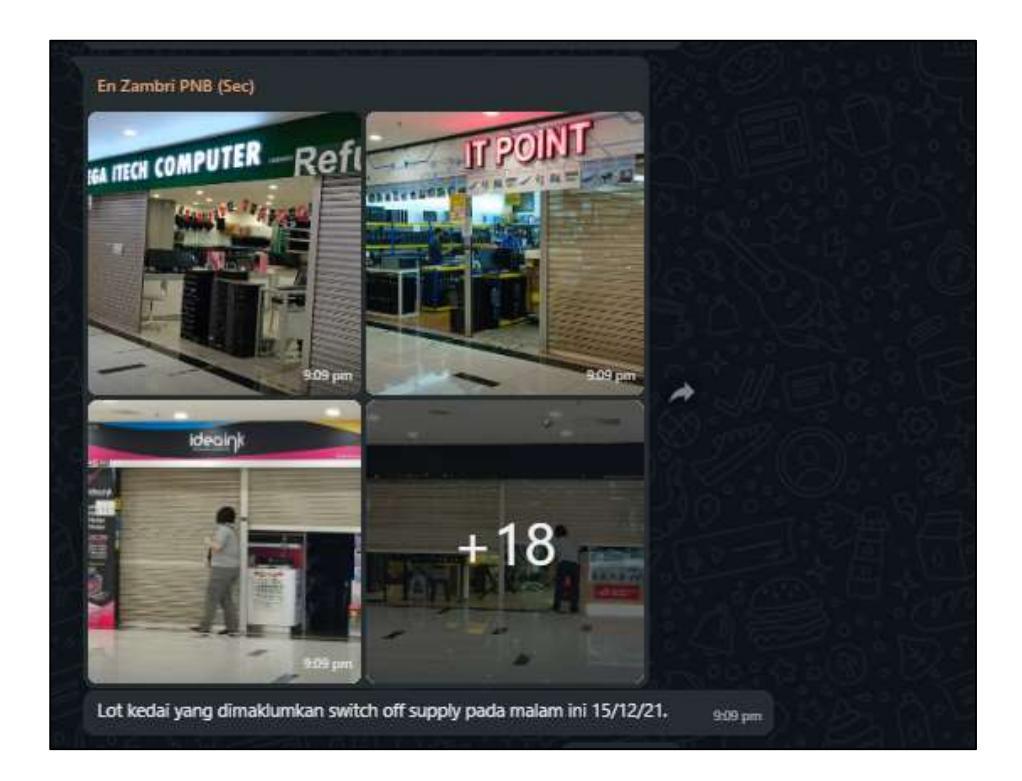
Figure 3.15: Security staff reporting new daily routine after the incident

After the incident, a new daily routine item has been added to the maintenance schedule of the shopping complex. The added item is to give reminder to all premises that handles electronic items within their premises, to completely turn off and cut off the power supply to these items before closing and leaving the premise for the day. This has been done by the security department staff daily and reported to the building manager as to ensure no such incident reoccurring.

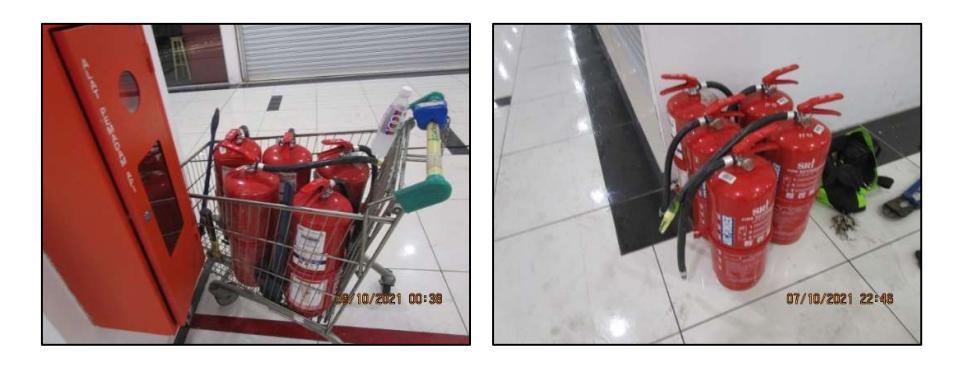
Figure 3.16: Fire extinguishers that have been used were collected to be replenished and refilled.

For this fire incident, a total of five units of fire extinguishers of ABC Powder Type were used in order to extinguish the fire.

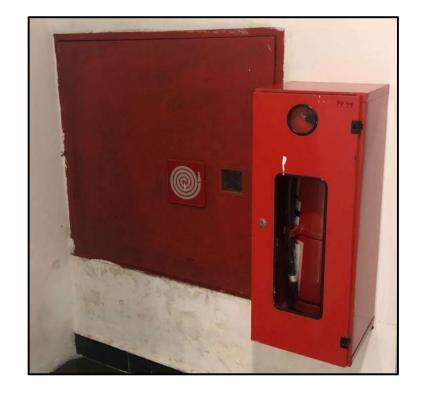
Figure 3.17: Fire Hose Reel that was used during the fire incident.

One unit of fire hose reel was used for this incident. the hose reel is located at around 50 metres to the premise involved in this incident.

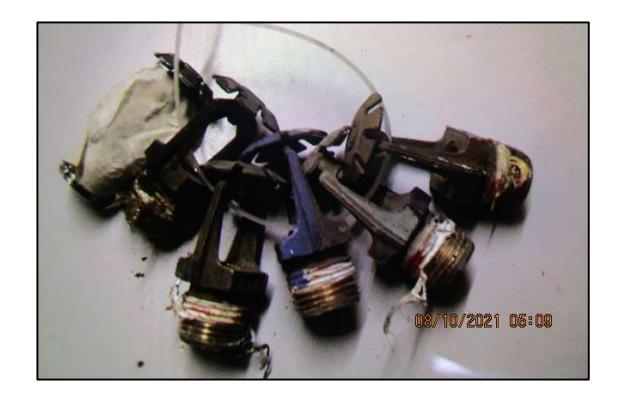
Figure 3.18: Fire sprinkler heads that burst during the incident

A total of six units of fire sprinklers were activated during this incident. The fire sprinklers were located within and in front of the involved premise.
