**DEPARTMENT OF BUILDING
UNIVERSITI TEKNOLOGI MARA
(PERAK)**

**CONSTRUCTION PROCESS OF SUPERSTRUCTURES
FOR A SINGLE STOREY HOUSE**

**Prepared by:
SARAH NADHIRAH BINTI NIZE
2017207038**

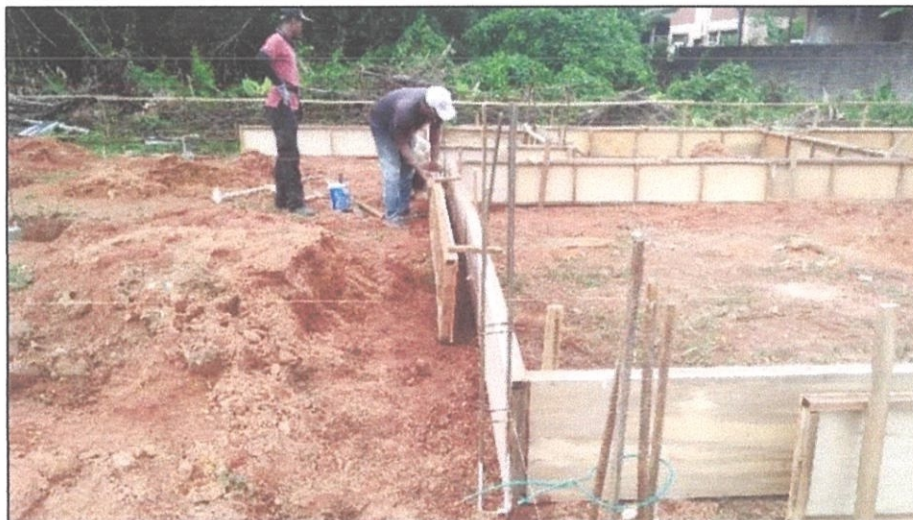
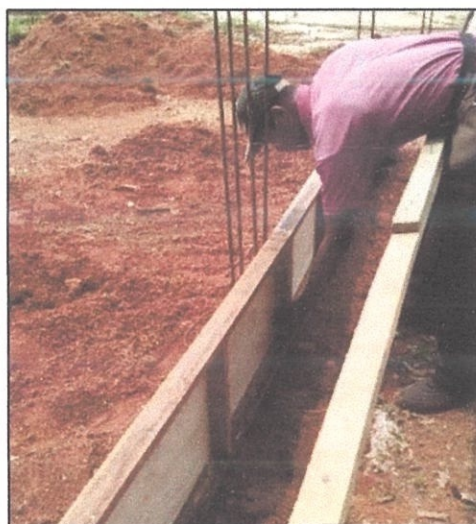
After the location of ground beam was determined and marked correctly, formwork was installed. Materials used for the formwork in this project are timber and plywood because it is easy to handle and remove. The plywood was cut based on the dimension from the drawing plan (Appendix A) before it was placed at its position. The formwork parts and connections were arranged in a way that makes formwork removal easy and simple to prevent damage to concrete and formwork panels so that it can be reused without extensive repair. Stakes were fixed on the sides of the formworks using nails to hold the form in place. Figure 3.2 shows installation of formwork for the ground beam.

Figure 3.2: Formwork Installation for Ground Beam

The formwork was strut properly and free from gap with no opening at joints to avoid concrete leakage during concreting work. The inner surface of the formwork was applied with oils to make it easier to remove the formwork later after the concrete is hardened. The installation of formwork for the ground beam took two days with three labours. Figure 3.3 shows the top view of the site project during the installation of formwork.

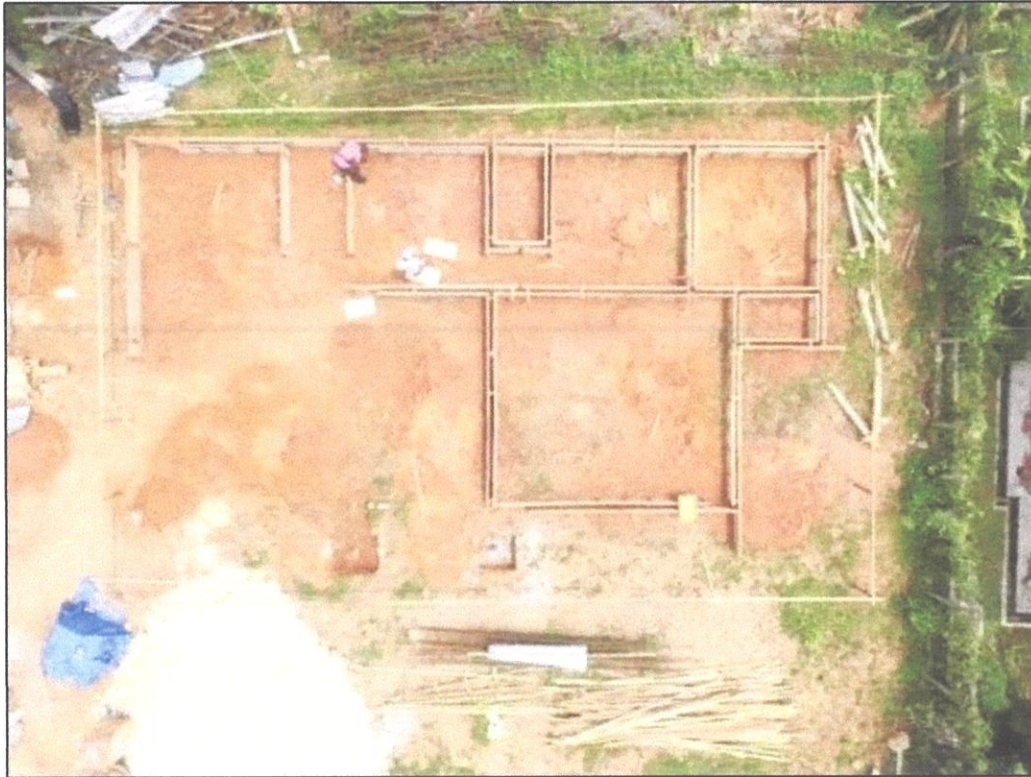
Figure 3.3: Top View of The Site During Formwork Installation

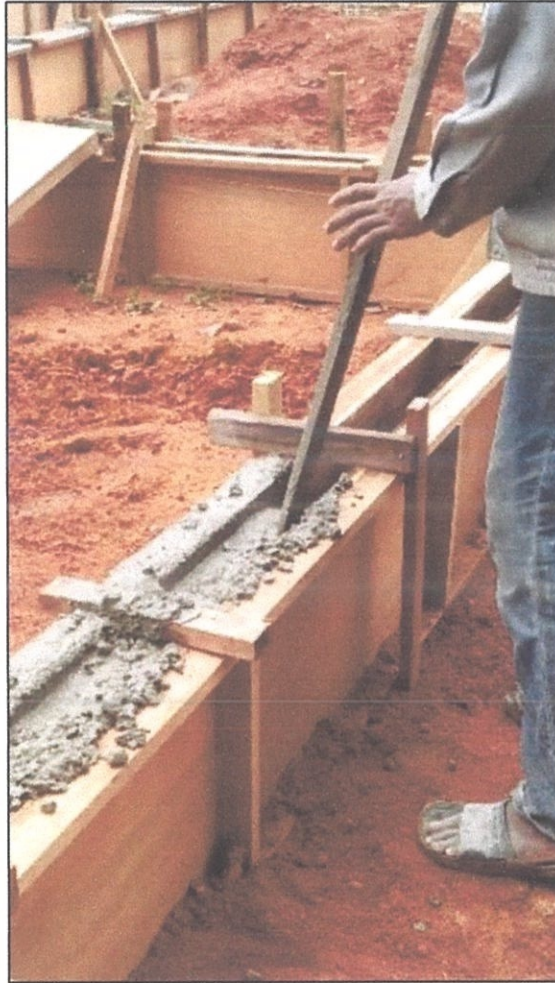
Figure 3.5: Concrete is Compacted

Then, the concrete was thoroughly compacted as shows in Figure 3.5 during the placing to ensure that it was completely surrounds the reinforcement and fills the formwork. Poor compaction of concrete can cause permeability issue which will make the steel corrosion and decrease the capability of the hardened concrete. Entrapped air was eliminated out of the concrete by knocking on the sides of the formworks and tool like finishing trowel was used to give a smooth surface of the beam. The concreting works for the ground beam take three days with four labours to complete. Figure 3.6 shows concrete is flattened on the surfaces using the trowel.

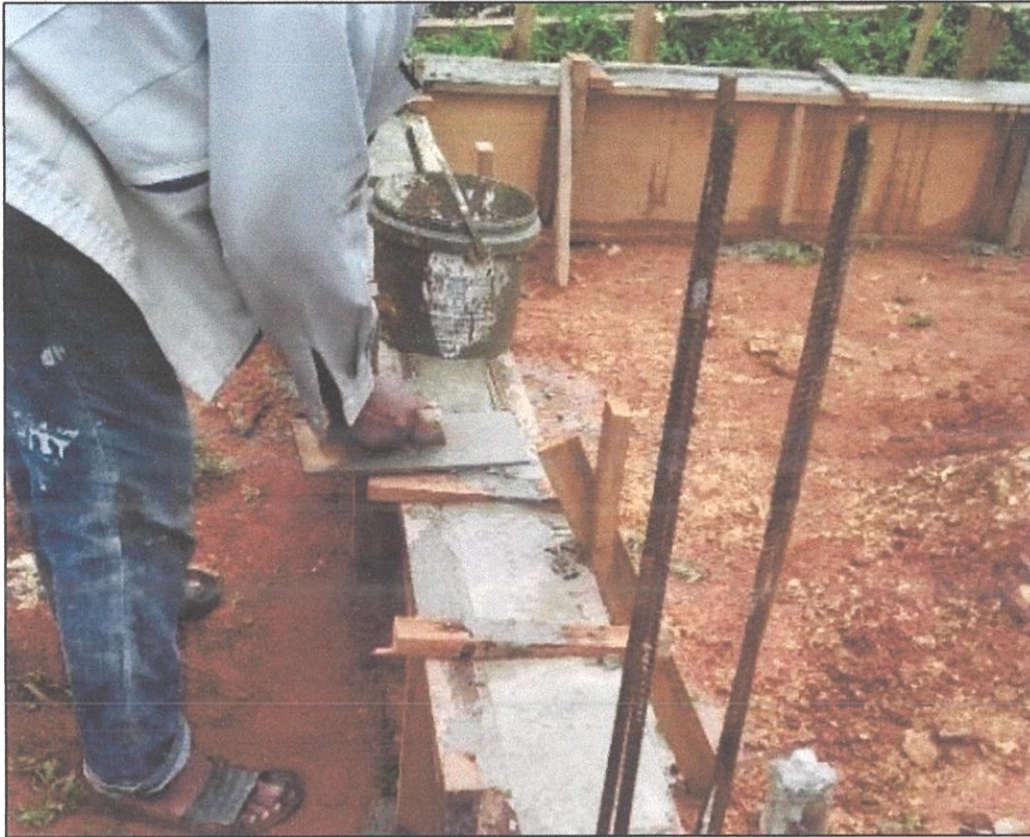
Figure 3.6: Concrete is Flattened on the Surface

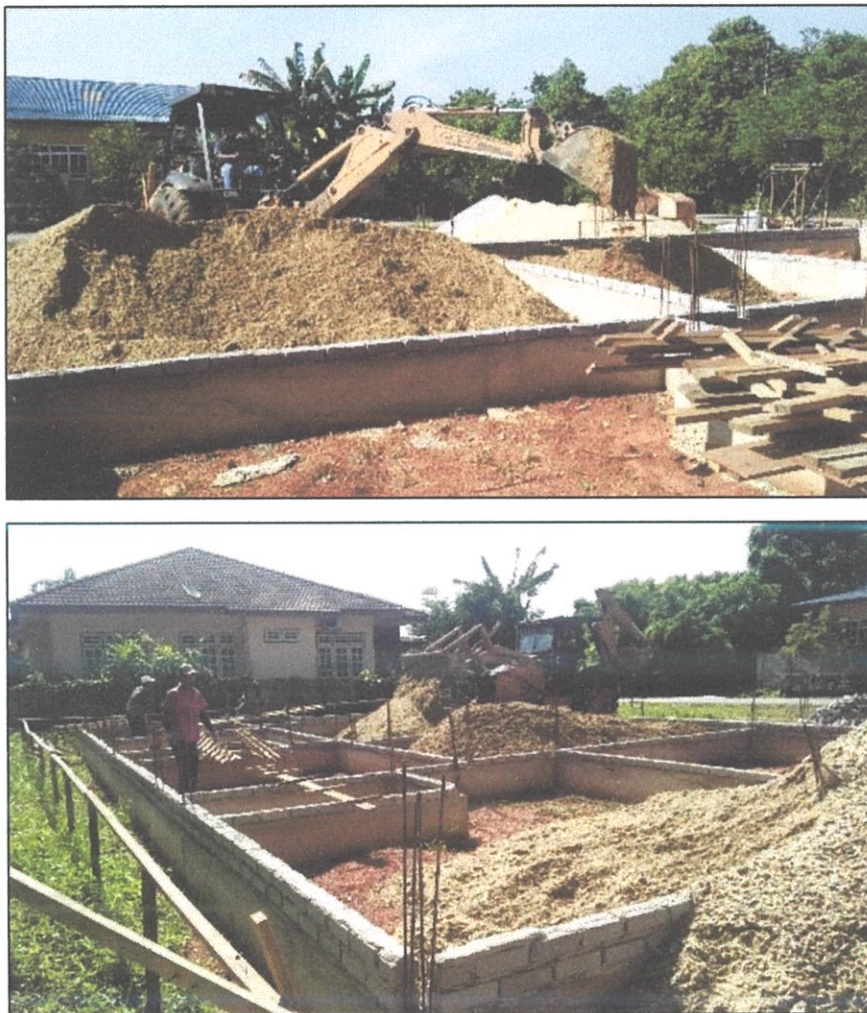
The first layer of a slab was filled with sand. The sand was spread evenly at the base of the slab with thickness 150 mm. River sand was used to provide uniformity for the slab. Backhoe was used to transport and placed the sand as shown in Figure 3.7 which was handle by a skilled labour. The sand was spread evenly using tools such as shovel. This work was done by three to four workers.

Figure 3.7: Sand Filling in The Slab Area

The sand needs to be compacted properly to prevent the concrete slab drops down. Even a small sensible amount of vibration on the earth can cause the sand to settle down and will make the structure unstable or collapse. A poorly compacted soil under a slab will end up with a hollow spot. When pressure is applied to it, the concrete will bend or stretch to fit in the hollow spot and will end up with cracks and the concrete slab drops down.

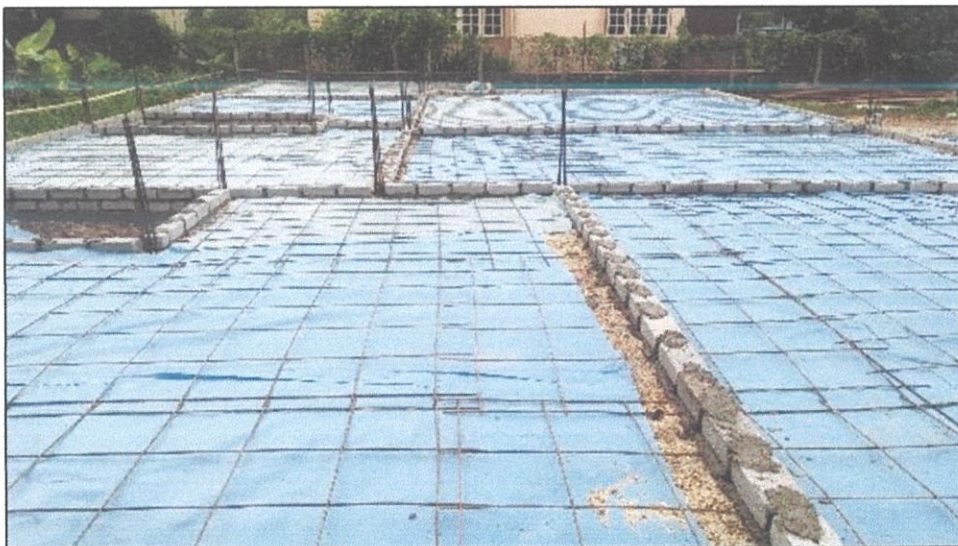
After the treatment, the sand was covered with plastic barrier before installing the wiremesh. Plastic barrier is a way to prevent the water in the concrete mix from getting into the sand layer as it can affect the water cement ratio in the concrete mix. When the water ratio is too much or too little, there will greater shrinkage with the possibility for more cracks and reduced compressive strength of the concrete. So, water ratio in the concrete mix should be at right amount to ensure that the concrete is strong enough to bear the load from the structures. This is why a plastic barrier under concrete was used for the slab. Figure 3.8 shows plastic barrier installed under the wiremesh.

Figure 3.8: Plastic Barrier Installed Under Wiremesh

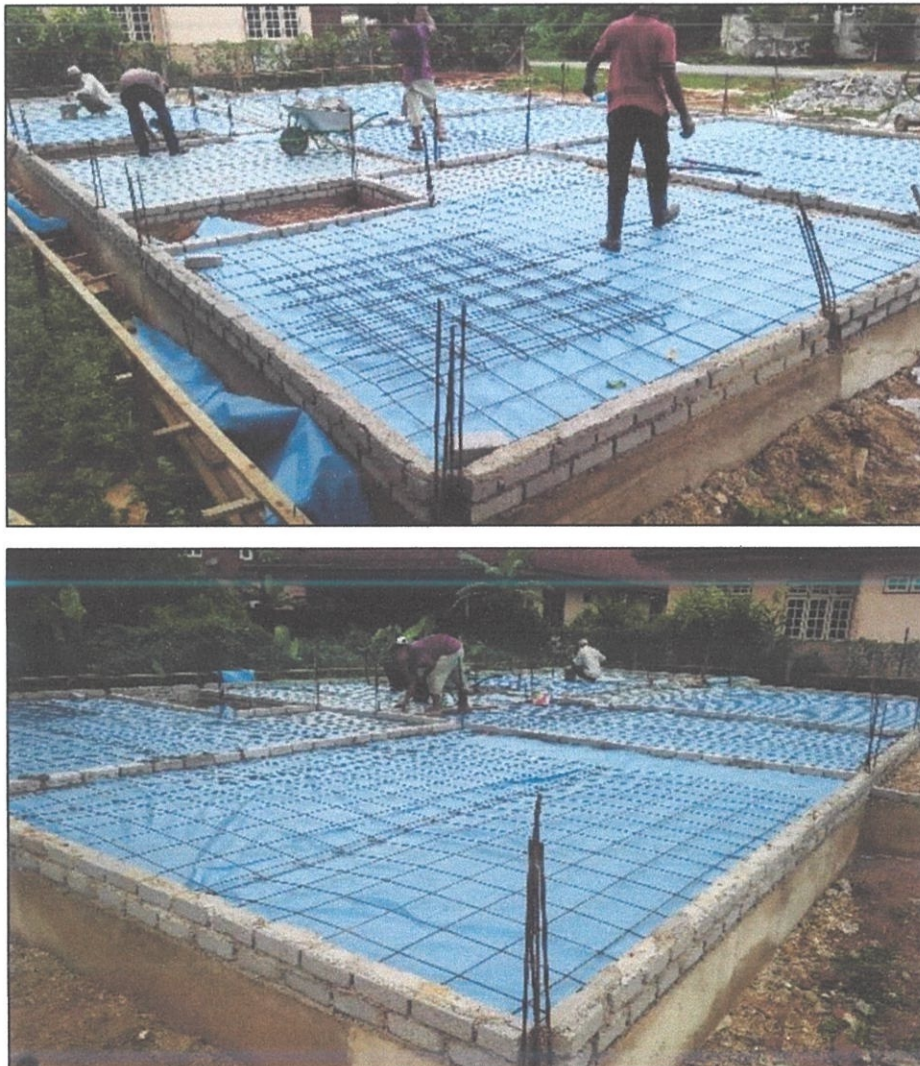
Before placing the wiremesh, concrete spacing blocks with the same height was spread throughout the slab area to ensure that the mesh was held in the center of the slab without moving as the concrete was poured. Then, wiremesh was placed on the spacing blocks. Wiremesh was used in the construction of slab to prevent cracks that form in the slab from spreading throughout the material and causing possible breakage. The wiremesh was placed overlapping one foot along the edges and it was tied together at the overlap using steel wire. It was arranged so that the wiremesh covered the entire slab area. This project used wiremesh type square mesh 8A that is 8 mm diameter of main wire with 200 mm spacing center to center. Figure 3.9 and Figure 3.10 shows the wiremesh were installed and the overlapped between wiremesh.

Figure 3.9: Wiremesh Installation

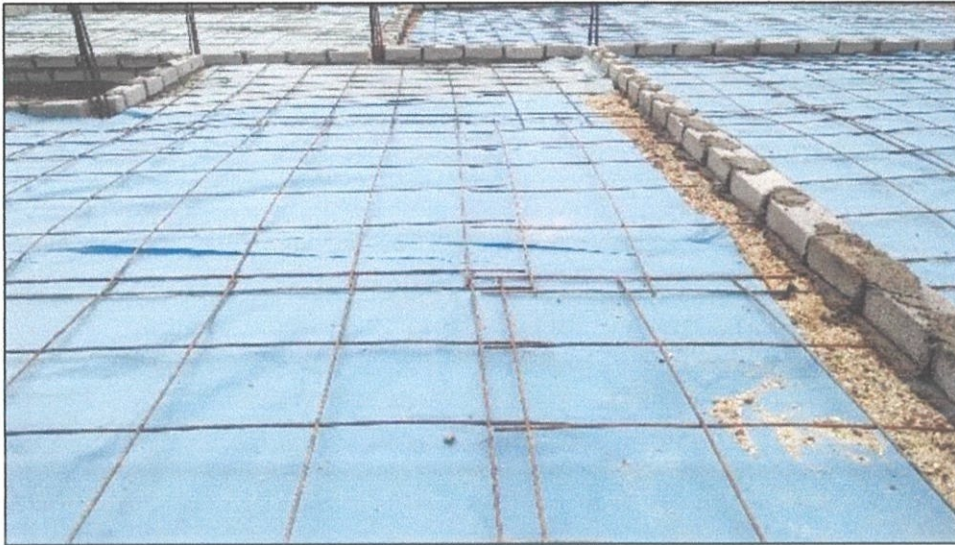
Figure 3.10: Overlapped Wiremesh

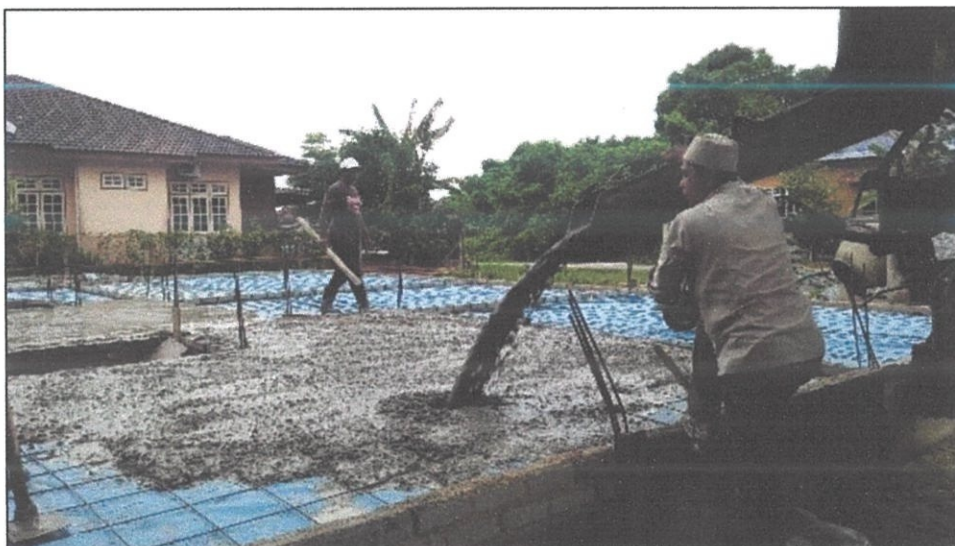
Concrete was poured and spread after finish installing the wiremesh. Ready mixed concrete was used for the slab which was poured from the concrete truck as it is time saving and save the energy of the labours. In order to avoid segregation of the concrete, it was poured as close as possible to the slab area. Figure 3.11 shows the concrete pouring for the slab.

Figure 3.11: Concrete Pouring for Slab

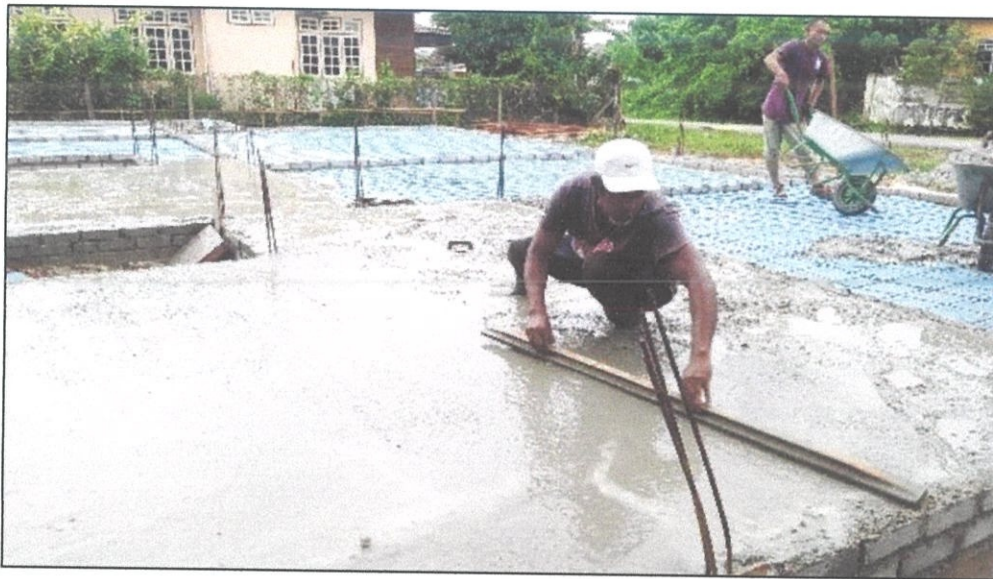
While the concrete was being poured, the concrete was spread evenly and was compacted on the slab area by three labours using tools like shovel, wheelbarrow and screed to give a good surface appearance of the slab. Figure 3.12 shows concrete spreading work on slab area. The concreting work take half of the day to completely finish. After concreting work finished, the slab was left for a day for the concrete to cure. The next work cannot be continued as long as the slab was not completely hardening. Figure 3.13 shows the slab were left for the curing process of the concrete.

Figure 3.12: Concrete Spreading

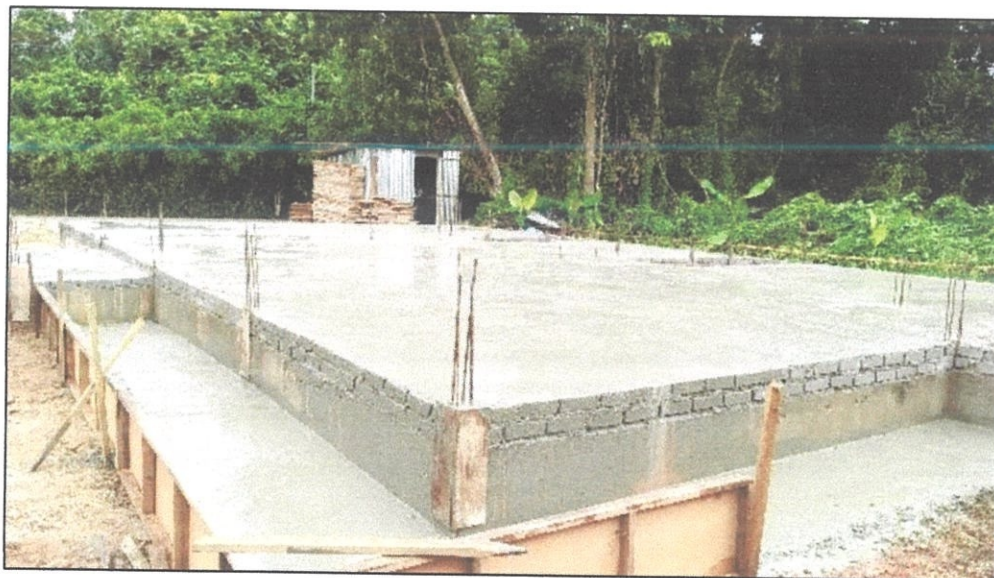
Figure 3.13: Curing Process of Concrete

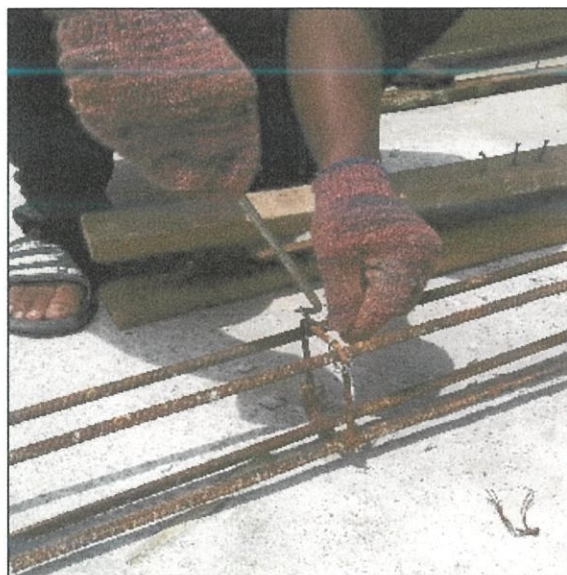
Each column has four numbers of 10 mm diameter bars as the main bar and 6 mm diameter steel that be placed 100 mm center to center spacing as the stirrups. The stirrups were tied to the vertical bar using steel wires. Type of main bar used was Y10 and R6 for the stirrup. Details of every column can be seen in column reinforcement schedule in Appendix D. The minimum lap length for column steel is 40 mm diameter. The size of the columns reinforcement bar is 10-inch x 10-inch with concrete cover 25 mm thickness. Figure 3.14 shows the stirrups were fixed the with the main bar.

Figure 3.14: Fixing Reinforcement Bar

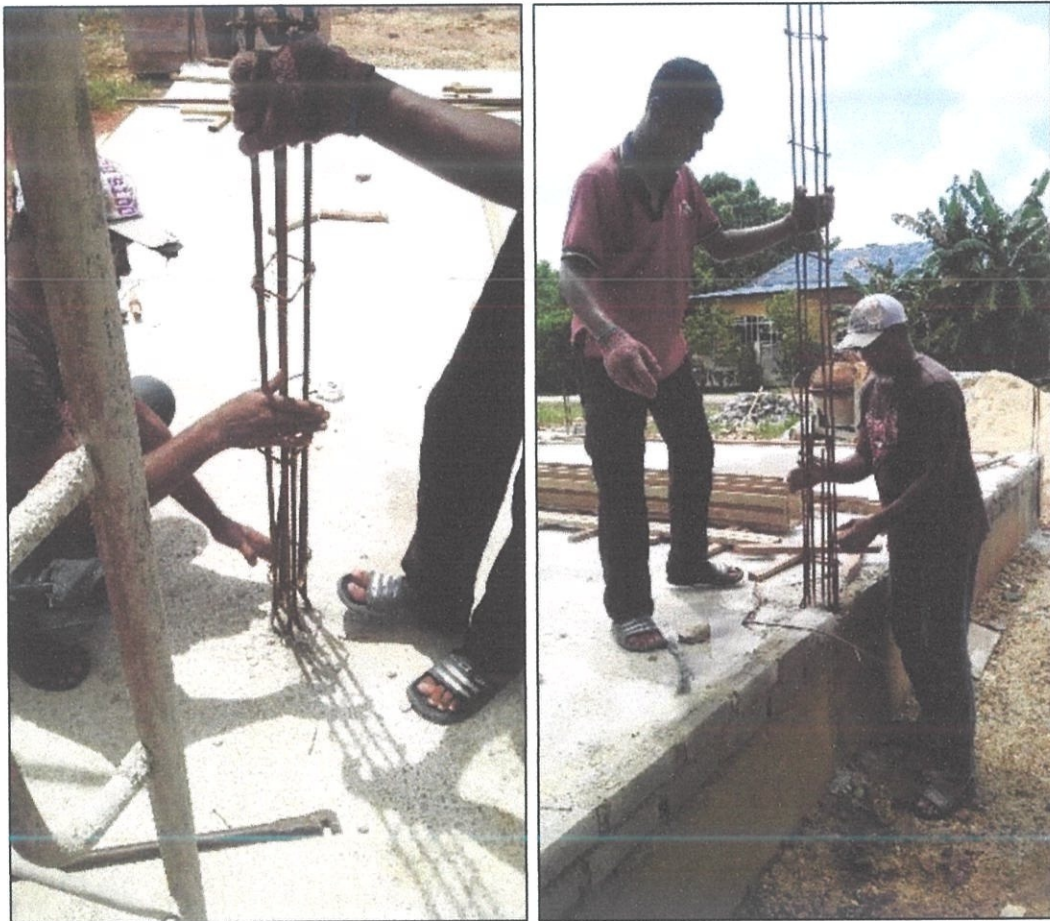
After the reinforcement was assembled, it was accurately fixed in the required position. It was tied to the starter bar vertically using steel wires to make sure that the reinforcement can stand firmly. It was also make sure that it was straight upright to give the specified concrete cover. Minimum concrete cover for column reinforcement is as per the details drawing which is 25 mm. All reinforcement was fastened before concrete was placed and secured against displacement. Figure 3.15 shows reinforcement bar installation.

Figure 3.15: Reinforcement Bar Installation

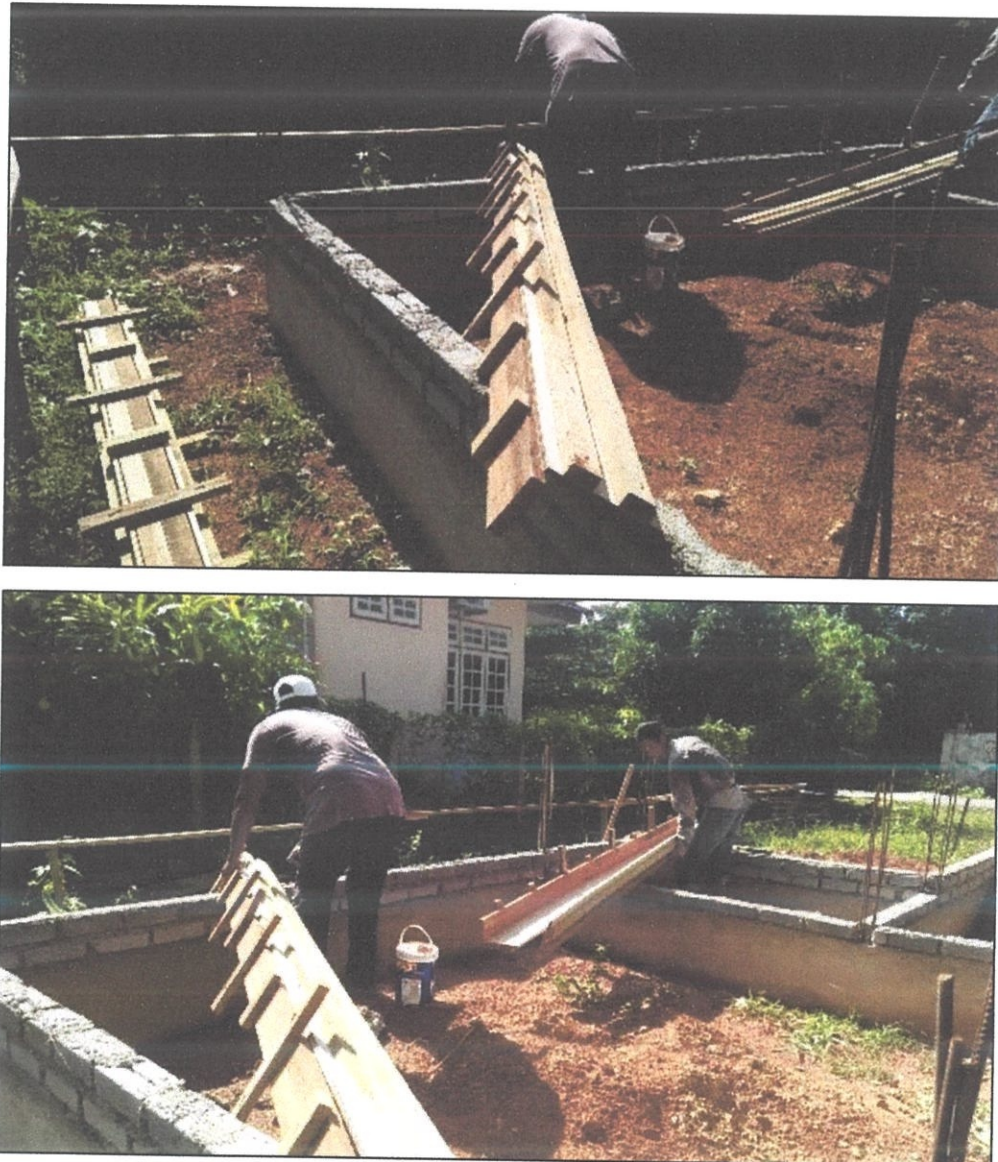
Formwork for column was firstly assembled with the first three panels of formwork. The panels were joined together using nail 75 mm length. Oil was applied at the inner surfaces of the formworks to make formwork removal easy without cause any damage to the concrete or formwork panels. Then, the formworks were installed at it place which is around the column reinforcement bar. Figure 3.16 shows assembling work of formwork for column.

Figure 3.16: Assembling Work of Formworks

Afterwards, the last panel of the formwork was joined to the rest after applying some oils at the inner surfaces. It was securely braced, supported and wedged to retain its position without displacement or deflection during the placing and compaction of concrete. Stakes were also fixed on the sides of the formworks to hold the form in place. The formwork was checked that it was free from gap to prevent any leakage of concrete during the concrete pouring. It was also make sure the column formworks were stand upright.

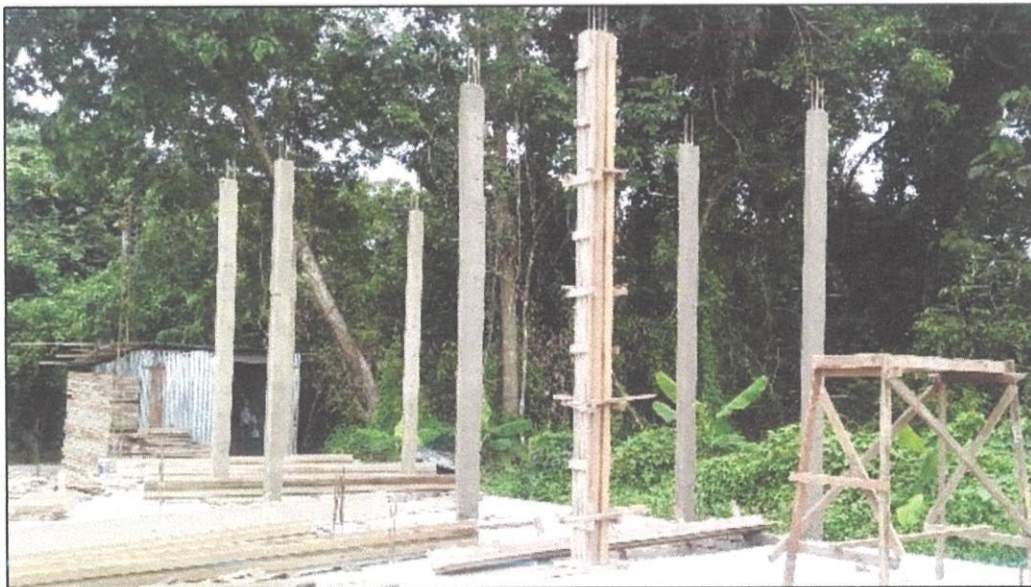
The process of formwork removal was done thoroughly to not to cause any damage to the concrete or the formworks itself. The formwork panels were cleaned to be reused to construct the remaining column. Figure 3.18 shows the concrete column after removing the formwork.

Figure 3.18: Column After Removing The Formwork

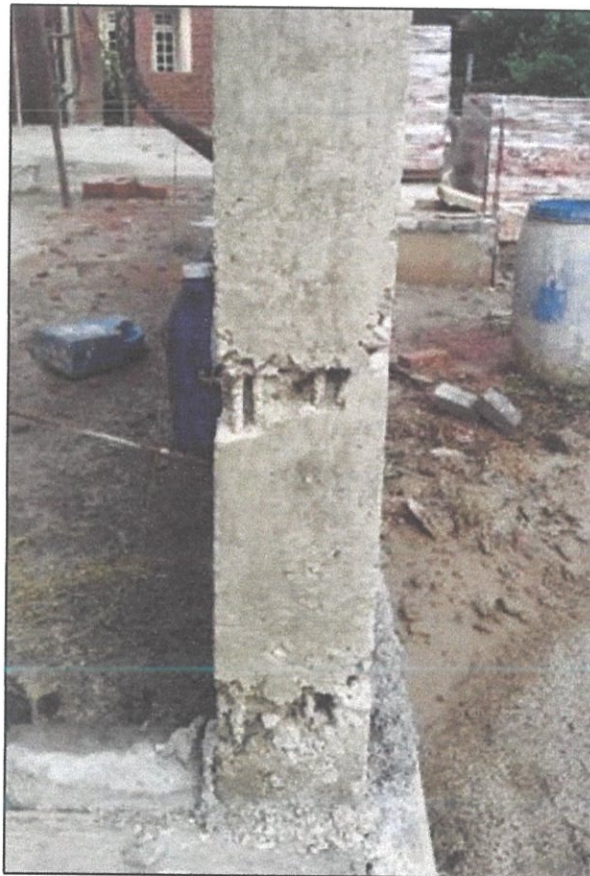
Honeycomb was found in the column because of the rain. During the concreting process of columns, it was raining and the water to cement ratio of the concrete paste were high which lead to excessive bleeding. The bleed water rises and remain trapped under aggregates and reinforcing which increase the capillary porosity and effect the density and durability of the concrete. This also happened because the concrete was not compacted properly. The small space of the formwork makes it difficult to compact the concrete. The figure 3.19 shows a spot of honeycomb happened.

Figure 3.19: Honeycomb on Column

The honeycomb was fixed by simply fill the void with concrete paste. The void was overfilled slightly. After the concrete paste has slightly harden, the excess concrete was trimmed off to give a smooth surface appearance.

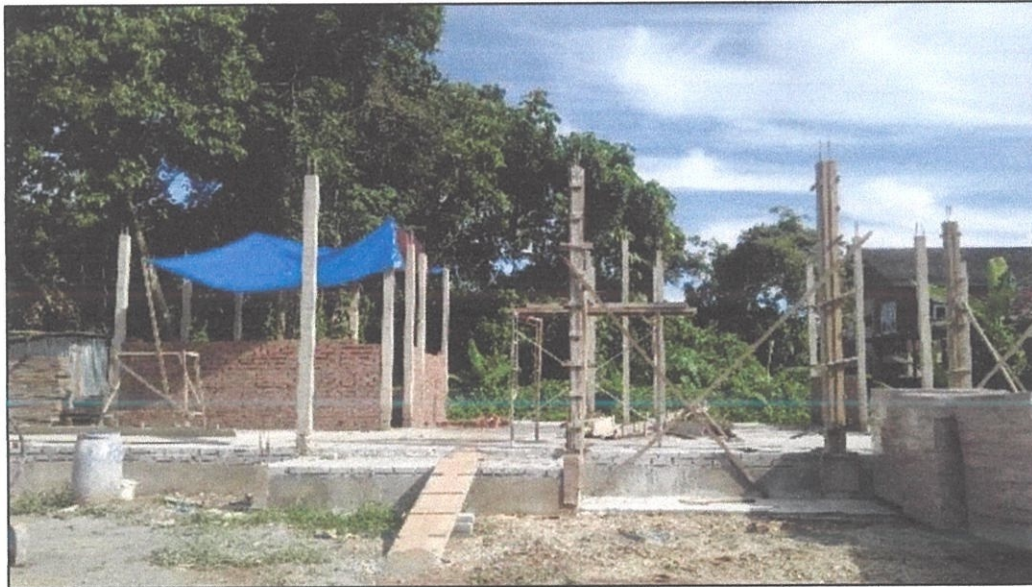
Figure 3.20: Site Condition Throughout The Delays

During the project period, there was a few miscommunication has happened between the contractor and the subcontractor. The labours were busy finishing their work at another site and did not come to work at this site project. This has caused the project to be delayed for three weeks due to the absence of the labours at site. Figure 3.20 shows the site conditon throughout the delays.

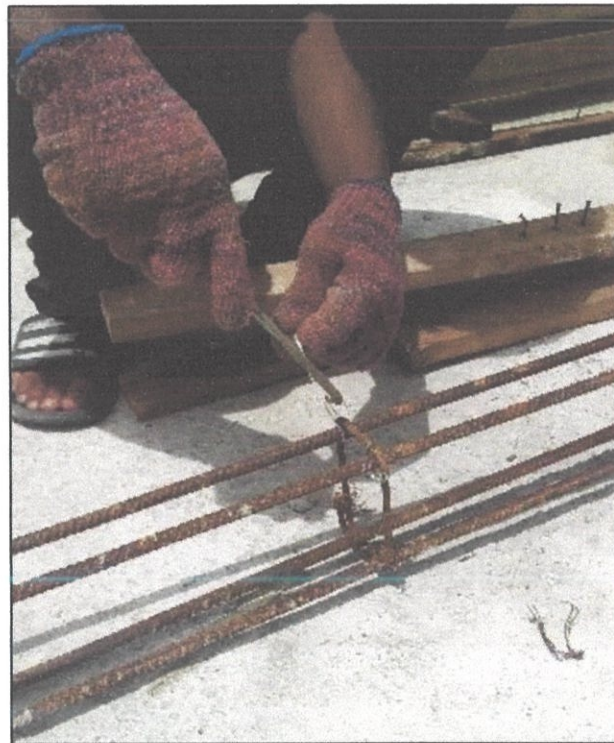
Before connecting the reinforcement bar to the starter bar for the column, the reinforcement bar was inspected. It was found that the stirrups were not fixed securely to each main bar. It was tied in the wrong way and causes the knot to lose and make the distance between each stirrups were not the same. This will make it hard to install the reinforcement bar and the reinforcement will be displaced during the placing and compaction of concrete. Moreover, it will affect the strength of the column if it is continued to install it.

Figure 3.21: Fixing Reinforcement Bar for Column

The loose knot was removed and the position of the stirrup was fixed. Then, the stirrups were tied securely to the main bar using steel wires. The reinforcement bar was checked for the last before attaching it to the starter bar for the column. Figure 3.21 shows the labour was fixing reinforcement bar for column.
