ADAPTIVE REUSE OF COLONIAL HOUSES INTO CAFÉS IN BANDA ACEH

ABSTRACT

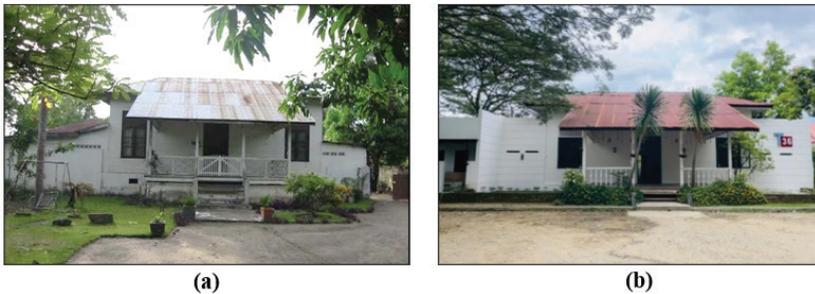
Figure 2. Café T36 Coffee (a) Before Adaptive Reuse (b) After Adaptive Reuse

The house is a single-story structure with the main portion being a wooden stilt house, while the renovated rear section features reinforced concrete. It has been transformed into a café through adaptive reuse, preserving the colonial-era facade and original architectural forms.

Category	Analysis	Changes
Period I 1970s		
Roof	Combination of central gable and pyramid on the right and left of the building, on the porch/terrace combined with a sloping roof	
Building Body	Painted white	
Openings	Symmetrical window-door openings. double-leaf doors, large window openings with louvers, and vents located 50 cm from the ceiling.	
Building Legs	House on stilts 70cm above ground level	
Ornament	There is a balustrade	
Interior Space	Changes to the addition of bathroom service space (red)	
Period II 2010s		
Roof	No change	
Building Body	No change in shape, change in repainting with orange color	
Openings	No changes, repainting the frame	
Building Legs	There was a change in ground level due to flooding, hence the backfilling.	
Ornament	Balustrade replaced with vertical arrangement and painted brown

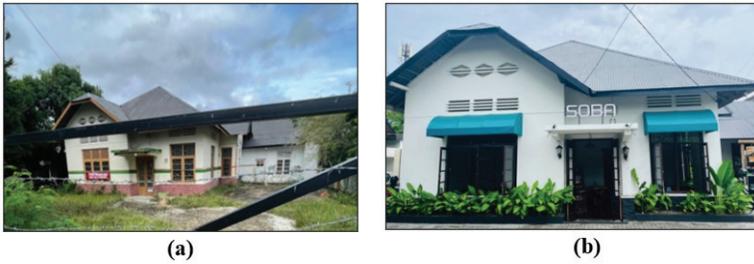
Figure 3. SOBA Café (a) Before Adaptive Reuse (b) After Adaptive Reuse
Source: Author

The building is a single-story structure made of concrete with a zinc roof, while wood is used for ventilation and window or door frames. It maintains a colonial aesthetic, evident in its large windows, double shutters, ventilation shapes, and pyramid roofs. Analysis shows that both cafés exhibit similar approaches to adaptive reuse, converting colonial houses into cafés through various renovations. Key renovations include changes to the building's artistic features, spatial patterns, furniture layout, circulation, lighting, and maintenance. These updates address damaged components, adapt the building for new functions, and enhance comfort and appeal to attract customers.

Category	Analysis	Changes
Period I 2010s		
Roof	The roof is shield-shaped, with a gavel decorated with horizontal ventilation grilles. The roof on the terrace uses a flat roof	
Building Body	Painted cream, with a horizontal accent trim added around the building in green and orange.	
Openings	symmetrical large openings, the use of double doors and large windows with iron shutters	
Building Legs	Presence of natural stone painted red	
Ornament	There are no ornaments	
Interior Space	The room is asymmetrical but still forms a grid. There is a corridor next to the building

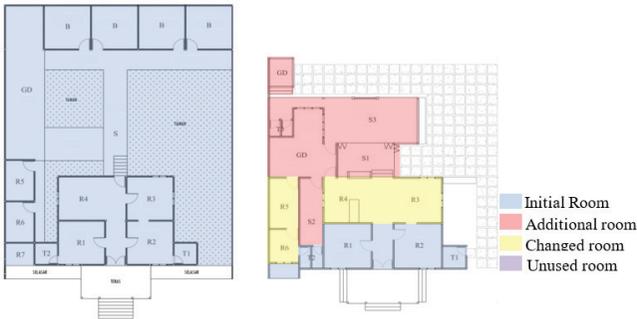
Figure 5. Plan of Changes of Room Function for Café T36 Coffee (Before and After Adaptive Reuse)

After analysis, Café T36 Coffee's room functions were updated: bedrooms (R1 and R2) are now private seating areas, bedroom (R3) is also a seating area, and the former family room (R4) is now a bar and cashier area. Small rooms and storage (R5, R6, R7) have been converted into a café office, employee break area, and storage.

<ul style="list-style-type: none"> -Rooms R1 and R2 were transformed into visitor areas. (red). -The study room (R3) was transformed into a visitor area (green). -The communal room (R4), formerly a family room, was repurposed as a bar and cashier area. (blue). -The small rooms (R5, R6, and R7), once bedrooms and storage, are now office space for the café. (yellow). The corridor and storage area (S and DG) were expanded to include a kitchen, a semi-outdoor seating area, and a prayer room (orange). <div style="text-align: right; margin-top: 10px;"> <ul style="list-style-type: none"> ■ Initial space ■ Additional space ■ Change space ■ Space not utilised </div>

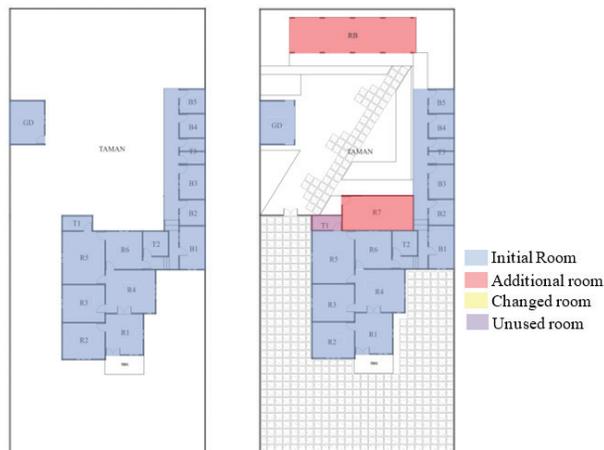
Figure 6. Plan of Changes of Room Function for SOBA Café (Before and After Adaptive Reuse)

At Soba Café, former bedrooms (R2, R3, R5) are now customer seating areas. The living room (R1) was converted into a private room for large groups. The family room (R4) is now a snack bar and cashier area. The kitchen (R6) remains unchanged, while the bathroom in the bedroom (T1) is out of order due to plumbing issues. Separate cubicles connected by a corridor are now used as employee areas.

<p>The SOBA Café building has not undergone any changes</p> <ul style="list-style-type: none"> -Room functions were updated by converting the living room (R1) and bedrooms (R2, R3, R5) into seating areas (red). -The family room (R4) was converted into a bar area with snack displays and a cashier desk (yellow). -Room (R6) is used as a kitchen, retaining its original function. -A new space was added as an outdoor bar area (orange), and the landscaping of the backyard was arranged (blue).
