# A Comparative Evaluation of Pedestrian Facilities Outside Schools: Current Conditions Against Design Guidelines

This study assesses the condition of pedestrian facilities outside school areas by comparing the findings from site observations with established design guidelines derived from national and global practices. The research uses qualitative data from site observations conducted in five (5) primary schools in Shah Alam. School selection was based on similar socio-economic characteristics, land use, and geographical proximity. The findings indicate that the existing pedestrian facilities significantly fail to meet the requirements outlined in current design guidelines. Critical deficiencies include inadequate infrastructure, poor maintenance, and the presence of obstacles that hinder safe pedestrian movement. Furthermore, the analysis reveals a lack of proactive oversight and maintenance by the responsible authorities, exacerbating safety risks for schoolchildren and community members who use the facilities. This paper highlights the urgent need for improved design, regular maintenance, and increased investment in pedestrian infrastructure to enhance safety and accessibilit

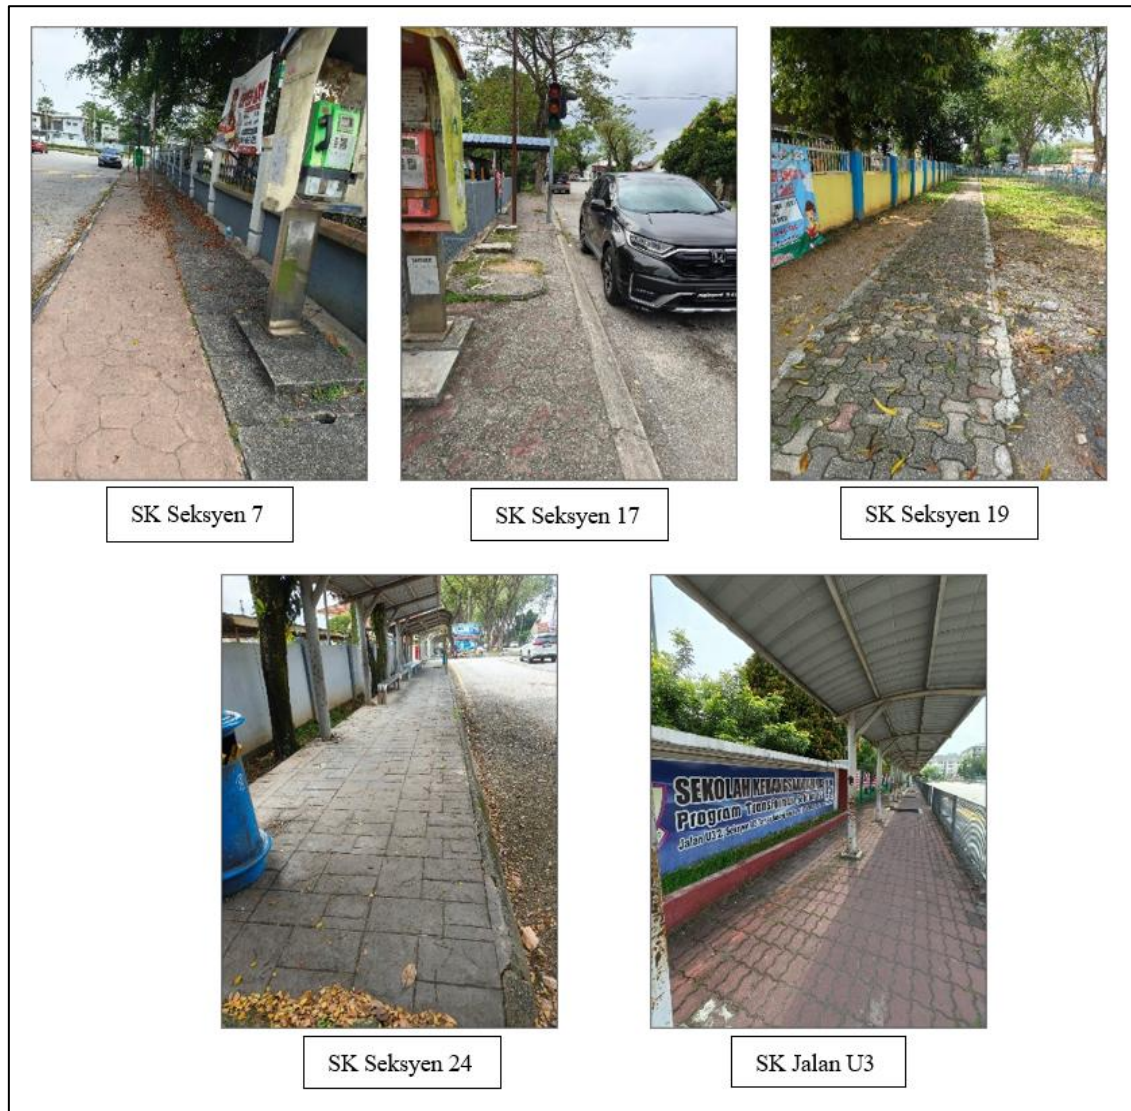
Fig. 1. (left) This Figure is Blurry, which is Unacceptable; (right) This Figure has a Higher Resolution

The site observation revealed a notable absence of dedicated street lighting for pedestrian facilities. This condition has raised concerns regarding safety and visibility among individuals using the pathways, especially at dark. Currently, the existing streetlamps are positioned along the road shoulder and are primarily installed to serve vehicular traffic, necessitating a shared lighting arrangement. Based on the researcher's experience walking in that area at night, the installed streetlamps do not adequately illuminate the pedestrian areas. This situation may lead to increased risks for pedestrians, as they may be less visible to drivers and face challenges navigating the pathway in low-light conditions.

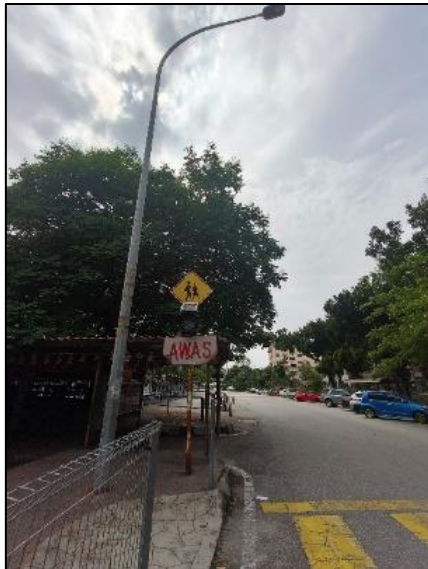
Fig. 2. Street Lighting at SK Seksyen 7

Furthermore, the distance between the road lights and the pedestrian facilities further exacerbates the issue, creating areas of shadow that could deter usage and compromise safety. During the site observation, the distance between road lighting measured is between 30 and 49 meters, which is too far apart. Therefore, to enhance pedestrian safety and encourage greater use of these facilities, it is imperative to consider installing dedicated lighting solutions at reasonable distances that prioritise the needs of pedestrians.

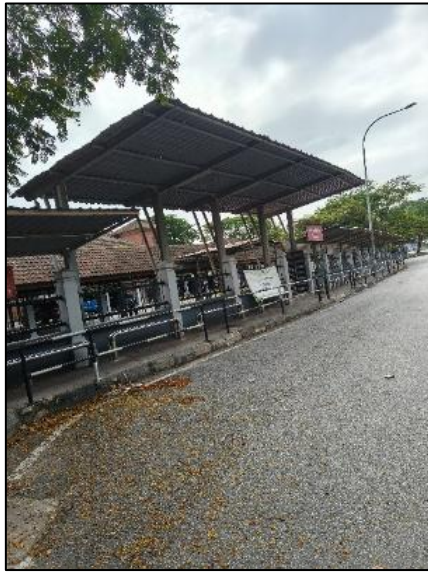
Fig. 3. Covered Walkway at SK Seksyen 7

Besides, the requirements of roofs on footpaths must be considered to ensure well-lit pathways that promote a secure and inviting environments for all users. All sidewalks within the designated school district should have roof covers to protect school children from the weather. These sheltered sidewalks are essential for the comfort and safety of children, helping to discourage them from loitering in inappropriate areas. However, the site observation revealed that the pedestrian facilities lack adequate protection from the elements, as no roofs or covered walkways are in place. The open-air design exposes pedestrians to the direct effects of weather conditions, such as rain, sun, and wind, making the walking experience less comfortable and potentially discouraging usage during inclement weather.

Moreover, the absence of a covered walkway also contributes to the poor lighting conditions observed along the pedestrian facilities. Without a roof or overhead structure to reflect and distribute the available light, the pathways remain dimly lit, particularly in areas where streetlamps are sparsely placed or inadequate. As a result, this combination of open-air exposure and insufficient lighting can create an unwelcoming environment for pedestrians, potentially compromising their sense of safety and security, especially at night or in low-light conditions. Thus, to enhance the usability and appeal of these pedestrian facilities, it is crucial to consider the installation of covered walkways or roofs that not only provide shelter from the elements but also help to improve lighting conditions along the pathways, creating a more inviting and accessible environment for all users, including schoolchildren.

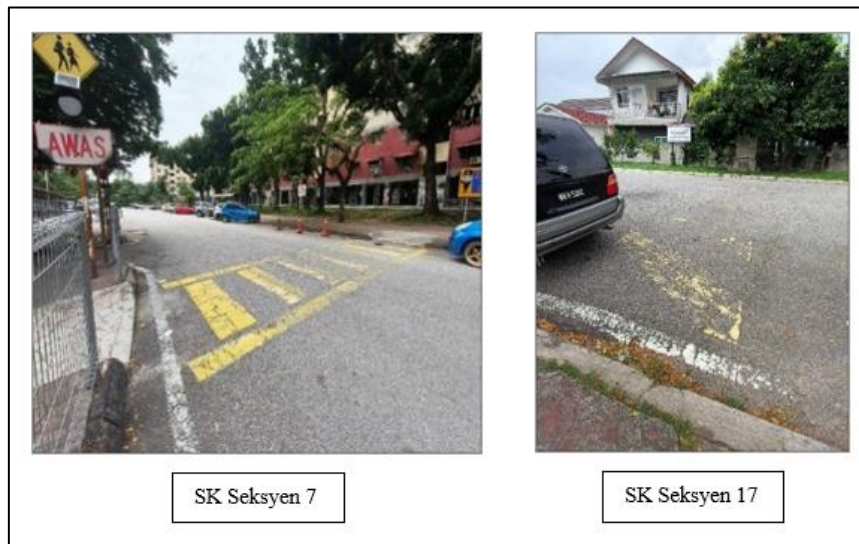
Fig. 4. Pedestrian Crossings in front of SK Seksyen 7 and SK Seksyen 17

Figure 4 is an image of pedestrian crossings located at SK Seksyen 7, which have clear markings compared to the crossings in SK Seksyen 17, which have unclear markings. Based on the above figure, it can be observed that the responsible authorities did not adequately maintain the existing facilities due to unclear road markings. The absence of clear markings may lead to confusion among pedestrians and drivers, potentially resulting in road accidents. It is particularly challenging for those individuals who are visually or mobility-impaired. This group may lack the necessary cues to navigate safely. Therefore, providing pedestrian crossings with high visibility to approaching other motorised users is essential, possibly using warning signs and traffic calming measures. Furthermore, this type of crossing typically does not prioritise pedestrians, requiring them to judge when it is safe to cross. Even though they can facilitate a smoother traffic flow, they pose significant risks, especially in areas with higher traffic volumes or speeds.

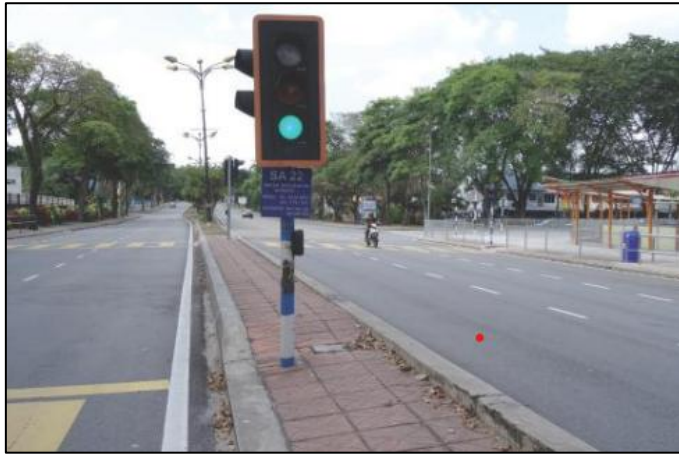
Fig. 5. Example of a Two (2) Level Crossing

A two (2) level crossing is a level crossing equipped with traffic lights, typically located on a wide road (double road with a road divider). It is generally built in urban areas, and its application is almost the same as that of a single-level crossing, where pedestrians must push a button on the traffic light pole provided before crossing (first time) and after crossing the road divider to proceed (refer to Figure 5). In other words, pedestrians will cross the road in stages while reducing waiting time for different users.

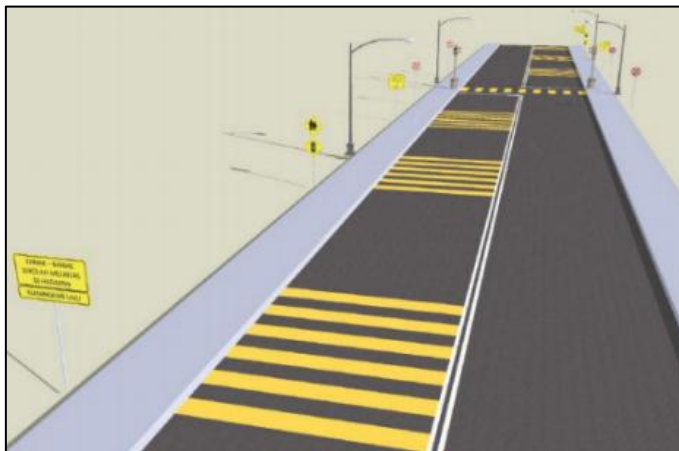
Fig. 6. Sketch of Signalised Pedestrian Crossing at School Zone

According to the Road Engineering and Geotechnics Department (2014), a level pedestrian crossing with traffic lights located outside the school area only should be built based on the existing standard design, which is referred to as Signalised Pedestrian Crossing School Zone, Drawing Number KPKR/J/R/STD AM 222-1 dan AM 222-4 (refer Figure 6).

Besides, there are several essential characteristics of signalised crossings, such as the number of traffic light poles installed is sufficient (minimum of two (2) poles), installing related notification and warning signs (traffic light crossing), and making it adequate and integrating the construction of pedestrian crossings with the construction of footpaths (existing tactile surfaces and curb ramps for crossings areas) and street lights. Additionally, the minimum distance between pedestrian crossings is 400m, taking into account the need for street lighting installation, particularly when there is pedestrian crossing activity at night. The sketches of pedestrian crossings with traffic lights are shown in Figure 6.1.

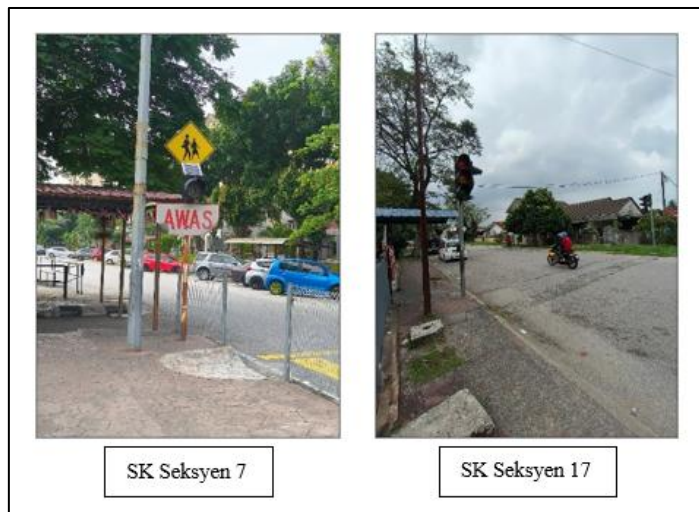
Fig. 7. Traffic Light in SK Seksyen 7 and SK Seksyen 17

Figure 7 shows the existing condition of pedestrian crossings in front of SK Seksyen 7 and SK Seksyen 17. Based on the observations, the traffic lights were not functioning in most school zones the researcher observed. There is no signage to notify of the presence of traffic lights provided, and the provision of traffic

lights does not meet the design standard set by the Road Engineering and Geotechnics Department. In the areas where traffic lights are not functioning, pedestrians are left to navigate the roads without any automated assistance. This situation can be particularly hazardous, as vehicle users may not expect pedestrians to cross without the guidance of traffic signals. School children who walk may feel uncertain about when to cross, leading to hesitation or risky behaviour.

Based on the current scenarios, local authorities must promptly address the issue. Temporary signage or manual traffic control may be proposed to guide pedestrians and other road users until the traffic lights are necessary. The researcher was informed that a guard assistant is appointed to control the traffic in front of the school, but this is not enough to ensure the safety of walking schoolchildren.
