UNIVERSITI  
TEKNOLOGI  
MARA

OCTOBER 2013

**Entitled:**  
**THE CONSTRUCTION OF IN-SITU CONCRETE STAIRCASE**

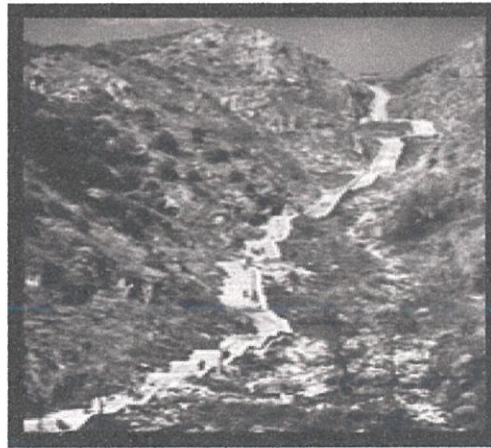
Figure 3.2: The early stair in the mountain.  
Source : <http://www.elevestairs.com>

However, the stairs also were used for the religion purpose. In China, the early stairs believed was used as the path to God and connection between earth and sky. These stairs were built by rock that was arranged in the valleys of mountains (as shown in figure 3.2). Other examples of stairs built for religious purposes are: the biblical Jacob's ladder, the tower of Babel, and the pyramids of Egypt (“The History of Stairs”, 2003).

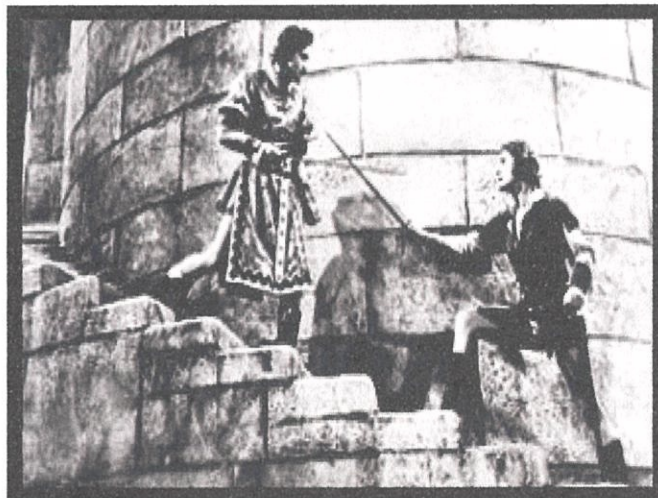
Figure 3.3: The spiral stairs in the castle.  
Source : <http://www.elevestairs.com>

The other purpose of the stair in ancient times was also for the military reasons. The best example was the construction of spiral stairs for the fort and the castle (as shown in figure 3.3). The spiral stairs was crucial in the defense towers because of the spiral shape will utilized the space as well provide access to the top. The Dark Ages were the great example of era that used a lot of spiral stairs in for military. This is because there were a lot of war and the fort become the best defense from the enemies. The shape of spiral stair was not casual but its allow strategic positions to the knights that defends the castle. The stair was designed with no railing component. It gives advantages to the soldier at the top to push enemies that march through the castle tower. The aim to push enemies towards the edge . Besides, these soldiers would have a lot of space to move his sword freely towards the enemy. While the soldier at the bottom will hit the wall many times, this is because the part range of the moves would be blocked by the right side ("The History of Stairs", 2003).

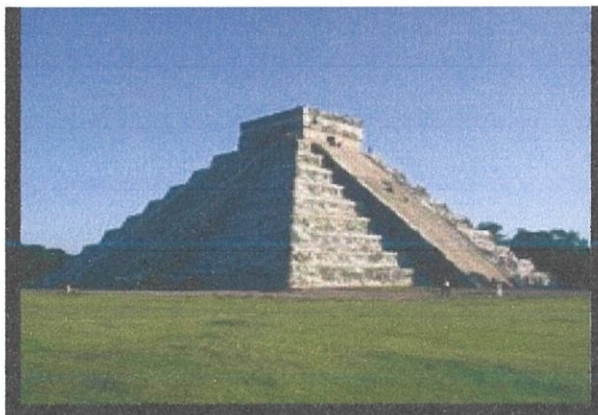
Figure 3.5: Castillo Stair, Chichén Itzá Mexico

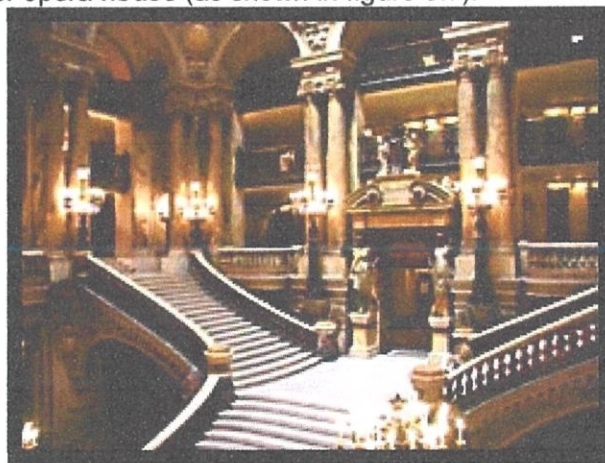
Figure 3.7: Paris Opera and Theater, Venice

According to John (1992), the composite stairs is a combination of helical or straight stairs with landings as a coupling. Usually these stairs were used in the majestic place such as government building or opera house (as shown in figure 3.7).

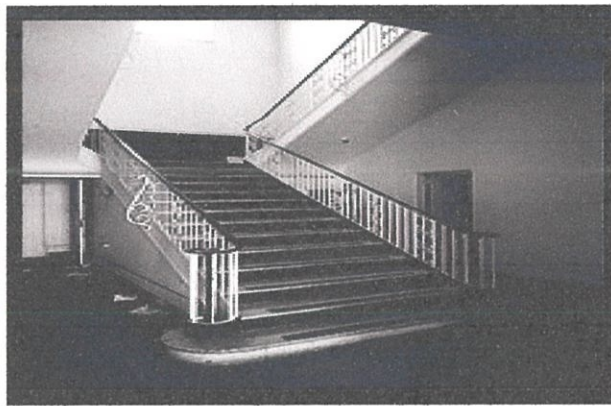
Figure 3.8: A Modern long stair

The end of the nineteenth century is known by many as the golden era of construction of stairs. The development of a mathematical system for calculating stairs and handrail was become important things in those era. The result was the precision and accuracy in calculating the riser, tread and landing of the stairs. Apart from that, the trend also leads to the art of the stairs from wood, metal, glass and stainless steel (as shown in figure 3.8). The new material to construct the stairs gives a sleek and futuristic looks (“The Twentieth Century, Modernism, and On”, 2008).

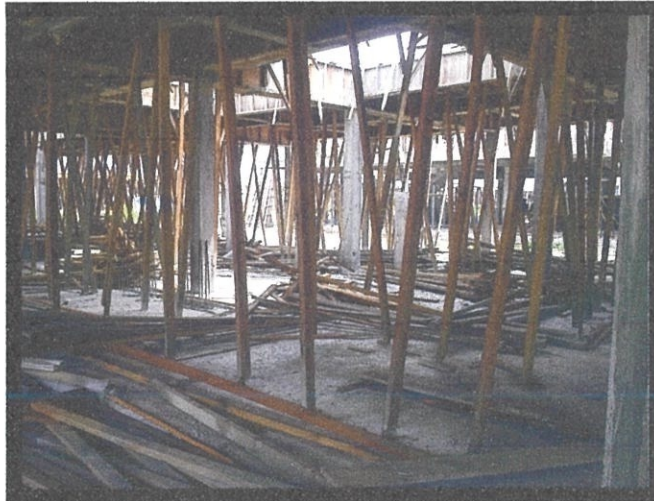
Photo 3.3: The view of the area which the stairs will be constructed

The area to construct the stairs needs to be cleared. Removes any forms, wood panels, plastic sheets, and steel from the area ( as shown in photo 3.3). Make sure that the foundation as the base to the stairs is flat. It was important to make sure the structure is stable because it will carry dead load of the people. Besides, this flat surface will ease the workers to build the stairs. After that, calculate the elevation, the height of one floor to the others. Measure the horizontal distance the staircase will span. Measure the width of each step from left to right area where the staircase will go. This calculation was stated in the appendix A.

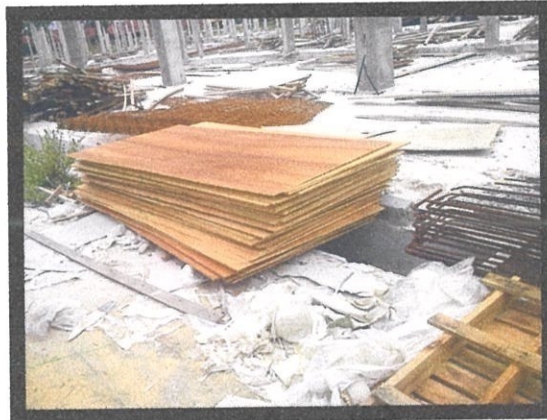
Photo 3.4: The low grade timber board which will be cut and shaped

The next process of the construction works was to build the formwork. The formwork used to shape the tread, the riser and also the string of the stair. The material of the formwork can be made from scrap or low grade timber (as shown on the photo 3.4). Usually the forms can be used several times. So, there no need to cut the new forms from the lumber board and it will speeds up the process. However, these would result to the low quality of the concrete stair surface. Usually, the workers used the chainsaw to cut the board into several pieces as the chainsaw provide nice cutting edge and easy to handle.

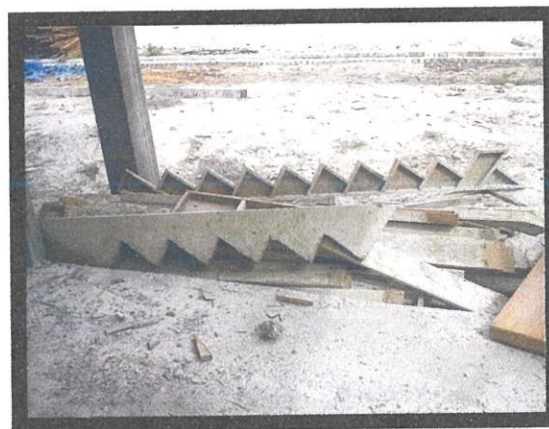
Photo 3.5: The side forms which cut from the timber boards

After the timber board was cut. There will be several shapes of formwork. There was half zigzag shape which used as the side forms (as shown in photo 3.5). Then, there was also long rectangular timber panel which used to shape the riser of the stairs.

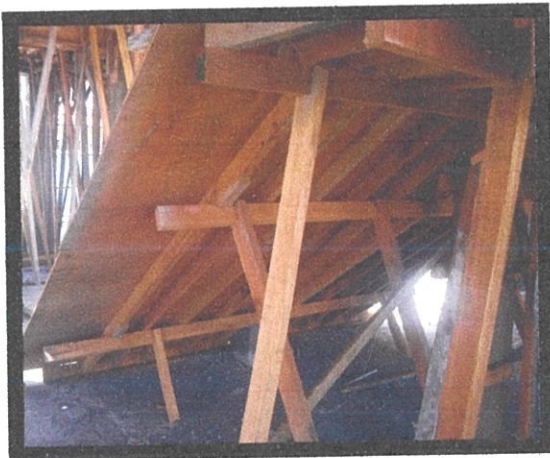
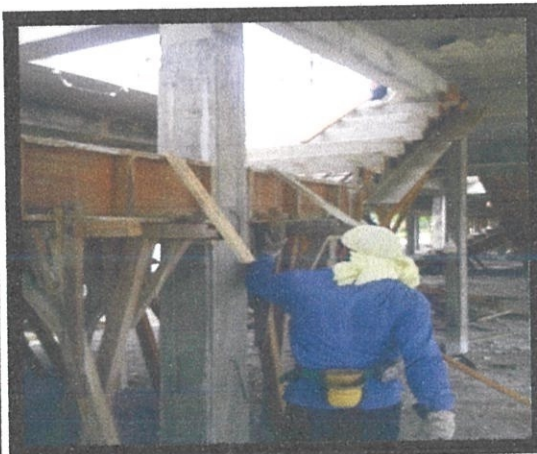
To support the formwork, the wooden braces were installed under the forms (as shown in photo 3.7 and 3.8). This also will avoid the outward movements when pouring the concrete.

Photo 3.7: The wooden bracing which supports the forms

Photo 3.8: The worker installed the wooden braces

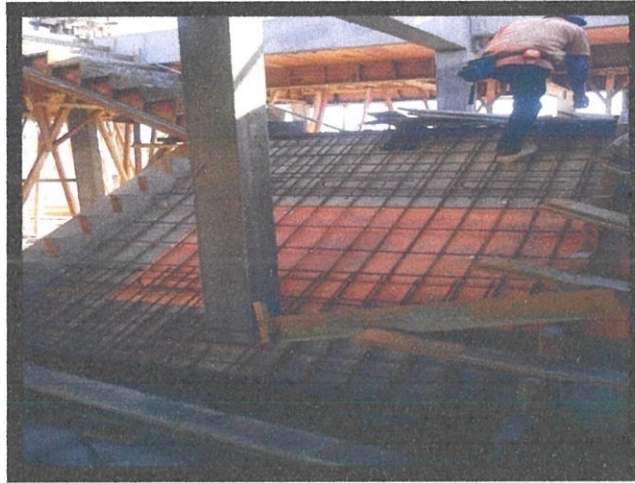
Photo 3.9: The worker installed the reinforcement bar.

Then, next step was to install the reinforcement bar to the formwork (as shown in photo 3.9). The type of reinforcement bars used for this construction were Y10 1nd Y12 (as shown in appendix A). For the landings the reinforcement bar was installed by two way overlapping .While the rest of the stairs we installed by one way overlapping. The main objective for installing the reinforcement bar was to increase the strength of the stairs. The stairs will be able to withstand with heavy dead load.

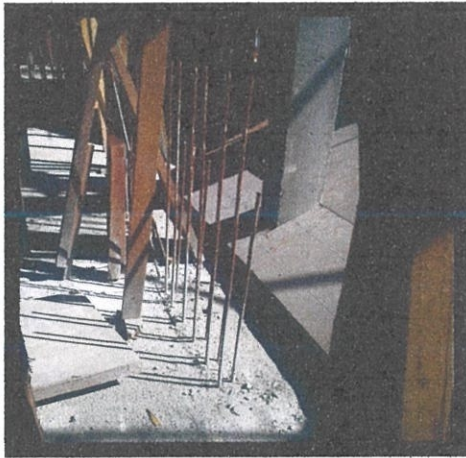
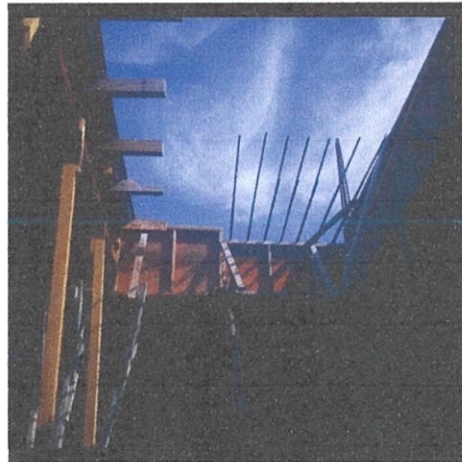
The reinforcement bar was installed by connecting it with the bonding bars(as shown in photo 3.10 and 3.11). The bonding bars connect the staircase structure to the first floor and ground floor.

Photo 3.10: The bonding bars at the ground floor.

Photo 3.11: The bonding bars at the first floor

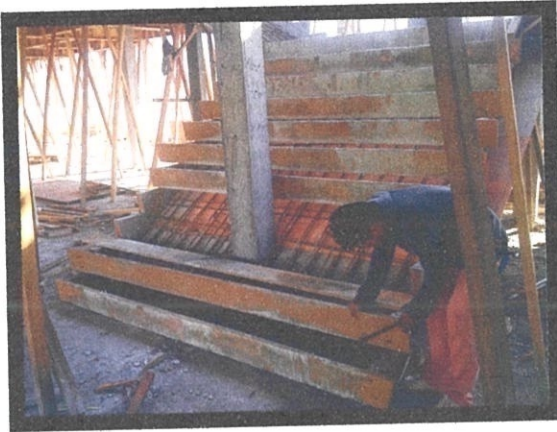
Photo 3.12: The workers installing the timber panels

After the process of installing the reinforcement bar is done, the timber panels can be installed (as shown in photo 3.12). These panels will form the shape of the tread and riser when the concrete was poured. The height of the panel must be equal to the height of the riser. The panel was installed to all the flight of the stairs. Beside, these panels also form the shape of the landings (as shown in photo 3.13).

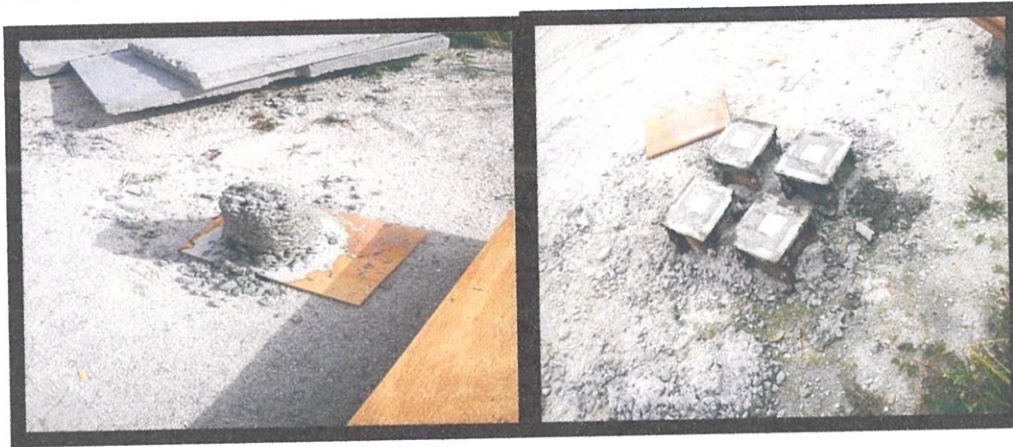
The concreting process is the most important method on this construction work. The workers would do the work carefully to avoid any mistake during the process. This was because the repairing process after pouring concrete was difficult to handle. The amount of concrete needed to cover the staircase area was 15 metre cube. The suitable grade for the concrete was grade 25. The slump test must be carried out at the site (as shown in photo 3.25). The slump must be follows the specific slump of 75mm+ or -25mm. If the slump collapse, the concrete would be rejected by site supervisor. Besides, the cube test also was carried out to test the strength of the concrete (as shown in photo 3.16).

Photo 3.15: The slump test of concrete

Photo 3.16: The cube test of the concrete

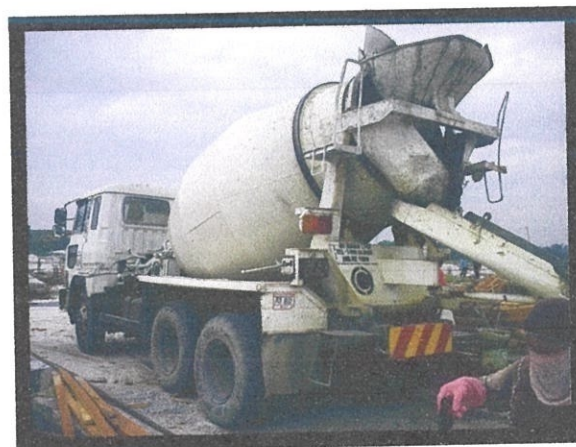
Photo 3.17: The concrete mixer lorry

Apart from the workers, the machineries also had crucial part to complete the concreting work. The concrete was carried by the mixer lorry from the batching plant (as shown in photo 3.17). However, the lorry can carry only 6 metre cube of concrete. Therefore, to fulfill the total order of 15 metre cube, the site supervisor had ordered several lorries from the batching plant.

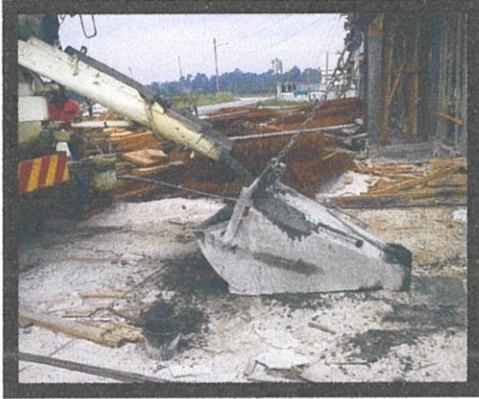
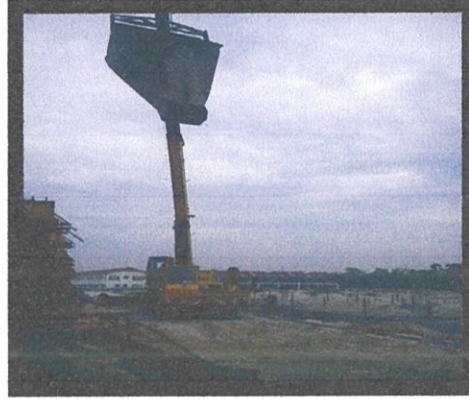
From the mixer lorry, the concrete was poured into the concrete bucket (as shown in photo 3.18). The bucket was attached to the chain which will be lifted by the mobile crane (as shown in photo 3.19) There was simple equation in which the 3 bucket full of concrete equal to 1 metre cube of the concrete. Therefore, the site supervisor can assume whether the amount of concrete delivered at site same as the amount stated at the delivery order.

Photo 3.18: The bucket of concrete

Photo 3.19: The mobile crane carrying the bucket

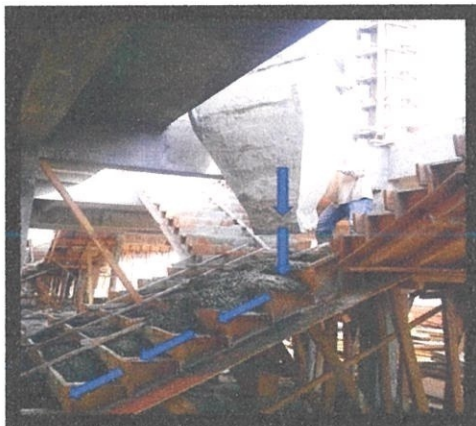
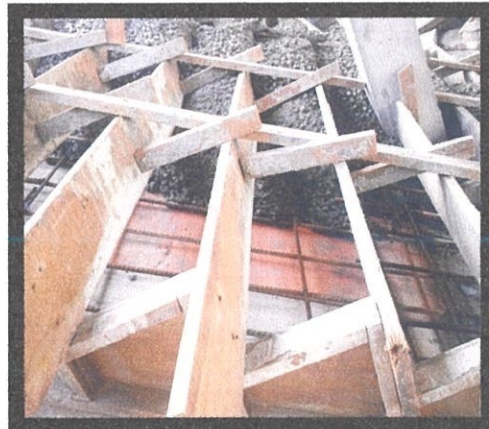
Before the concrete was poured, the inner parts of the formworks was greased to make it easier to dismantle the panels once the cement had dried Then, cement is poured into the form panels. The cement must be highly viscous as runny mix will cause the steps to slump downwards. The concrete was poured from the upper part of the forms (as shown in photo 3.20). Then, the concrete fall down to the lower part the forms (as shown in photo 3.21).

Photo 3.20: The workers poured the concrete to the forms.

Photo 3.21: The concrete flew in the forms

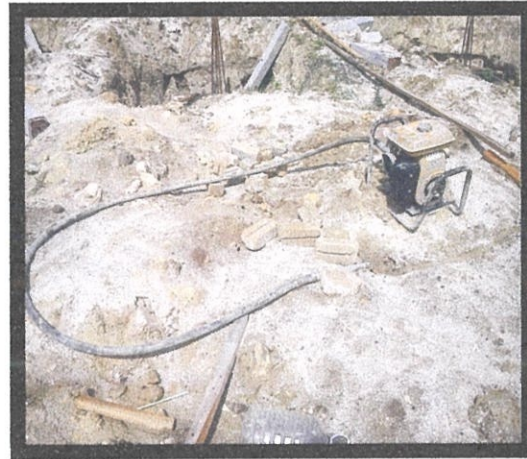
Photo 3.22: The concrete vibrator

At the lower part of the forms, there were several workers that waiting the concrete to fall down at the lowest riser panel. After that, the workers insert a concrete vibrator to the forms (as shown in photo 3.22). The function of the vibrator was to eliminate the void in the concrete that resulted from the air bubbles. This would ensure the structure rigidity and strength.

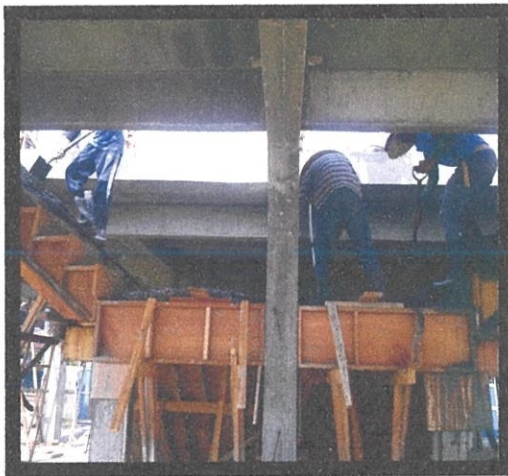
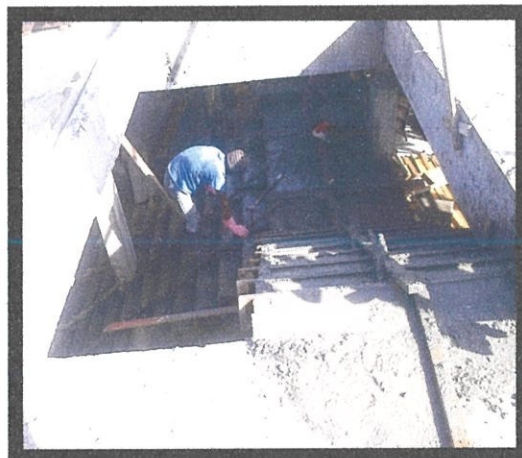
Any excess concrete at the lowest riser transported to the upper riser by using shovel then vibrate by the vibrator. Then, the process was continued until the concrete was fully reached at the uppermost part of the staircase forms panels( as shown in photo 3.33).Finally, the workers flatten the concrete surface by using the steel trowel .(as shown in photo 3.34). As the result, the surface looks finer and less bubble.

Photo 3.23: The workers transport the excess concrete to upper panels

Photo 3.24: The workers flatten the surface with steel trowel.

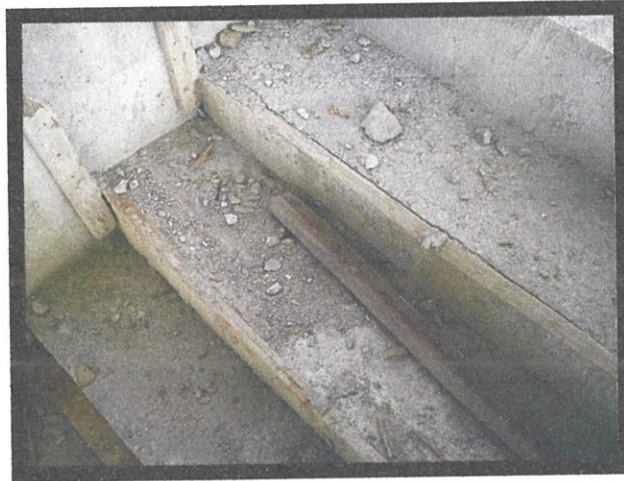
Photo 3.25: The tread and riser that attained final shape.

The staircase concrete was left to dry about a week in the hot weather. One week was the optimum time for the concrete to attain its final shape (as shown in photo 3.25). For your information, this construction works does not need the curing works because the staircase surface would be installed with the floor finishes.

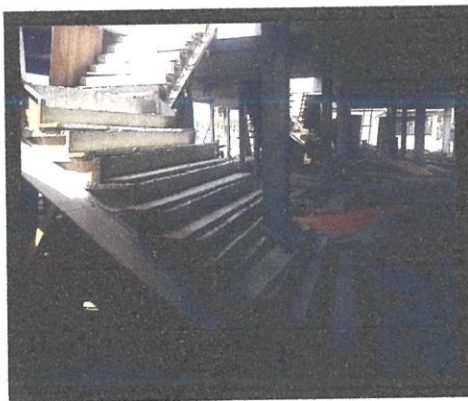
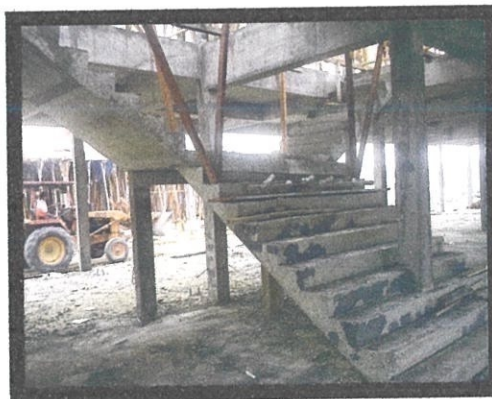
Then, the workers began by removing the staircase riser panels (as shown in photo 3.26). The workers remove it carefully in order not to damage the structure or the formwork panels. If panels were not damaged its can be used again for another place. After the workers finish removing the panels, all these panels would be cleared from the area of the staircase (as shown in photo 3.27).

Photo 3.26: The staircase after dismantle the riser

Photo 3.27: The staircase after remove the riser boards

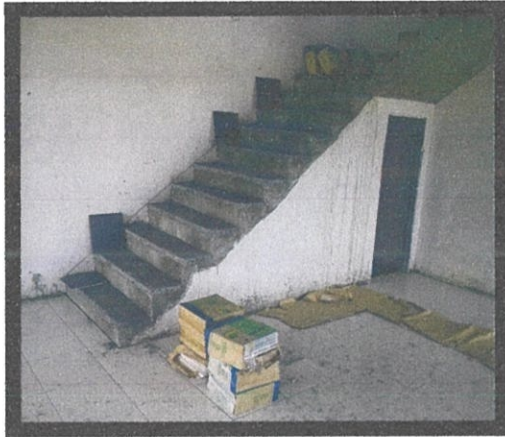
The final process for the construction of in-situ concrete staircase was adding the finished to the structure. The finishes for this works was ceramic tiles. The staircase surface need to be marked before the tiling works (as shown in photo 3.28). The marking acts as a guide to the workers during install the ceramic tiles. Then, the surface was applied with mortar and screed to make it rough. After that, the ceramic tiles can install to the surface of the stairs (as shown in photo 3.29).

Photo 3.28: The staircase surface that was marked

Photo 3.29: The installation of the ceramic tiles

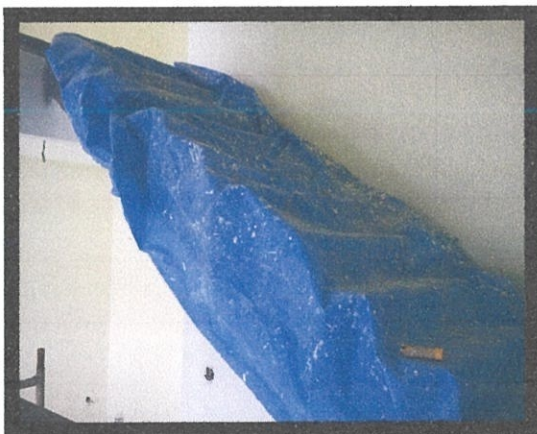
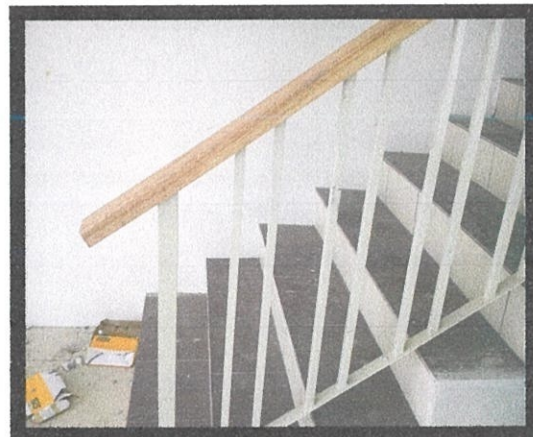
The entire stairs was covered with the plastic sheet (as shown in photo 3.30). The plastic sheet protects the surface from the traffic. The drying process takes about three days. After that, the workers can install the handrail and the balusters to the staircase as safety and artistic features (as shown in photo 3.31). The baluster was made from metal and the handrail from the timber.

Photo 3.30: The stair was covered with plastic sheet

Photo 3.31: The handrail and baluster were installed to the stair

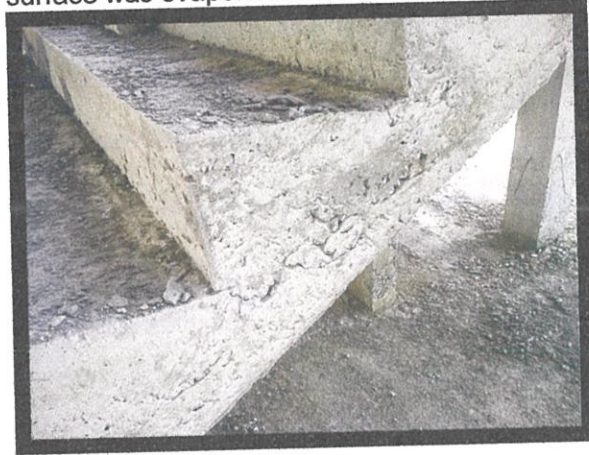
Photo 3.32: The crack on the stair surface

The surfaces become crack and not smooth (as shown in Photo 3.32). This happens because the staircase surface was evaporated fast because of the hot weather.

The solution to the surface crack was to plaster the surface. The workers can plaster the surface with the mortar (as shown in photo 3.33). The result was the surface of stairs become smooth and flat.

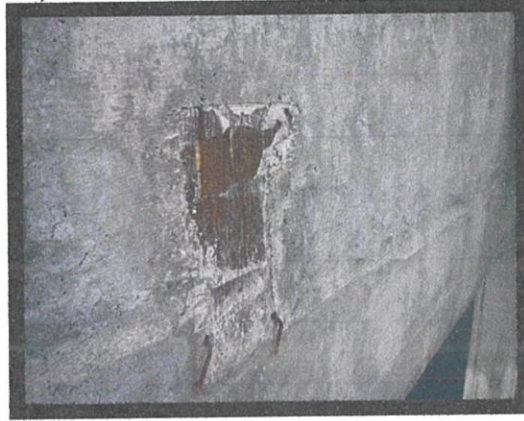
Photo 3.34: The crack was plastered with mortars

There was the remains of formworks that stick the surface of the concrete (as shown in photo 3.34). This happens because of the formworks using to the construction works was not fully grease with the diesel fuel. The wood would likely sticks to the concrete during the dismantle process. So, this problem was not easy to repair as the wood was hard to remove.

There is a solution for this type of problem. Make sure that all the inner parts of the formworks were grease completely. This was important because the diesel oil can avoid the formworks and the concrete surface to stick together. This also would easy up the formworks dismantle process and not leaves any remains to the concrete surface.
